Brookhurst Wood - Sites G and H Geoenvironmental Report

Biffa Waste Services Ltd

June 2010

CAPITA SYMONDS
STRUCTURES

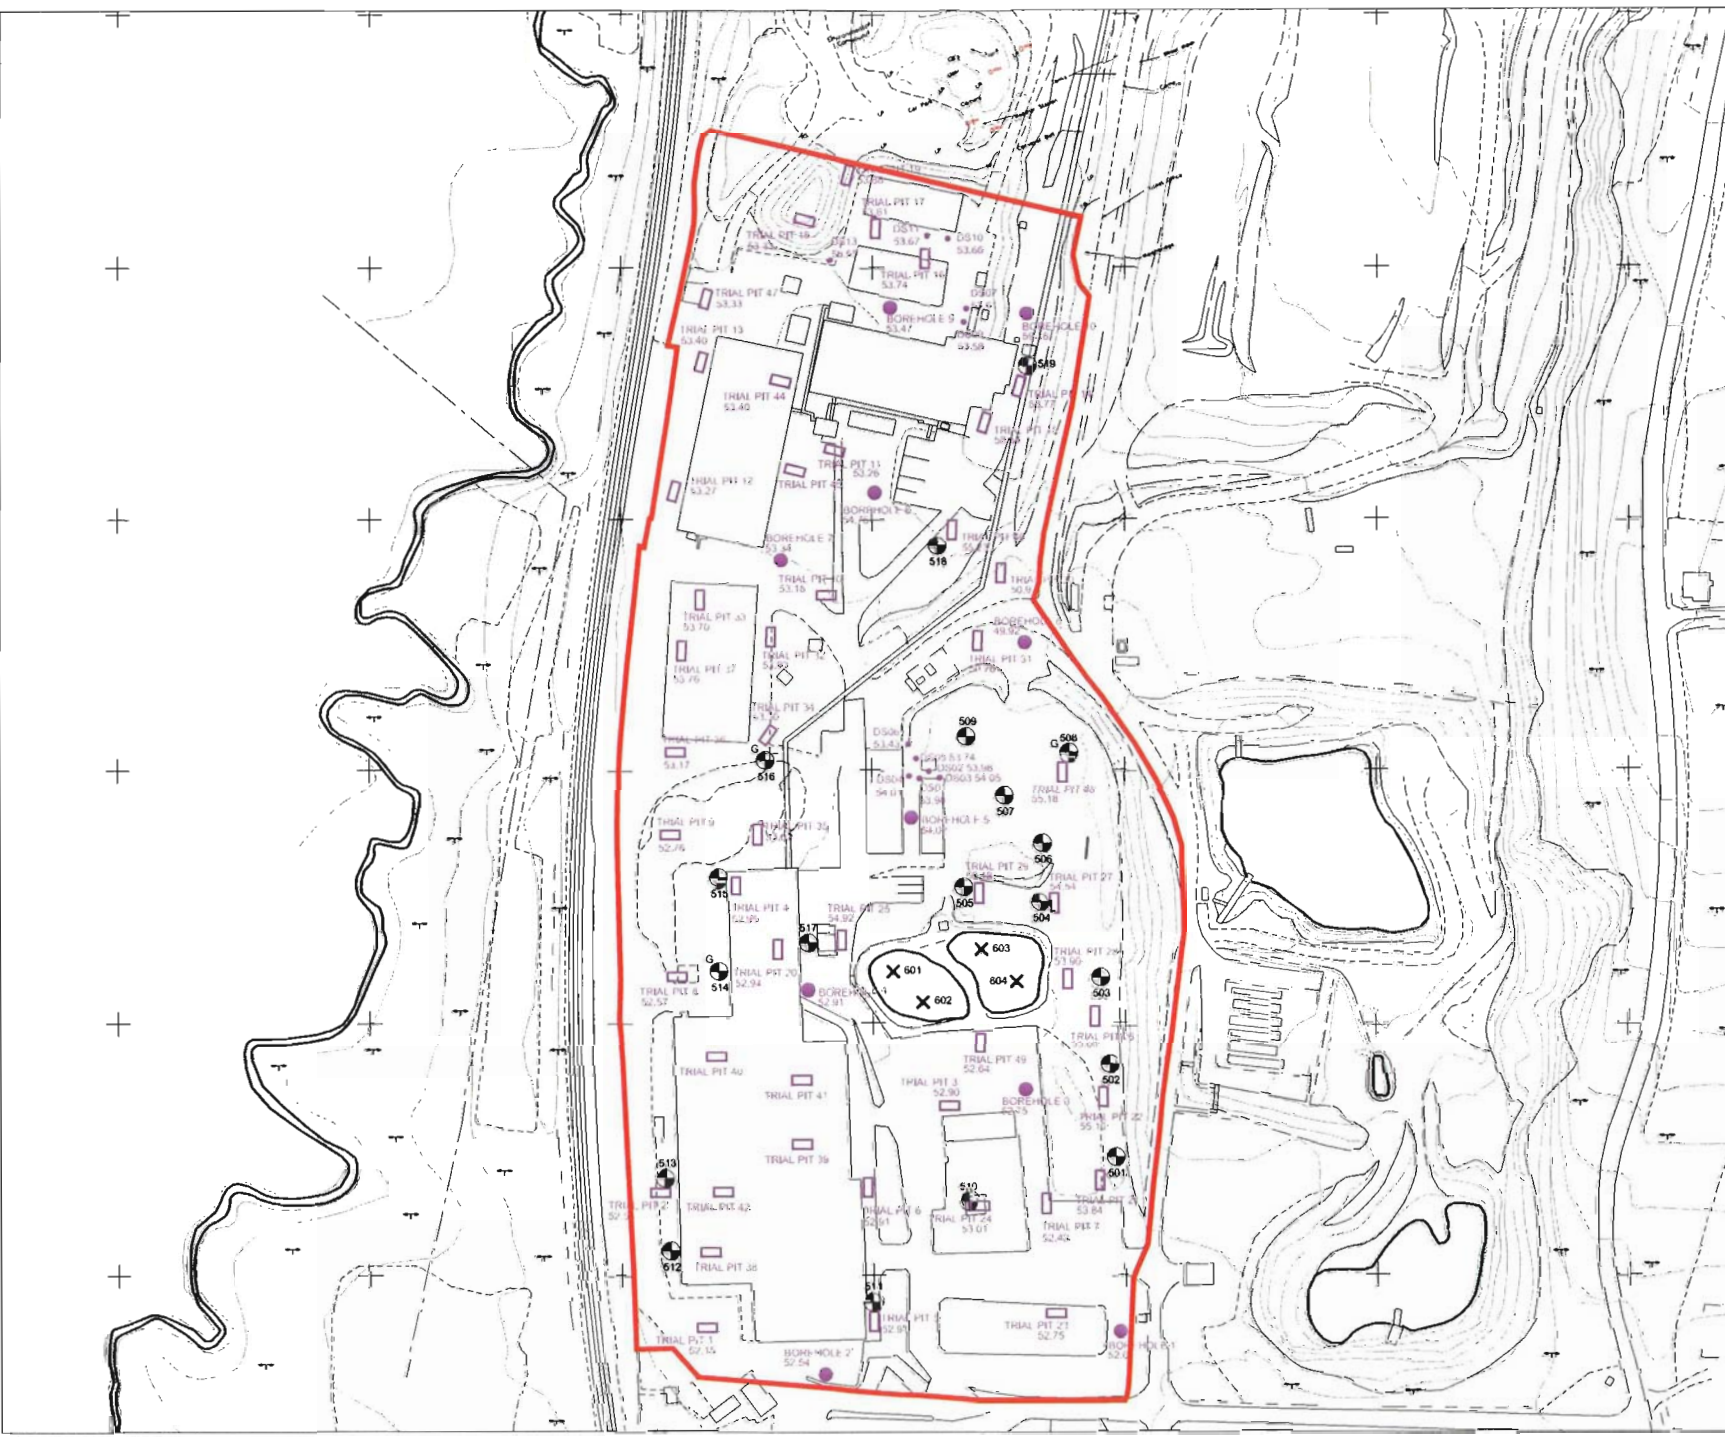
- KEY
- █ SITE No
 - WINDOW SAMPLE HOLE (2010)
 - G GAS INSTALLATION (2010)
 - X GRAB SAMPLE OF POND SLT.1 (2010)
 - EXISTING BOREHOLE (2005)
 - EXISTING TRIAL PIT (2005)
 - EXISTING DYNAMIC SAMPLE HOLE (2005)

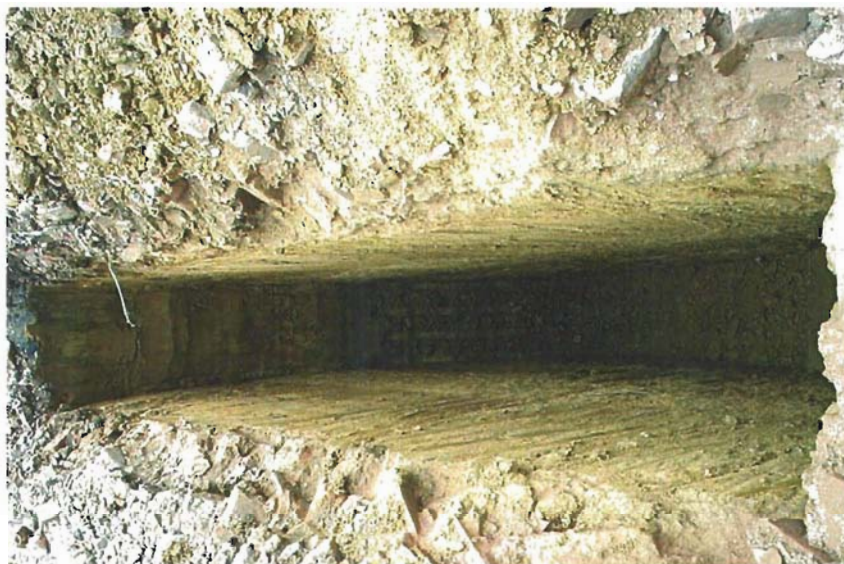
Sample	Type	Unit	Depth (m)	Description
		1	0 – 0.45	MADE GROUND. Aggregate of crushed bricks and flints gravels, in a dry granular sandy matrix, unconsolidated.
		2	0.45 – 3.7	CLAY. Pale brown with some grey / blue patches, highly weathered clay, very firm to brittle laminated and interbedded with cemented horizons in places. Clay becoming harder and more brittle with depth highly fractured and friable particularly along laminae. Waxy texture with some moisture along fracture planes, some folded laminae visible
Notes:	Slight trickle of ground water at 3.3 metres

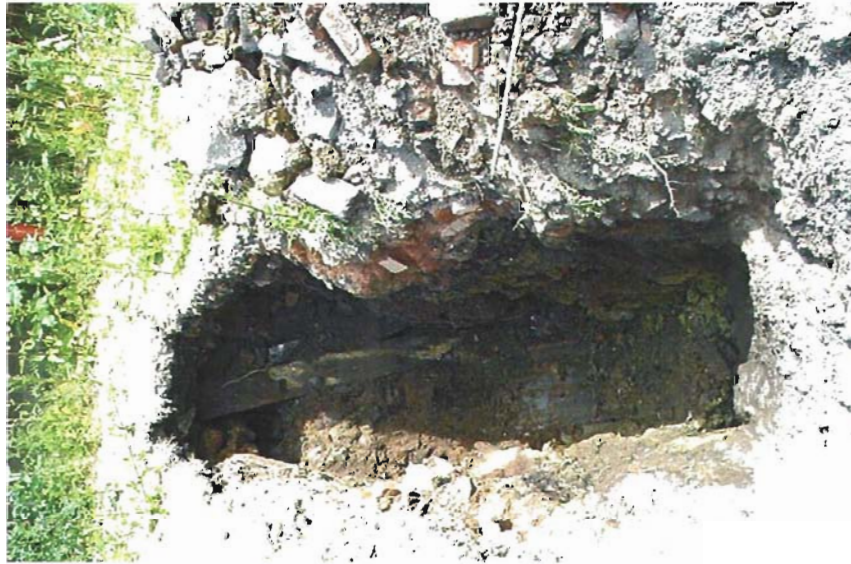
Sample	Type	Unit	Depth (m)	Description
		1	0 – 2.1	<p>MADE GROUND. Unconsolidated aggregate of red bricks crushed bricks, concrete and sand. Some clay patches with plastics and metal rods included. Refusal at 2.1 metres.</p> <p>Eastern side of pit collapsed as a void space, red brick structure clearly visible. Old Kiln flue.</p>
Notes:	Pit stopped at 2.1m due to obstructions. This obstruction later confirmed to be a Kiln Flue.

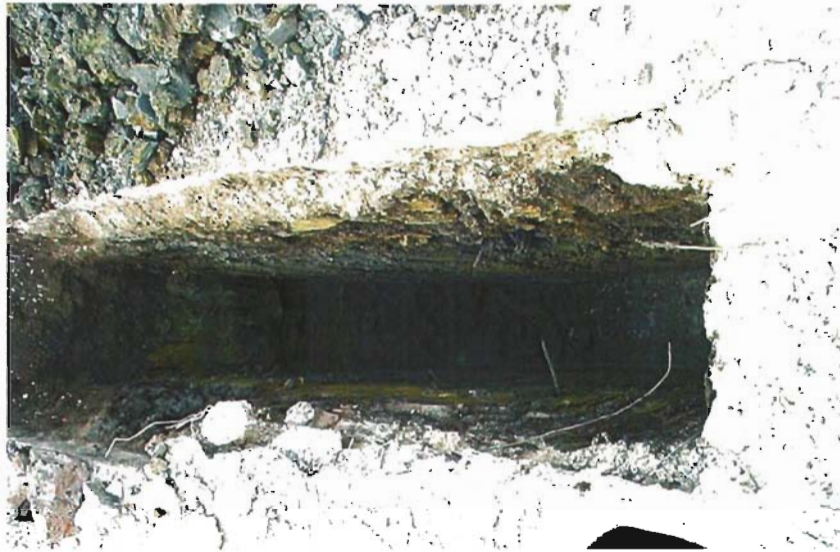
Sample	Type	Unit	Depth (m)	Description
		1	0 – 0.3	CONCRETE
		2	0.3 – 0.5	MADE GROUND. Poorly sorted aggregate of clay and ash, with various pebbles and lumps of carbonaceous material. Some rootlets and a stale odour.
		3	0.9 – 3.3	CLAY. Very firm brown weathered clay with sticky texture. Some grey patches, roots and black patches around roots. Becoming hard brittle and laminated around 2.2m blue / grey clay fractured and friable with some moisture in fractures and some weathering.
Notes:

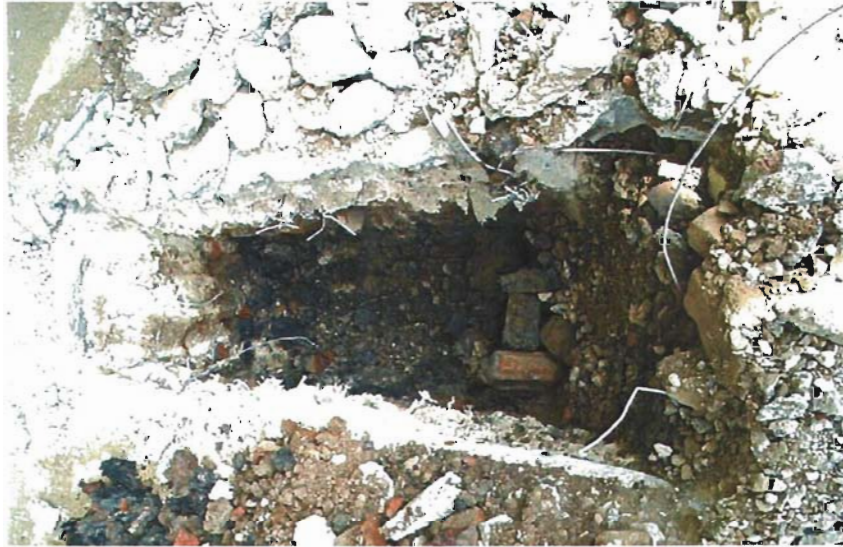
Sample	Type	Unit	Depth (m)	Description
		1	0 – 0.1	CONCRETE
		2	0.1 – 0.3	MADE GROUND. Sand and gravel
		3	0.3 – 1.0	MADE GROUND. Aggregate of stiff clay and brick. Very heavily stained black with strong hydrocarbon smell, some wood and plastic. Concrete slab at base of made ground.
		4	1.0 – 3.4	CLAY. Hard to brittle weathered brown clay, laminated and fractured throughout. Smell of hydrocarbon, old pipe in top of clay possibly old fuel line.
Notes:

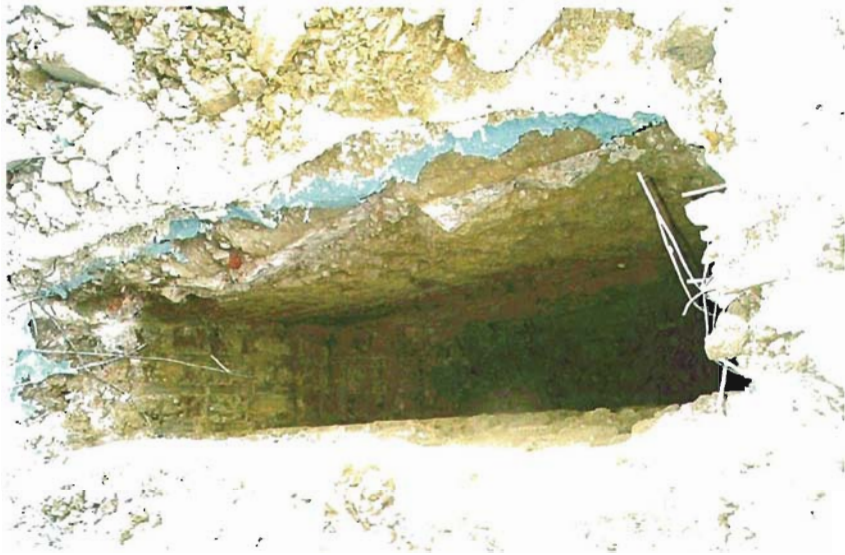
Sample	Type	Unit	Depth (m)	Description
		1	0 – 0.6	CONCRETE. Reinforced ring around kilns 200mm over 200mm gravel with 200mm slab below.
		2	0.6 – 2.3	CLAY. Pale brown weathered clay hard and brittle, laminated and fractured throughout
Notes:

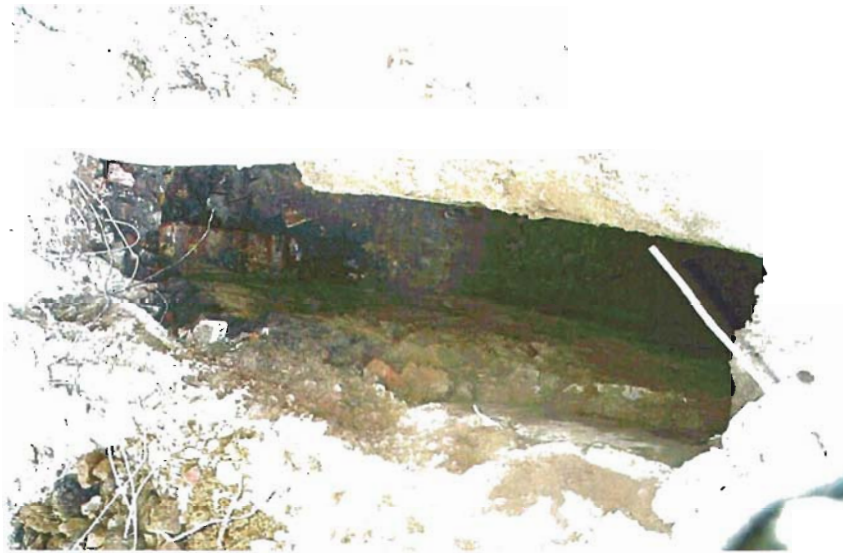
Sample	Type	Unit	Depth (m)	Description
		1	0 – 1.2	MADE GROUND / CONCRETE. Reinforced ring around kilns 200mm over 200mm gravel with 200mm slab below. Further layer of sand and gravel with concrete slab at base
		2	1.2 – 3.4	CLAY. Pale brown weathered clay hard and brittle, laminated and fractured throughout. Clay in close proximity to kilns very hard and baked due to heat from kilns.
Notes:	South side of pit red brick structure confirmed to be a section of an old Kiln flue, these are common around this area.

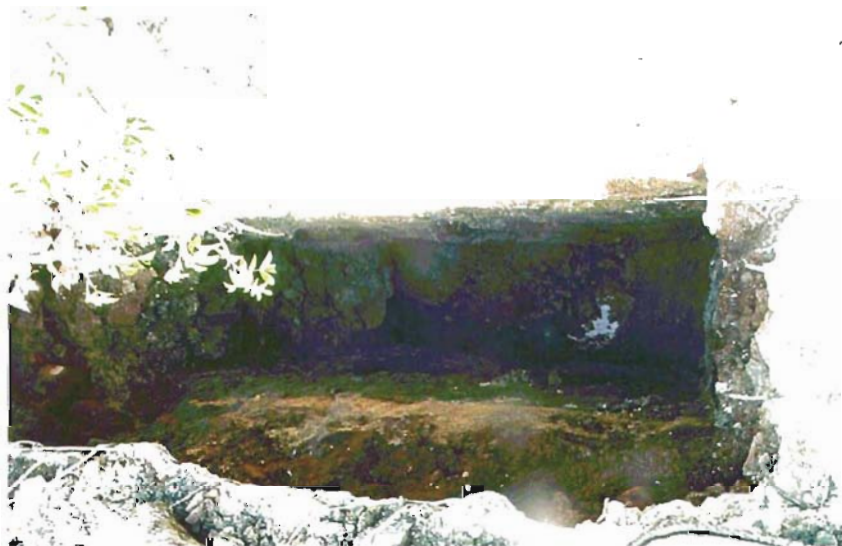
Site:	WEALDEN BRICKWORKS	Client:	GAZELEY
Job No.:	CS007890	Hole No.:	TP8
Level :	52.57mOD	Date:	20/6/2005

Sample	Type	Unit	Depth (m)	Description
		1	0 – 0.1	CONCRETE
		2	0.1 – 0.9	MADE GROUND. Aggregate of crushed bricks, Sand and gravel
		3	0.9 – 3.0	CLAY. Very firm to hard brown weathered clay, with some grey un-weathered patches and cemented mudstone nodules. Clay becoming less weathered with depth but becoming hard and brittle, laminated and fractured, very friable along laminae some moisture in fractures.
Notes:	Trickle of groundwater at 2.0 metres.

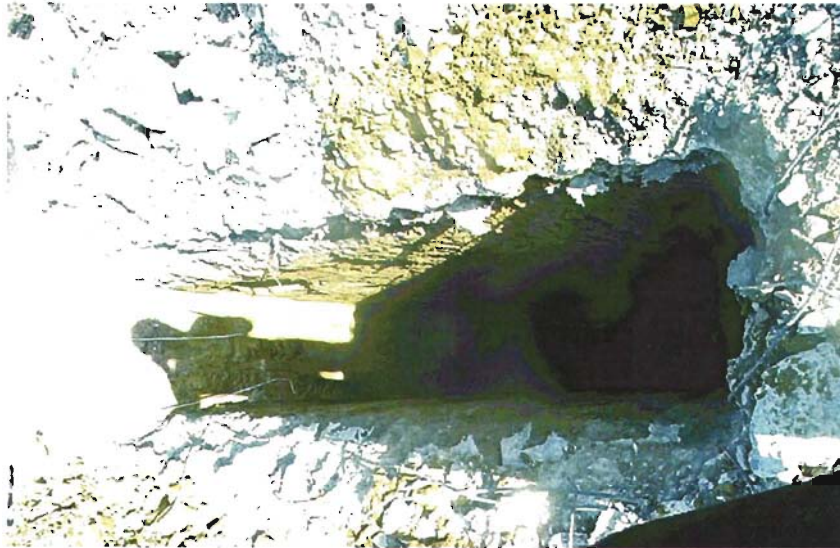
Sample	Type	Unit	Depth (m)	Description
		1	0 – 2.5	MADE GROUND. Unconsolidated ash and dry clay mix (300mm) over red brick structure, identified as kiln flue
		2	2.5 – 3.8	CLAY. Hard cemented clay, laminated and fractured, clay adjacent to the old kiln flue was baked by heat into a red brick like material which is extremely hard.
Notes:

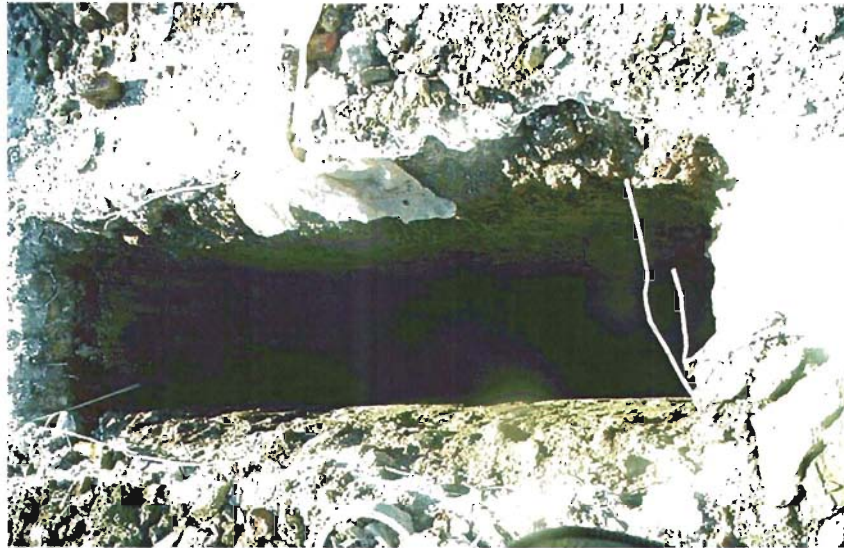
Site:	WEALDEN BRICKWORKS	Client:	GAZELEY
Job No.:	CS007890	Hole No.:	TP11
Level :	53.26mOD	Date:	20/6/2005

Sample	Type	Unit	Depth (m)	Description
		1	0 – 0.2	CONCRETE
		2	0.2 – 0.5	MADE GROUND. Aggregate of crushed bricks and sandy ash like material with some gravel.
		3	0.5 – 2.7	CLAY. Laminated brown weathered clay, fractured and brittle becoming less weathered with depth to a blue / grey laminated and fractured clay with waxy texture.
Notes:

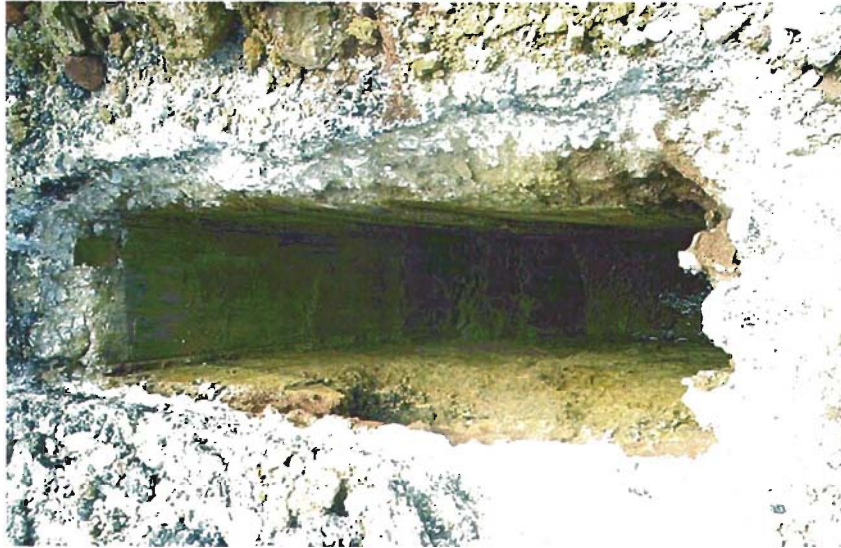
Site:	WEALDEN BRICKWORKS	Client:	GAZELEY
Job No.:	CS007890	Hole No.:	TP12
Level :	53.27mOD	Date:	20/6/2005

Sample	Type	Unit	Depth (m)	Description
		1	0 – 0.2	CONCRETE
		2	0.2 – 0.8	MADE GROUND. Unconsolidated aggregate of crushed bricks, clay, ash. Drainage pipe struck at 0.7, no water.
		3	0.8 – 3.3	CLAY. Pale brown weathered clay, fractured and laminated friable along joints. Becoming very hard and cemented with depth, fractured and brittle.

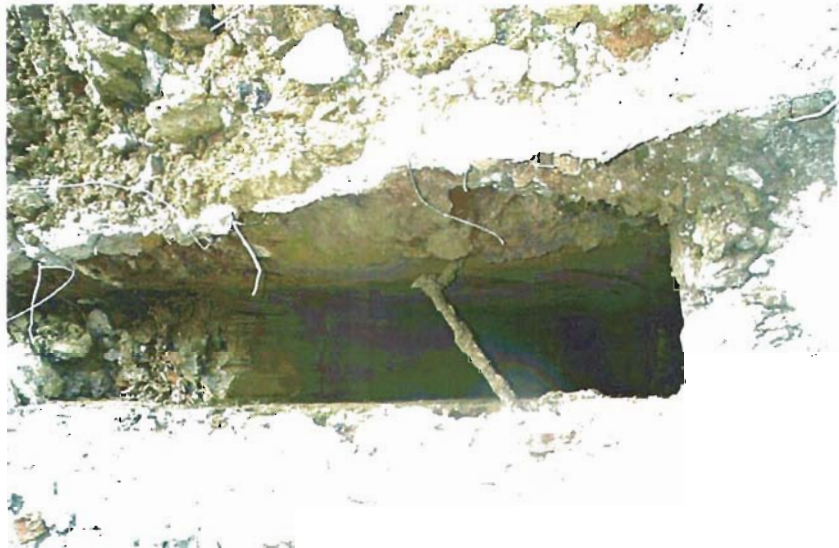
Site:	WEALDEN BRICKWORKS	Client:	GAZELEY
Job No.:	CS007890	Hole No.:	TP13
Level :	mOD	Date:	20/6/2005

Sample	Type	Unit	Depth (m)	Description
		1	0 – 0.2	CONCRETE
		2	0.2 – 0.8	MADE GROUND. Cohesive aggregate of crushed bricks, clay, ash. Sticky and firm texture
		3	0.8 – 3.7	CLAY. Pale brown weathered clay, stiff flexible, Becoming very hard and cemented with depth, laminated, fractured and brittle, friable along laminae and cracks.
Notes:

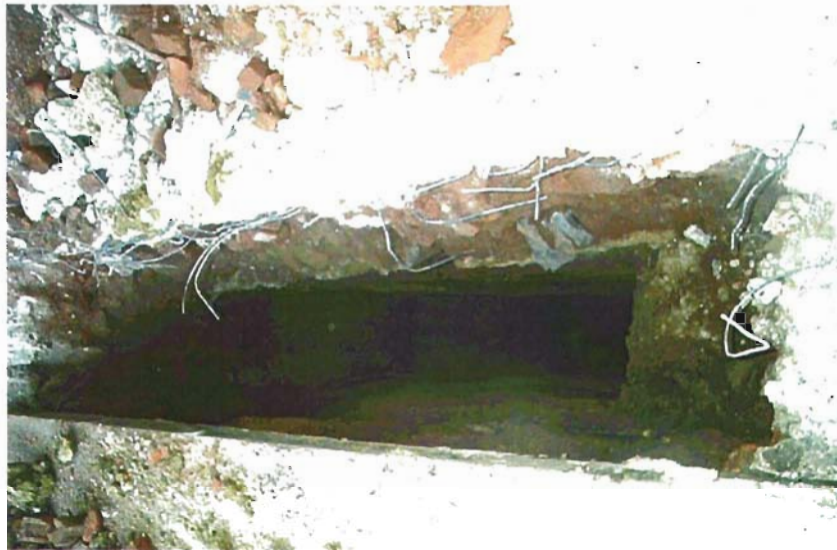
Site:	WEALDEN BRICKWORKS	Client:	GAZELEY
Job No.:	CS007890	Hole No.:	TP14
Level :	58.77mOD	Date:	20/6/2005

Sample	Type	Unit	Depth (m)	Description
		1	0 – 0.2	CONCRETE
		2	0.2 – 1.3	MADE GROUND. Uncohesive aggregate of crushed bricks, clay, ash. Coarse and dry.
		3	1.3 – 3.9	CLAY. Pale brown weathered clay, stiff flexible, with some un-weathered grey spots. Becoming very hard and cemented with depth, laminated, fractured and brittle, friable along laminae and cracks.
Notes:

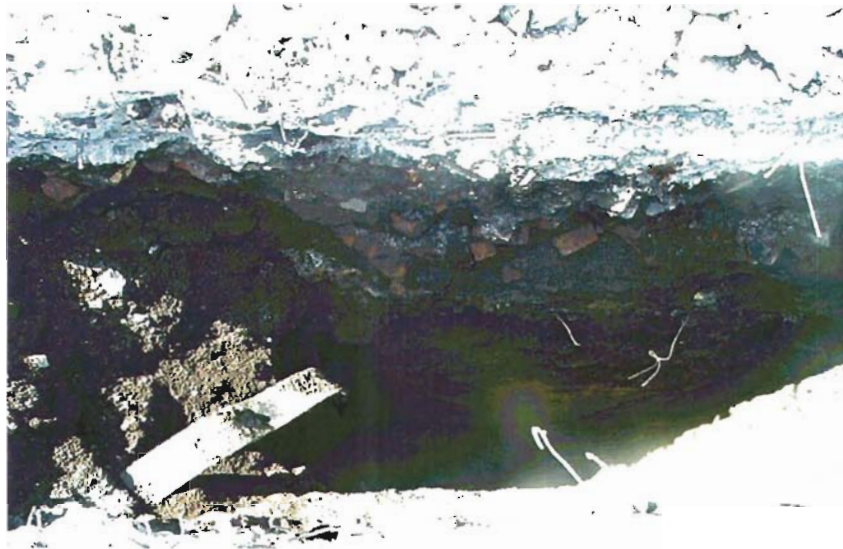
Site:	WEALDEN BRICKWORKS	Client:	GAZELEY
Job No.:	CS007890	Hole No.:	TP15
Level :	58.64mOD	Date:	20/6/2005

Sample	Type	Unit	Depth (m)	Description
		1	0 – 0.2	CONCRETE
		2	0.2 – 4.7	MADE GROUND. Fairly cohesive aggregate of clay, crushed brick, with a lot of whole bricks, ash mixed throughout. Some patches of weald clay through, top metre mostly bricks. Becoming mostly stiff Weald clay, weathered pale brown with some grey / blue un-weathered patches. Roots present with black organic material around roots, some sandier weathered patches. Small brick inclusions proving made ground.
Notes:	No natural ground encountered maximum depth achieved by excavator

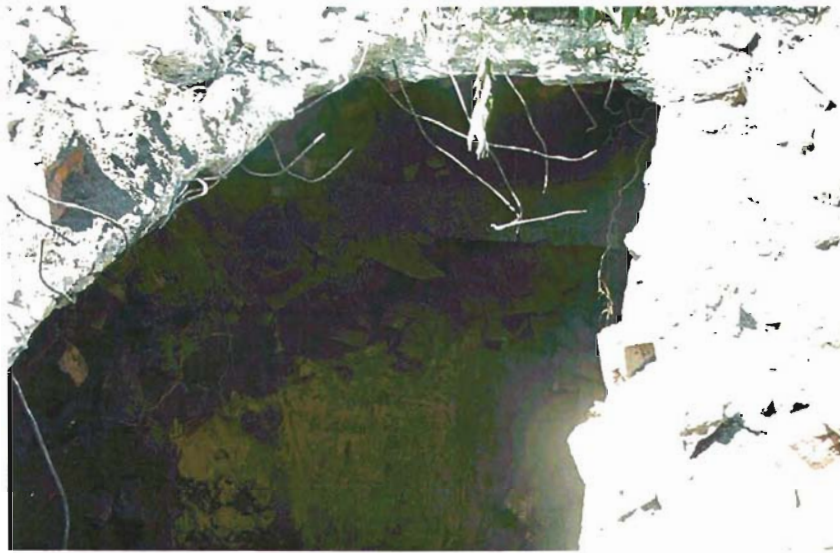
Sample	Type	Unit	Depth (m)	Description
		1	0 – 0.2	CONCRETE
		2	0.2 – 3.3	MADE GROUND. Kiln Flue
Notes:	No natural ground encountered maximum depth achieved by excavator

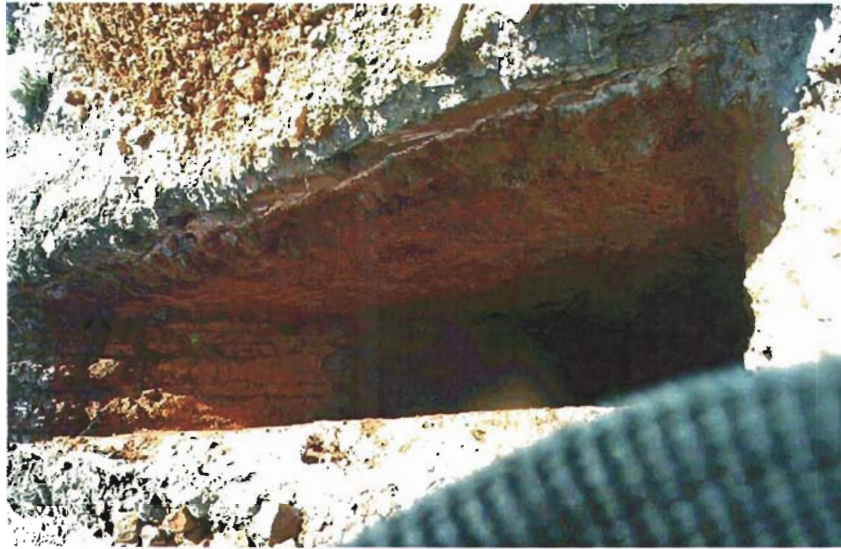
Site:	WEALDEN BRICKWORKS	Client:	GAZELEY
Job No.:	CS007890	Hole No.:	TP17
Level :	53.61mOD	Date:	20/6/2005

Sample	Type	Unit	Depth (m)	Description
		1	0 – 0.5	MADE GROUND. Compacted clay and brick, top 0.2 very hard becoming less compacted near base.
		2	0.5 – 2.1	CLAY. Extremely hard red cemented clay with no structures. Close proximity to old kilns. Clay has clearly been baked into a hard red brick like material.
		3	2.1 – 4.0	CLAY. Brown weathered clay, laminated and fractured , becoming less weathered with depth to a grey / blue laminated and fractured clay, brittle and friable
Notes:	Baked clay material common across site where clay is in close proximity to old kilns and flues, which have been in operation for over 100 years. Heat from these kilns etc. has baked the clay into a brick like material.

- 8.8 The 2005 investigation found that the clay beneath the former brick kilns had been baked, becoming hard and brittle in a zone beneath and around the kilns.

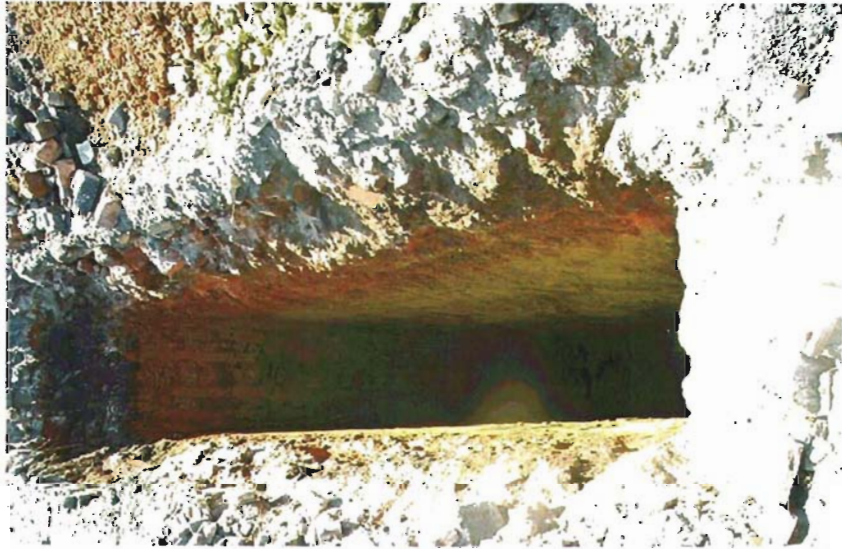
Site:	WEALDEN BRICKWORKS	Client:	GAZELEY
Job No.:	CS007890	Hole No.:	TP18
Level :	53.55mOD	Date:	20/6/2005

Sample	Type	Unit	Depth (m)	Description
		1	0 – 0.6	MADE GROUND. Compacted clay and brick, top 0.2 very hard becoming less compacted near base. Layer of laid paving bricks in situ at top.
		2	0.6 – 1.2	CLAY. Extremely hard red cemented clay with no structures. Close proximity to old kilns. Clay has clearly been baked into a hard red brick like material.
		3	1.2 – 3.95	CLAY. Brown weathered clay, laminated and fractured , becoming less weathered with depth to a grey / blue laminated and fractured clay, brittle and friable
Notes:	Baked clay material common across site where clay is in close proximity to old kilns and flues, which have been in operation for over 100 years. Heat from these kilns etc. has baked the clay into a brick like material.

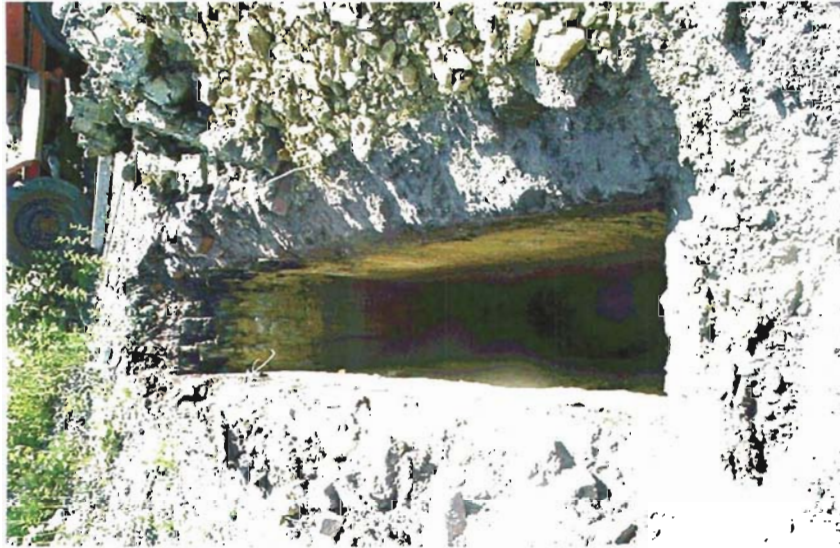
Site:	WEALDEN BRICKWORKS	Client:	GAZELEY
Job No.:	CS007890	Hole No.:	TP19
Level :	53.88mOD	Date:	20/6/2005

Sample	Type	Unit	Depth (m)	Description
		1	0 – 0.7	MADE GROUND. Compacted at surface but becoming unconsolidated with depth. Aggregate of brick and ash, reddish brown in colour, dry with higher percentage of ash near base.
		2	0.7 – 3.7	CLAY. Stiff grey clay with plastic texture with some brown weathered patches, roots present, with some sandier spots. Becoming hard brittle and fractured at 1.7 metres, into the typical laminated, friable clay.
Notes:

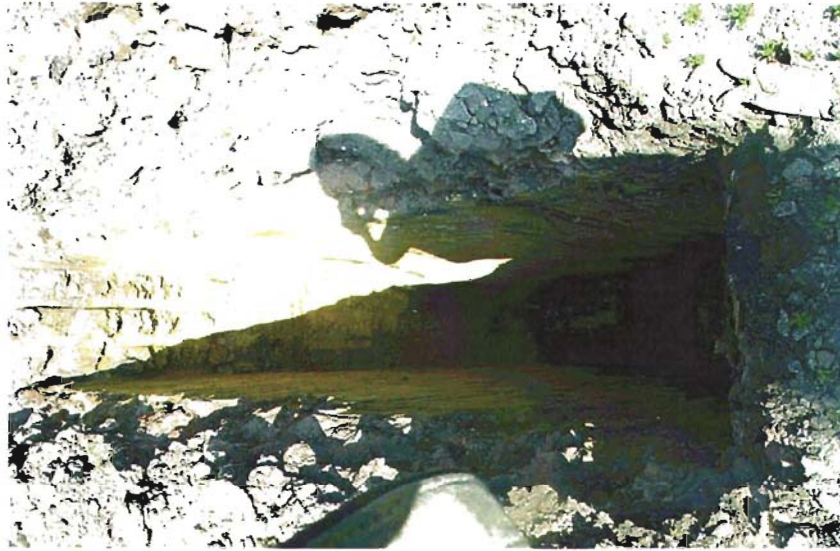
Site:	WEALDEN BRICKWORKS	Client:	GAZELEY
Job No.:	CS007890	Hole No.:	TP20
Level :	52.94mOD	Date:	20/6/2005

Sample	Type	Unit	Depth (m)	Description
		1	0 – 0.5	MADE GROUND. Unconsolidated aggregate of bricks, ash, with glass, ceramics in a coarse granular matrix, with lumps of carbonaceous material.
		2	0.5 – 3.8	CLAY. Stiff brown weathered clay, becoming hard, brittle and laminated with depth. Weathered along laminae and fracture planes, some moisture in cracks, waxy texture. Some folding of layers obvious.
Notes:

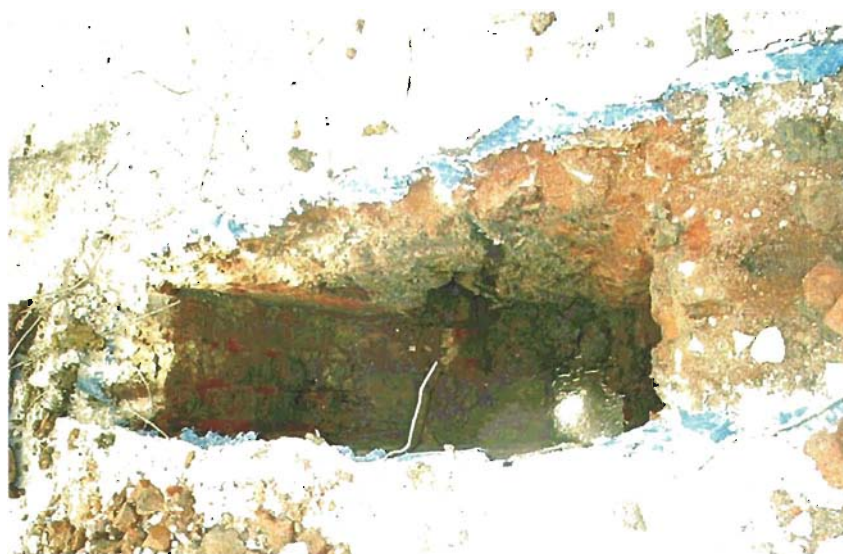
Sample	Type	Unit	Depth (m)	Description
		1	0 – 0.2	CONCRETE
		2	0.2 – 1.9	MADE GROUND. Clay and brick aggregate, cohesive and wet, with sand. South side of pit has red brick structure, just below the surface level, old kiln flue. Refusal at 1.9m unknown obstruction possibly base slab of flue. Made ground variable with wood, gravel, metal and plastic in, with hydrocarbon odour at base of pit.
Notes:

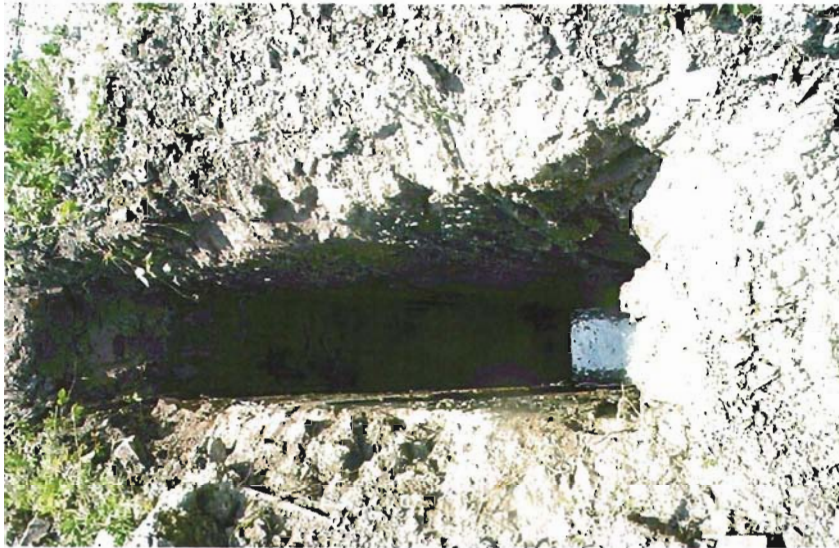
Site:	WEALDEN BRICKWORKS	Client:	GAZELEY
Job No.:	CS007890	Hole No.:	TP22
Level :	55.10mOD	Date:	20/6/2005

Sample	Type	Unit	Depth (m)	Description
		1	0 – 3.8	MADE GROUND. Top 0.6m unconsolidated aggregate of bricks and ash, very dry. Below this various layers of clay and crushed brick, with ash, ceramics, glass and wood. Generally cohesive, with a unidentified chemical odour.
Notes:	Water is base of hole, unknown entry point probably around 3.5 metres.

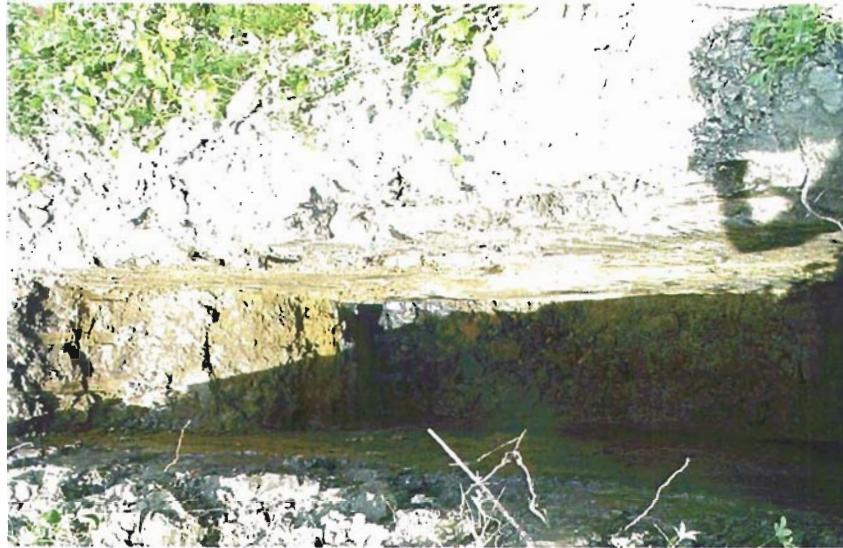
Site:	WEALDEN BRICKWORKS	Client:	GAZELEY
Job No.:	CS007890	Hole No.:	TP23
Level :	52.75mOD	Date:	20/6/2005

Sample	Type	Unit	Depth (m)	Description
		1	0 – 0.9	MADE GROUND. Dry semi-cohesive aggregate of clay, brick with plastics, roots and some ash. Dry and desiccated at surface.
		2	0.9 – 3.0	CLAY. Stiff grey clay with weathered brown patches throughout, with some root material. Becoming hard, brittle with depth. Laminated and fractured, friable along laminae, with weathering along fractures planes, some moisture.
Notes:

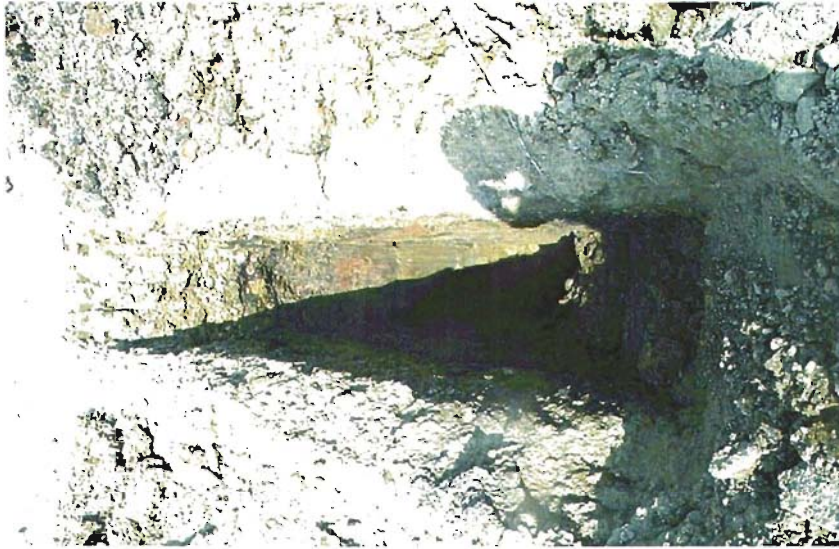
Site:	WEALDEN BRICKWORKS	Client:	GAZELEY
Job No.:	CS007890	Hole No.:	TP26
Level :	55.60mOD	Date:	20/6/2005

Sample	Type	Unit	Depth (m)	Description
		1	0 – 0.9	MADE GROUND. Building sand
		2	0.9 – 1.9	MADE GROUND. Semi cohesive aggregate of clay ash and brick. Very high percentage of ash
		3	1.9 – 3.8	CLAY. Blue / grey becoming brown and heavily weathered, hard brittle clay, fractured and laminated.
Notes:

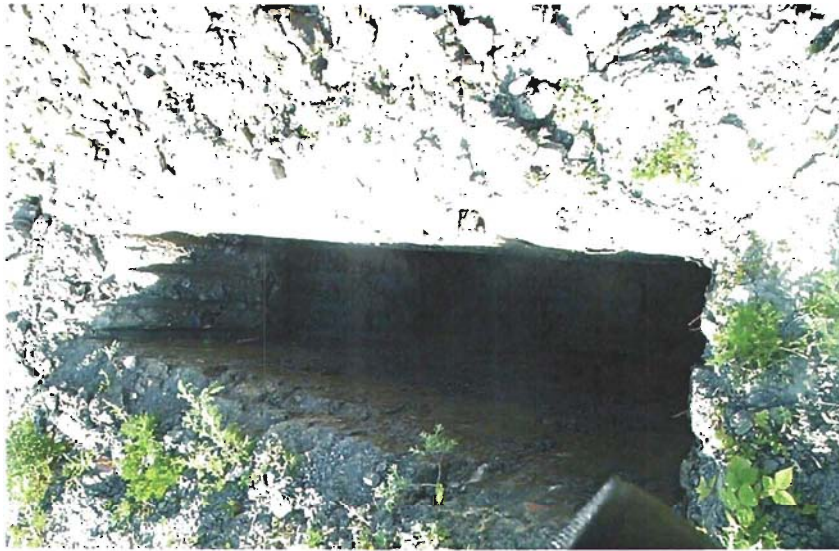
Site:	WEALDEN BRICKWORKS	Client:	GAZELEY
Job No.:	CS007890	Hole No.:	TP27
Level :	54.54mOD	Date:	20/6/2005

Sample	Type	Unit	Depth (m)	Description
		1	0 – 0.3	MADE GROUND. Uncohesive aggregate of clay bricks and ash, dry and crumbly.
		2	0.3 – 2.5	CLAY. Pale brown weathered clay, stiff flexible, with some un-weathered grey spots. Becoming very hard and cemented with depth, laminated, fractured and brittle, friable along laminae and cracks.
Notes:

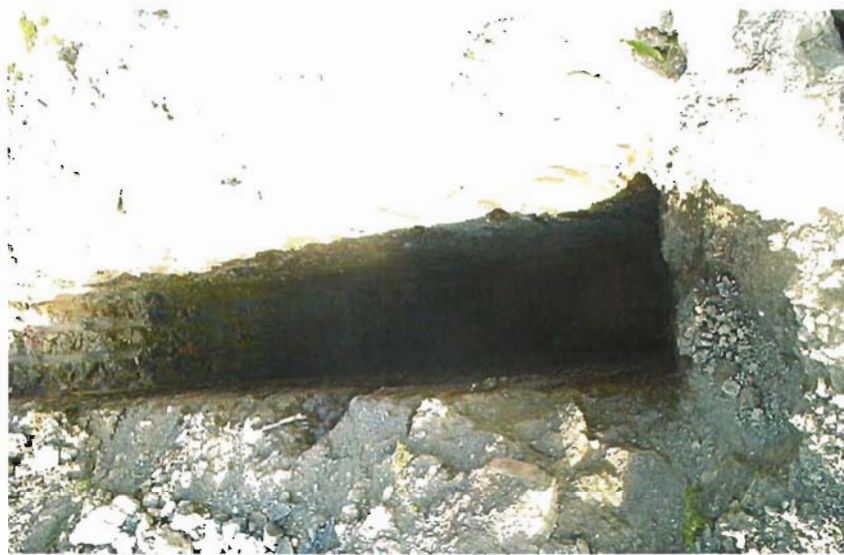
Site:	WEALDEN BRICKWORKS	Client:	GAZELEY
Job No.:	CS007890	Hole No.:	TP28
Level :	53.90mOD	Date:	20/6/2005

Sample	Type	Unit	Depth (m)	Description
		1	0 – 1.6	MADE GROUND. Semi cohesive aggregate of clay bricks and ash.
		2	1.6 – 4.3	CLAY. Blue / grey laminated and fractured clay. Hard and brittle friable along laminae and fracture planes, waxy texture with moisture and weathering in fracture planes.
Notes:

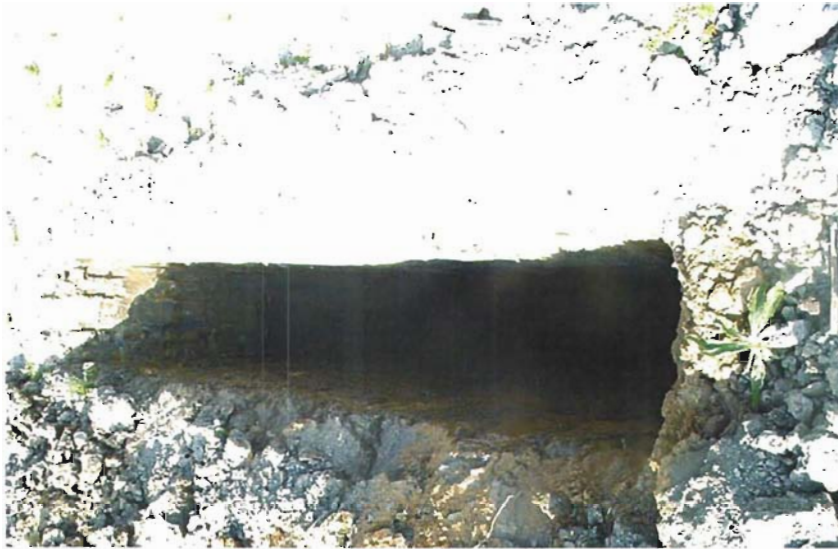
Site:	WEALDEN BRICKWORKS	Client:	GAZELEY
Job No.:	CS007890	Hole No.:	TP29
Level :	55.18mOD	Date:	20/6/2005

Sample	Type	Unit	Depth (m)	Description
		1	0 – 2.0	MADE GROUND. Semi cohesive aggregate of clay bricks and ash.
		2	2.0 – 4.5	CLAY. Blue / grey laminated and fractured clay. Hard and brittle friable along laminae and fracture planes, waxy texture with moisture and weathering in fracture planes.
Notes:

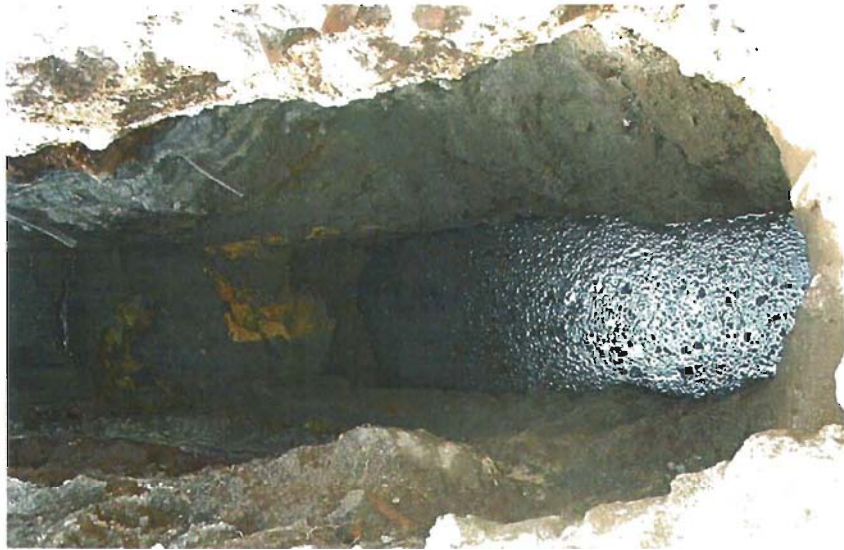
Sample	Type	Unit	Depth (m)	Description
		1	0 – 4.0	MADE GROUND. Top 2 metres semi cohesive aggregate of clay brick and ash, wet texture flexible. Changing into primarily clay based aggregate, very stiff and cohesive with brick and ash, some roots and hydrocarbon odour. Water in the bottom of the pit most likely from adjacent lagoon or silt pond. Oily substance visible floating on top of water.
Notes:

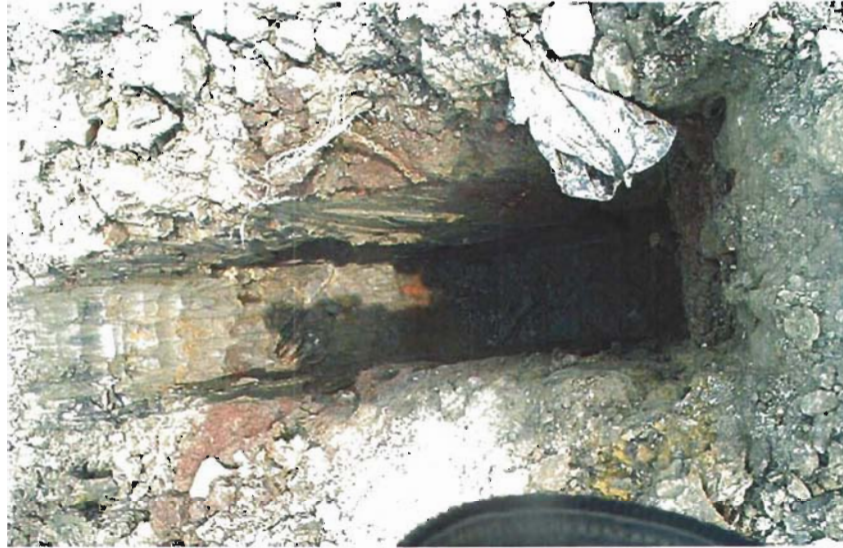
Site:	WEALDEN BRICKWORKS	Client:	GAZELEY
Job No.:	CS007890	Hole No.:	TP31
Level :	50.78mOD	Date:	20/6/2005

Sample	Type	Unit	Depth (m)	Description
		1	0 – 2.8	MADE GROUND. Semi cohesive aggregate of clay, brick with a lot of wood and some metal. Becoming less cohesive more granular and dryer with depth
		2	2.8 – 2.9	CLAY. Very hard blue / grey clay, laminated, fractured and brittle along laminae and fractures planes, waxy texture, with some moisture and weathering in fractures.

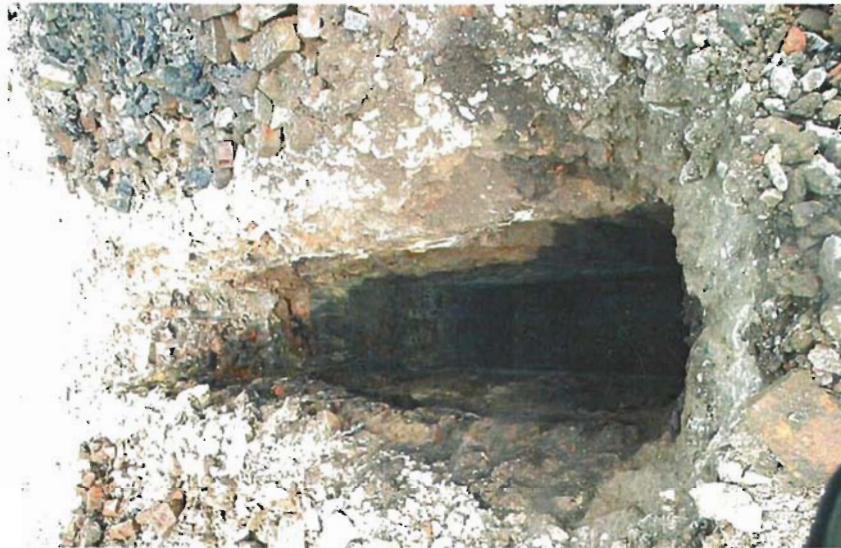
Site:	WEALDEN BRICKWORKS	Client:	GAZELEY
Job No.:	CS007890	Hole No.:	TP32
Level :	53.83mOD	Date:	20/6/2005

Sample	Type	Unit	Depth (m)	Description
		1	0 – 1.7	MADE GROUND. Unconsolidated aggregate of bricks and gravels in a coarse granular matrix.
		2	1.7 – 3.2	CLAY. Blue / grey, hard laminated clay, fractured and brittle, some moisture in fractures, and small trickle of water into base of pit.
Notes:

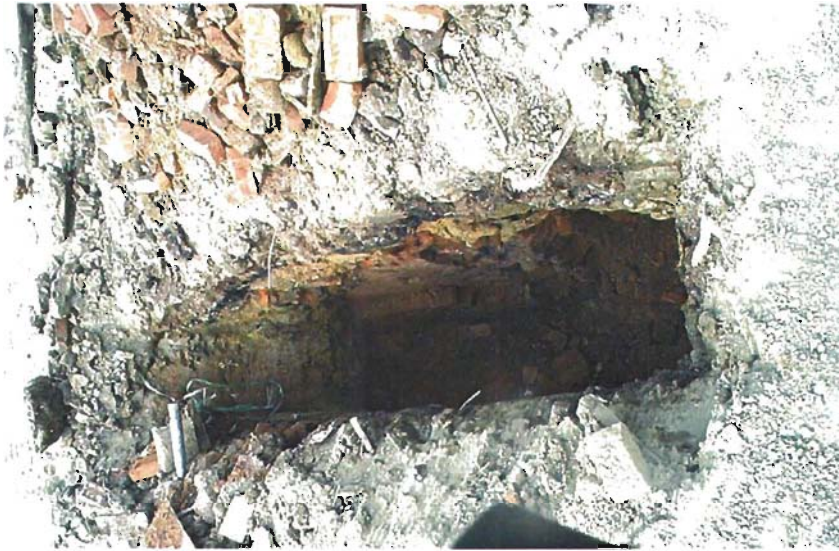
Sample	Type	Unit	Depth (m)	Description
		1	0 – 0.6	MADE GROUND. Unconsolidated aggregate of bricks and gravels in a coarse granular matrix.
		2	0.6 – 3.2	MADE GROUND. Kiln flue, possibly backfilled with brick, difficult to tell as it collapsed on itself
Notes:

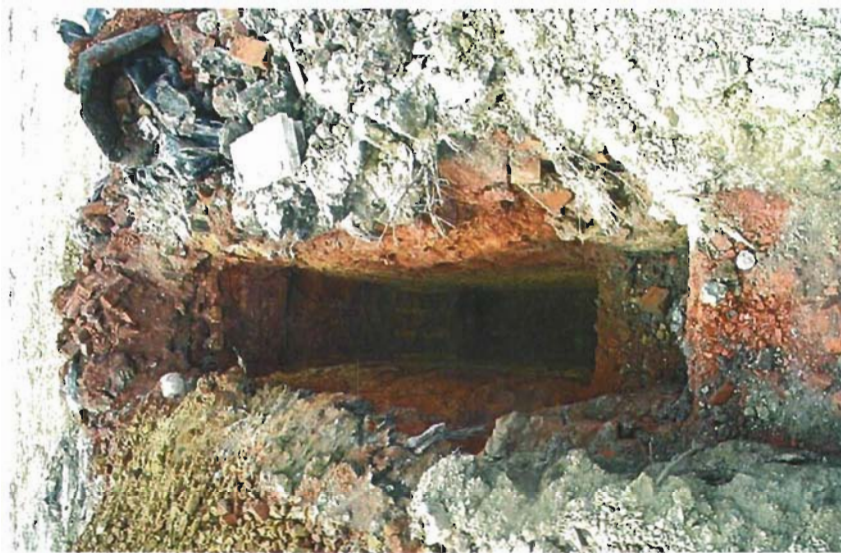
Site:	WEALDEN BRICKWORKS	Client:	GAZELEY
Job No.:	CS007890	Hole No.:	TP34
Level :	53.30mOD	Date:	20/6/2005

Sample	Type	Unit	Depth (m)	Description
		1	0 – 1.6	MADE GROUND. Unconsolidated aggregate of bricks and gravels in a coarse granular matrix. Top corner of kiln flue encountered, visible as red brick structure.
		2	1.6 – 3.2	CLAY. Brown weathered clay, hard and brittle, laminated throughout, fractured and friable along laminae and fracture planes
Notes:

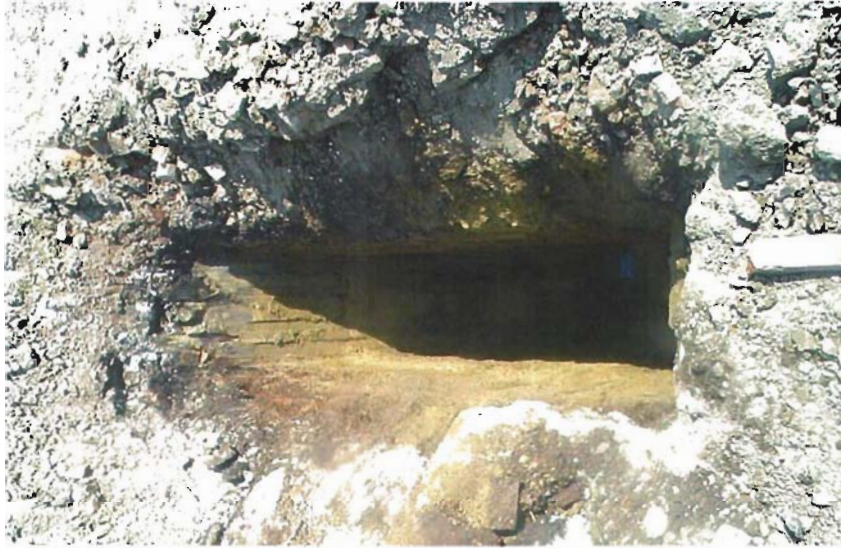
Site:	WEALDEN BRICKWORKS	Client:	GAZELEY
Job No.:	CS007890	Hole No.:	TP35
Level :	53.03mOD	Date:	20/6/2005

Sample	Type	Unit	Depth (m)	Description
		1	0 – 0.9	MADE GROUND. Unconsolidated aggregate of bricks and gravels in a coarse granular matrix, with a lot of ash at the base and a hydrocarbon odour.
		2	0.9 – 3.2	CLAY. Brown weathered clay, hard and brittle, laminated throughout, fractured and friable along laminae and fracture planes
Notes:

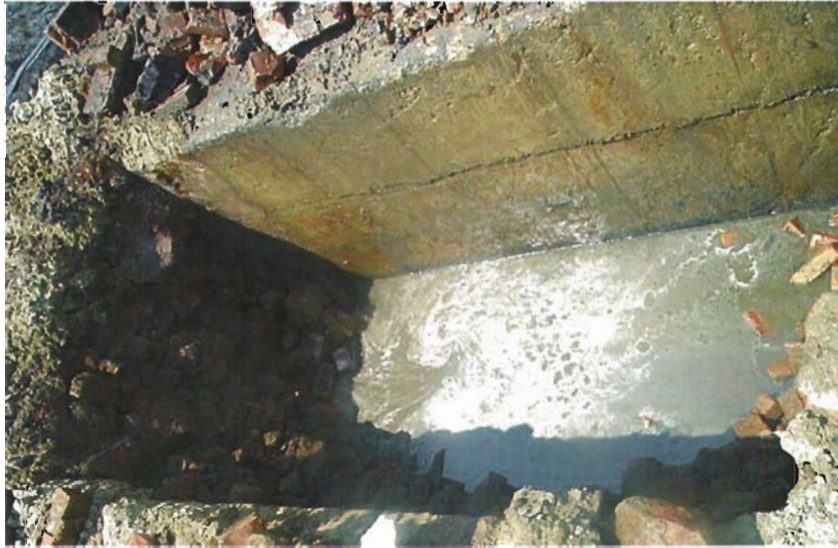
Site:	WEALDEN BRICKWORKS	Client:	GAZELEY
Job No.:	CS007890	Hole No.:	TP36
Level :	53.17mOD	Date:	20/6/2005

Sample	Type	Unit	Depth (m)	Description
		1	0 – 2.0	MADE GROUND. Mostly whole bricks, bits of wall structures, plastics and metal rods. Concrete walls on either side of pit, part of a made structure, possibly old sand pit now backfilled. A lot of water in fill material and pit.
Notes:	Pit terminated as not likely to encounter any natural surfaces.

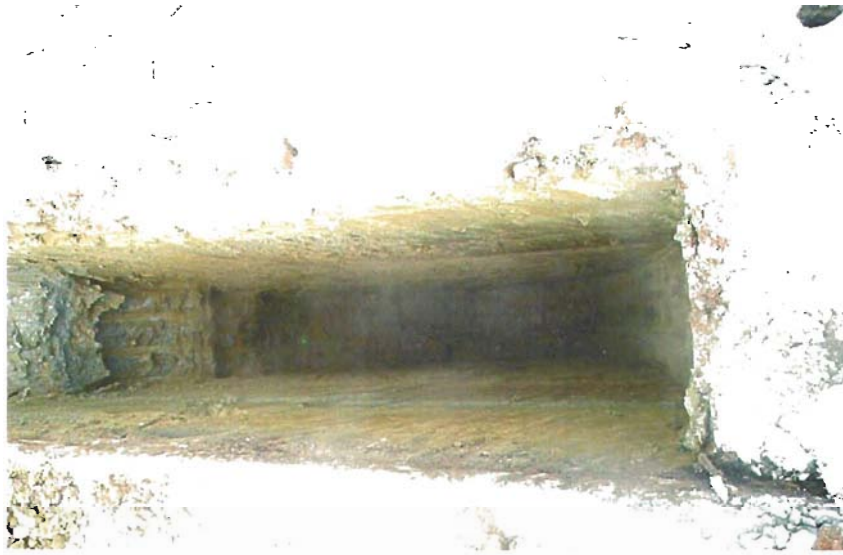
Site:	WEALDEN BRICKWORKS	Client:	GAZELEY
Job No.:	CS007890	Hole No.:	TP37
Level :	53.76mOD	Date:	20/6/2005

Sample	Type	Unit	Depth (m)	Description
		1	0 – 0.3	CONCRETE.
		2	0.3 – 4.3	CLAY. Stiff flexible grey / blue clay, slightly weathered brown in parts, becoming hard brittle and laminated at 2.5 metres. Heavily weathered and fractured at depth, with waxy texture and some moisture in fractures.
Notes:

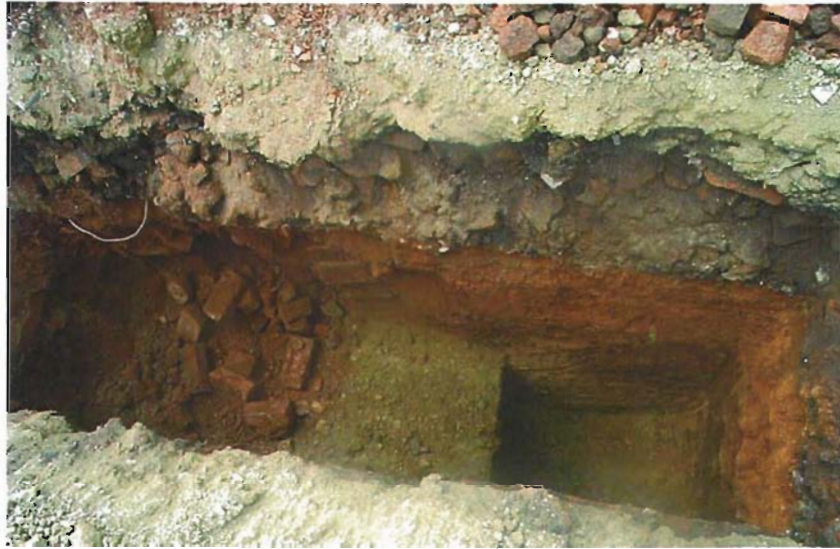
Sample	Type	Unit	Depth (m)	Description
		1	0 – 2.5	MADE GROUND. Unconsolidated aggregate of bricks and gravels in a coarse granular matrix. Top of kiln flue encountered, visible as red brick structure on south side of pit, down to 2.5 m
		2	0.5 – 2.5	CLAY. Very hard cemented red clay, baked by heat from flue, grading into hard weathered, laminated clay, fractured and brittle.
Notes:
