Brookhurst Wood - Sites G and H Geoenvironmental Report

Biffa Waste Services Ltd

June 2010

CAPITA SYMONDS
STRUCTURES

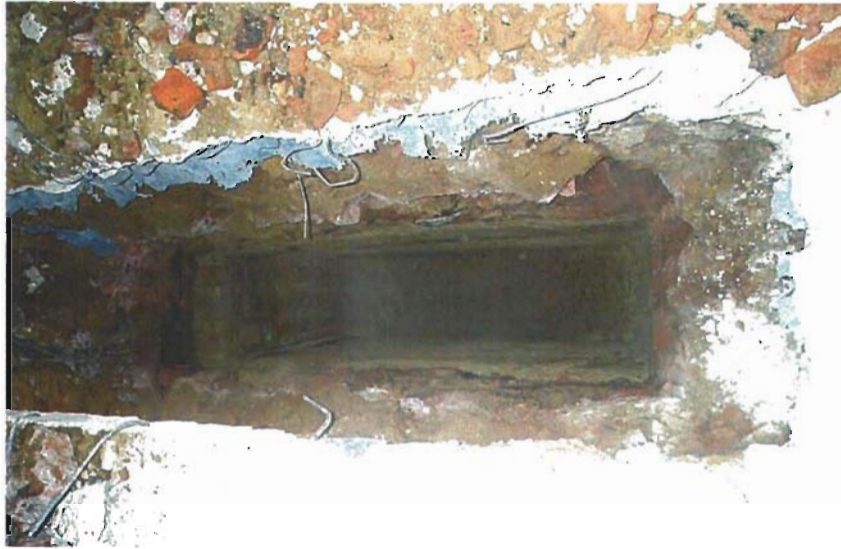
Site:	WEALDEN BRICKWORKS	Client:	GAZELEY
Job No.:	CS007890	Hole No.:	TP38
Level :	mOD	Date:	27/6/2005

Sample	Type	Unit	Depth (m)	Description
		1	0 – 1.3	CONCRETE 200mm, over MADE GROUND. Unconsolidated aggregate of crushed brick and gravel, in coarse granular sand and ash matrix., over CONCRETE 200mm, over MADE GROUND, ash and brick, over CONCRETE 200mm, over made ground.
		2	1.3 – 3.2	CLAY. Brown weathered and fractured clay, laminated, hard and brittle. Waxy texture, friable along laminae, some moisture in fractures at depth.
Notes:

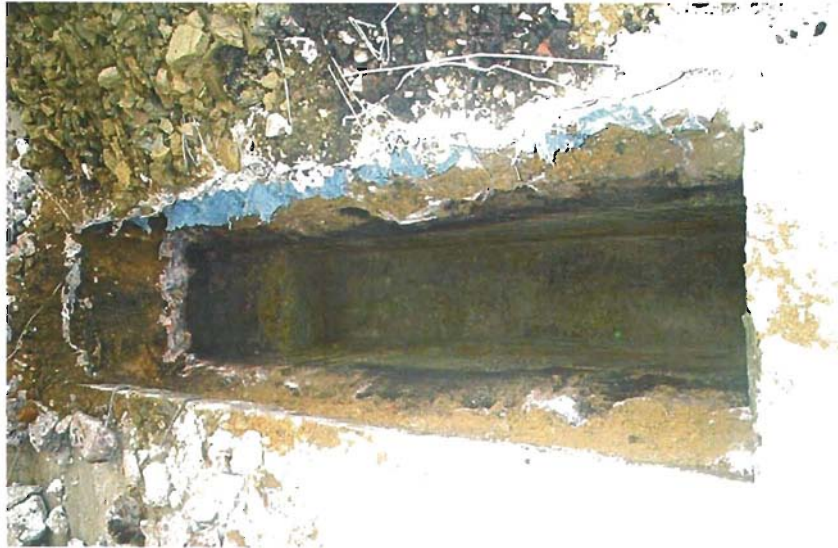
Site:	WEALDEN BRICKWORKS	Client:	GAZELEY
Job No.:	CS007890	Hole No.:	TP39
Level :		Date:	27/6/2005

Sample	Type	Unit	Depth (m)	Description
		1	0 – 0.2	CONCRETE
		2	0.2 – 0.5	MADE GROUND. Crushed brick and ash aggregate with some gravel, coarse and granular.
		3	0.5 – 0.7	CONCRETE
		4	0.7 – 1.2	MADE GROUND. Aggregate of predominantly ash with crushed brick.
		5	1.2 – 2.6	CLAY. Hard brown and weathered, laminated and fractured, becoming harder and more cemented with depth
Notes:

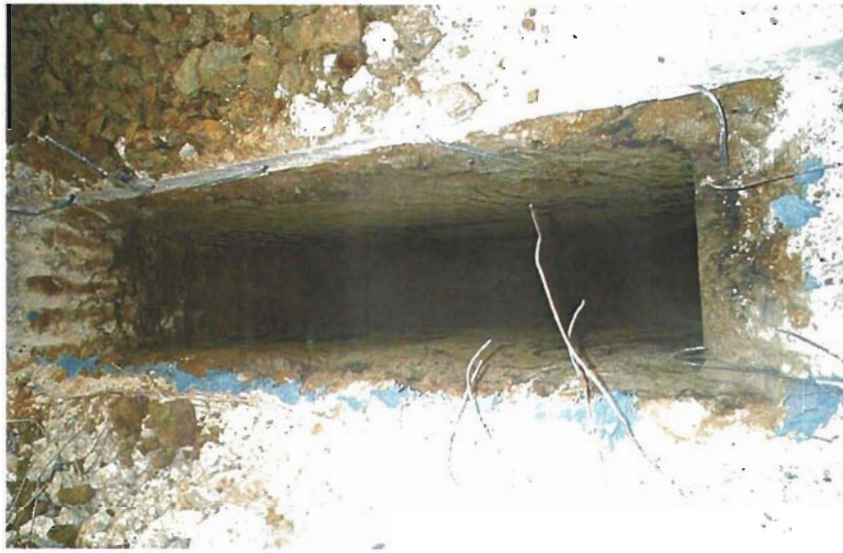
Site:	WEALDEN BRICKWORKS	Client:	GAZELEY
Job No.:	CS007890	Hole No.:	TP40
Level :		Date:	27/6/2005

Sample	Type	Unit	Depth (m)	Description
		1	0 – 0.2	CONCRETE
		2	0.2 – 0.6	MADE GROUND. Sand and gravel over unconsolidated aggregate of crushed brick and ash, some dry clay.
		3	0.6 – 3.5	CLAY. Brown weathered, hard and brittle laminated clay weathered and fractured along laminae. Becoming very friable with depth, with some moisture in fracture planes.
Notes:

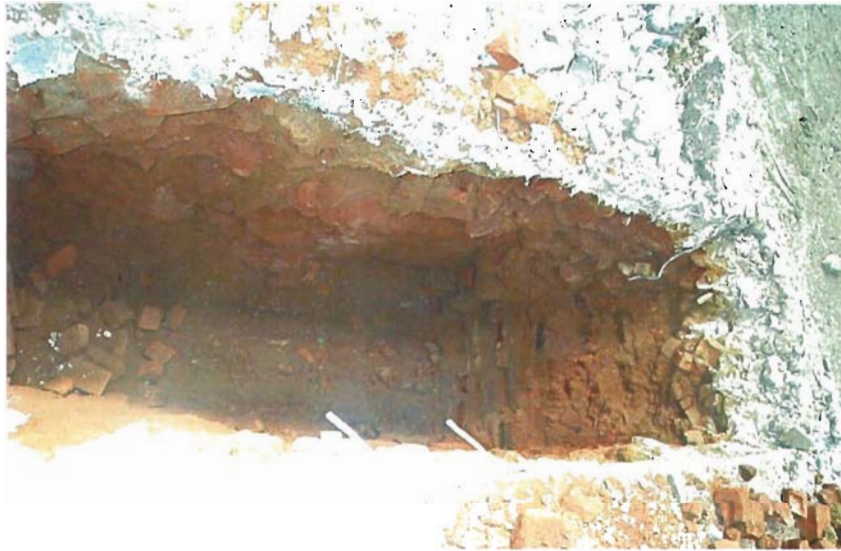
Sample	Type	Unit	Depth (m)	Description
		1	0 – 0.15	CONCRETE
		2	0.15 – 1.8	MADE GROUND. Large amount of whole red bricks to 1 metre, changing into laid red brick structure down to base, possibly old backfilled flue or brick clamp.
Notes:	Refusal at 1.8 metres

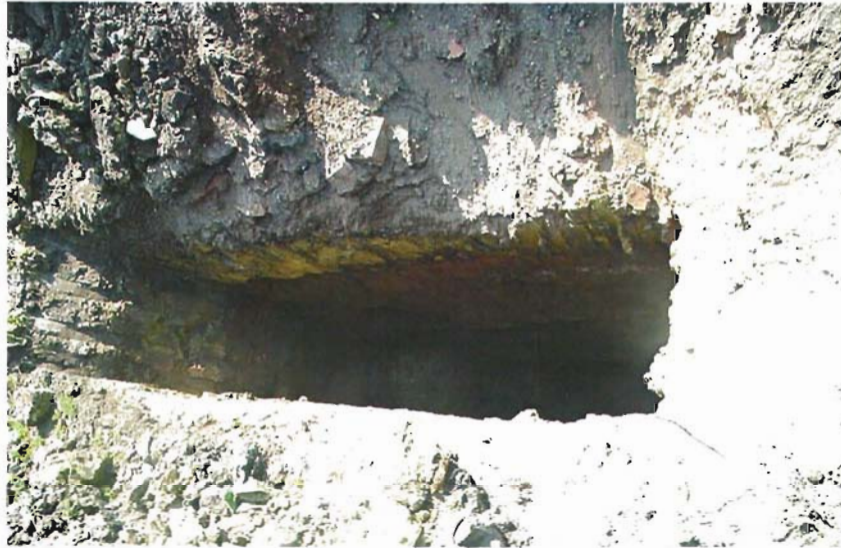
Site:	WEALDEN BRICKWORKS	Client:	GAZELEY
Job No.:	CS007890	Hole No.:	TP43
Level :		Date:	27/6/2005

Sample	Type	Unit	Depth (m)	Description
		1	0 – 4.2	MADE GROUND. Top 0.4 metres dry unconsolidated clay and gravels, with brick and ash material. Changing into cohesive clay and brick mix with ash layers down to 4.0 metres. Some domestic waste visible in fill including mixed ceramics, bottles, textiles, plastics. Possibly just touching natural clay at 4.0 metres, when a blue clay is encountered with some roots, only small amount retrievable from pit.
Notes:

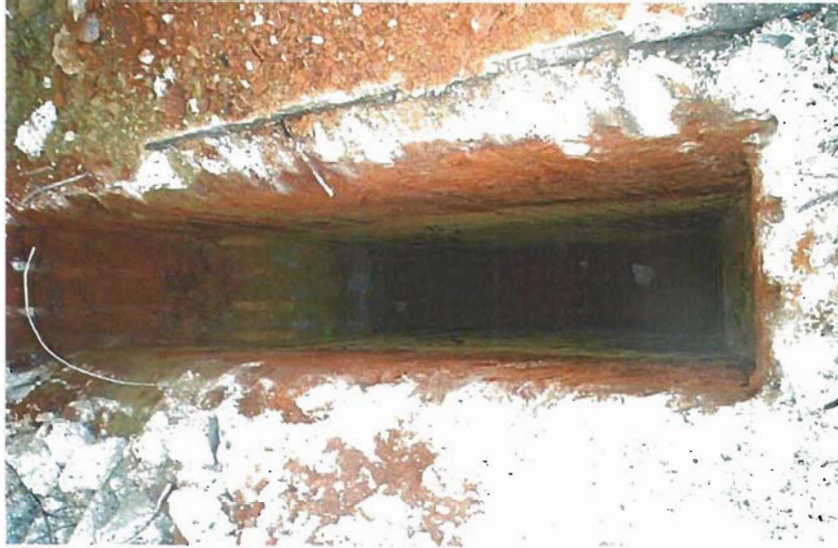
Site:	WEALDEN BRICKWORKS	Client:	GAZELEY
Job No.:	CS007890	Hole No.:	TP44
Level :	53.40mOD	Date:	27/6/2005

Sample	Type	Unit	Depth (m)	Description
		1	0 – 0.25	CONCRETE
		2	0.25 – 0.35	MADE GROUND. Sand and Gravel
		3	0.35 – 1.4	CLAY. Baked red clay, hard and cemented, like brick material, close to old kiln. Some moisture detected possibly perched groundwater in pore space.
		4	1.4 – 3.8	CLAY. Brown highly weathered clay, very friable. Laminated and fractured throughout, waxy texture with some moisture in fractures. Becoming harder and more brittle with depth to a cemented mudstone.
Notes:	Small pool of water in base of pit most likely from perched groundwater

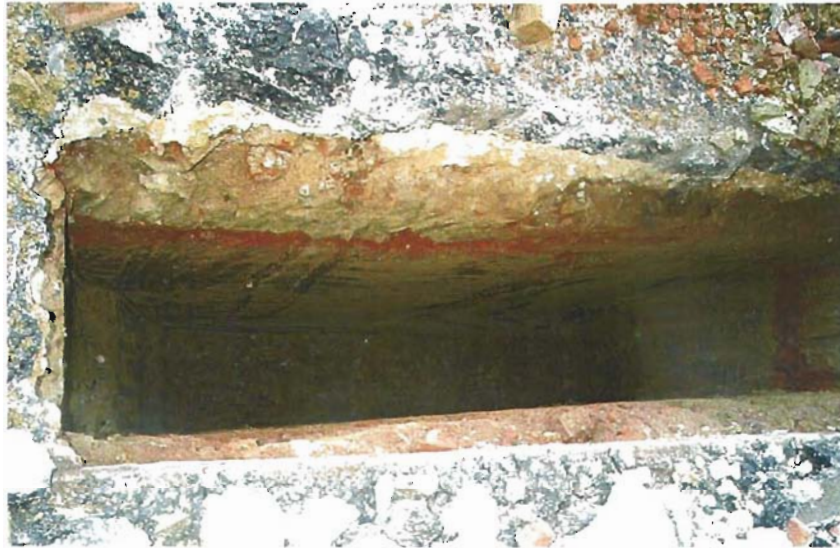
Site:	WEALDEN BRICKWORKS	Client:	GAZELEY
Job No.:	CS007890	Hole No.:	TP45
Level :	mOD	Date:	27/6/2005

Sample	Type	Unit	Depth (m)	Description
		1	0 – 0.1	ASPHALT
		2	0.1 – 0.3	MADE GROUND. Sand and gravel
		3	0.3 – 0.5	MADE GROUND. Bricks and sand aggregate
		4	0.5 – 0.8	MADE GROUND. Worked stiff clay layer, brown weathered flexible clay with high percentage of ash 80 % +
		5	0.8 – 2.7	CLAY. Baked red clay, hard and cemented, some moisture possibly perched groundwater. Grading into the natural brown weathered, laminated and fractured clay, becoming harder and more brittle with depth. Some moisture in fractures
Notes:

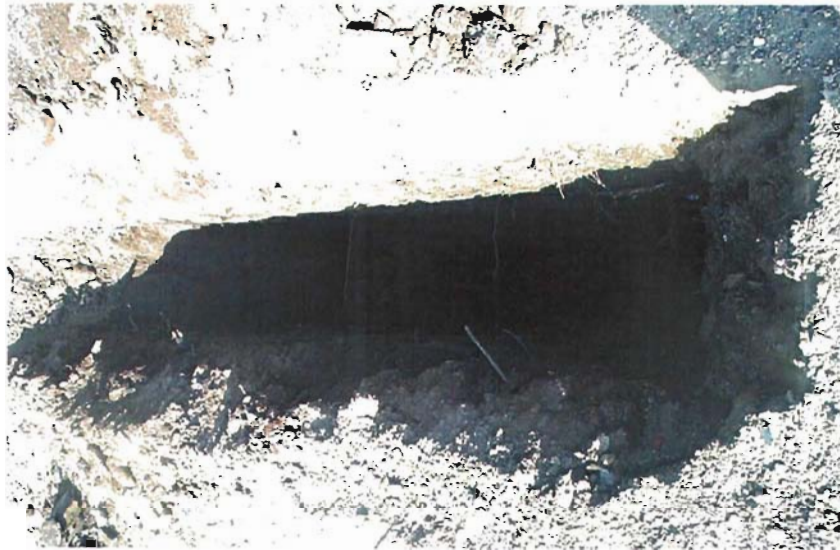
Site:	WEALDEN BRICKWORKS	Client:	GAZELEY
Job No.:	CS007890	Hole No.:	TP46
Level :	55.23mOD	Date:	27/6/2005

Sample	Type	Unit	Depth (m)	Description
		1	0 – 4.8	MADE GROUND. Brown aggregate of clay and ash. Some cohesive clay layers, not very thick. Primarily an aggregate of ash, bricks, roots, gravels, with some ceramics and glass. Abundant rootlets in top 1 metre, overall semi cohesive unit.
Notes:

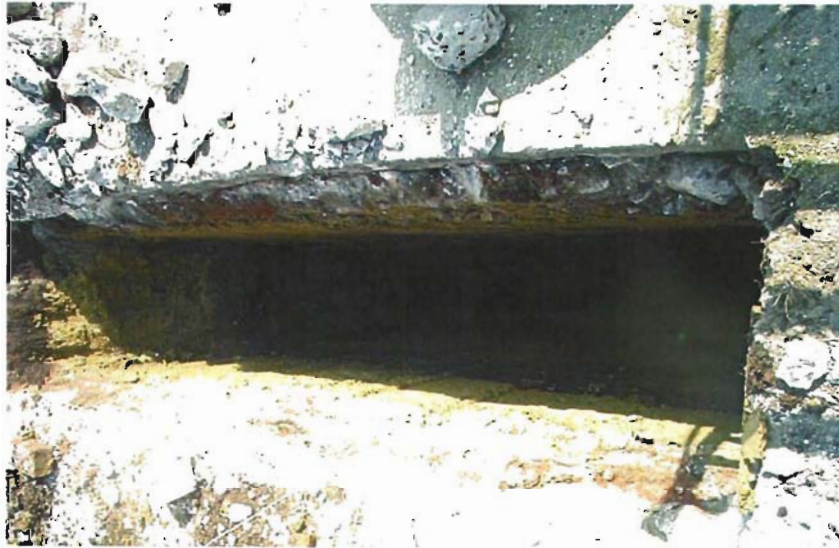
Site:	WEALDEN BRICKWORKS	Client:	GAZELEY
Job No.:	CS007890	Hole No.:	TP47
Level :	53.33mOD	Date:	27/6/2005

Sample	Type	Unit	Depth (m)	Description
		1	0 – 0.1	CONCRETE
		2	0.1 – 1.4	MADE GROUND. Crushed brick and ash layer at top over a stiff clay layer 350 mm, on brown and weathered with some un weathered patches. Generally sticky and cohesive with some red brick fragments 750mm, on 300mm of crushed brick and ash.
		3	1.4 – 4.1	CLAY. Brown weathered stiff clay, cohesive and flexible, becoming hard and brittle with depth, changing to laminated fractured clay, weathered and friable along laminae and fractures.
Notes:

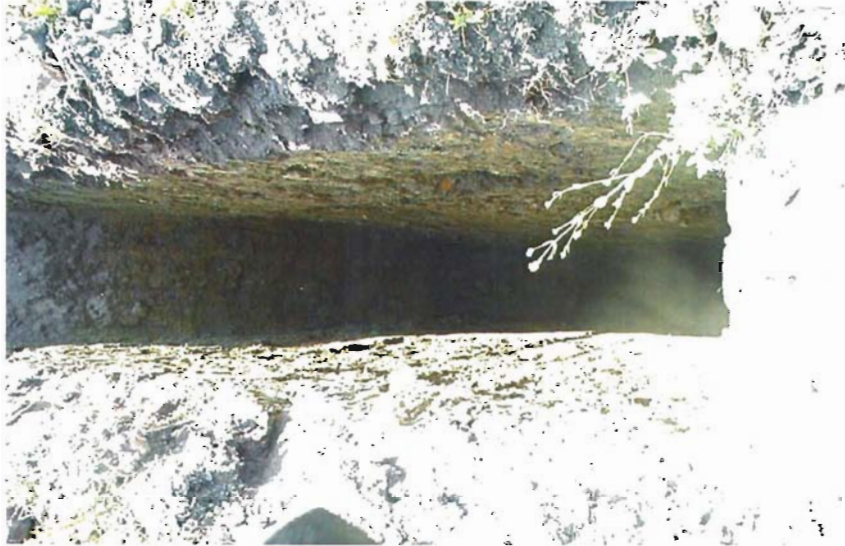
Site:	WEALDEN BRICKWORKS	Client:	GAZELEY
Job No.:	CS007890	Hole No.:	TP48
Level :	55.18mOD	Date:	27/6/2005

Sample	Type	Unit	Depth (m)	Description
		1	0 – 5.4	MADE GROUND. Top 0.5 metres non cohesive aggregate of brick, clay and ash. Becoming stiff and cohesive with depth, primarily clay based aggregate, grey weathered brown clay with some brick fragments and root material. No natural ground encountered only worked clay to base.
Notes:

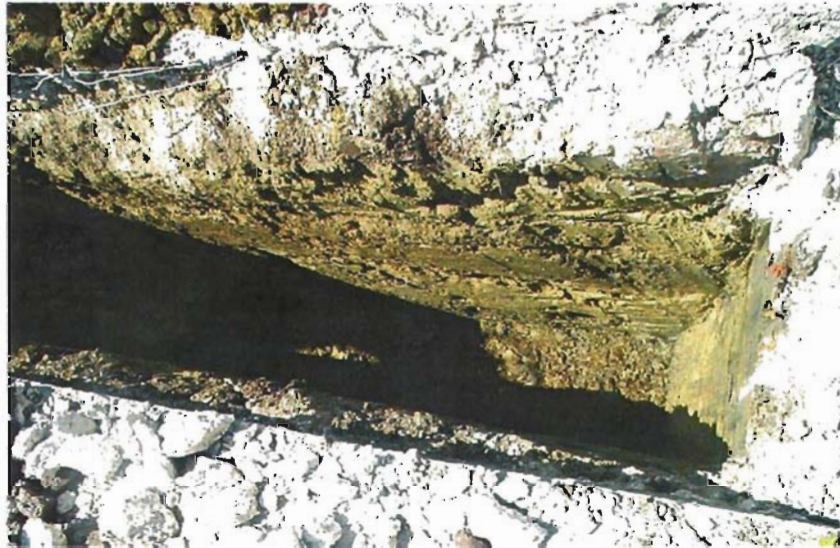
Site:	WEALDEN BRICKWORKS	Client:	GAZELEY
Job No.:	CS007890	Hole No.:	TP49
Level :	52.69mOD	Date:	27/6/2005

Sample	Type	Unit	Depth (m)	Description
		1	0 – 0.2	CONCRETE
		2	0.2 – 0.4	MADE GROUND. Uncohesive aggregate of brick and ash, coarse and granular.
		3	0.4 – 2.6	CLAY. Brown weathered stiff clay, semi cohesive at top rapidly becoming hard and brittle with depth, changing to laminated fractured clay, weathered and friable along laminae and fractures.
Notes:
