# Brookhurst Wood MBT Facility

Environmental Permit Variation - EPR/HP3238GW  
Site Condition Report

Biffa Waste Services Limited

Project reference: EPR/HP3238GW/V05  
Project number: 60586541  
60586541-ACM-XX-00-RP-MBT-SCR-R04

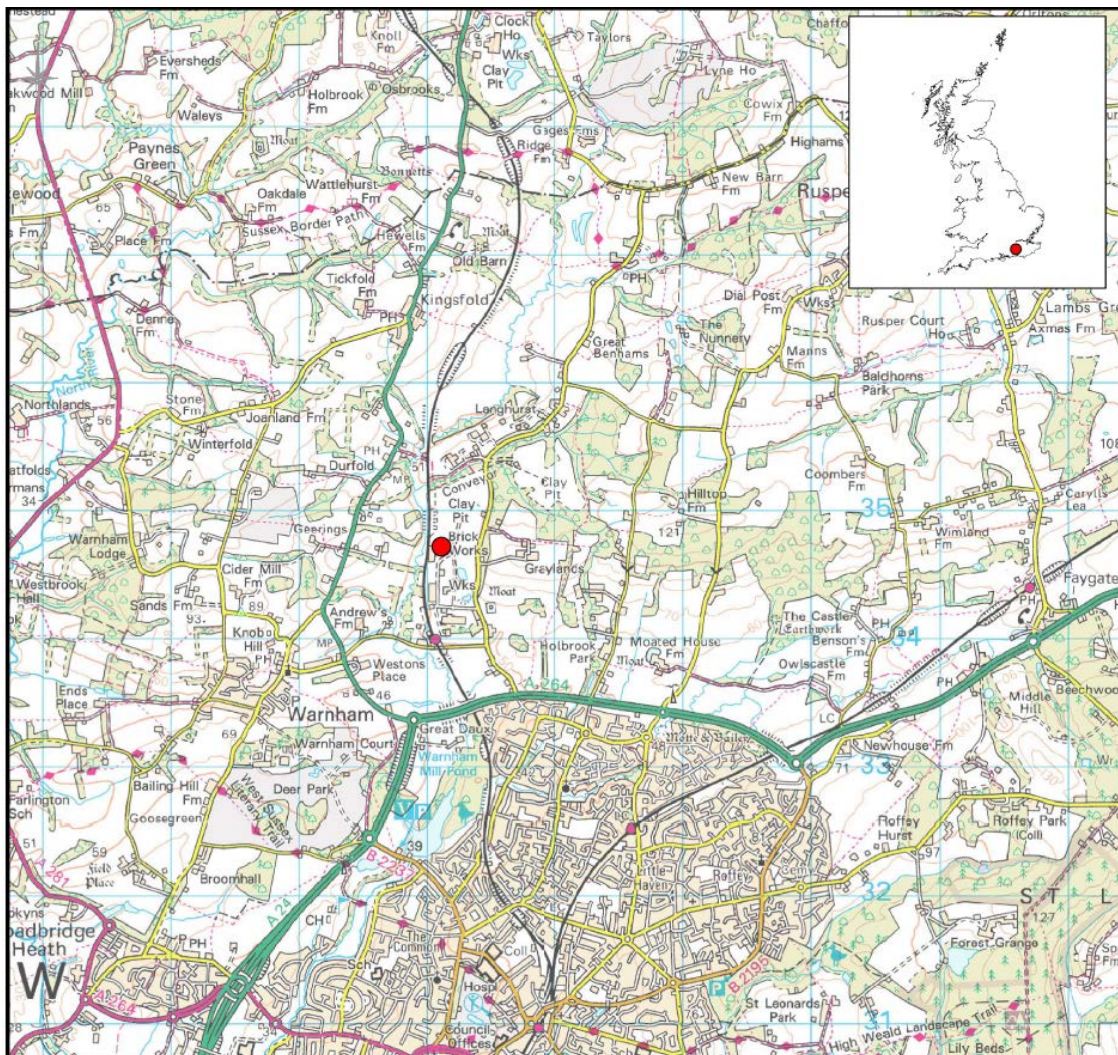
**Figure 1: Site Location Plan**

The MBT site is located approximately 1km to the north of Horsham and 1.5km northeast of Warnham, with the village of Kingsfold around 1.7km to the north/northwest. The proposed waste transfer and storage area will extend the existing MBT area from 3.9 hectares to 5.4 hectares. The centre of the extension area is located at grid reference National Grid Reference (NGR) E517050, N134483 at Brookhurst Wood, Langhurstwood, Horsham, West Sussex.

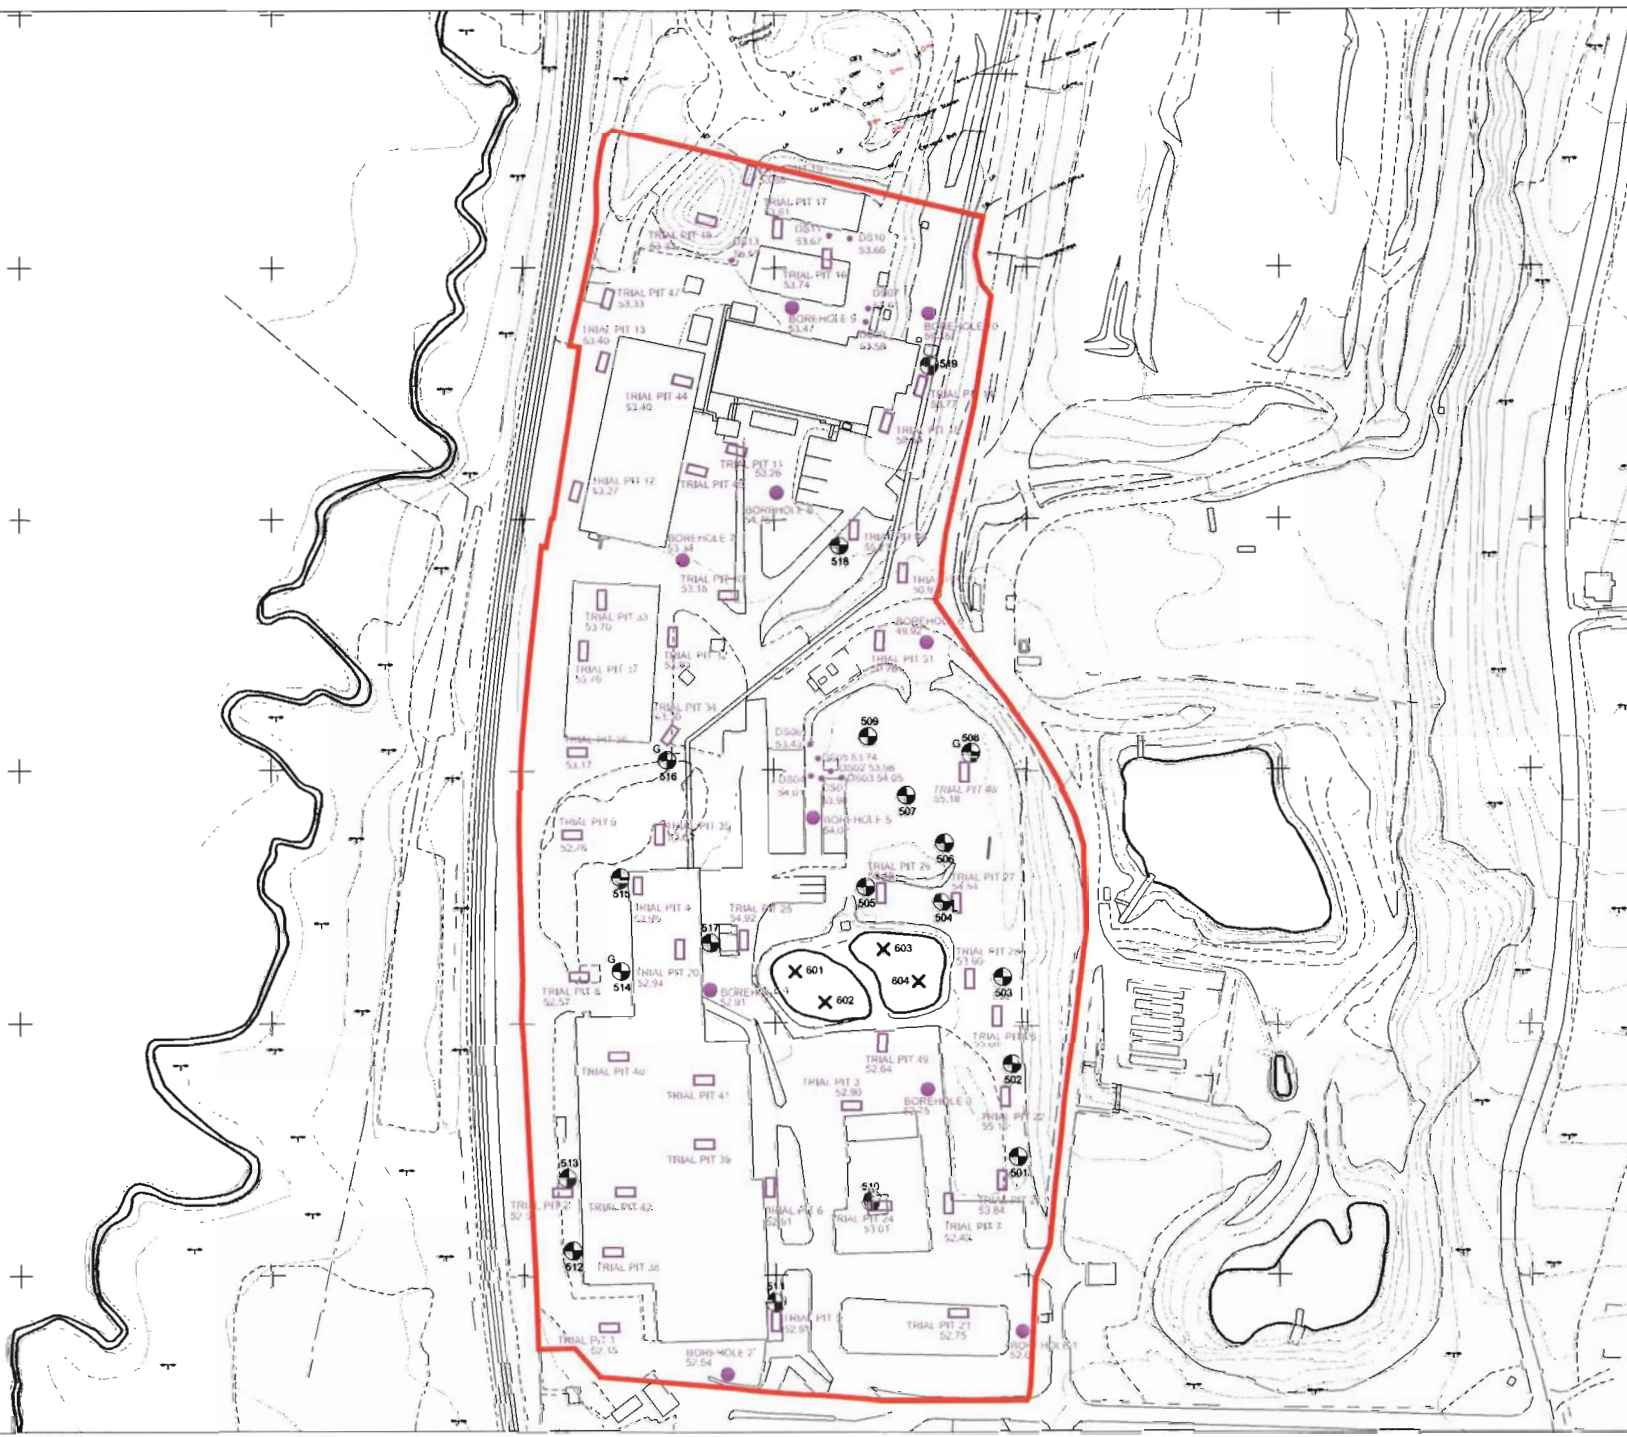
- KEY
- SITE No
  - WINDOW SAMPLE HOLE (2010)
  - G GAS INSTALLATION (2010)
  - X GRAB SAMPLE OF POND SLT.1 (2010)
  - BOREHOLE (2005)
  - EXISTING TRIAL PIT (2005)
  - BOREHOLE DYNAMIC SAMPLE HOLE (2005)

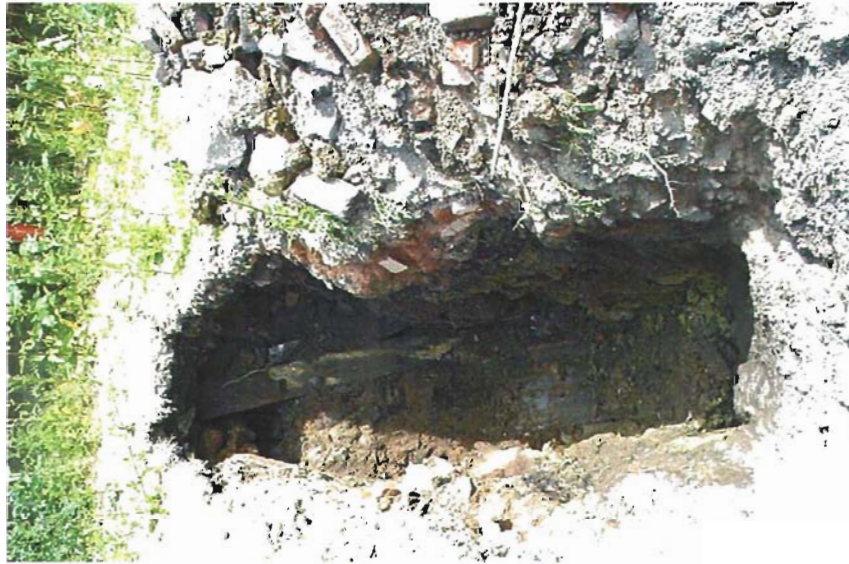
Sample	Type	Unit	Depth (m)	Description
		1	0 – 2.1	<p>MADE GROUND. Unconsolidated aggregate of red bricks crushed bricks, concrete and sand. Some clay patches with plastics and metal rods included. Refusal at 2.1 metres.</p> <p>Eastern side of pit collapsed as a void space, red brick structure clearly visible. Old Kiln flue.</p>
<b>Notes:</b>	Pit stopped at 2.1m due to obstructions. This obstruction later confirmed to be a Kiln Flue.

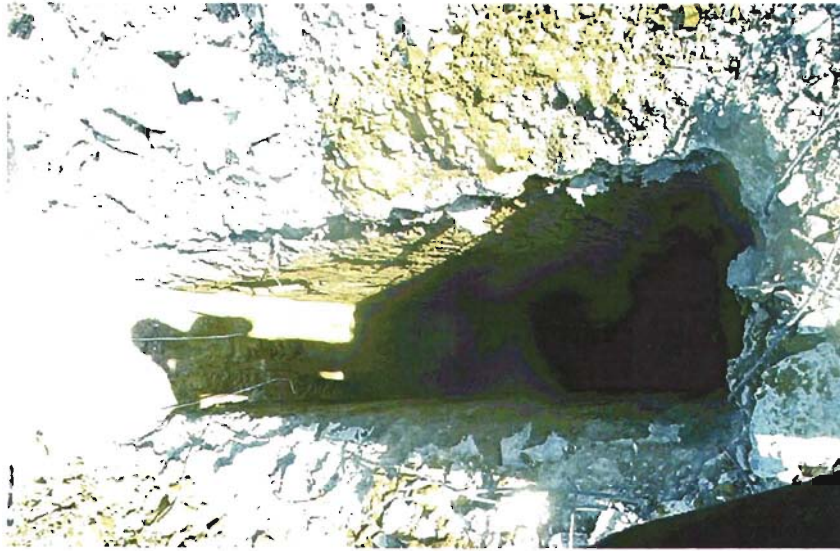
<b>Site:</b>	WEALDEN BRICKWORKS	<b>Client:</b>	GAZELEY
<b>Job No.:</b>	CS007890	<b>Hole No.:</b>	TP9
<b>Level :</b>	52.76mOD	<b>Date:</b>	20/6/2005

Sample	Type	Unit	Depth (m)	Description
		1	0 – 2.5	MADE GROUND. Unconsolidated ash and dry clay mix (300mm) over red brick structure, identified as kiln flue
		2	2.5 – 3.8	CLAY. Hard cemented clay, laminated and fractured, clay adjacent to the old kiln flue was baked by heat into a red brick like material which is extremely hard.
<b>Notes:</b>

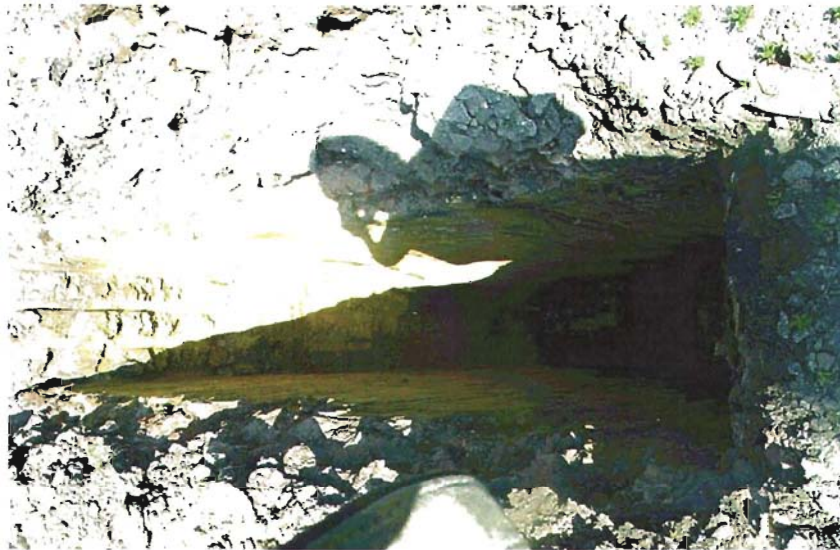
<b>Site:</b>	WEALDEN BRICKWORKS	<b>Client:</b>	GAZELEY
<b>Job No.:</b>	CS007890	<b>Hole No.:</b>	TP19
<b>Level :</b>	53.88mOD	<b>Date:</b>	20/6/2005

Sample	Type	Unit	Depth (m)	Description
		1	0 – 0.5	MADE GROUND. Unconsolidated aggregate of bricks, ash, with glass, ceramics in a coarse granular matrix, with lumps of carbonaceous material.
		2	0.5 – 3.8	CLAY. Stiff brown weathered clay, becoming hard, brittle and laminated with depth. Weathered along laminae and fracture planes, some moisture in cracks, waxy texture. Some folding of layers obvious.
<b>Notes:</b>

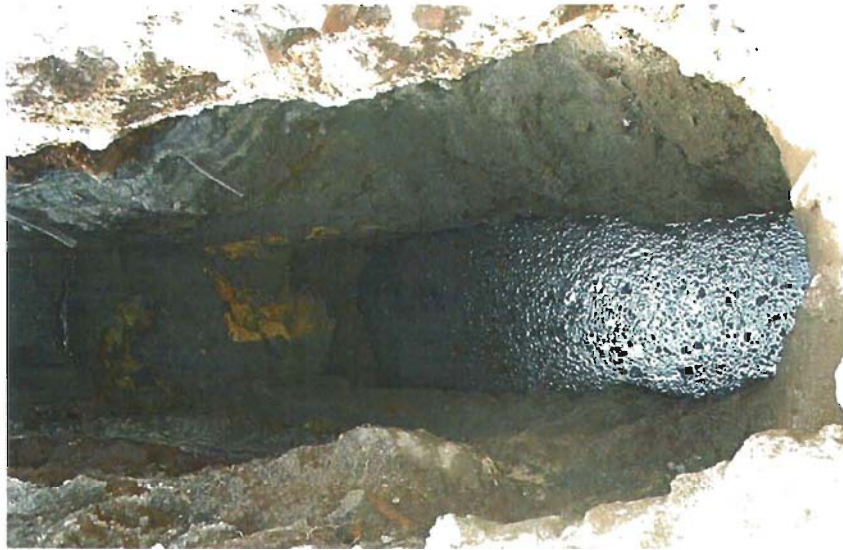
Sample	Type	Unit	Depth (m)	Description
		1	0 – 4.0	MADE GROUND. Top 2 metres semi cohesive aggregate of clay brick and ash, wet texture flexible. Changing into primarily clay based aggregate, very stiff and cohesive with brick and ash, some roots and hydrocarbon odour. Water in the bottom of the pit most likely from adjacent lagoon or silt pond. Oily substance visible floating on top of water.
<b>Notes:</b>

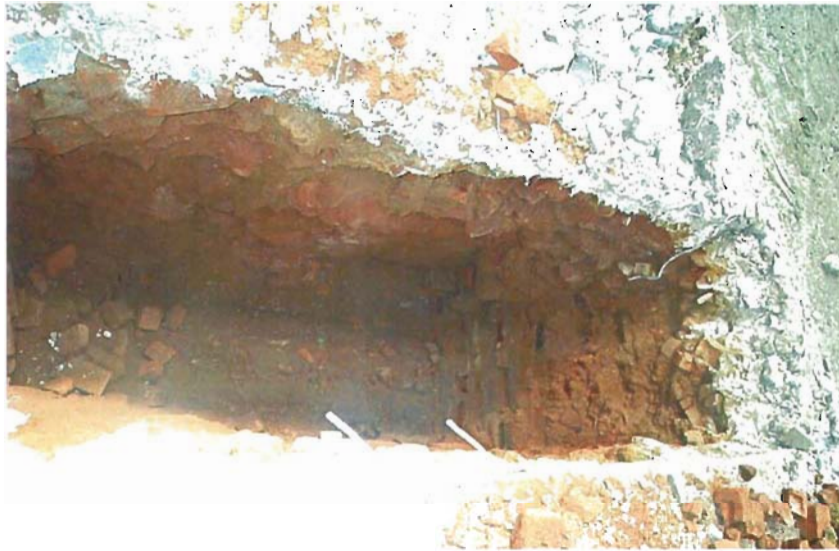
<b>Site:</b>	WEALDEN BRICKWORKS	<b>Client:</b>	GAZELEY
<b>Job No.:</b>	CS007890	<b>Hole No.:</b>	TP42
<b>Level :</b>		<b>Date:</b>	27/6/2005

Sample	Type	Unit	Depth (m)	Description
		1	0 – 0.15	CONCRETE
		2	0.15 – 1.8	MADE GROUND. Large amount of whole red bricks to 1 metre, changing into laid red brick structure down to base, possibly old backfilled flue or brick clamp.
<b>Notes:</b>	Refusal at 1.8 metres

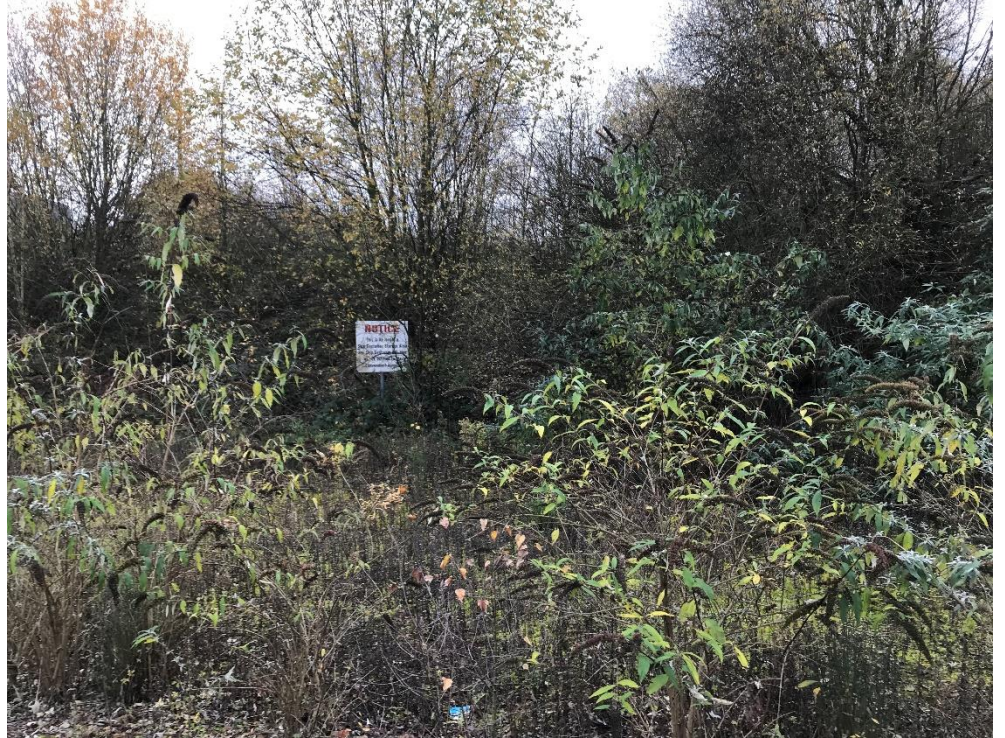
At the north east access point looking into the wooded area. Notice stating that skips are not to be placed in that area as per requirement from the Environment Agency.

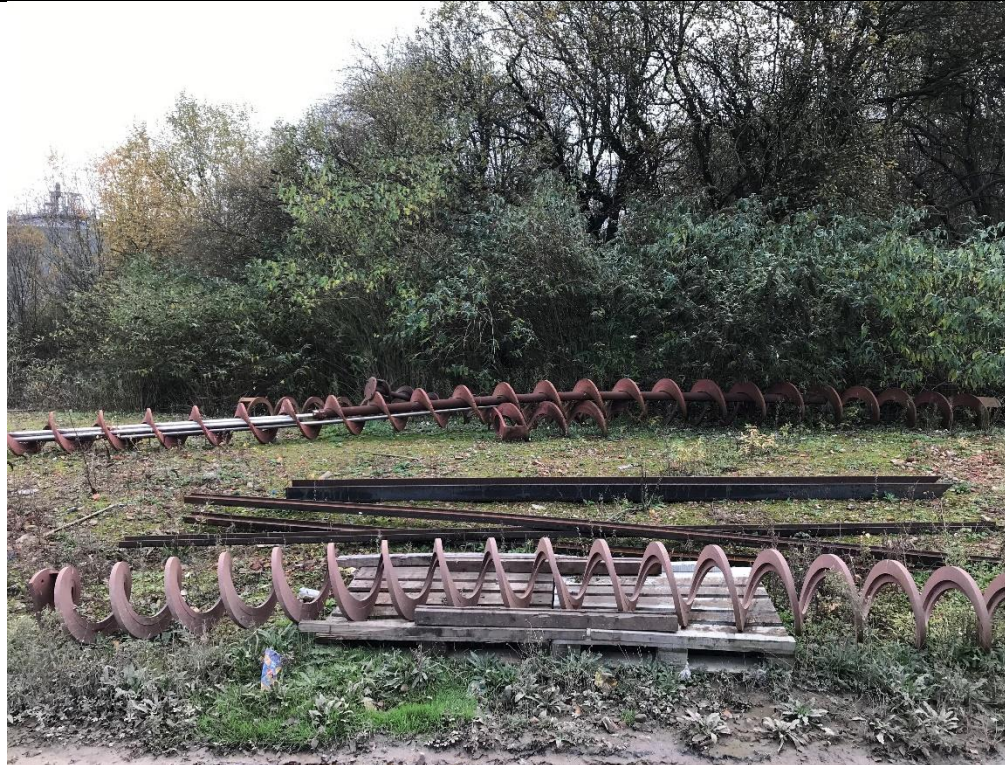
In the north of the site. Miscellaneous Metal and wood.

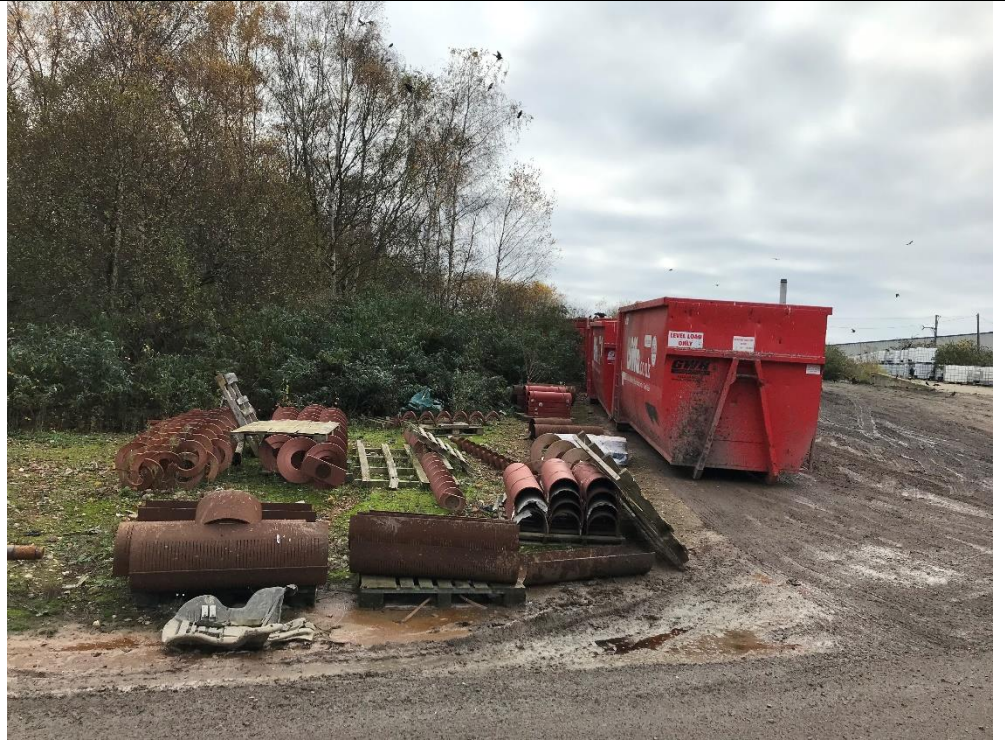
In the north of the site. Miscellaneous Metal and wood. Skips present.

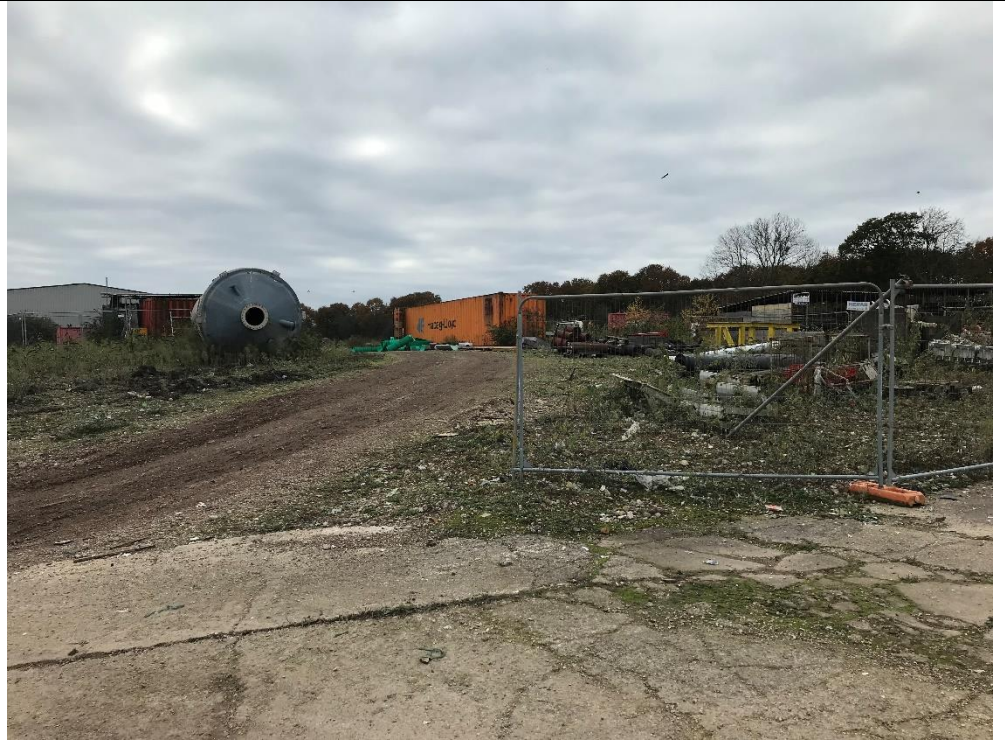
In the north of the site. Within a small area of scrub. Large (seemingly empty) tank, rusted metal pipes, concrete slabs and municipal waste (plastic bags/ crisp packets/ Styrofoam).

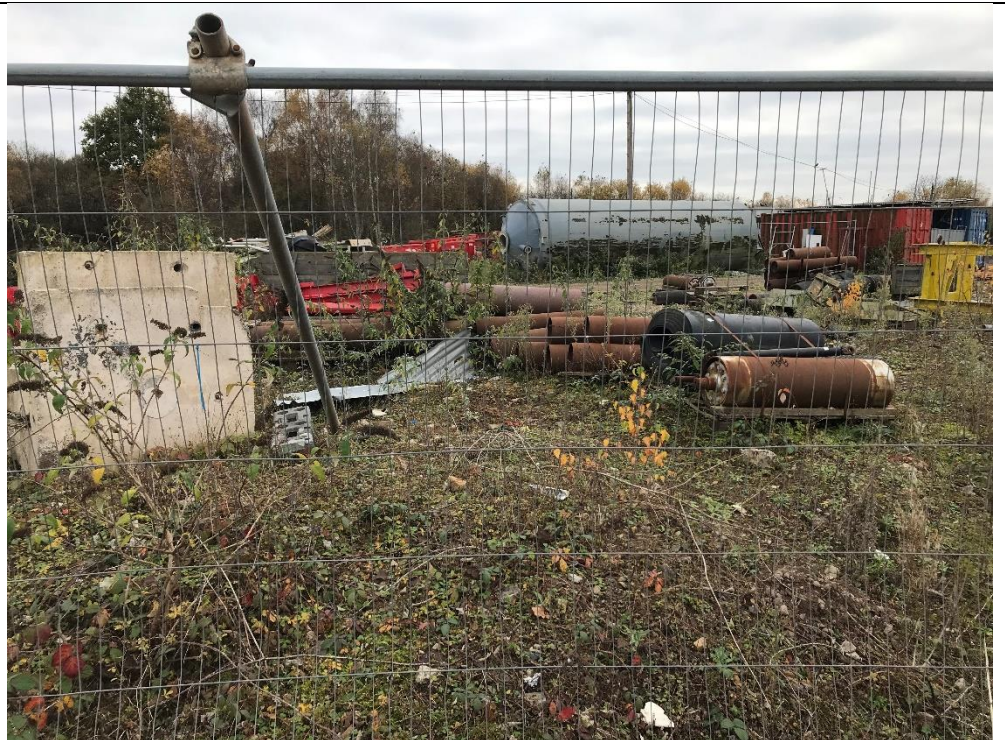
North east corner of the site. Looking into the area of scrub.

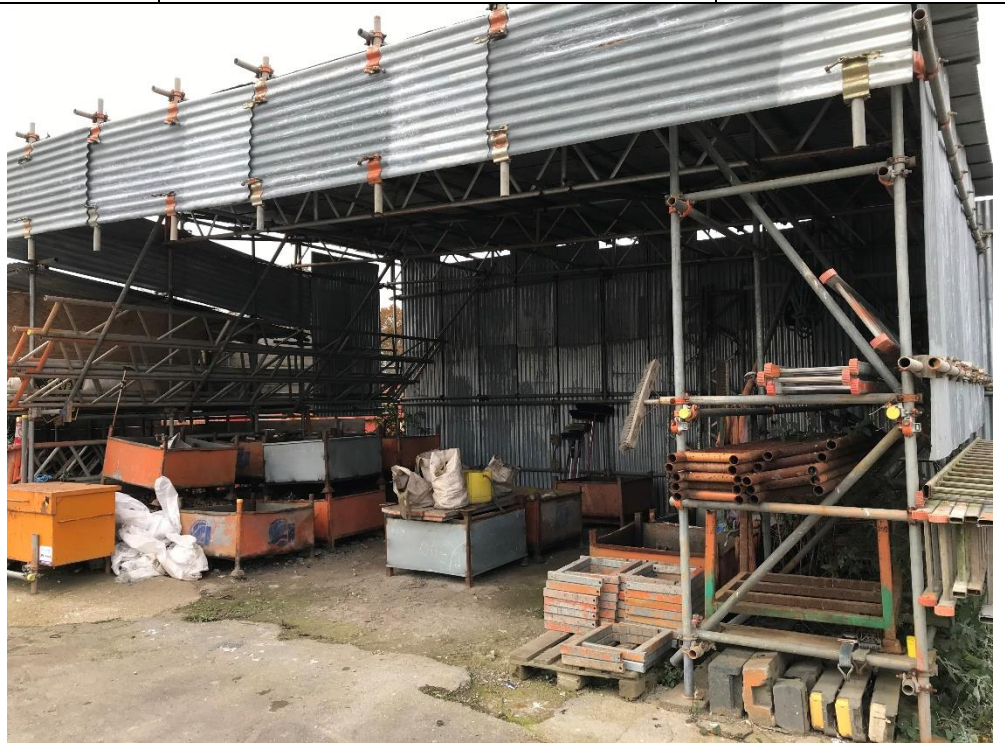
Storage shed containing rusted metal pipes, sheeting and structures in the north west corner of the site on an area of hard standing.

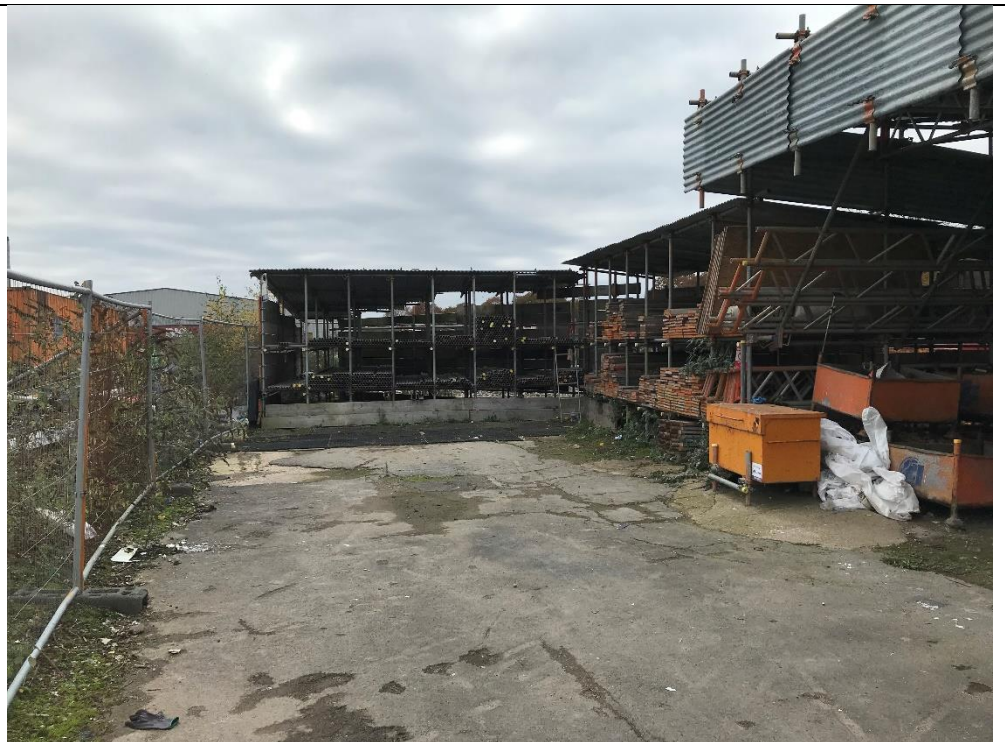
North west area of the site. Next to the storage shed. Facing another metal storage structure.

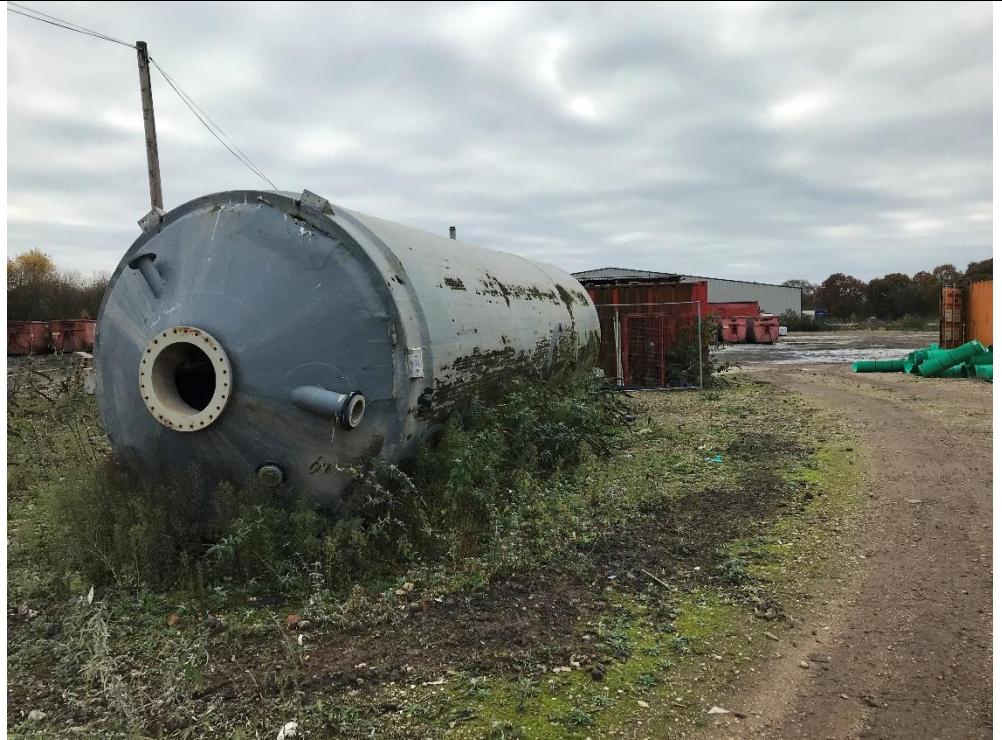
**Description**  
Large empty tank within the area of scrub in the north of the site.

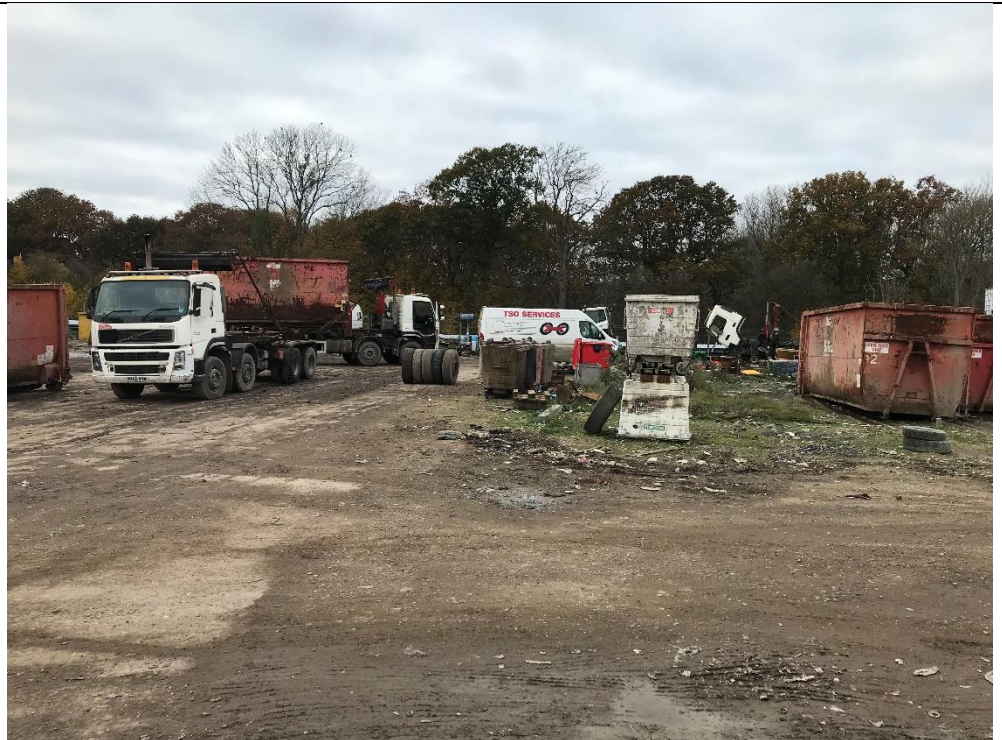
**Photo No.**  
10

**Description**  
Trucks and skips parked/ placed along the western boundary of the site.

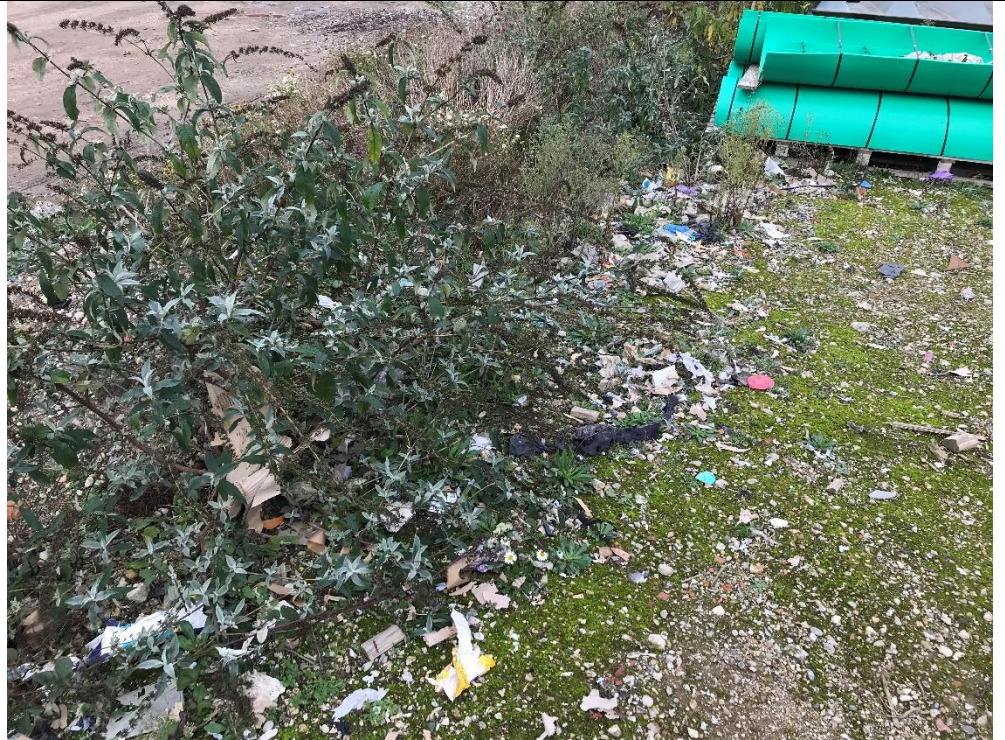
Waste within the scrub area in the north of the site. Possibly wind blown from the wider landfill site.

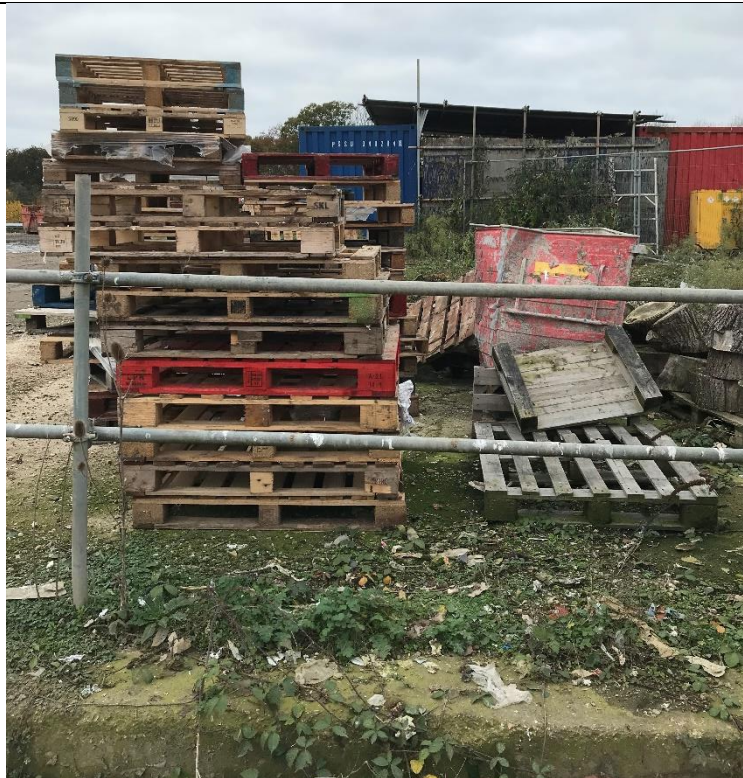
**Photo No.**  
12

Stacked wooden pallets.

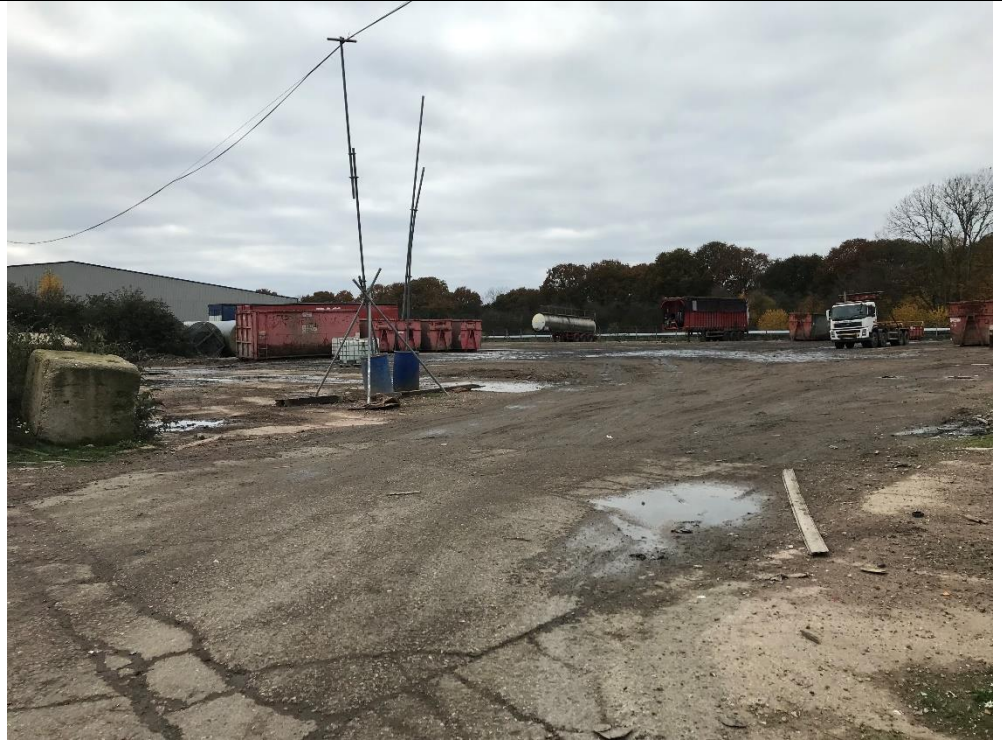
Overhead lines crossing the center of the site. Line is held up by makeshift structure (metal rods).

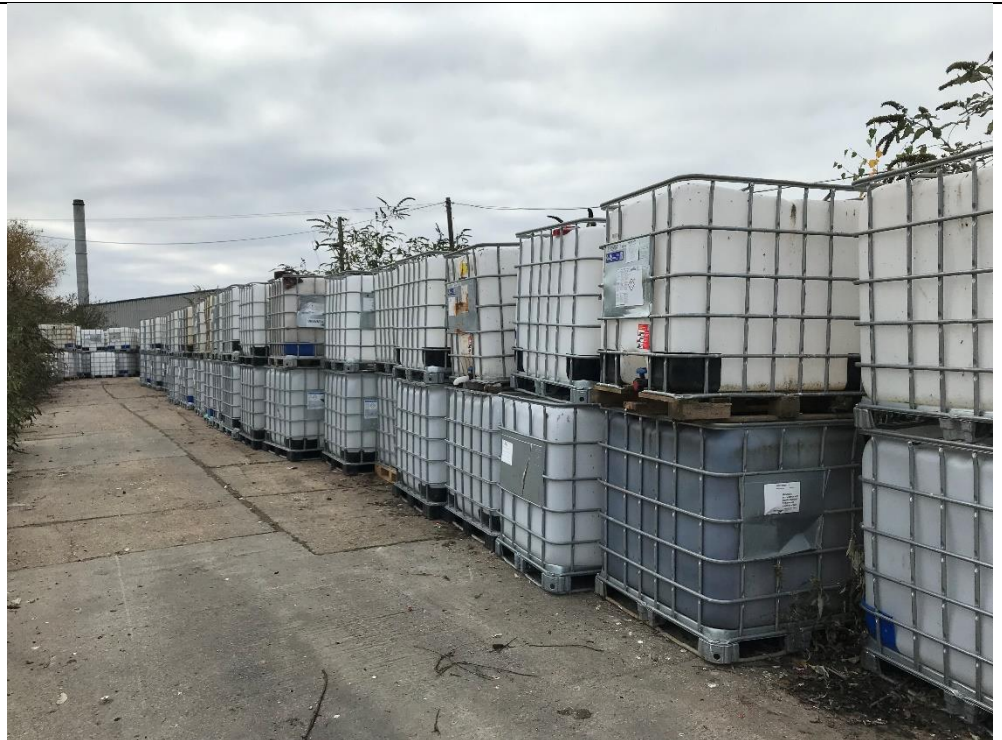
**Photo No.**  
14

Row of IBCs sitting on hard standing.

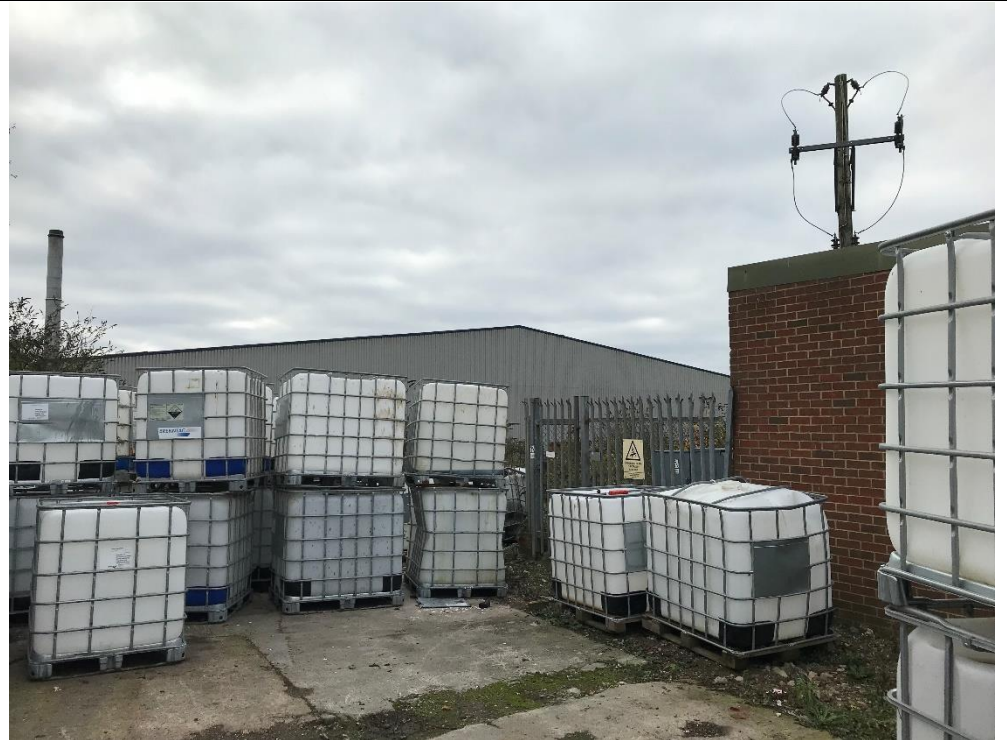
End of the row of IBCs. Brick building sits at the end of the row.

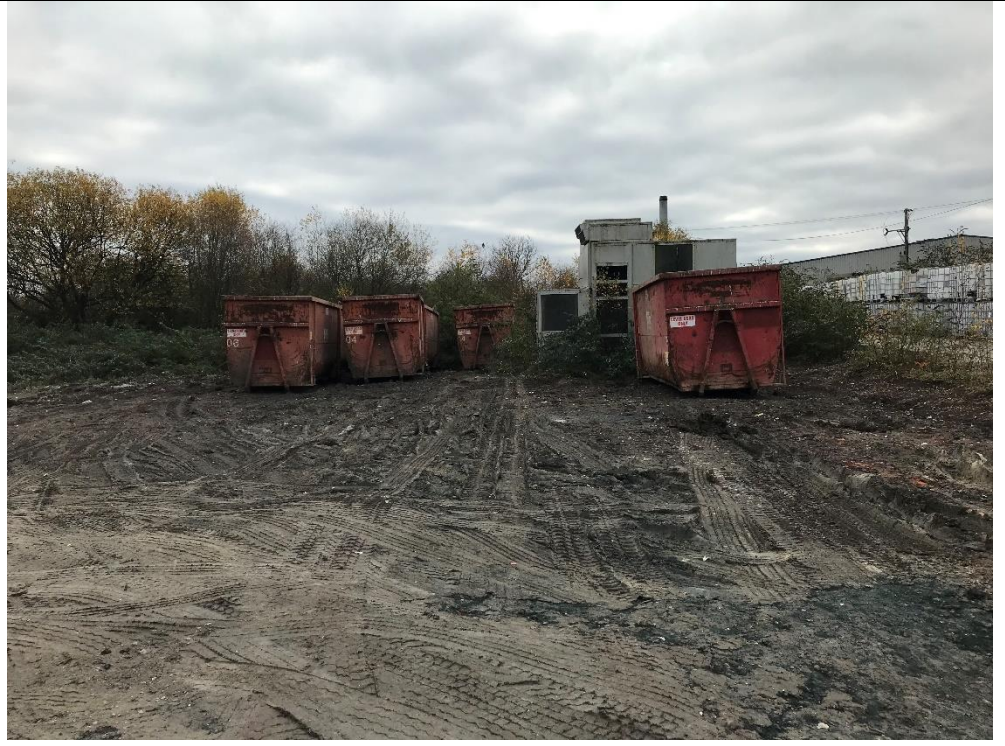
**Description**  
Skips lined up in the center of the site. Adjacent to the wooded area.

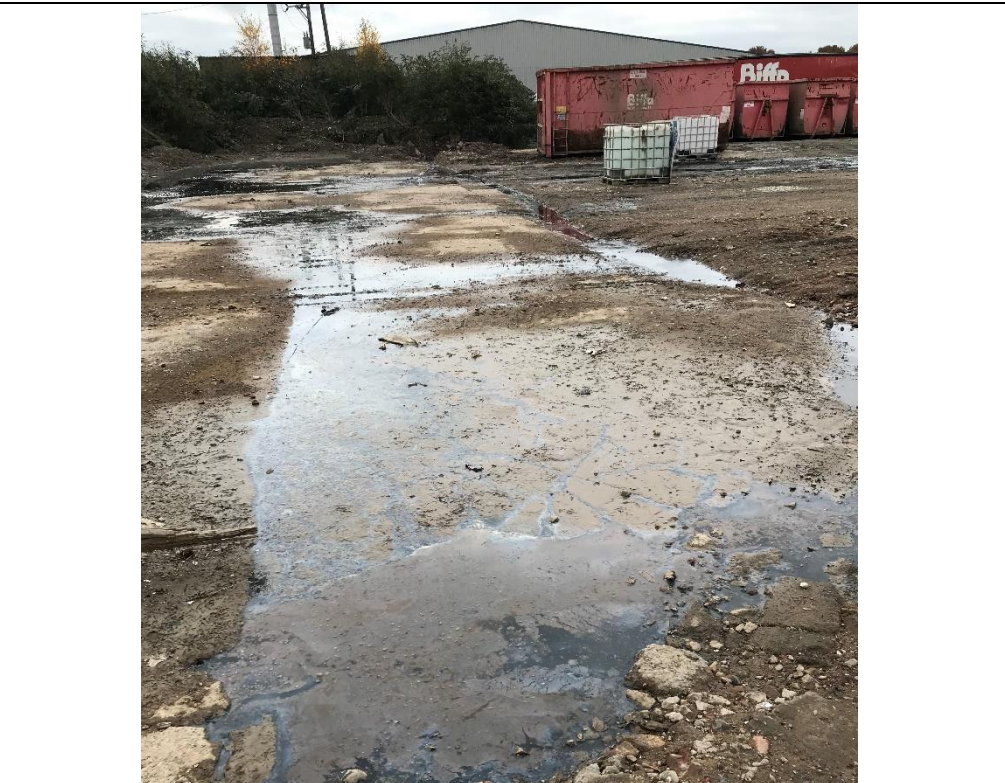
**Photo No.**  
18

**Description**  
Puddles formed within the open area in the center to south west of the site. The Puddle had an oily sheen which could be an indication of petroleum or organic bacteria. No discernable smell.

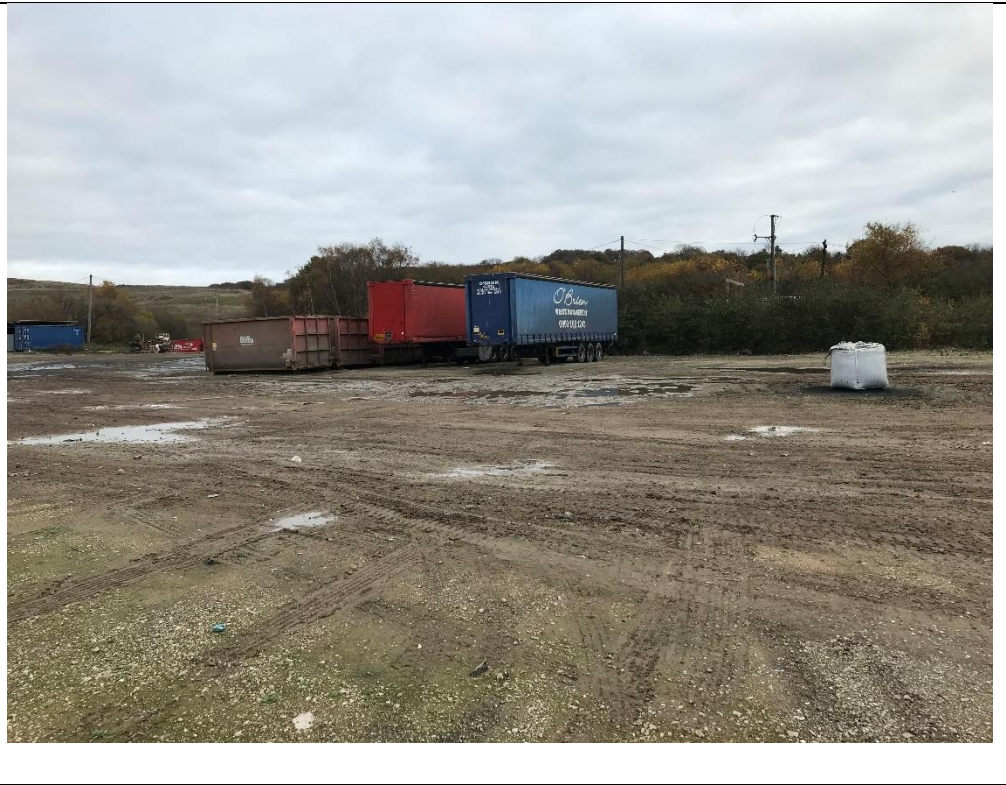
**Photo No.**  
20

**Description**  
Skips and shipping containers placed in the south of the site.

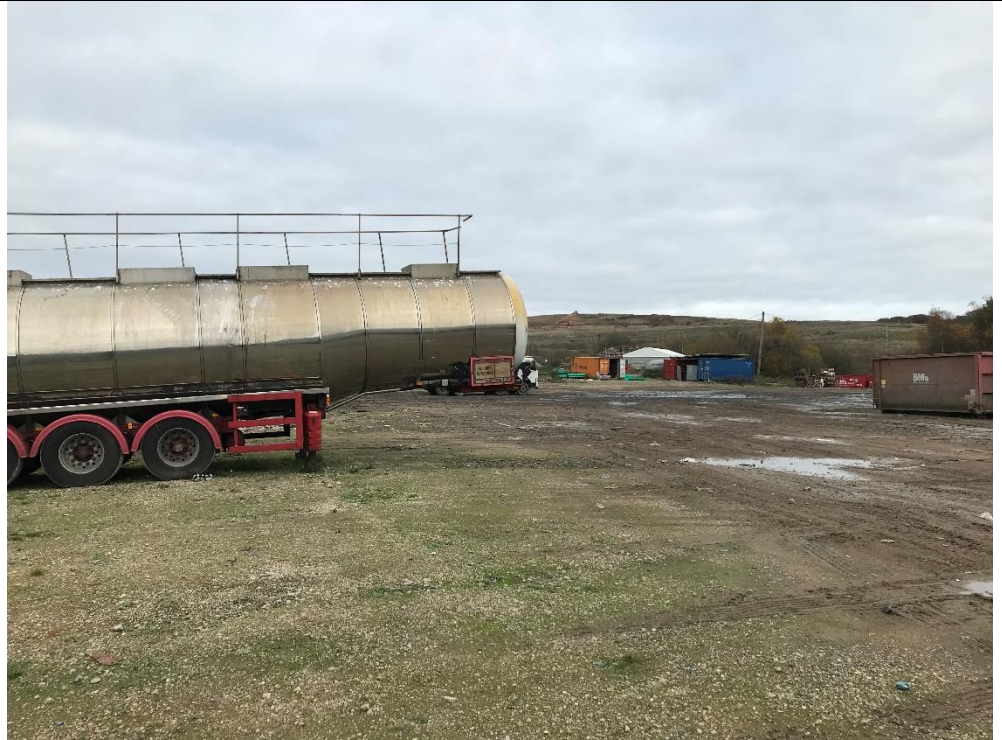
A tanker present in the south west of the site.

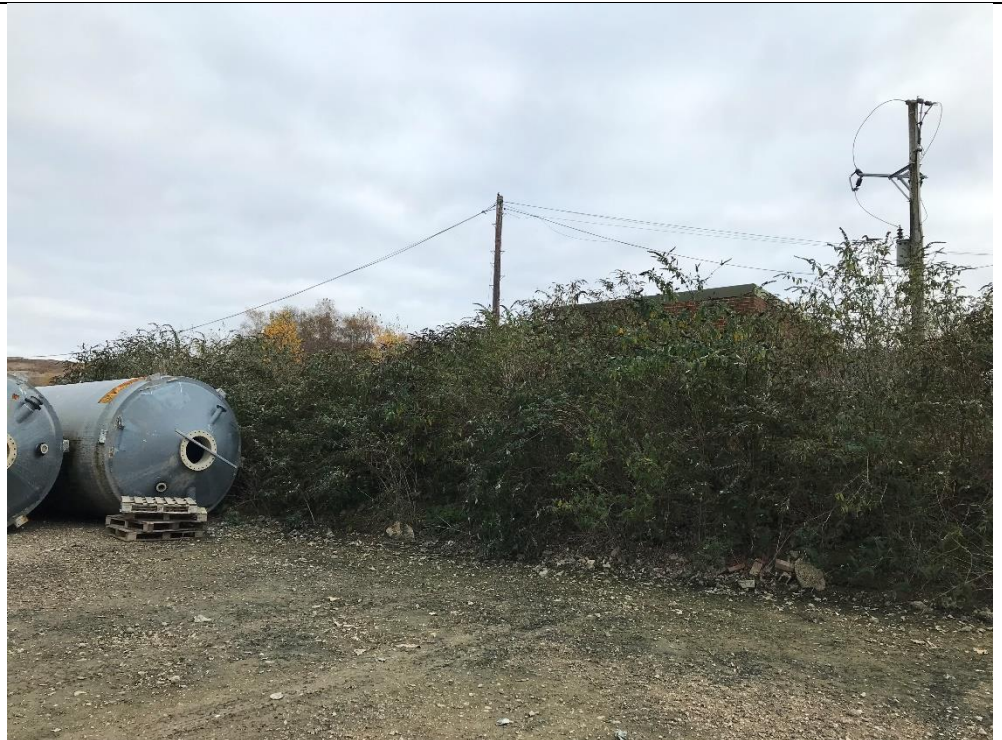
**Photo No.**  
22

Seemingly empty tanks in the south of the site. Brick building in the background with overhead lines crossing through.

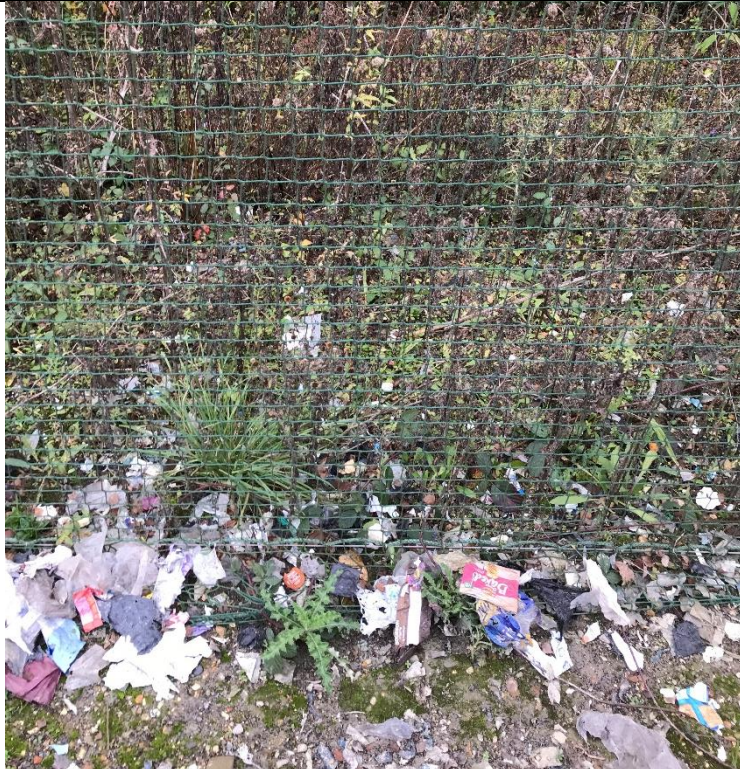
**Photo No.**  
26

Possible wind-blown waste at the south east boundary of the forested area.
