# Clockhouse Quarry Restoration Environmental Permit Application

## Site Condition Report

### **SUEZ Recycling and Recovery UK Limited**

SLR Project No.: 402.065294.00001

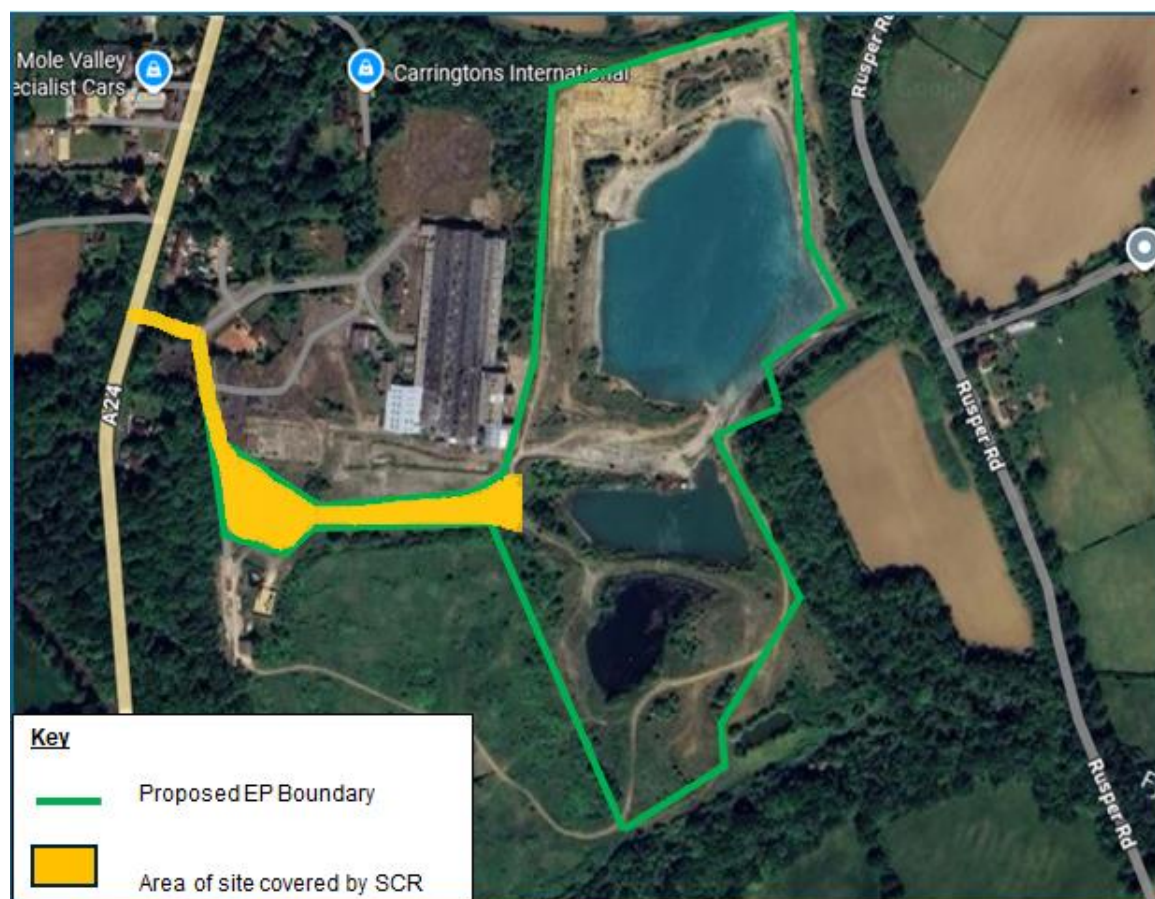
**Figure 1-1 Relevant areas of the proposed EP area for the SCR**

In line with the H5 Guidance, this SCR relates only to areas of the proposed EP that will not be subject to the permanent deposit of waste. The area covered by this SCR and its context within the wider EP is shown on Figure 1-1.
