LAND OFF HINDMANS WAY, DAGENHAM

Site Investigation & Contamination Assessment

Report Ref: BEK-22137-2 (Rev B)

August 2023

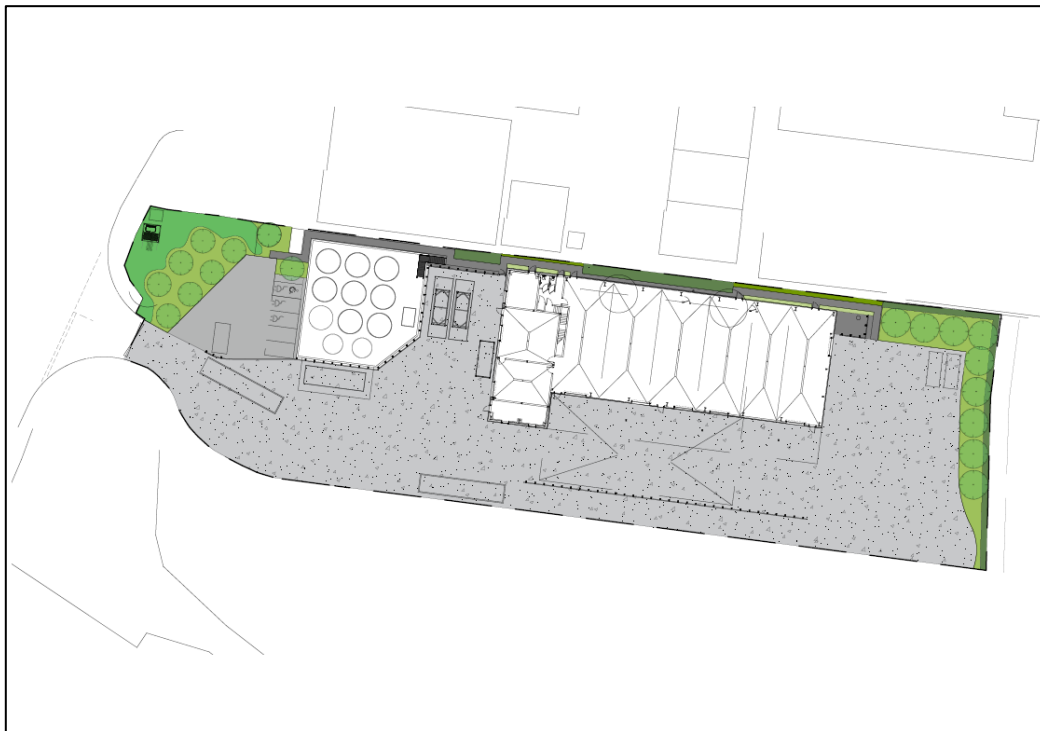
Figure 1: Proposed Site Layout

1.3.1 It is proposed to construct a large warehouse type building with machinery and loadings bays under a canopy to the west. There will be a row of 11 processing tanks to the south of the new build.

1.3.2 The proposed development is illustrated on the 'Landscape Proposals Plan' shown on TMA Drawing No 230336-TMA-XX-XX-DR-L-3000, dated August 2023, a copy of which is presented in Appendix E. An extract of the drawing is presented as Figure 1 below:

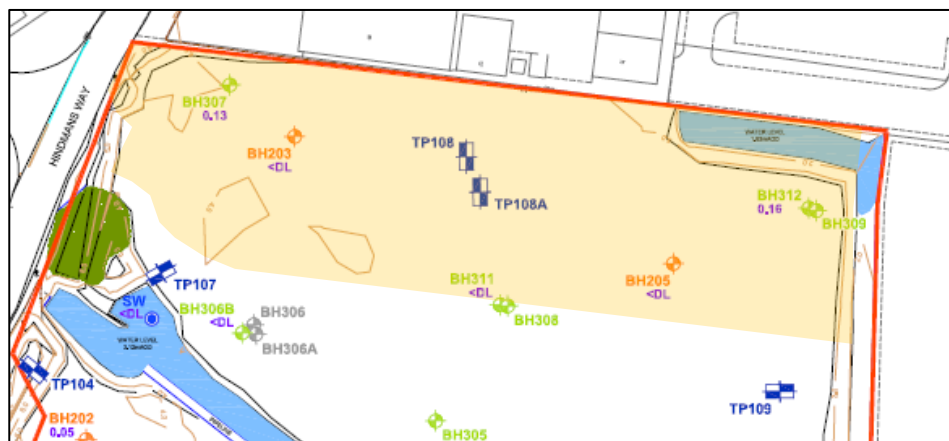
Figure 2: Previous SI Locations within Current Planning Boundary (orange shading)

- 2.3.2 Previous site investigation locations relevant to the current site are highlighted on Figure 2 below:

- 2.3.3 The investigation took place in March 2013 and it can be seen from Figure 2 that there are nine locations within the current planning boundary. The area of the site relative to this assessment herein is referred to as 'Maskell North' in the SLR reports.
- 2.3.4 Boreholes BH203, BH205, BH311 and BH312 were drilled using a cable and percussion borehole rig to a maximum depth of 15.80 m and monitoring wells were installed in each one. Boreholes BH307, BH308 and BH309 were drilled using a windowless sampler borehole rig to a maximum depth of 2.7 m. Trial Pits TP108 and TP108A were excavated using a JCB 3CX to a maximum depth of 2.4 m.

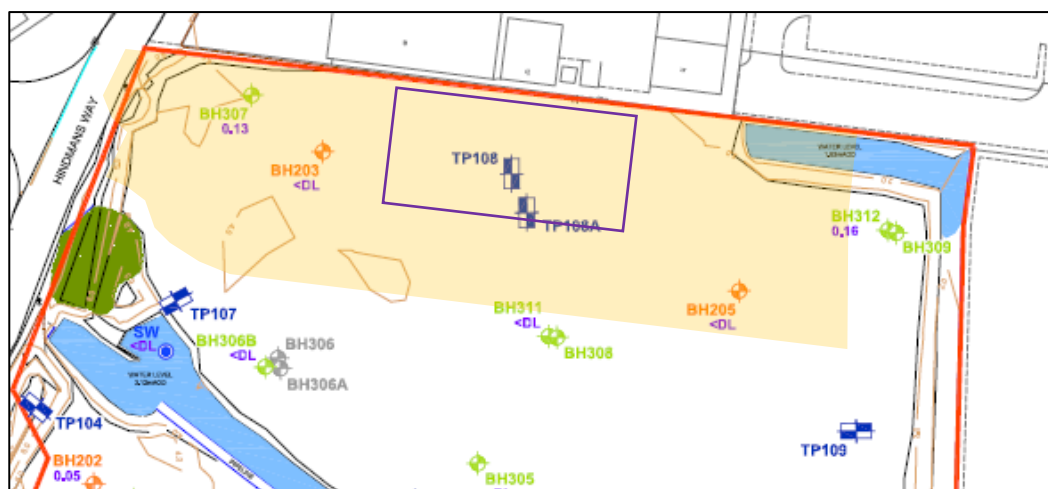
Figure 3: Previous SI Locations within Current Planning Boundary (orange shading) and Approximate Outline of Proposed New Building (purple outline)

- 2.5.3 The contamination assessment by SLR has identified potential pollutant linkages with respect to human health via gas/vapour inhalation, risks to surface water features and risks to water pipes and has recommended further site investigation assessment to quantify these risks further. Further assessment is also required to inform waste classification of the soils.
- 2.5.4 There is very limited information on the deeper ground conditions at the site (only four of the locations extend below the made ground and only two of which extend below 4.7 m). In addition, Figure 3 below shows the approximate outline of the proposed new build on site, it can be seen that only the two shallow trial pits are present within this location.

- 2.5.5 BEK recommends further site investigation to provide a full geo-environmental assessment for the site, addressing the potential risks from contamination to human health (principally from ground gas and vapours) and to provide information on deeper ground conditions as will be required by the piling contractors to inform pile specification. The locations should target the footprint of the proposed new warehouse building, as well as other locations on site. Gas/groundwater monitoring wells should be installed in selected boreholes

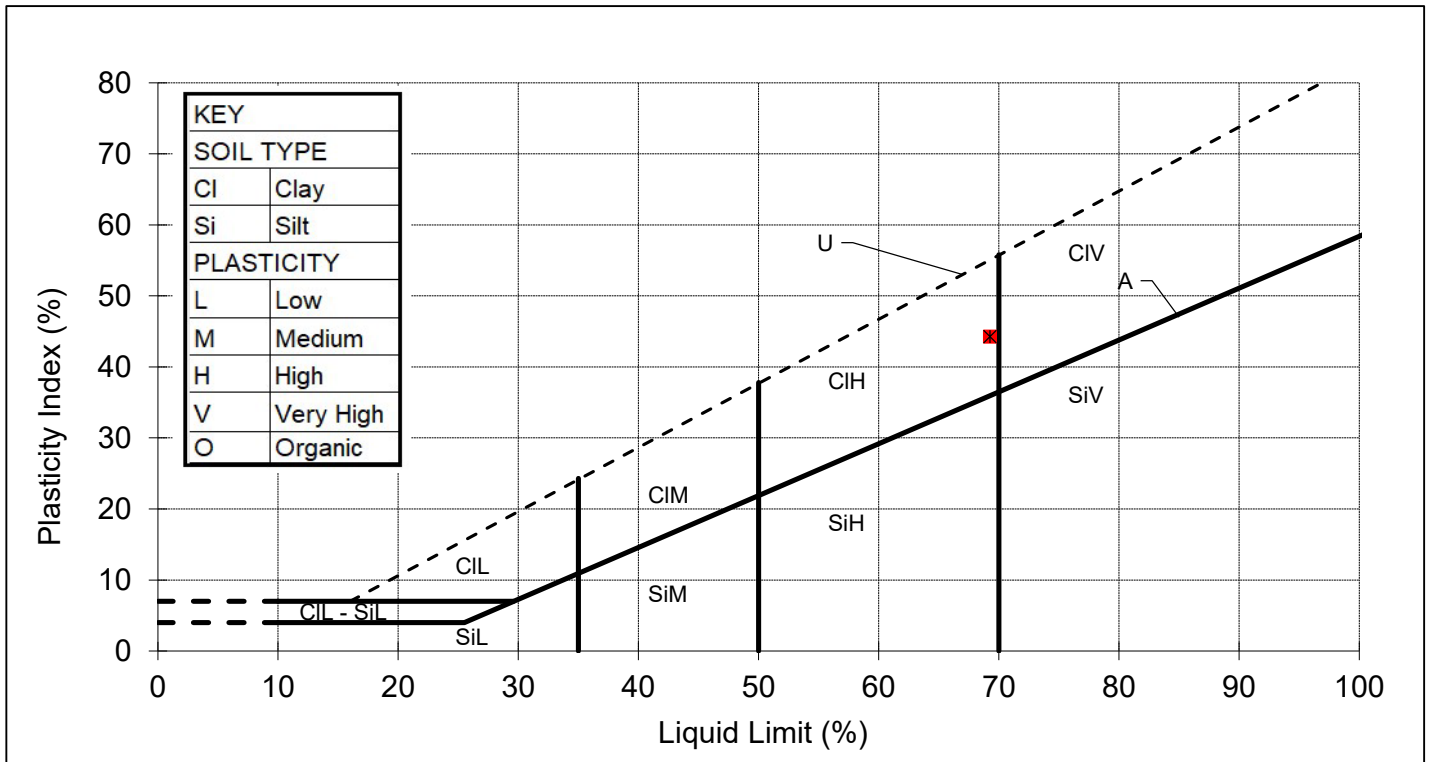
Test Readings mm (average)	Moisture Content %	Correction Factor	Correction factor from Clayton and Jukes 1978	
Determination 1 (avg)	19.1	68.2		1.017
Determination 2 (avg)	19.0	68.0

Natural Moisture Content (%)	Liquid Limit (%)	Plastic Limit (%)	Plasticity Index (%)	Passing 425 micron (%)
47.9	69	25	44	100

- 5.7 Clay samples recovered from Borehole BH1 (4 to 4.5 m), BH4 (4.5 to 5.0 m) and BH8 (4 to 4.5 m) were submitted for Atterberg tests in the laboratory conditions to determine the plasticity index of the clay.
- 5.8 The plasticity results are reasonably consistent and can be categorised as very high volume change potential. Foundation formation depths should therefore be taken based on very high volume change potential. Clay heave potential must be considered as part of the foundation design and must be appraised in accordance with NHBC Ch.4.2 requirements

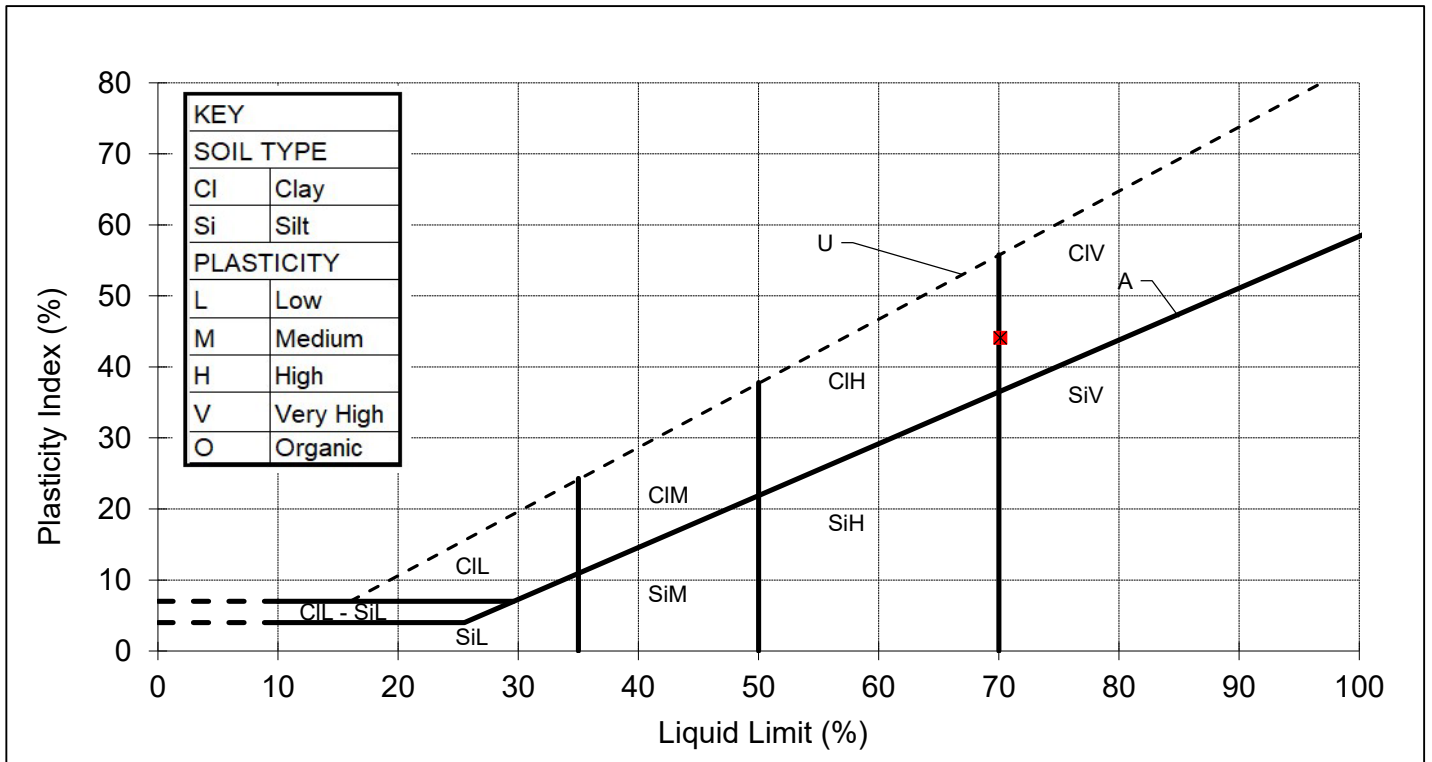
Test Readings mm (average)	Moisture Content %	Correction Factor	Correction factor from Clayton and Jukes 1978	
Determination 1 (avg)	20.0	70.1		1.001
Determination 2 (avg)	20.0	70.0

Natural Moisture Content (%)	Liquid Limit (%)	Plastic Limit (%)	Plasticity Index (%)	Passing 425 micron (%)
38.5	70	26	44	100

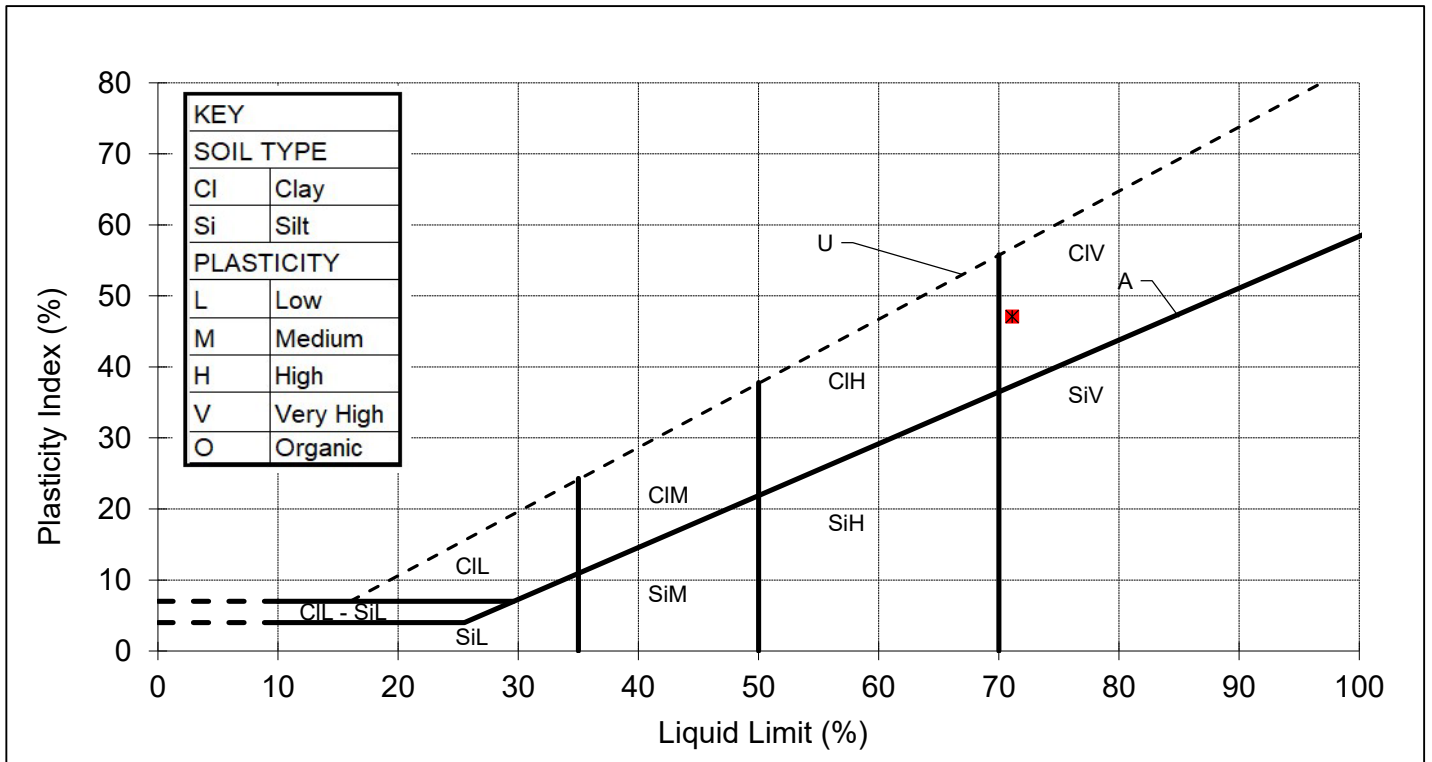
Test Readings mm (average)	Moisture Content %	Correction Factor	Correction factor from Clayton and Jukes 1978
Determination 1 (avg)	18.2	1.030	
Determination 2 (avg)	18.5

Natural Moisture Content (%)	Liquid Limit (%)	Plastic Limit (%)	Plasticity Index (%)	Passing 425 micron (%)
58.2	71	24	47	100

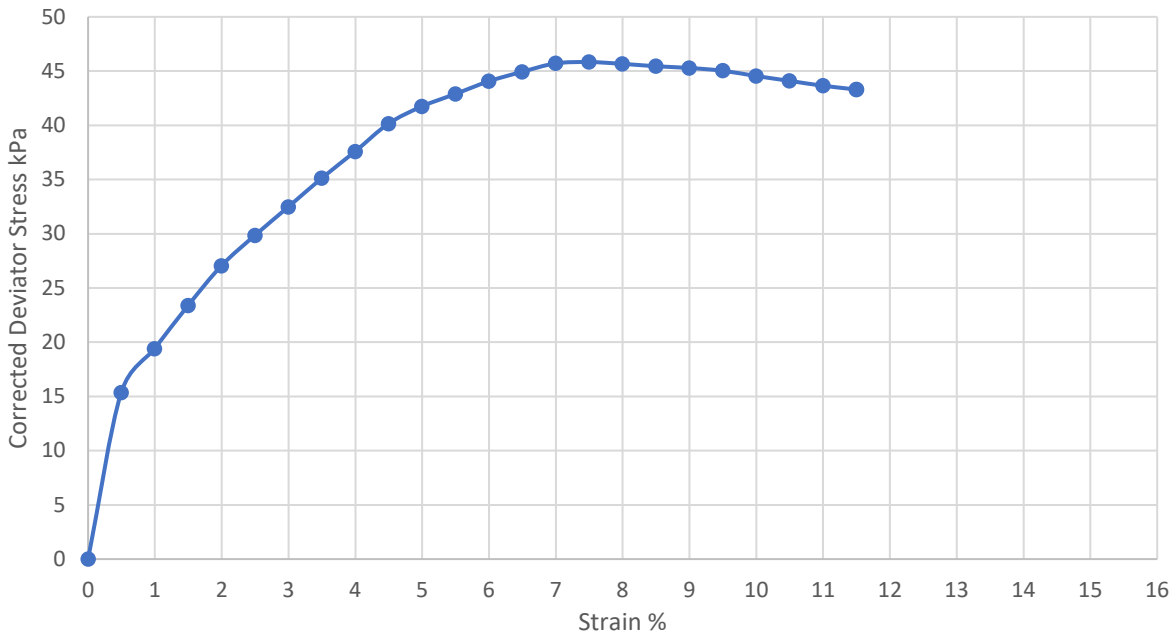
CORRECTED DEVIATOR STRESS vs AXIAL STRAIN

Sample Length (mm)	450	Specimen depth from top of Sample (mm)	80
	Sample Orientation	Vertical	Specimen Condition	Undisturbed
	Specimen Length (mm)	203	Specimen Water Content (%)	65.8
	Specimen Diameter (mm)	101	Specimen Bulk Density (Mg/m3)	1.63
	Membrane Thickness (mm)	0.4	Specimen Dry Density (Mg/m3)	0.98
	Membrane Correction	2.60

Cell Pressure (kPa)	Failure Strain (%)	Rate of Strain (%/min)	Corrected Deviator Stress (kPa)	Shear Strength Cu (kPa)
105	7.5	2.0	46	23

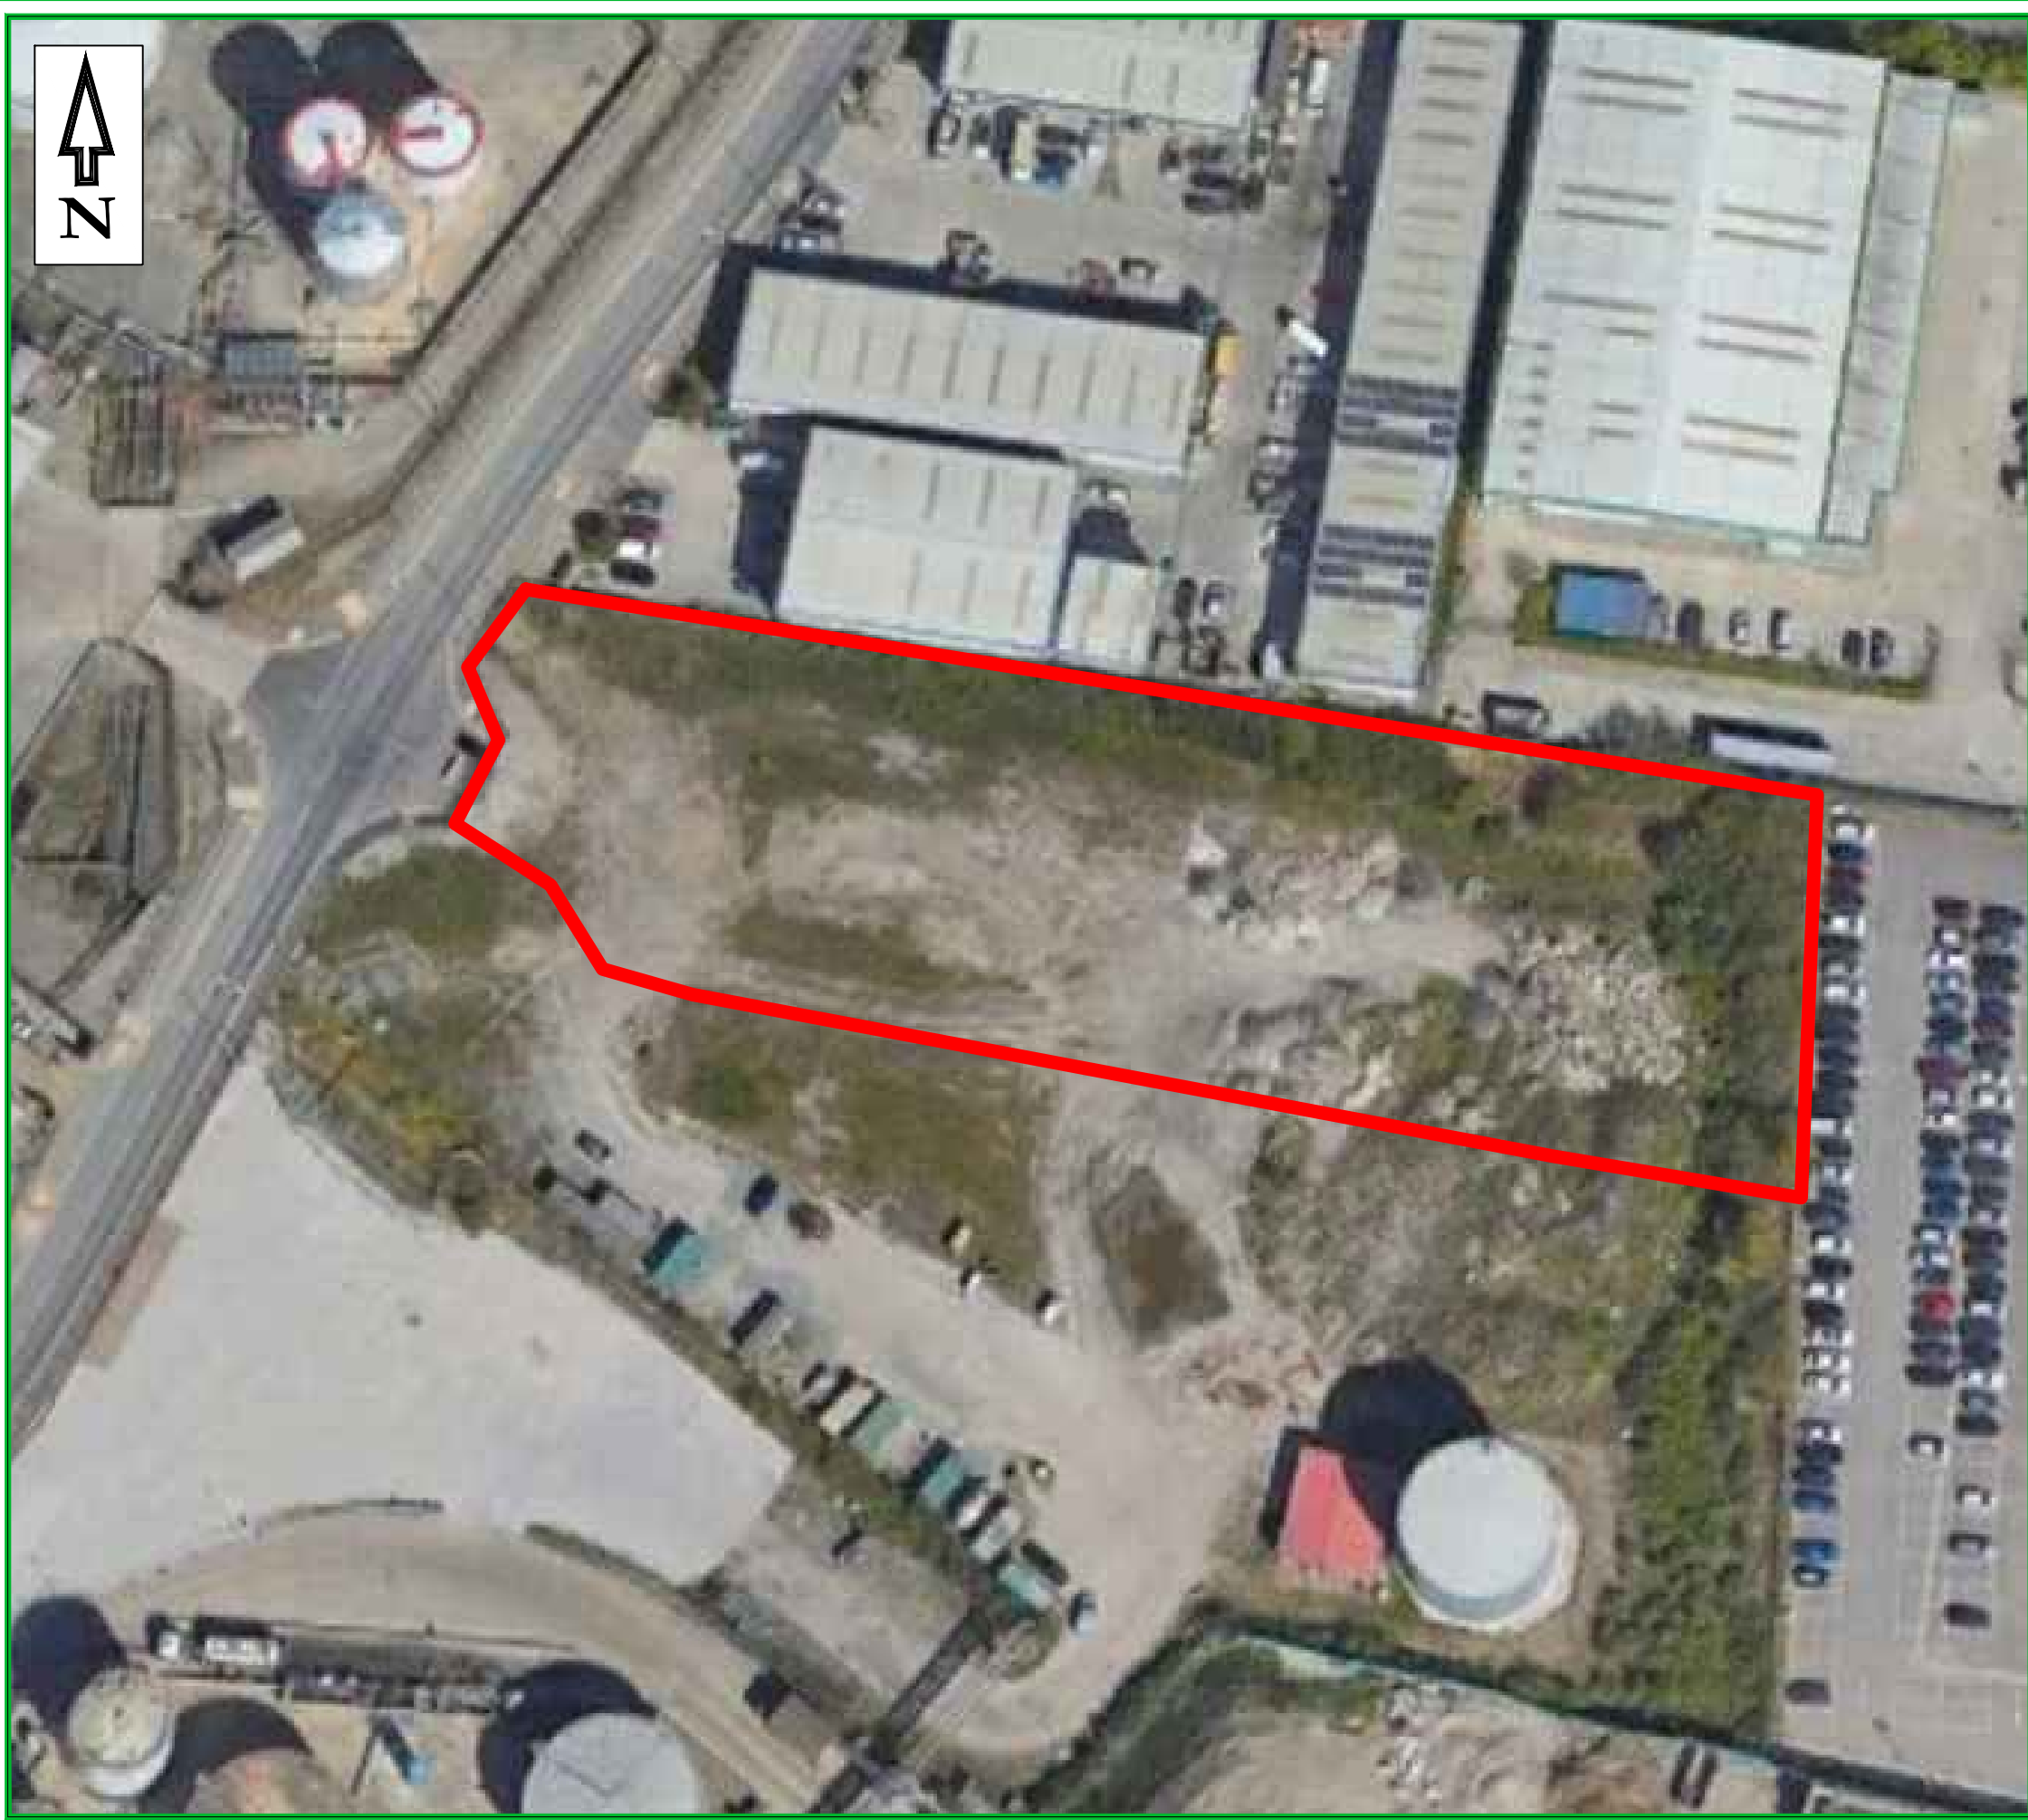
DRAWING No. 22137-2	REV. -
------------------------	-----------

— SITE FOOTPRINT

1.1.2 The site location and layout are presented on BEK Drawing No 22137-1 and BEK Drawing No 22137-2, respectively. Copies of these drawings are presented in Appendix E.

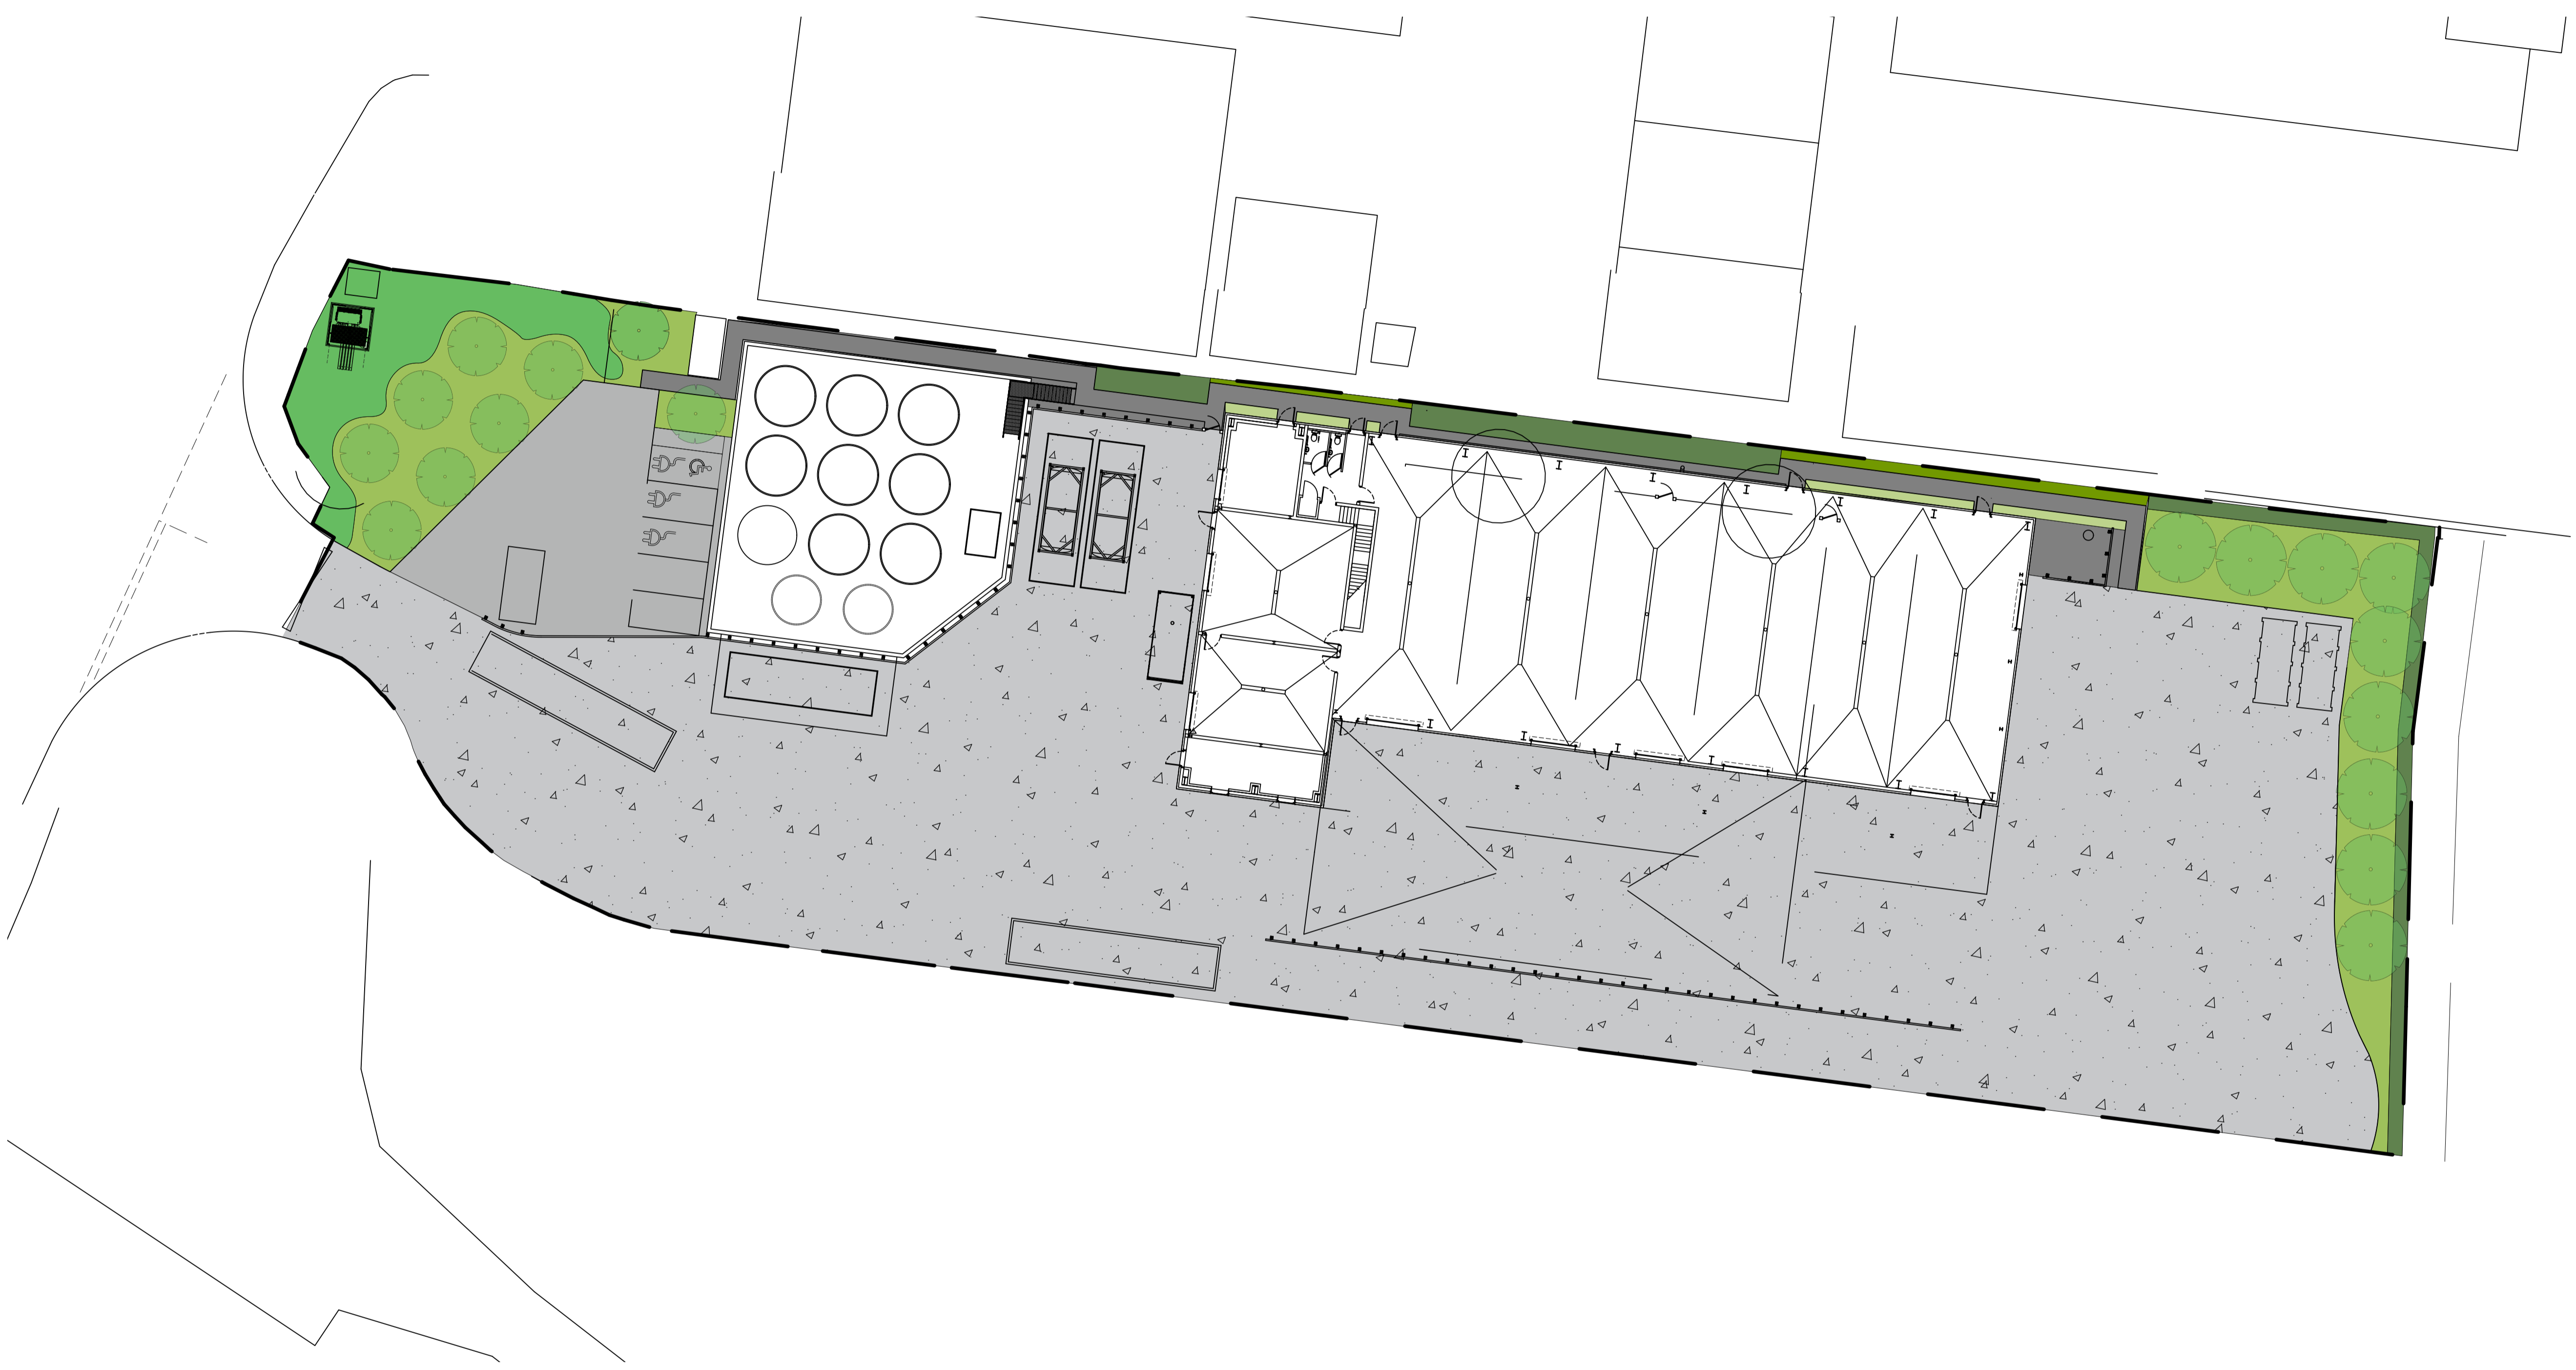
Base drawing:
 Title: Landscape Proposals Plan Stage: Stage 3

Proposed Pedestrian Tarmac
