Phase II Ground Investigation Report

Grange Road, Hedge End, Southampton, Hampshire SO30 2GD

Reference: I6245/GIR

June 2017

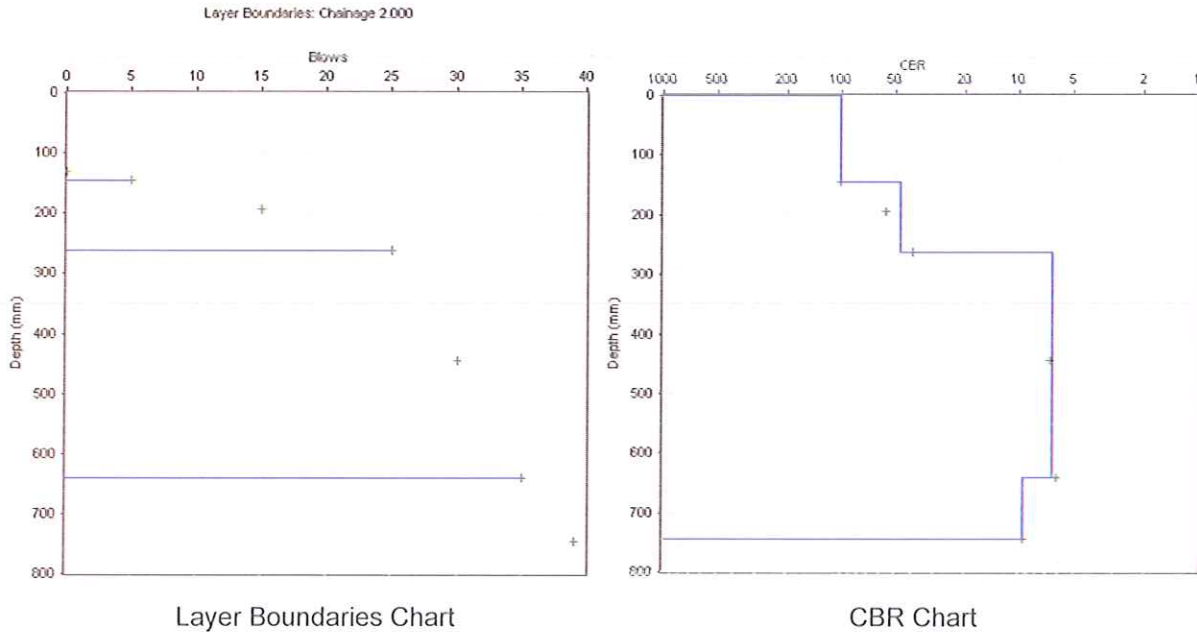
Chainage (km): 2.000
 Direction:
 Location/Offset: Carriageway
 Cone Angle: 60 degrees
 Zero Error (mm): 200
 Test Date: 17/05/2017

Surface Type: Unpaved
 Thickness (mm): 0
 Base Type:
 Thickness (mm):
 Surface Moisture: Wet
 Moisture adjustment factor: Not adjusted

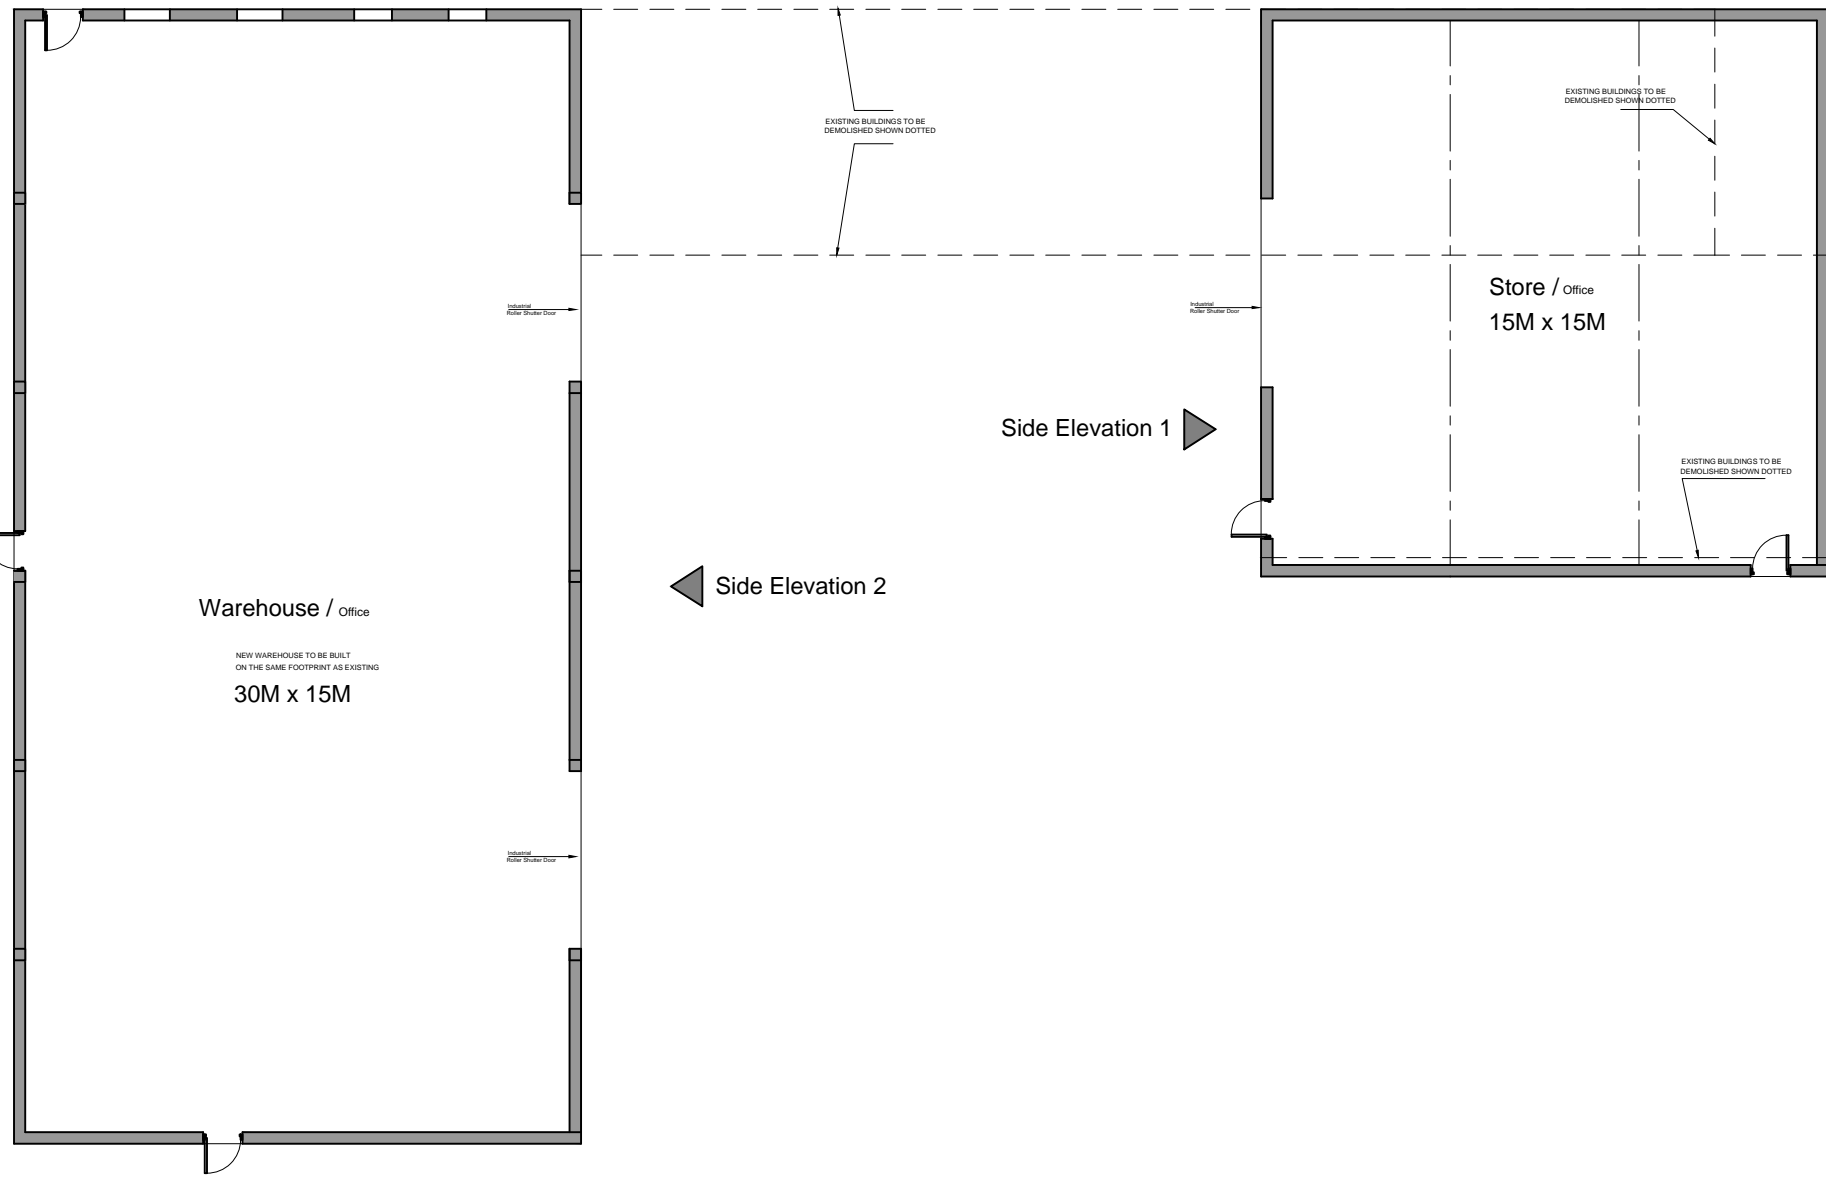
West Elevation

PROJECT
 Demolition of existing 3 Buildings and Replacement with 2 New Buildings.
 Grange Road, Hedge End. SO30 2GD
