# Lundwood STF Bioaerosol Risk Assessment

This document discusses the risk associated with bioaerosols that could arise as a result of anaerobic digestion and its directly associated activities

## Lundwood STF: Bioaerosol Risk Assessment

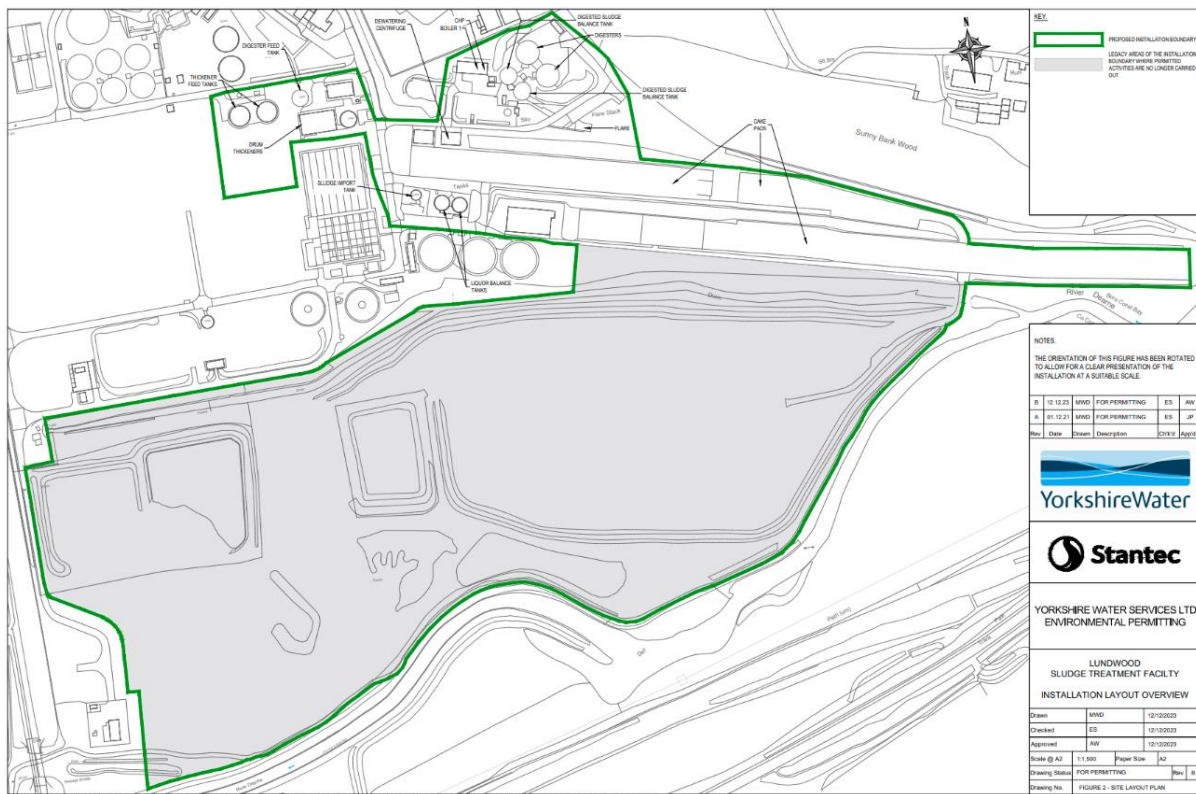
Fig 1 – Lundwood STF showing the installation boundary (green) and associated assets some of which may have the potential to cause bioaerosols

At Lundwood STF, there are a number of sources adjacent to each other, it is therefore not possible to monitor the bioaerosol effect from individual point sources. Bioaerosol monitoring will therefore be considered as a combined single area (fig 1).

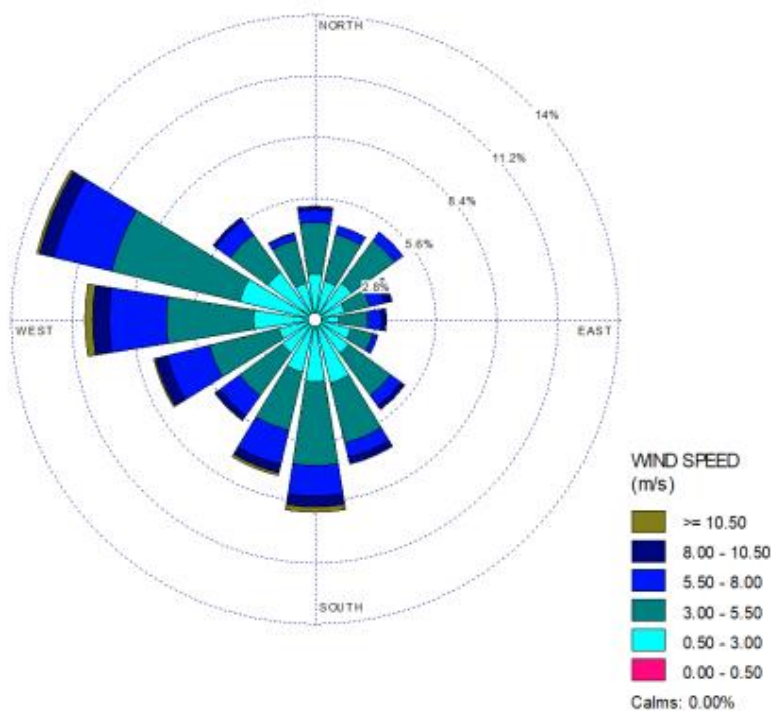
Fig 2 – Lundwood STF NWP Wind Rose Plot (NWP)

As there are no representative meteorological stations for Lundwood STF, numerical weather predicted (NWP) meteorological data for Lundwood STF has been used for predicting the wind direction frequency for Lundwood STF. NWP meteorological data has been adopted for this assessment due to the complexity of the topography on site and is likely to give more accurate wind directions and frequencies. The wind rose plot for Lundwood STF is included in Figure 2.

The wind conditions will always be taken into consideration when conducting the bioaerosol monitoring. 1 upwind and 3 downwind samples in a fan shape will be undertaken. As the monitoring will be dictated by onsite wind conditions, the sampling locations may not match the prevailing wind as dictated in figure 2.

In November 2021, a one off monitoring assessment was undertaken, the monitoring locations are replicated in figure 3. The wind conditions did not match the expected wind results (figure 2) on the day of assessment. Wind conditions will always be noted and reported on within the bioaerosol monitoring report.

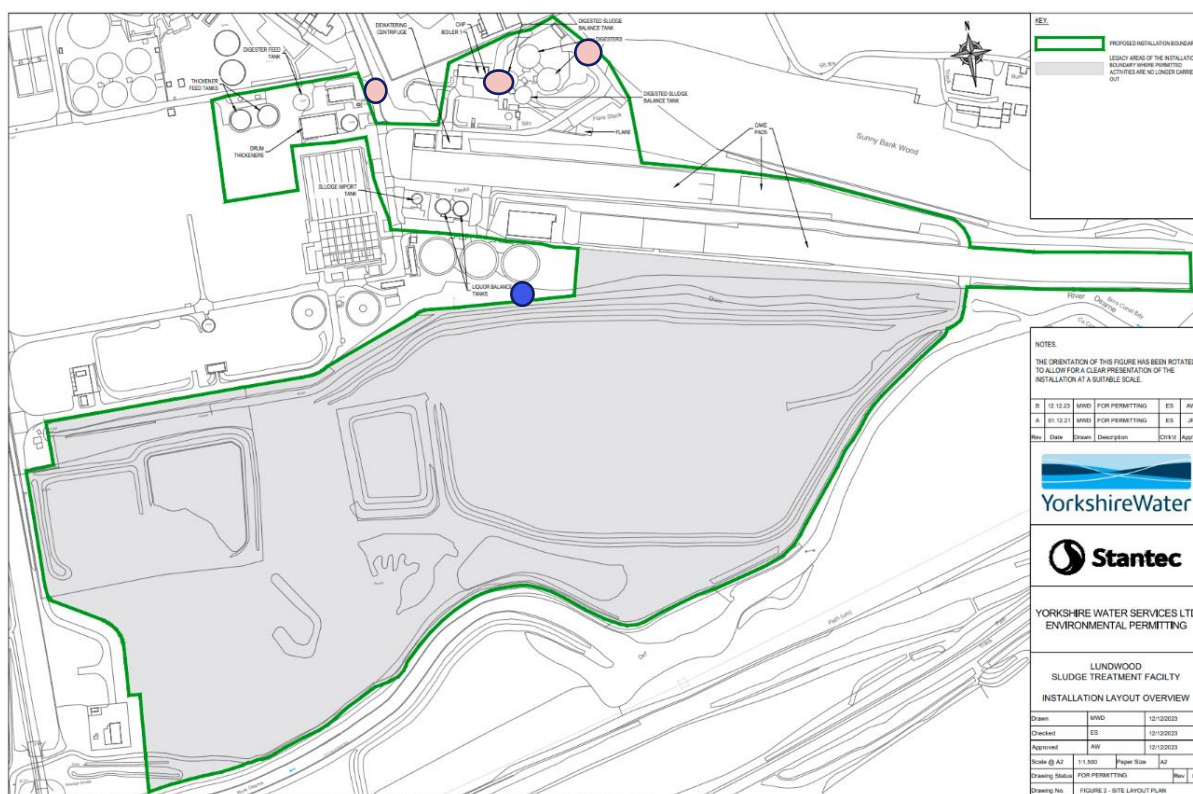
Figure 3 – Lundwood STF Site Plan showing the installation boundary (green) with bioaerosol monitoring locations marked (blue dot = upwind, pink dot = downwind)

One upwind sampling location (marked with a blue dot on fig 3) was used to measure upwind concentrations of bioaerosols. Three samples were taken in a fan shape arrangement downwind of STF operations.

Any future monitoring locations will be dictated by the onsite wind conditions at the time of sampling and may or may not match figure 3. Downwind monitoring locations will be placed so that it captures the key bioaerosol locations, which will incorporate the dewatering, digestion and thickening/cake pad area.

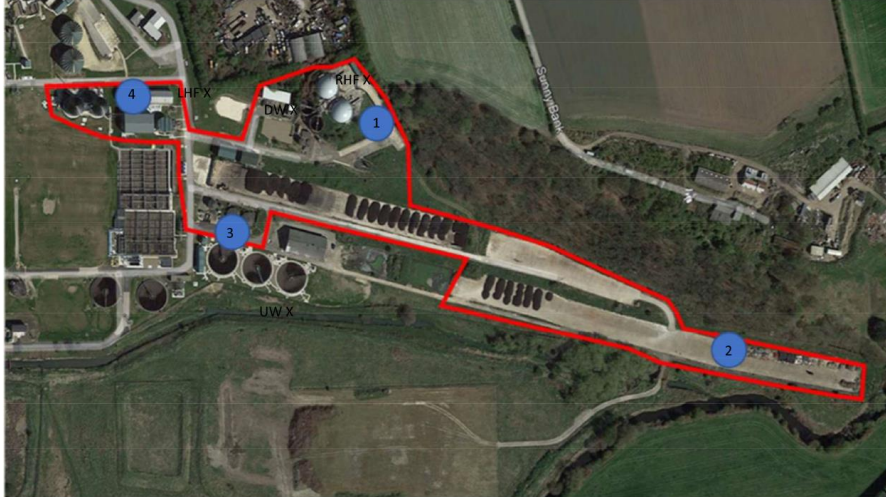
Site boundary marked on red.

A standard map is shown on the next page. The operational boundary of the site is shown in red and the sample points are shown and labelled.
