SITE CONDITION / BASELINE REPORT

Wellskye Ltd
Blyth Road
Carlton Forest
Worksop
S81 0TP

Document Reference No. WL/BLY/SCR/0424

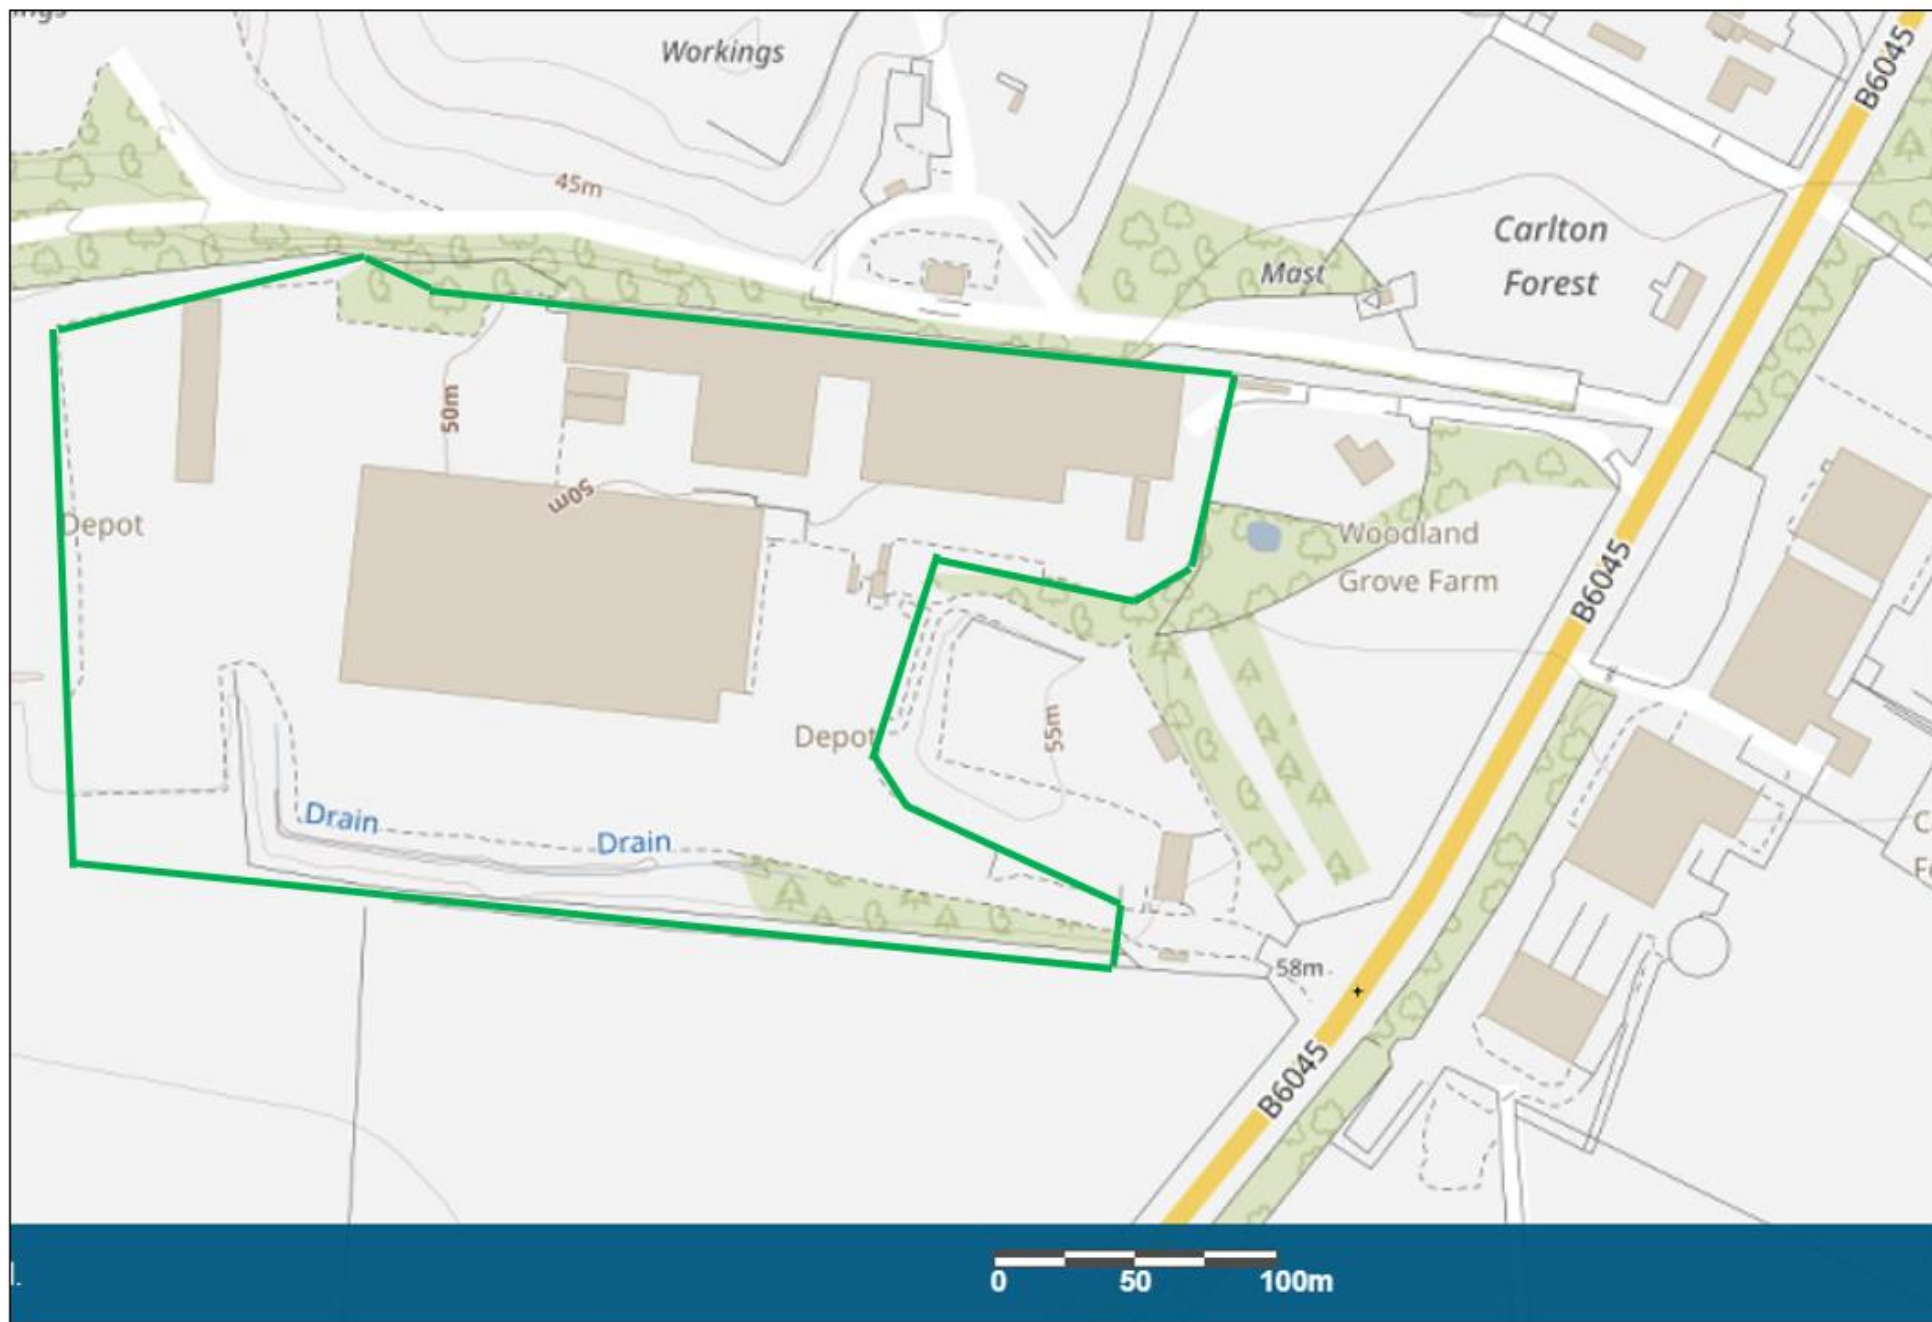
Plan No. WL/BLY/PA/01 – Permitted area of the site

This report is to be read in conjunction with drawing numbers WL/BLY/0424/01, WL/BLY/0424/02 and WL/BLY/0424/03 and attached to the Environment Management System Version 1.0, April 2024 for the site at Appendix 1. The area to which this report relates is shown on the attached plan WL/BLY/SCR/01
