Buckton Vale Quarry Access Road

Environmental Setting and Site Design (ESSD) Report

Report No. K4859-ENV-R004-01

25 October 2022

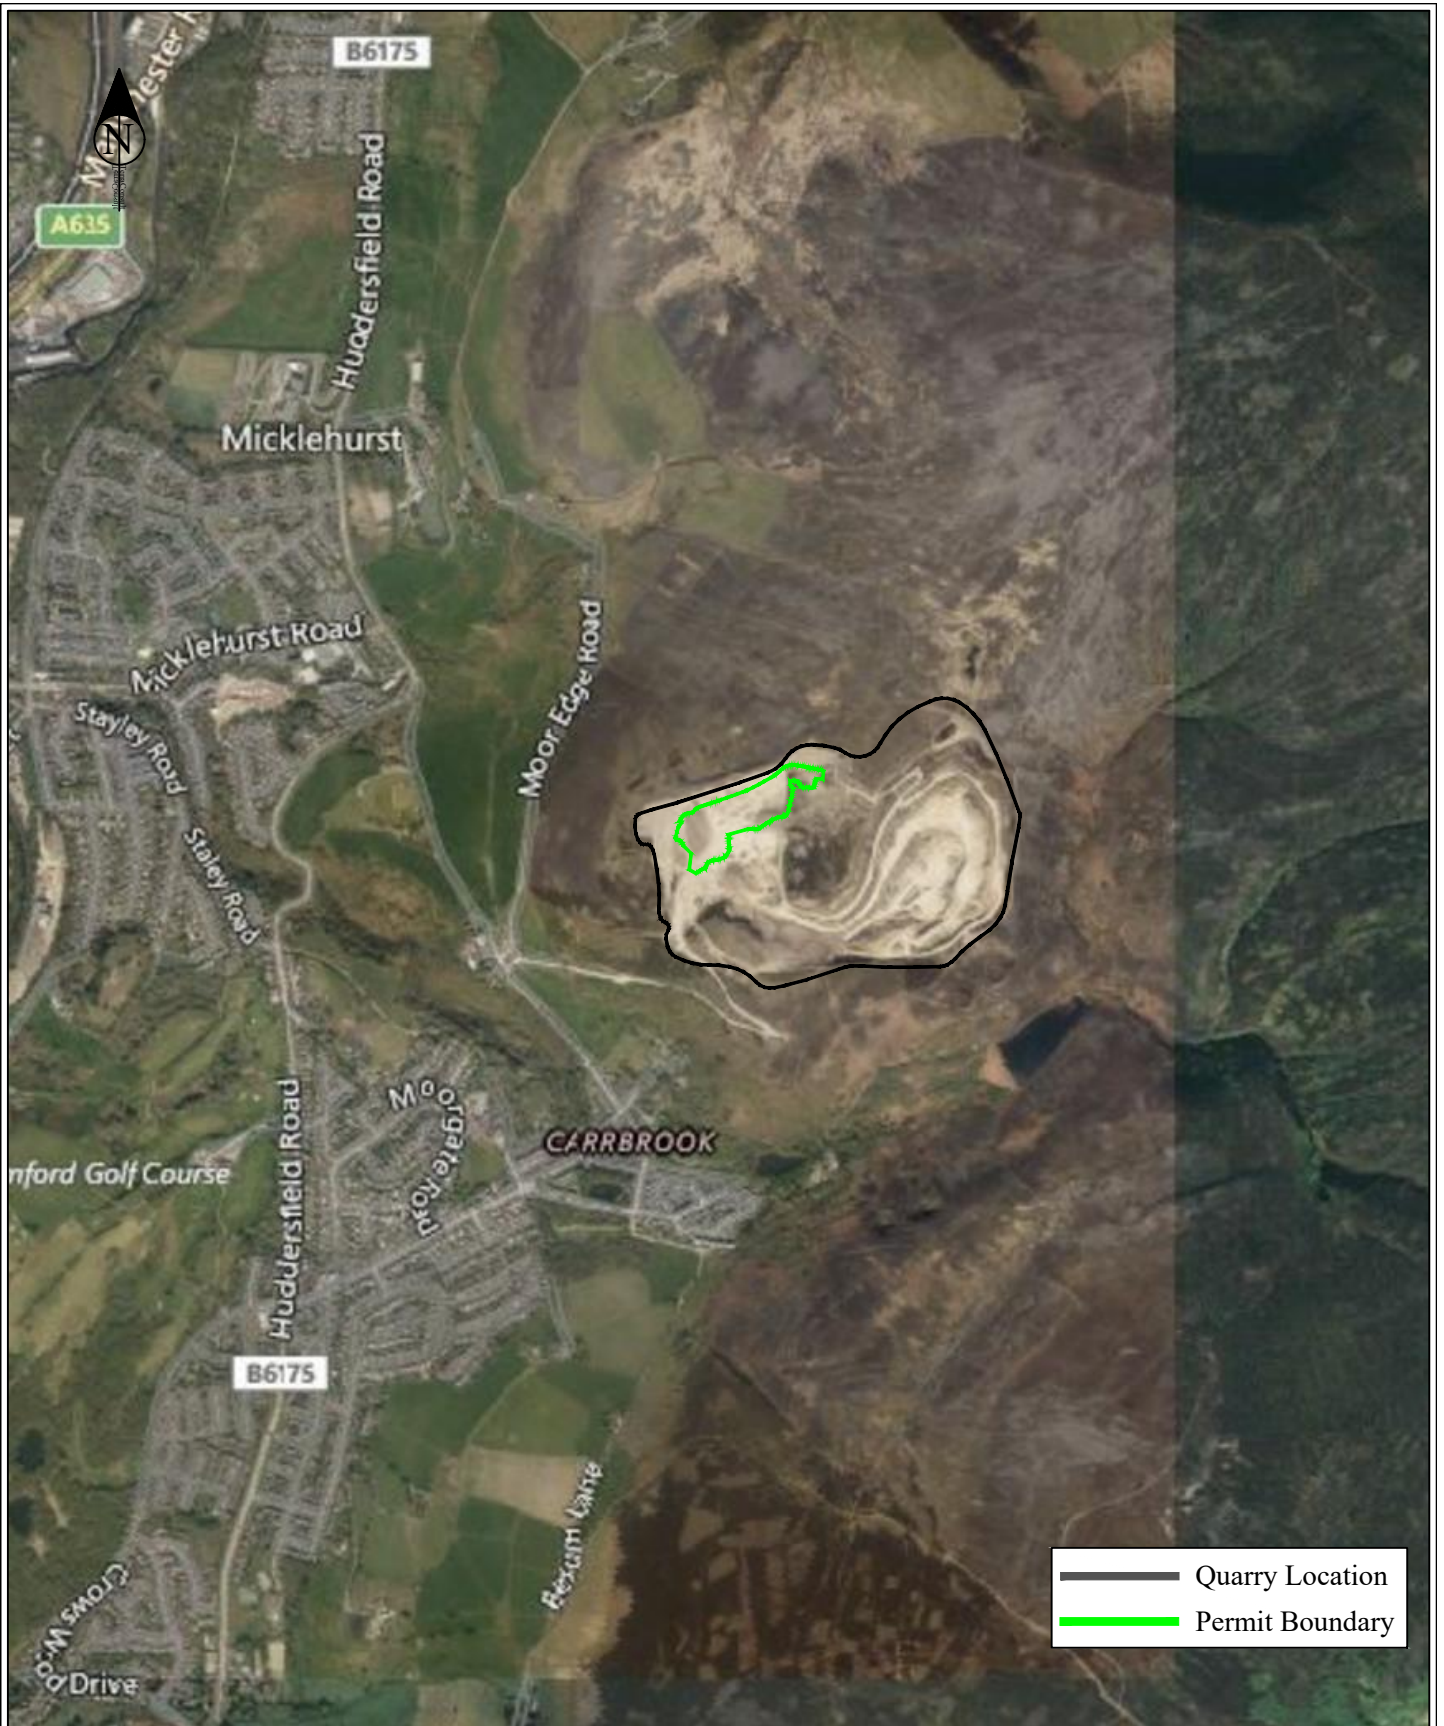
TerraConsult	Site	Scale		1:15,000	@ A4
	BUCKTON VALE QUARRY	Drawing No.		4859/1/004	
Title		Rev	Date	Description	
	SITE LOCATION PLAN				
File			4859.1.004 Site Location		
Bold Business Centre, Bold Lane, Sutton, St Helens WA9 4TX	Client	Date	06/20	Engineer	PP
CHURCHILL ENVIRO LIMITED		Drawn	PP	Checked	JB

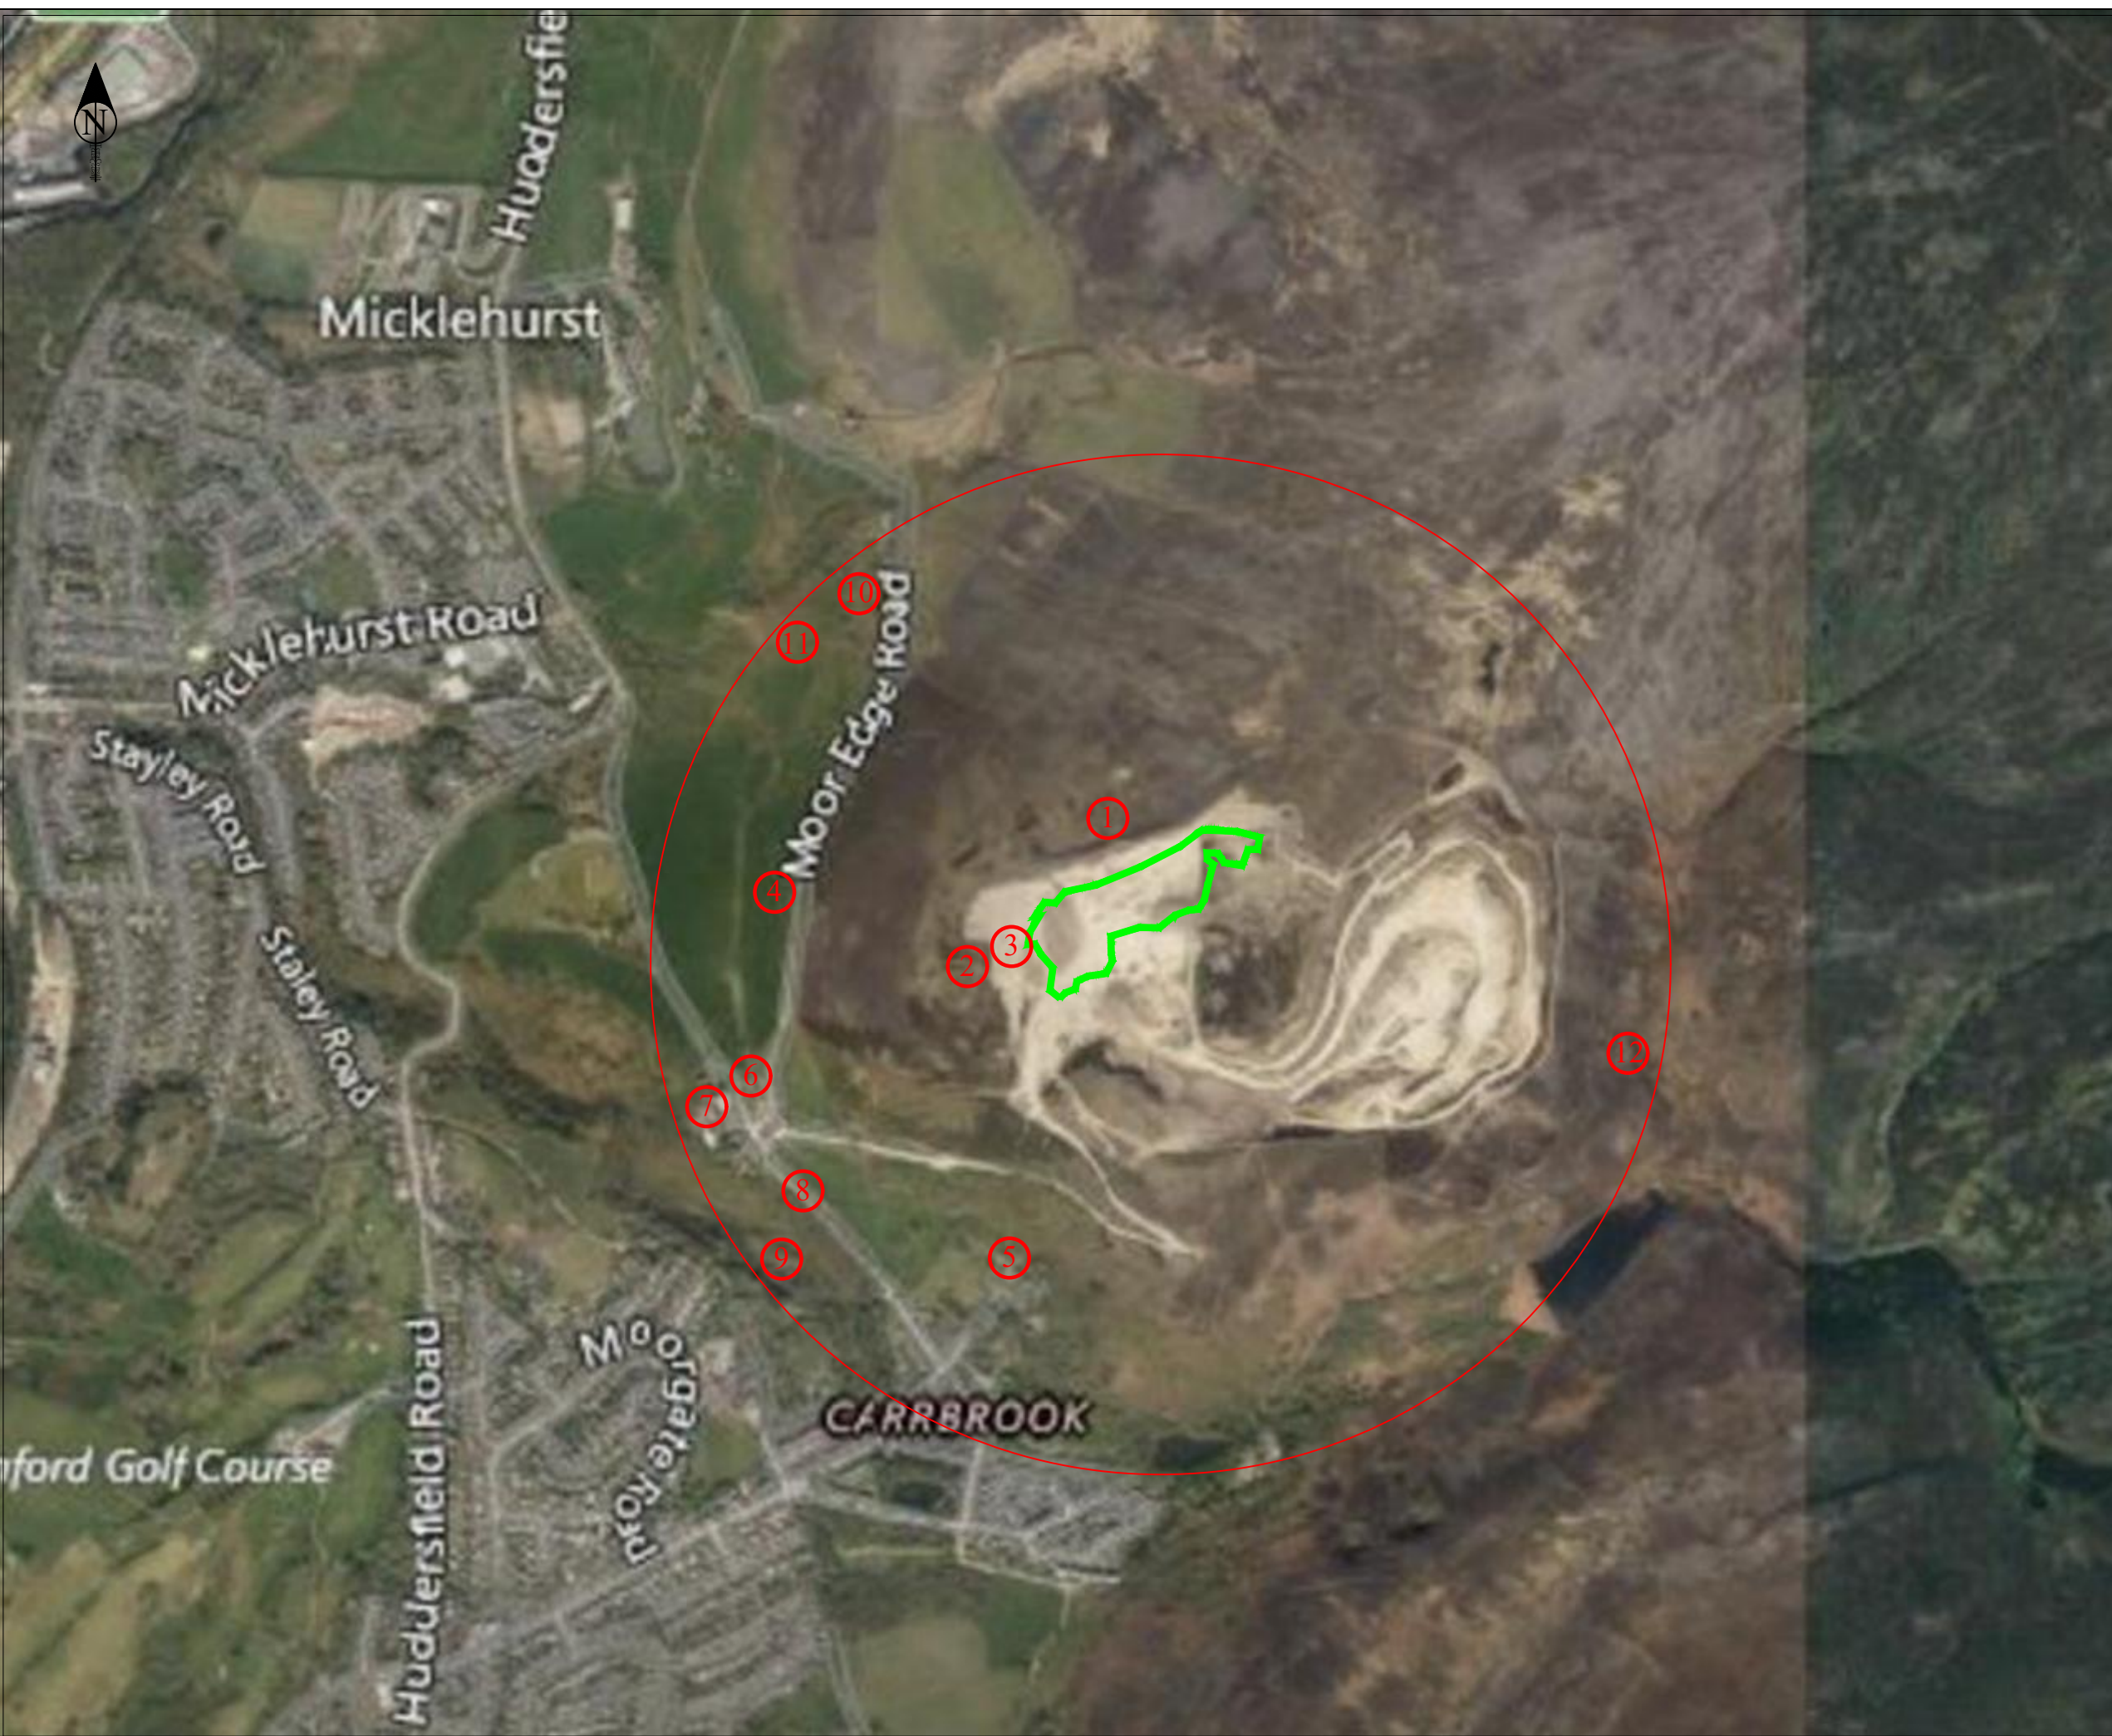
Title
Sensitive Receptor Plan

- 1 Sensitive Receptors within 500m of permit boundary
- Buffer Zone
- Proposed Permit Boundary

There are a number of properties and other potential receptors close to the proposed permit boundary; these are listed in Table 1 below and their location shown on drawing referenced 4859/1/006.
