Langley Inert Landfill

Stability Risk Assessment Report

A103725

CEMEX UK Materials Limited

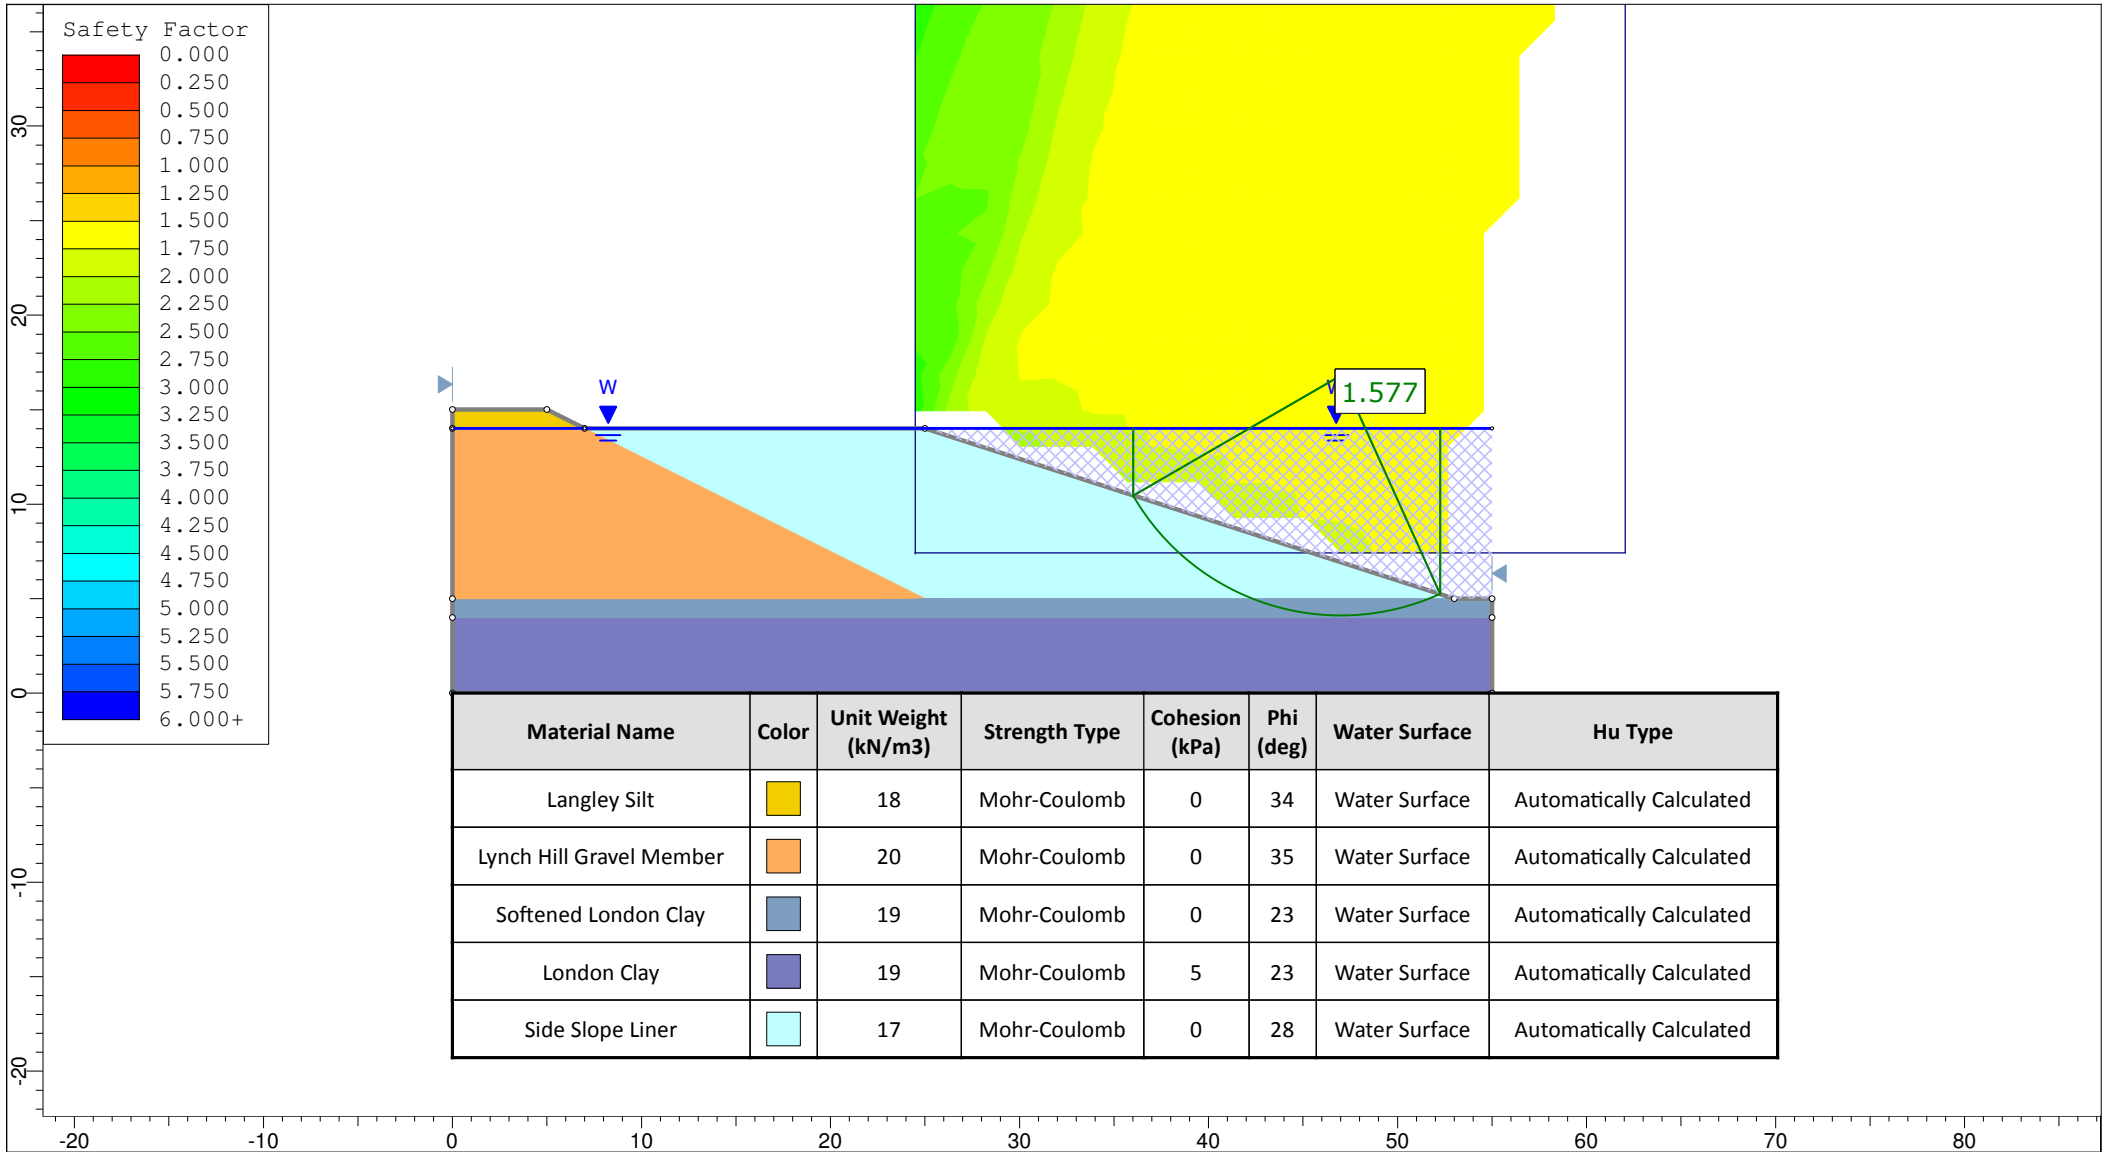
Project			Side Slope Liner - DA1 C1 Drained - below water only		
	Analysis Description			DA1 C1 Drained		
	Drawn By	MGS	Scale	1:400	Company	WYG Ltd
	Date	09/08/2017, 10:28:53			File Name	Side Slope Liner - DA1 C1 - Drained - Underwater Only.slim

Run	File Name	Stress Condition	Factor of Safety (FOS)		Notes
			C1	C2	
09	Side Slope Liner – DA1 C1 – Drained – Underwater Only	Effective (Drained)	1.577 (Surface)		Underwater Placement of material consolidation under self-weight. Liner face angle = 1(v): 3(h)
10	Side Slope Liner – DA1 C2 – Drained – Underwater Only	Effective (Drained)		1.324 (Surface)	
11	Side Slope Liner – DA1 C1 – Undrained - Upper Added	Total / Effective	1.426 (Deep Seated)		Placement of upper liner material, 20.00m crest width, short term undrained conditions.
12	Side Slope Liner – DA1 C2 – Undrained - Upper Added	Total / Effective		1.228 (Deep Seated)	
13	Side Slope Liner – DA1 C1 – Drained - Upper Added	Effective (Drained)	1.433 (Deep seated)		Placement of upper liner material, 20.00m crest width, long term drained conditions.
14	Side Slope Liner – DA1 C2 – Drained - Upper Added	Effective (Drained)		1.146 (Surface)	
15	Side Slope Liner – DA1 C1 – Drained – 5m instep bench	Effective (Drained)	1.319 (Deep Seated)		Placement of upper liner material, design 20.00m crest width and 5.00m bench, long term drained conditions.

- 2.7.6 Initially the stability of the side slope liner beneath the standing water level was investigated using the software program SLIDE. The results indicate that partial factor combination C2 offers the most onerous conditions and to achieve a factor of safety of 1.00 the face angle of the side slope liner material is $1(v) : 3(h)^\circ$. Although a factor of safety of 1.00 is indicative of a material on the point of failure if a slope is allowed to attain its own natural angle of repose by definition this will be at a factor of safety of 1.00.

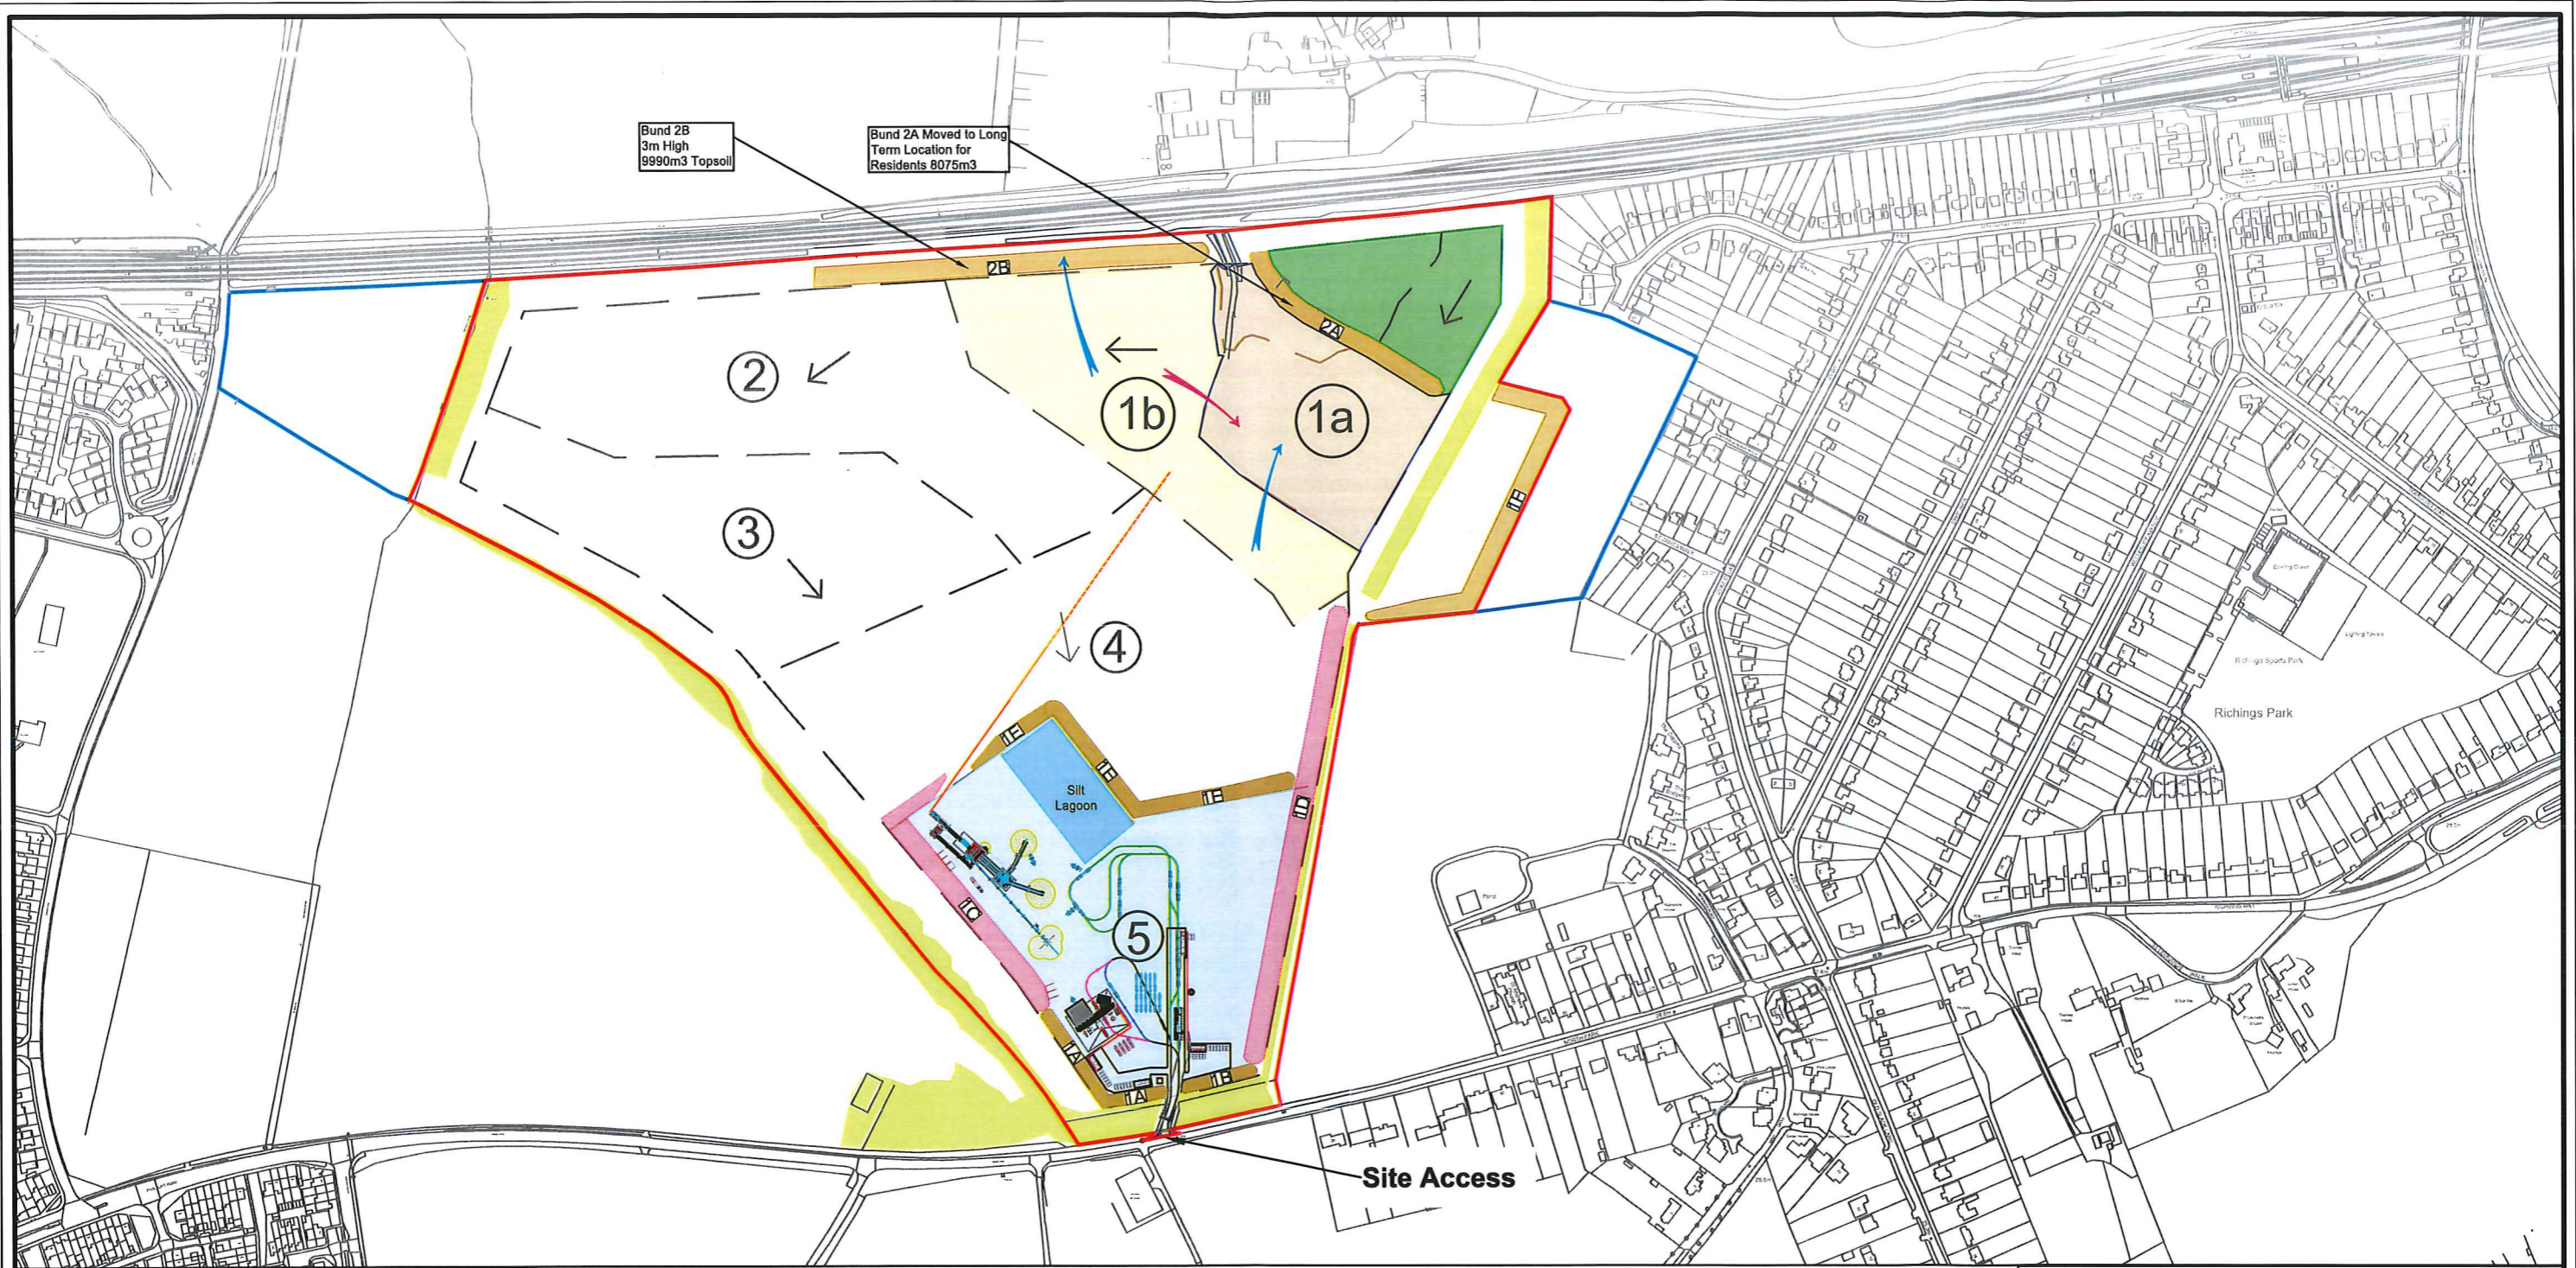
Drawn By:	T Paiman	Company:	CEMEX UK Operations Limited
Date:	June 2017	Site:	Land off North Park road, Richings Park
Scale:	1:5000 @ A3	Project:	Mineral Extraction
Chkd:		Title:	Method of Working and Restoration Phases Phase 1b (Year 1 Month 7-Year 1 Month10)
OS Ref:		Dwg No:	P1/739/4B
			Phase 1b

Bund 2B
3m High
9990m³ Topsoil

Bund 2A Moved to Long
Term Location for
Residents 8075m³

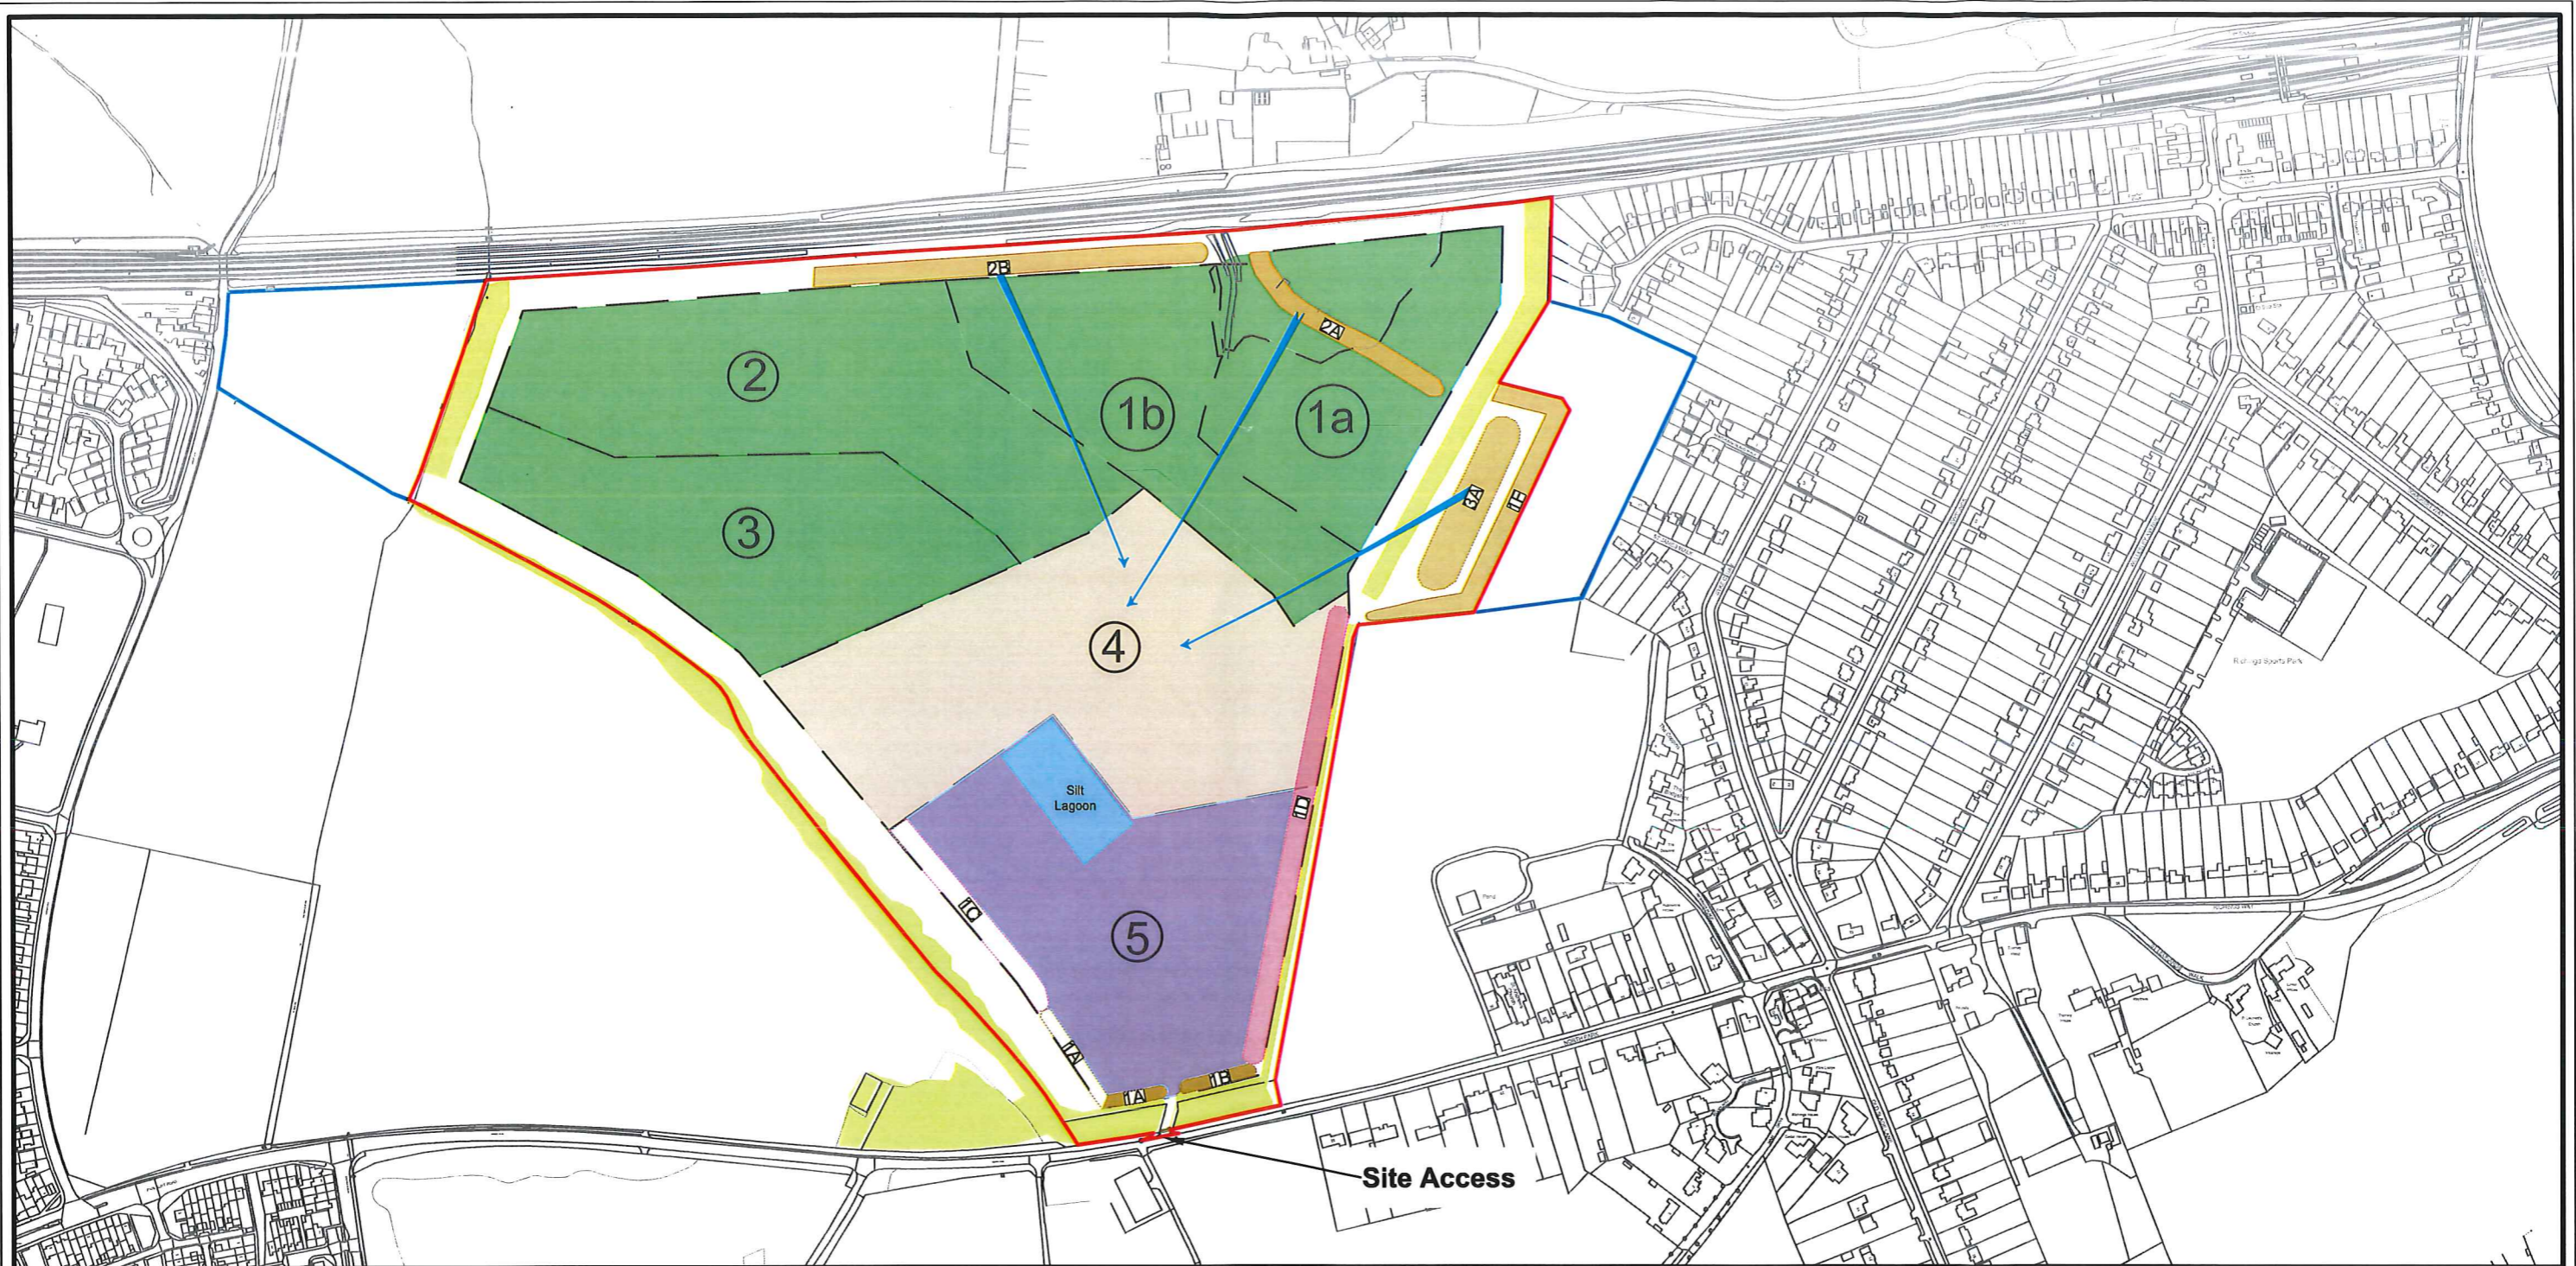
Drawn By:	T Paiman	Company:	CEMEX UK Operations Limited
Date:	June 2017	Site:	Land off North Park road, Richings Park
Scale:	1:5000 @ A3	Project:	Mineral Extraction
Chkd:		Title:	Method of Working and Restoration Phases Phase 5 (Year5 Month1-Year6 Month1)
OS Ref:		Dwg No:	P1/739/4B
			Phase 5
