Proposed Data Centre at Thorney Lane Business Park, Iver

Ground Contamination Desk Study and Preliminary Risk Assessment

Reference: ARP-276894-24-XX-XX-LQ-RP-00005

Issue 3 | 8 December 2025

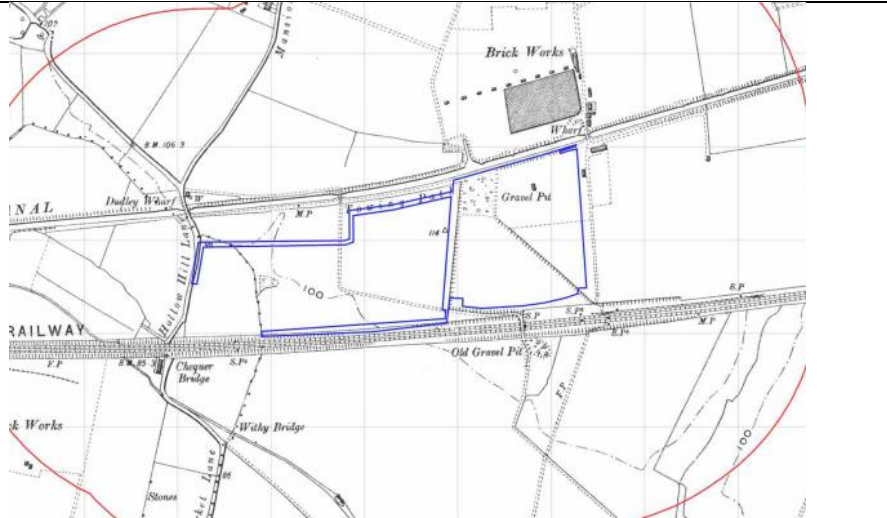
<p>1:10,560 County Series Mapping – 1897 -1898</p>	Limited given age and limited site activity.

Dates	Land-use / activity	Potential contamination
Up to Circa (c.) 1897	<p>A gravel pit was present in the northwest of the main site. A change in ground level is indicated running northwest-southeast through the main site area and may indicate quarrying had already occurred in the western part of this area. The rest of the site is shown as undeveloped open fields.</p> <p>The Great Western Railway line and Grand Union Canal (Slough Branch) were already present by 1897 to the south and north of the site respectively. The railway line was constructed on a raised embankment for the section adjacent to the site while the canal was at a lower-level cutting.</p> <p>In the wider area a brick works is shown directly north of the main site of the far side of the canal. An old gravel pit is indicated to the south of the site immediately beyond the railway line. .</p>

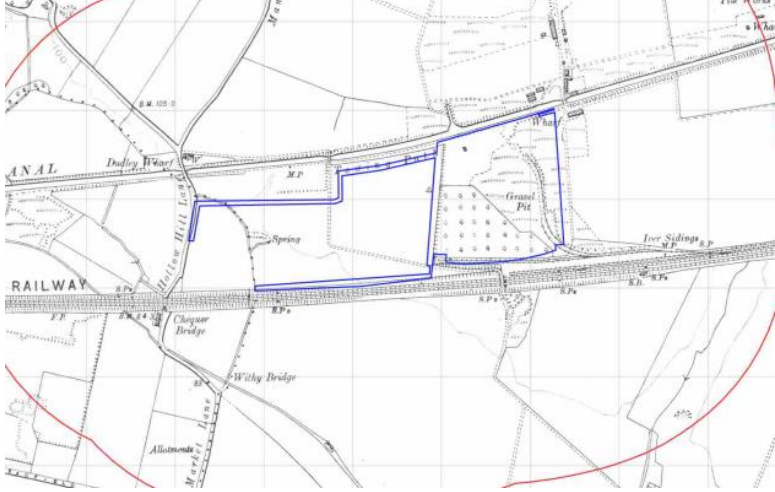
c. 1884 - 1945	<p>The gravel extraction expanded over time spreading eastwards over the eastern site area. A railway siding connected the gravel pit to the main railway line to the south. By c.1923 the pit had been partially restored to the western and southern boundaries dominated by vegetation.</p> <p>By 1924, the brickworks to the north had been demolished.</p>	Unknown Made Ground associated with infilled gravel pits.

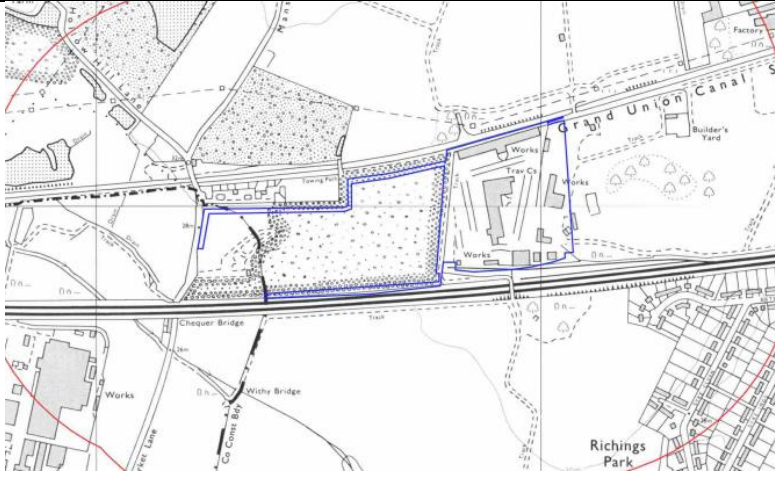
<p>1:10,000 National Grid Mapping - 1974</p>	<p>Moderate potential, mainly from fuel oils, with metals, other hydrocarbons/organic compounds and asbestos and placement of fill of unknown origin prior to construction.</p>

<p>1:10,560 County Series Mapping - 1923</p>	
<p>1945 - 1974</p>	<p>Within the main (eastern) site the quarrying appears to have finished in the late 1940s with the excavation face moving east of the site area. Quarrying to the east of the site appears to have been completed by the mid-1960s based on aerial imagery showing this area had been backfilled.</p> <p>The main site area was redeveloped in the late 1960s/early 1970s as a concrete works and engineering works operated by Bison Concrete Limited. The historical mapping shows various travelling cranes, workshops, engineering works and electrical substation within the site area. Above ground tanks are identified in two areas, which are most likely associated with fuel oil storage. It is likely that some degree of earthworks and infilling was undertaken for the redevelopment give the uneven ground surface shown on the previous mapping.</p> <p>By 1970, the area to the east of the site is shown as vegetation and a builder's yard which indicated that restoration (and possible landfilling) had occurred.</p> <p>Mapping from c.1974 shows gravel extraction covering the field to the west. The excavation edges are very close to the boundaries of the western area of the site.</p>

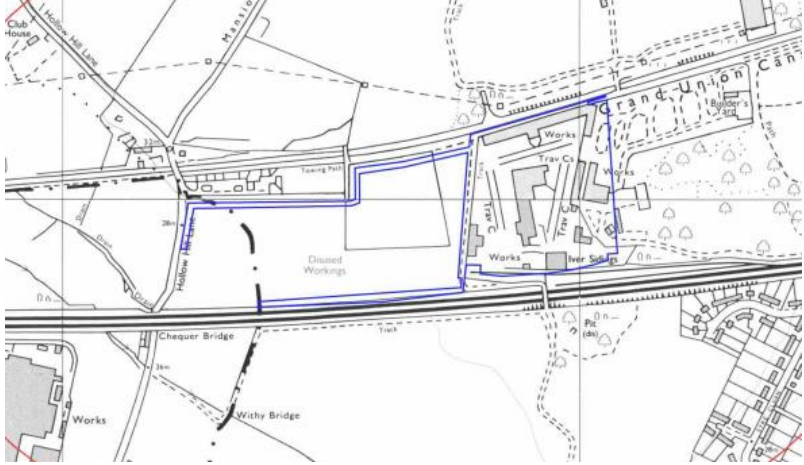
<p>1974 to 1990</p>	<p>The main site area remained relatively unchanged from the 1970s until the mid-1990s with some additional buildings constructed on site and expansion of the business park to the east of the site.</p> <p>Mapping from 1988, shows the western field labelled as 'disused workings and appears to have been infilled. This area is recorded as a local authority landfill. The records are limited as it predates the main regulation of landfills in the 1990s but there are some records which indicate it accepted domestic waste up until c.1990. Further details on the landfill are included in Section 3.2.</p>	<p>Moderate potential on the main site mainly from fuel oils, with metals, other hydrocarbons/organic compounds and asbestos.</p>

<p>1:10,000 National Grid Mapping – 1987-1988</p>	<p>Landfill leachate in addition to the above.</p>
<p>1990 - 2015</p>	<p>In 2002, Bison Concrete Limited was granted planning for the construction of a waste transfer station (Ref: 02/08203/CM).</p> <p>From c.2005, an area of the site (at Unit 13) was used by Cappagh Public Works Ltd for the material recycling. A successful appeal was made in 2007 against an enforcement notice served by the County Council in 2005 that alleged that there was a material change from a builder's yard to a waste transfer, storage and processing. A variation to the existing planning application was made (Ref: 09/01533/CM), where the Environment Agency requested a site investigation which resulted in three boreholes being drilled with groundwater sampling. The report was found to be satisfactory and the relevant condition discharged.</p> <p>On 02/05/2007 there was an oil/fuel pollution incident at the eastern site boundary which resulted in Significant (Category 2) impacts to water and land. No further detail is provided.</p> <p>By 2008, the concrete works had closed, and aerial photos indicate that the laydown areas for concrete products had been cleared. By 2010, most of the site had been demolished (except adjacent to the eastern site boundary including the Speedy Fuels building) and there were large stockpiles of demolition material present on site. It is possible that some of this material was placed as part of the earthworks to create a construction platform.</p> <p>From 2010, part of the site was used as a vehicle dismantling yard. In 2011, a planning application (Ref: 11/00150/FUL) was granted for the redevelopment of the site to provide storage and maintenance compound incorporating office and maintenance buildings.</p> <p>In April 2010, a large fire badly damaged a building in the northeast of the site (refer to eastern area GQRA [1] for location and details). The building was clad in asbestos cement sheeting. There were reports of explosions possibly from gas cylinders in one of the units used as a car parts body workshop.</p> <p>In 2015, a further planning application was granted for a wood recycling facility (Ref: CM/00252/CM).</p> <p>In April 2015, the Maidenhead Advertiser reported that as many as 60 tyres were dumped on open ground and set alight near the Thorney Business Park. It is not clear where this fire occurred, although it appears to be located offsite.</p> <p>Various other licensed waste licences were granted for the site between 2013 and 2015, including Quattro (UK) Limited for material recycling and the treatment of waste and a vehicle 'depollution' facility.</p>	<p>Moderate potential, mainly from fuel oils, with metals, other hydrocarbons/organic compounds and asbestos and placement of fill of unknown origin prior to construction and from recycling operations.</p> <p>Landfill leachate in addition to the above.</p> <p>Contamination from the fire, including spread of asbestos fibres and PFAS from firefighting foams.</p>

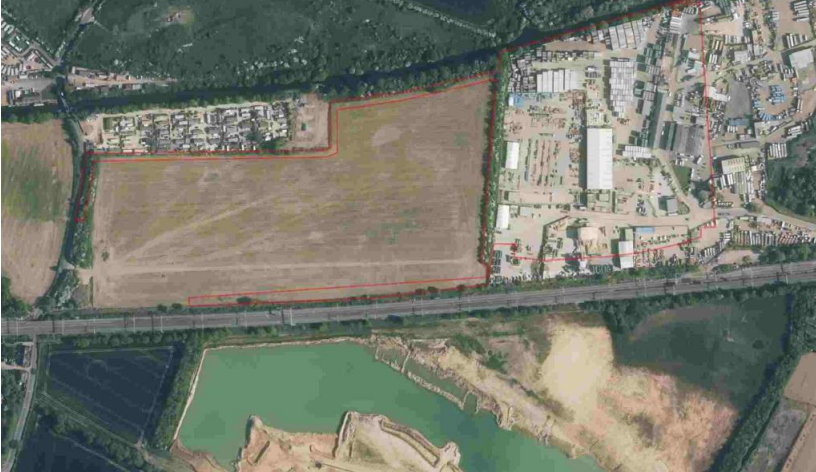
<p data-bbox="288 1659 509 1688">Aerial Imagery - 2022</p>	<p data-bbox="1187 725 1418 864">Moderate potential, mainly from fuel oils, with metals, other hydrocarbons/organic compounds.</p> <p data-bbox="1187 869 1418 925">Landfill leachate in addition to the above.</p>

<p data-bbox="288 667 509 696">Aerial imagery – 2013</p>	
c.2016 to present	<p data-bbox="288 725 1139 949">The eastern site area was part of the wider Thorney Business Park and remained relatively unchanged until the recent demolition works in 2024/2025. Trade directory entries list a wide variety of activities on site including car breakers and dismantlers, concrete manufacturers and distributors, garage services, oil fuel distributors (Speedy Fuels), packaging supplies and road haulage. There are also several waste exempt activities such as storage and treating of waste, use of waste in construction, screening and blending of waste, treatment of waste wood and waste plant matter and recovery of scrap metal.</p> <p data-bbox="288 954 1059 1010">The western area of the site appears to have remained unchanged as part of an agricultural field. Access roads remain largely unchanged.</p> <p data-bbox="288 1014 1123 1155">Google earth images from circa 2018 show earthworks at the location of the current traveller’s community compound. Subsequent images from 2019 to 2021 appear to show stockpiles of assorted (waste) materials. Later images (also 2021) show further earthworks in progress followed by the introduction of trailer / caravan units and possible scrap vehicles along the western site boundary.</p>
