Unexploded Ordnance risk assessment

Detailed Unexploded Ordnance (UXO) Risk Assessment

Project Name	Thorney Lane, Iver
Client	Concept Engineering Consultants Ltd
Site Address	Thorney Lane, Iver, SLO 9HE
Report Reference	DA20371-00
Date	23 rd July 2024
Author	JBM
Quality Assurance	PB
Final Check	ERG

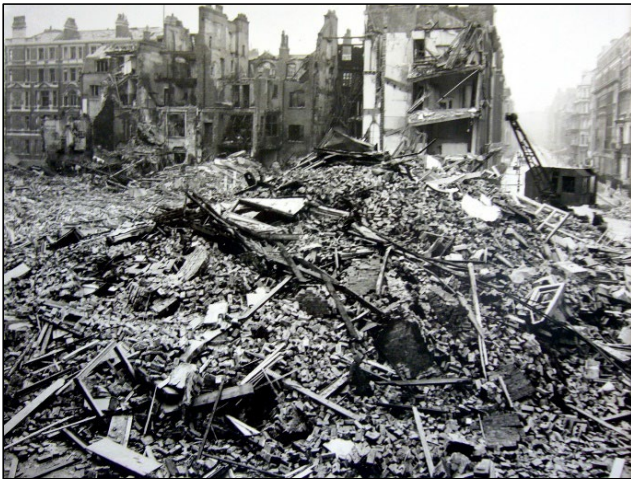
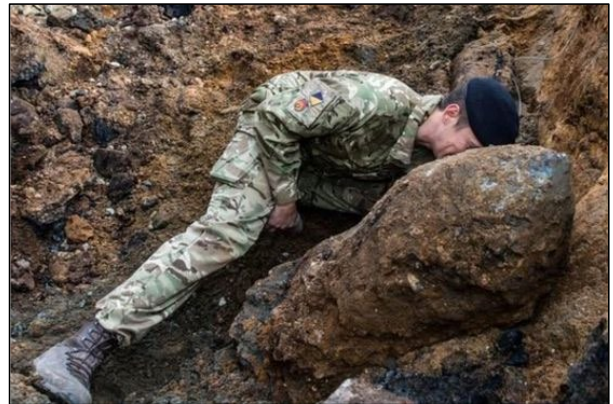
Top: J-curve Effect - Due to angle of entry, unexploded bombs would often end their trajectory at a lateral offset from point of entry, often ending up beneath adjacent extant structures/sites.

The photograph **above** shows a 250kg unexploded bomb found in Bermondsey in 2015, pointing upwards, demonstrating 'J-curve'.

One of the most common scenarios for UXO going unnoticed was when a UXB fell into a 'bomb site' (such as the area shown **Top Left**), the entry hole of the bomb obscured by any debris and rubble present. Note that the entry hole of a 50kg UXB could be as little as 20cm in diameter (**Left**).

J-curve is the term used to describe the characteristic curve commonly followed by an air delivered bomb dropped from height after it penetrates the ground. Typically, as the bomb is slowed by its passage through underlying soils, its trajectory curves towards the surface. Many UXBs are found with their nose cone pointing upwards as a result of this effect. More importantly, however, is the resulting horizontal offset from the point of entry. This is typically a distance of about one third of the bomb's penetration depth, but can be higher in certain conditions (see **Annex E**).

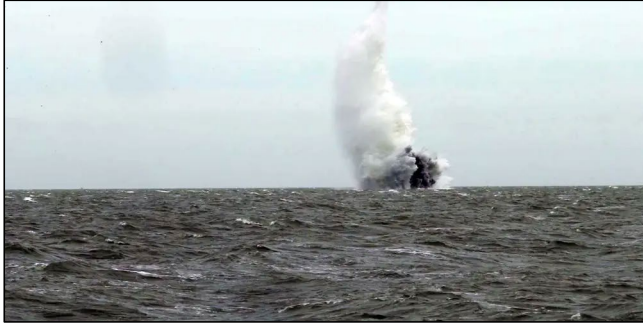
500kg German HE Bomb, February 2018

An unexploded World War Two bomb found near London City Airport has been detonated.

The 500kg device was discovered at the King George V Dock on Sunday during planned work at the airport.

The 1.5m-long German bomb - which was found in a bed of silt, 15m underwater - was carefully removed from the Thames and placed in a secure location a mile away from the coast of Essex.

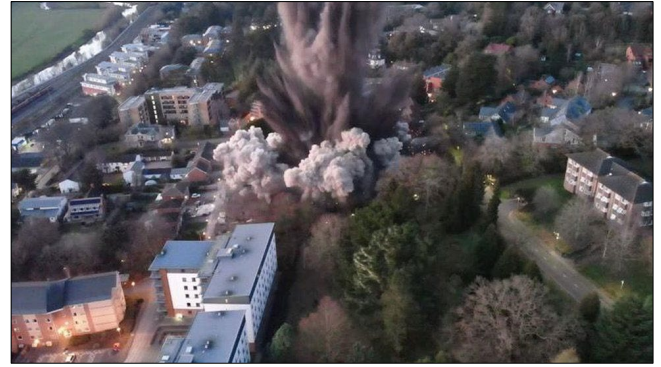
1000kg German HE bomb, February 2021

More than 2,600 households and 12 university halls of residence were cleared before the 2,200lb (1,000kg) device **was destroyed** on Saturday.

Police have reported large pieces of metal debris hitting buildings and said some properties in the 100m (330ft) exclusion zone had sustained "structural damage".

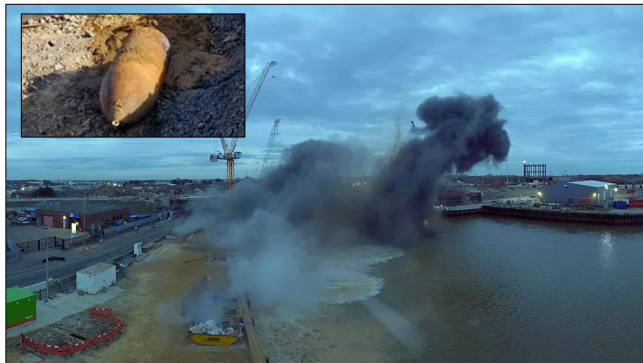
250kg German HE Bomb, February 2023

A World War Two bomb found in Great Yarmouth has detonated while work was being done to defuse it, causing a huge blast that was heard for miles.

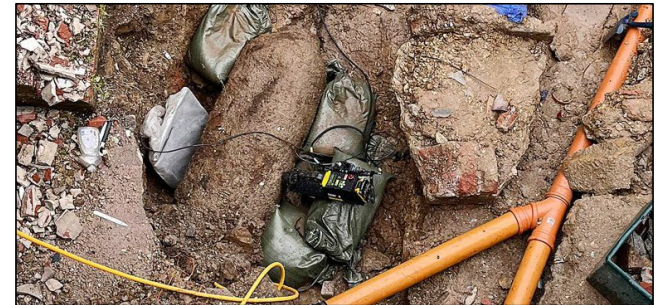
A 500kg (1,102lb) German World War Two bomb that forced the evacuation of thousands of people in Plymouth has been detonated at sea.

The unexploded device was **found in a garden** on St Michael Avenue on Tuesday, sparking four days of disruption.

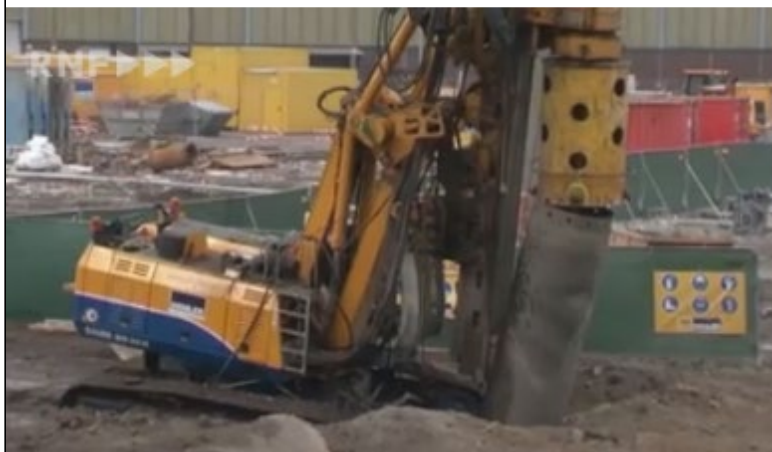
BASF has confirmed that an explosive device, most likely a World War II-era bomb, caused the blast that left one person injured Tuesday at a plant construction site in Germany.

The explosion was reported at BASF's Ludwigshafen toluene diisocyanate (TDI) plant, which recently broke ground for a 300,000 metric tons per year TDI production plant and other construction to expand its facilities.

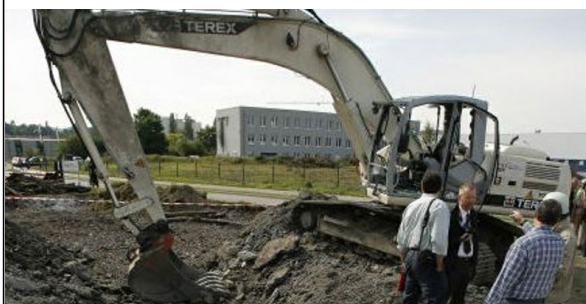
WWII bomb injures 17 at Hattingen construction site

Seventeen people were injured on Friday when a construction crew unwittingly detonated a buried World War II-era bomb in Hattingen.

An excavator apparently drove over a 250-kilogramme (550 pound) American bomb, damaging surrounding buildings. Most of the injured suffered auditory trauma from the blast, and the excavator operator suffered injuries to his hands, police in the German state of North Rhine-Westphalia said.

"The hole was astoundingly small for such a large bomb full of so many explosives," Armin Gebhard, head of the Arnsberg department for military ordnance removal, told *The Local*. "But of course it damaged all the surrounding buildings too. We are really happy it wasn't worse."

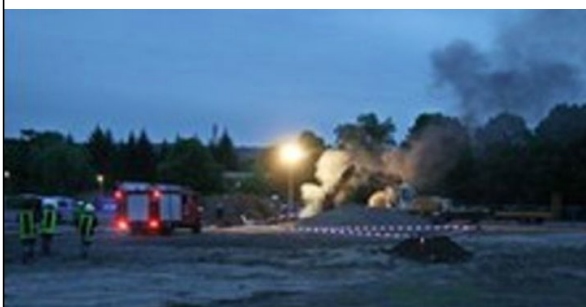
World War II bomb kills three in Germany

A special commission is investigating the causes of the explosion, while prosecutors are considering whether the team leader should face charges of manslaughter through culpable negligence, the BBC's Oana Lungescu reports from Berlin.

The blast happened an hour before the defusing operation was due to start.

More than 7,000 people were immediately evacuated when the 500kg bomb was found. Several schools, a kindergarten and local companies remain closed.

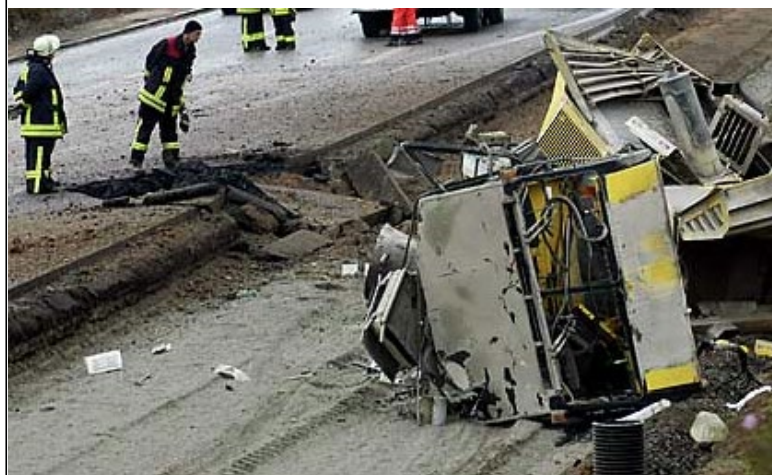
World War II Bomb Explodes on German Motorway

A highway construction worker in Germany accidentally struck an unexploded World War II bomb, causing an explosion which killed him and wrecked several passing cars.

A World War II bomb has exploded during construction work on a German highway, killing one worker and injuring several motorists who were driving past, police said.

The worker had been cutting through the road surface near the south-western town of Aschaffenburg when his machine struck the bomb and triggered it. Police said they weren't sure yet what type of bomb it was. "The explosion seems to have been too small for it to have been an aircraft bomb," a police spokesman said.

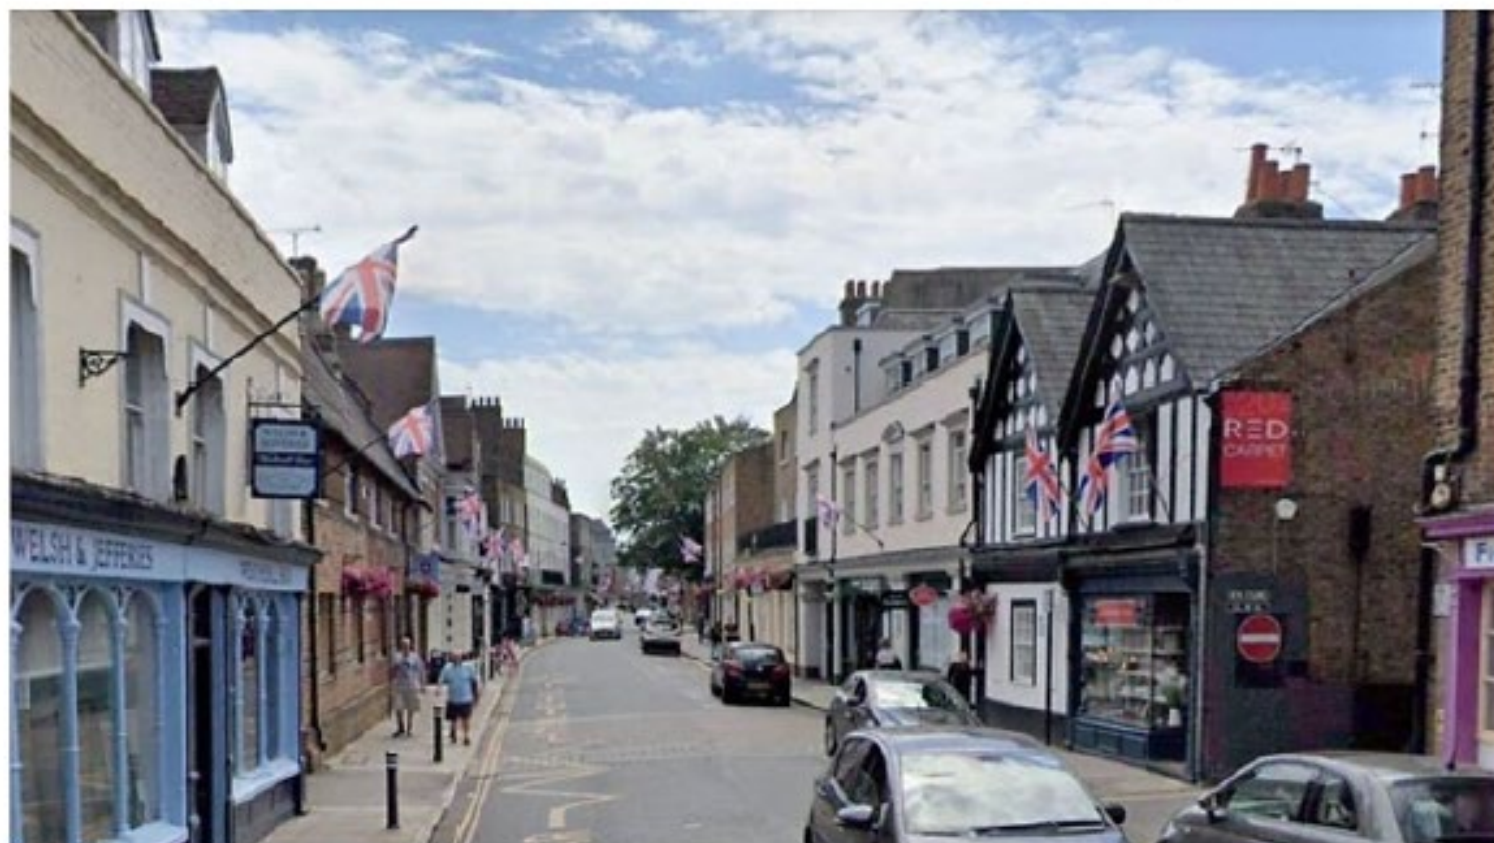
Police were called to the public car park on High Street in Eton, Berkshire, at about 6.25pm on Sunday (Photo: Google)

Police and bomb disposal experts were called to Eton, Berkshire, on Sunday evening after an unexploded device was found in a public car park.

Thames Valley Police said about 50 residents were evacuated from their homes as a precaution, and police erected a 50 metre cordon around the area in the high street, where the bomb, believed to be from the Second World War, was found.

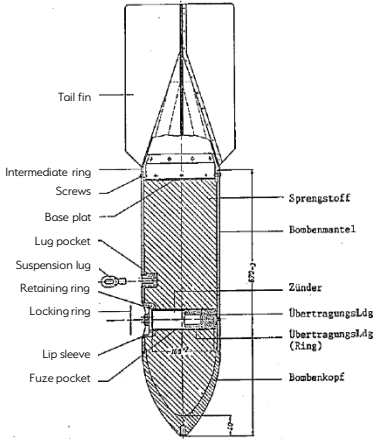
SC 50kg High Explosive Bomb

Bomb Weight	40-54kg (88-119lb)
Explosive Weight	25kg (55lb)
Fuze Type	Impact fuze/electro-mechanical time delay fuze
Bomb Dimensions	1,090 x 280mm (42.9 x 11.0in)
Body Diameter	200mm (7.87in)
Use	Against lightly damageable materials, hangars, railway rolling stock, ammunition depots, light bridges and buildings up to three stories.
Remarks	The smallest and most common conventional German bomb. Nearly 70% of bombs dropped on the UK were 50kg.

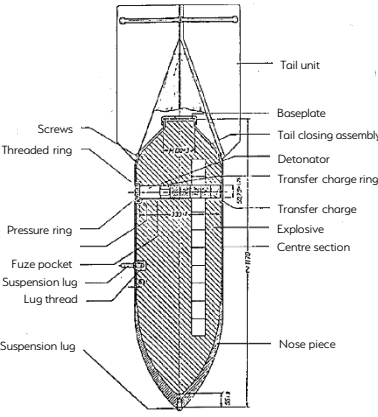
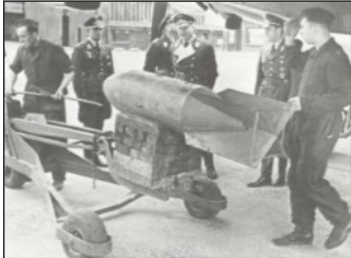
SC 250kg High Explosive Bomb

Bomb Weight	245-256kg (540-564lb)
Explosive Weight	125-130kg (276-287lb)
Fuze Type	Electrical impact/mechanical time delay fuze
Bomb Dimensions	1640 x 512mm (64.57 x 20.16in)
Body Diameter	368mm (14.5in)
Use	Against railway installations, embankments, flyovers, underpasses, large buildings and below-ground installations.
Remarks	It could be carried by almost all German bomber aircraft and was used to notable effect by the Junkers Ju-87 Stuka (<i>Sturzkampfflugzeug</i> , or dive-bomber).

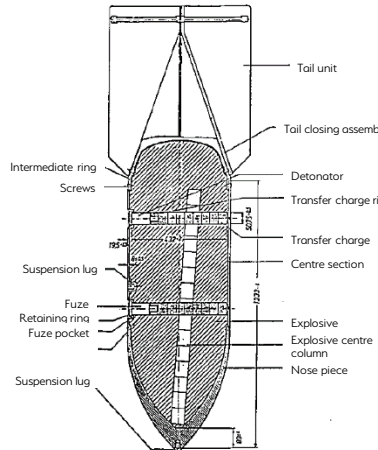
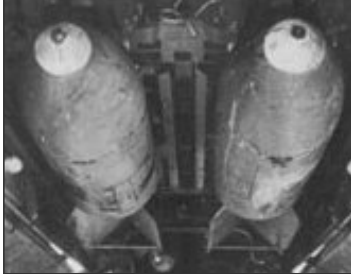
SC 500kg High Explosive Bomb

Bomb Weight	480-520kg (1,058-1,146lb)
Explosive Weight	250-260kg (551-573lb)
Fuze Type	Electrical impact/mechanical time delay fuze
Bomb Dimensions	1957 x 640mm (77 x 25.2in)
Body Diameter	470mm (18.5in)
Use	Against fixed airfield installations, hangars, assembly halls, flyovers, underpasses, high-rise buildings and below-ground installations.
Remarks	40/60 or 50/50 Amotol TNT, Trialene. Bombs recovered with Trialene filling have cylindrical paper-wrapped pellets, 1-15/16in. in length and diameter.

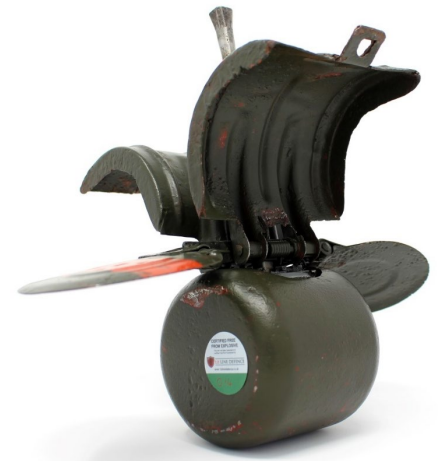
SD2 Anti-Personnel 'Butterfly Bomb'

Bomb Weight	Approx. 2kg (4.41lb)
Explosive Weight	Approx. 7.5oz (225 grams) of Amatol surrounded by a layer of bituminous composition.
Fuze Type	41 fuze (time) , 67 fuze (clockwork time delay) or 70 fuze (anti-handling device)
Body Diameter	3in (7.62 cm) diameter, 3.1in (7.874) long
Use	Designed as an anti-personnel/fragmentation weapon. They were delivered by air, being dropped in containers of 23-144 sub-munitions that opened at a predetermined height, thus scattering the bombs.
Remarks	Quite rare. First used against Ipswich in 1940, but were also dropped on Kingston upon Hull, Grimsby and Cleethorpes in June 1943, amongst various other targets in UK. As the bombs fell the outer case flicked open via springs which caused four light metal drogues with a protruding 5 inch steel cable to deploy in the form of a parachute & wind vane, which armed the device as it span.

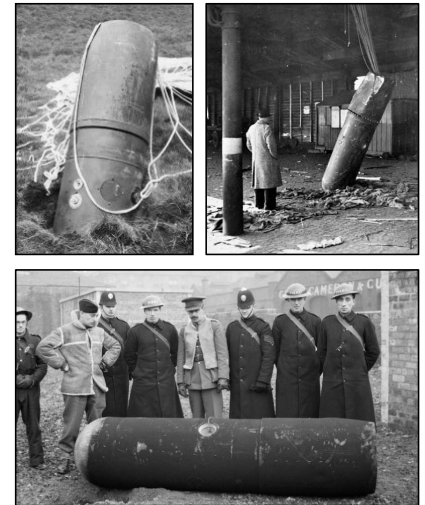
Parachute Mine (Luftmine B / LMB)

Bomb Weight	Approx. 990kg (2176lb)
Explosive Weight	Approx. 705kg (1,554lb)
Fuze Type	Impact/time delay/hydrostatic pressure fuze
Dimensions	2.64m x 0.64m (3.04m with parachute housing)
Use	Against civilian, military and industrial targets. Used as blast bombs and designed to detonate above ground level to maximise damage to a wider area.
Remarks	Deployed a parachute when dropped in order to control its descent. Had the potential to cause extensive damage within a 100m radius.

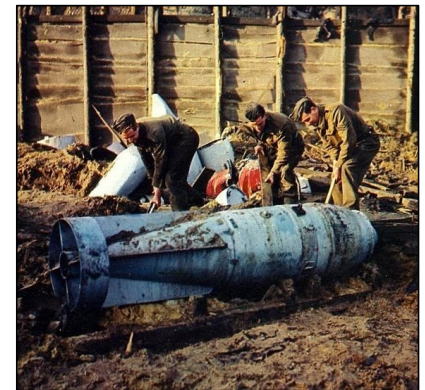
SC 1000kg High Explosive Bomb

Bomb Weight	Approx. 993-1027kg (2,189-2,264lb)
Explosive Weight	Approx. 530-620kg (1168-1367lb)
Fuze Type	Electrical impact/mechanical time delay fuze.
Filling	Mixture of 40% amatol and 60% TNT, but when used as an anti-shipping bomb it was filled with Trialen 105, a mixture of 15% RDX, 70% TNT and 15% aluminium powder.
Bomb Dimensions	2800 x 654mm (110 x 25.8in)
Body Diameter	654mm (18.5in)
Use	SC-type bombs were General Purpose Bombs used primarily for general demolition work. Constructed of parallel walls with comparatively heavy noses, they are usually of three-piece welded construction.

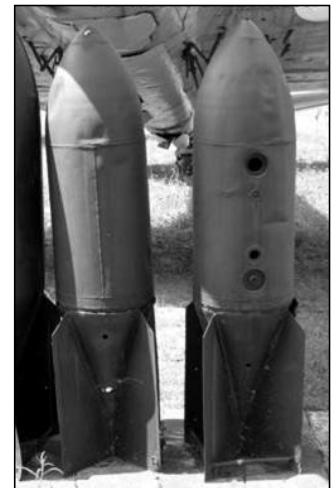
Flam C-250 Oil Bomb

Bomb Weight	480-520kg (1,058-1,146lb)
Explosive Weight	250-260kg (551-573lb)
Fuze Type	Electrical impact/mechanical time delay fuze
Bomb Dimensions	1957 x 640mm (77 x 25.2in)
Body Diameter	470mm (18.5in)
Use	Against fixed airfield installations, hangars, assembly halls, flyovers, underpasses, high-rise buildings and below-ground installations.
Remarks	40/60 or 50/50 Amatol TNT, Triale. Bombs recovered with Trialen filling have cylindrical paper-wrapped pellets, 1-15/16in. in length and diameter.

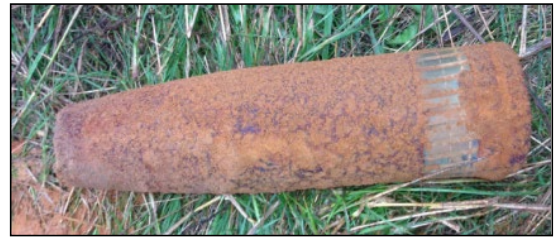
3.7 Inch QF Anti-Aircraft Projectile

Projectile Weight	28lb (12.6 kg)
Explosive Weight	2.52lbs
Fuze Type	Mechanical Time Fuze
Dimensions	3.7in x 14.7in (94mm x 360mm)
Rate of Fire	10 to 20 rounds per minute
Use	The 3.7in AA Mk 1-3 were the standard Heavy Anti-Aircraft guns of the British Army and were commonly used on the Home Front.
Ceiling	30,000ft to 59,000ft

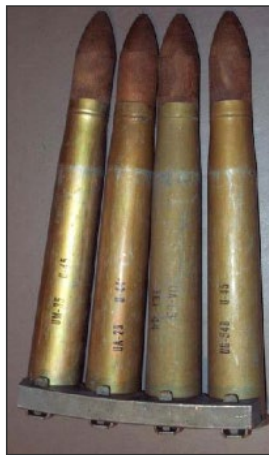
40mm Bofors Projectile

Projectile Weight	1.96lb (0.86kg)
Explosive Weight	300g (0.6lb)
Fuze Type	Impact Fuze
Rate of Fire	120 rounds per minute
Projectile Dimensions	40 x 180mm
Ceiling	23,000ft (7000m)
Remarks	Light quick fire high explosive anti-aircraft projectile. Each projectile fitted with small tracer element. If no target hit, shell would explode when tracer burnt out. Designed to engage aircraft flying below 2,000ft.

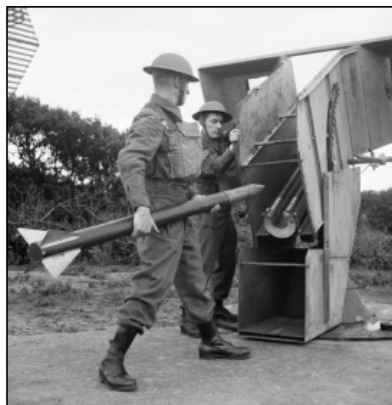
3in Unrotated Projectile (UP) Anti-Aircraft Rocket ("Z" Battery)

HE Projectile Weight	3.4kg (7.6lb)
Explosive Weight	0.96kg (2.13lb)
Filling	High Explosive – TNT. Fitted with aerial burst fuzing
Dimensions of projectile	236 x 83mm (9.29 x 3.25in)
Remarks	As a short range rocket-firing anti-aircraft weapon developed for the Royal Navy. It was used extensively by British ships during the early days of World War II. The UP was also used in ground-based single and 128-round launchers known as Z Batteries. Shell consists of a steel cylinder reduced in diameter at the base and threaded externally to screw into the shell ring of the rocket motor.

Figure 185—3-in. U.P. Antiaircraft Rocket Components
