Proposed data centre at Thorney Business Park

Ground contamination assessment report eastern site area

Reference: 276894-24-ARP-XX-XX-RP-EC-00001

Issue 4 | 4 December 2025

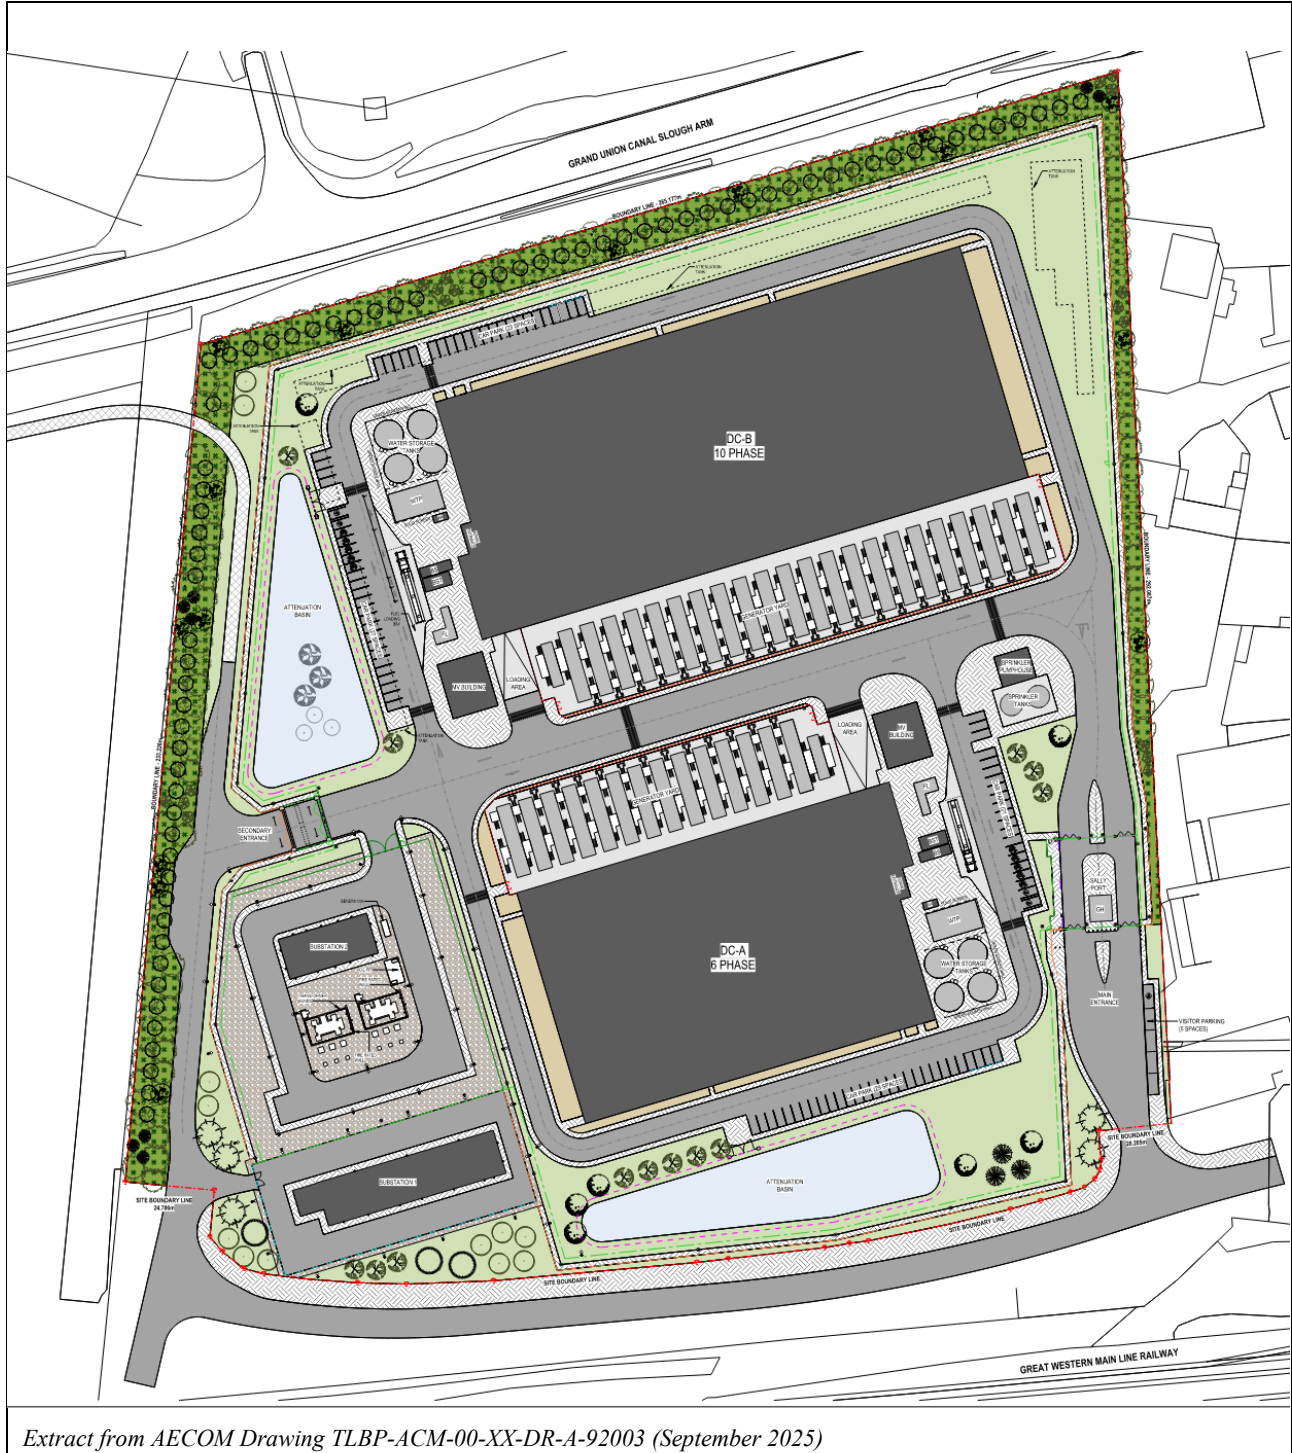
Figure 2 Proposed development plan

This report focusses on the eastern area of the site which includes the main development area for the proposed data centre and associated infrastructure and will comprise the construction of two data centre buildings and ancillary offices, plant, emergency backup generators and associated fuel storage, landscaping, sustainable drainage systems, an emergency access route, and parking and ancillary works. The proposed development plan for the eastern area of the site is shown below as Figure 2.

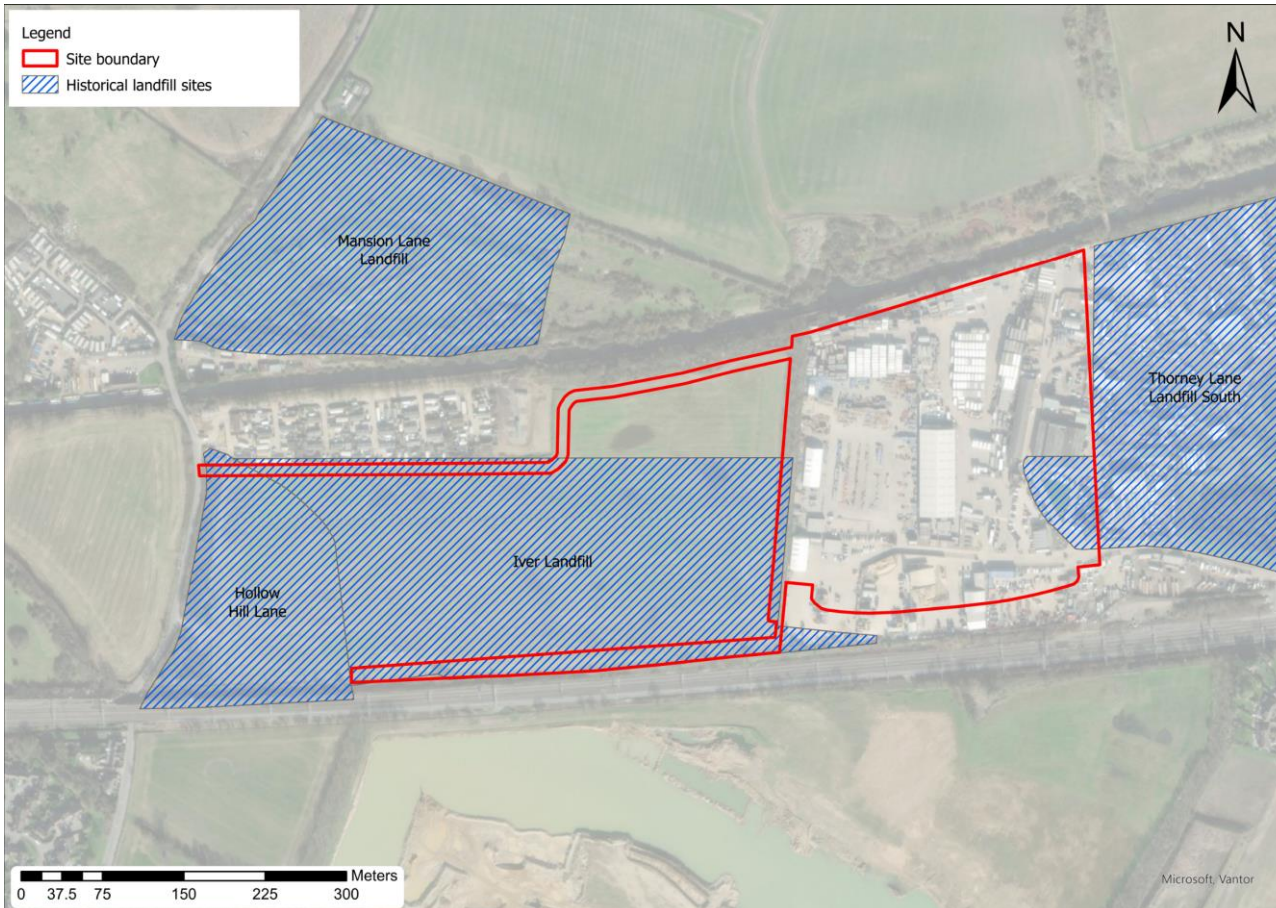
Figure 4 Extent of historic landfills adjacent to site

The majority of the site was quarried for mineral extraction and then backfilled. Mineral extraction and infilling also occurred in the rest of Thorney Business Park to the east of the site and in the field to the west of the site. Details of the available landfilling records are included in the PRA. These indicate only a small area in the southeast of the eastern site area is considered as a historic landfill by the EA. Historic landfills are recorded immediately east (Thorney Lane Landfill South) and west (Iver Landfill and Hollow Hill Lane) of the site. A map showing the extent of the Environment Agency historic landfill boundaries is included as Figure 4.

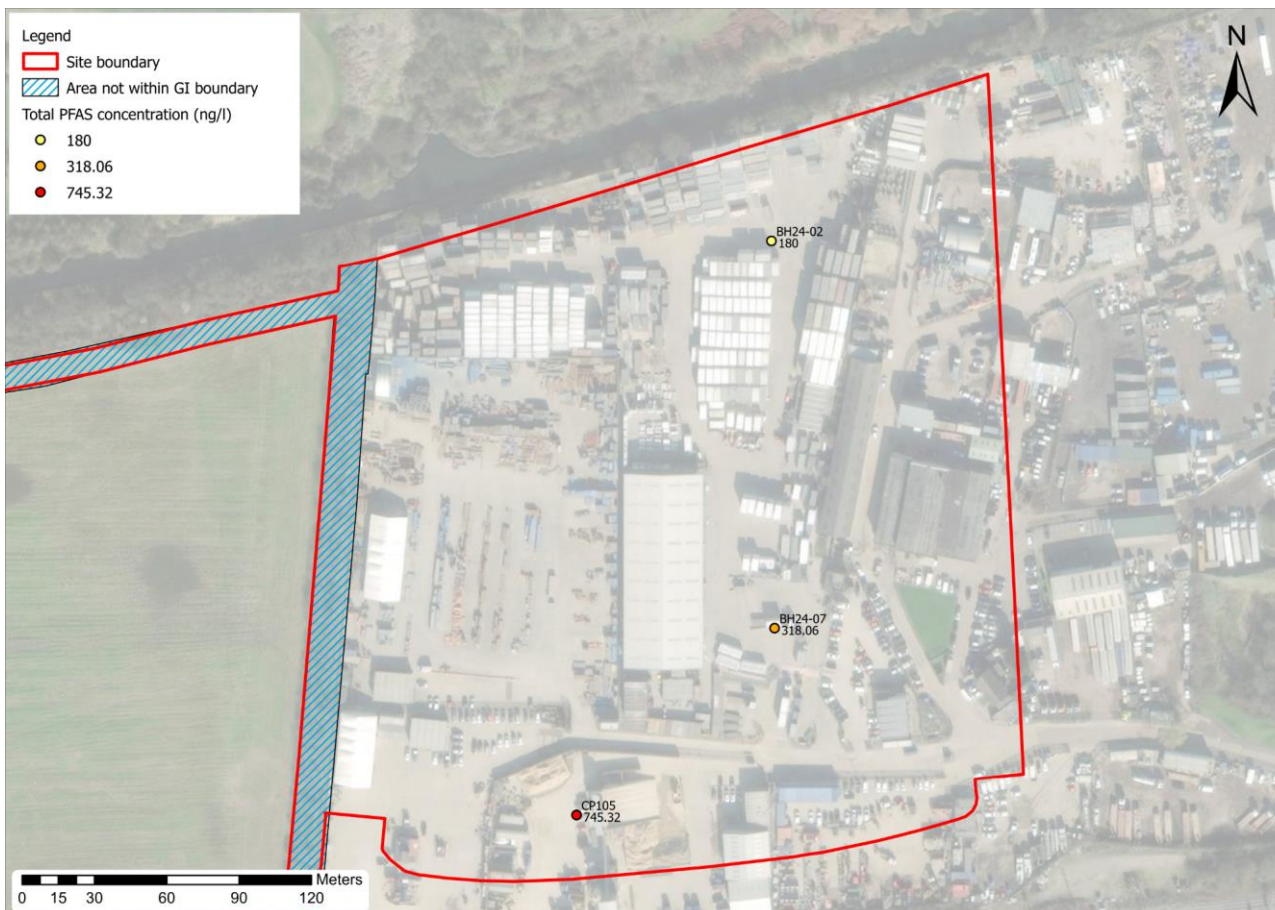
Figure 16 Distribution of sum PFAS in deep groundwater

PFAS was detected in all six samples. The maximum total PFAS concentrations recorded at these locations is shown in Figure 16.

A summary of the main PFAS compounds detected in the deep groundwater samples is shown in Table 22. Similar PFAS compounds occur in CP105 and BH24-07 though concentrations tend to be higher in the former and the profile is generally similar except for a higher proportion of PFOS in BH24-07.
