Project No 24/3980

Project Name Thorney Lane Phase 1 Due Diligence

Detailed Unexploded Ordnance (UXO) Risk Assessment

Project Name	Thorney Lane, Iver
Client	Concept Engineering Consultants Ltd
Site Address	Thorney Lane, Iver, SLO 9HE
Report Reference	DA20371-00
Date	23 rd July 2024
Author	JBM
Quality Assurance	PB
Final Check	ERG

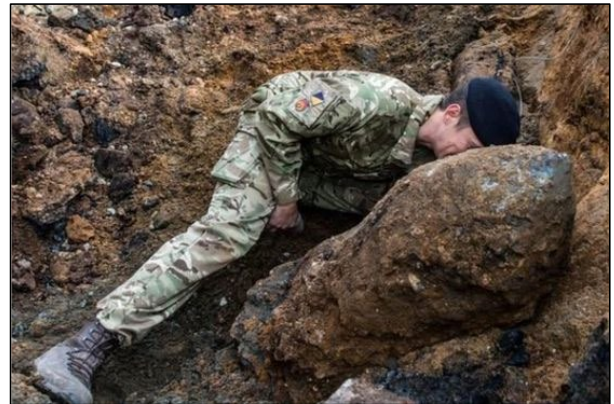
One of the most common scenarios for UXO going unnoticed was when a UXB fell into a 'bomb site' (such as the area shown **Top Left**), the entry hole of the bomb obscured by any debris and rubble present. Note that the entry hole of a 50kg UXB could be as little as 20cm in diameter (**Left**).

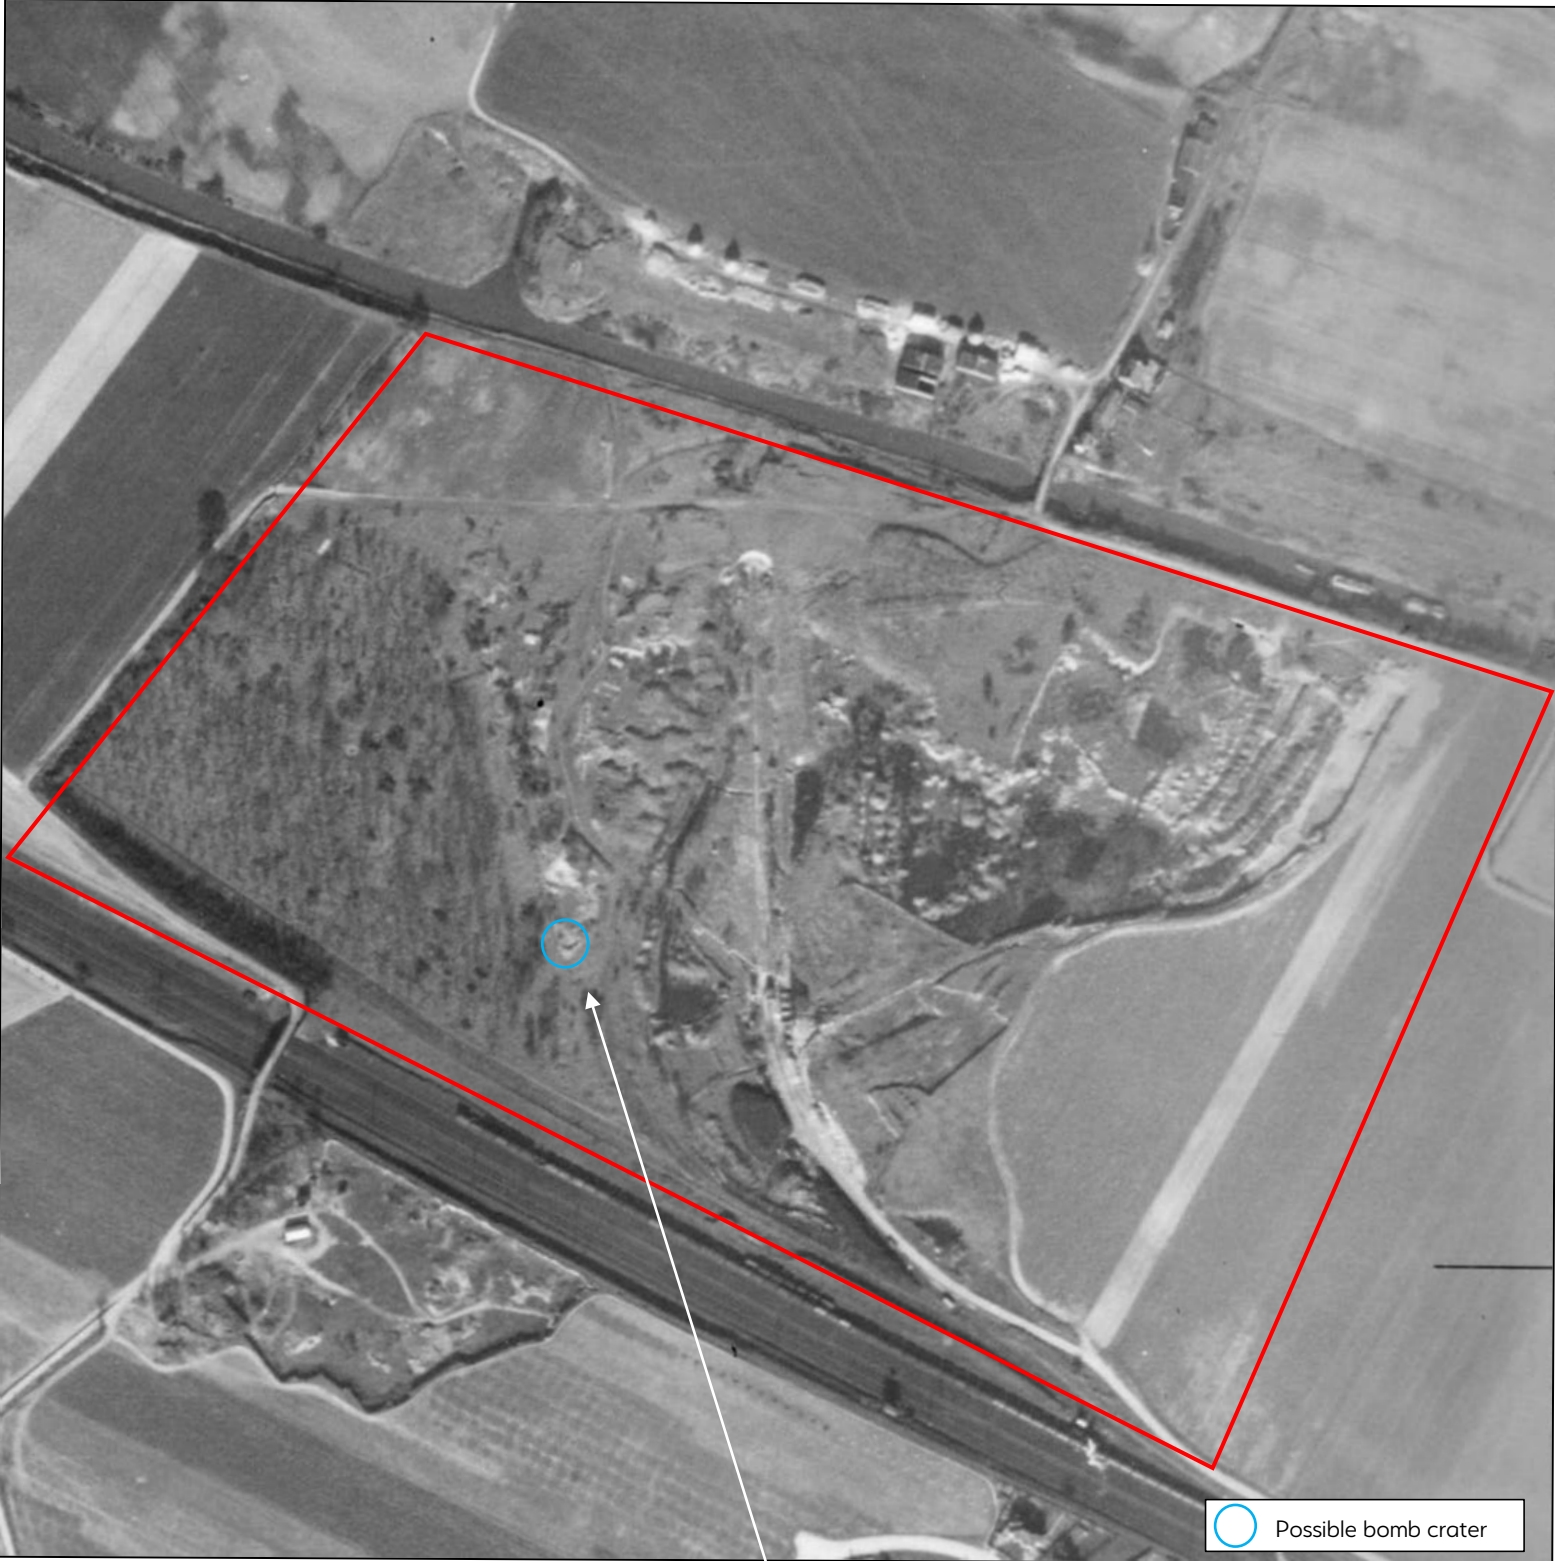
<p>12th October 1945 (Annex N5-N6)</p>	<p>In this post-WWII vertical photograph, the composition of the site and its immediate surrounds appears largely analogous to the previous photography.</p> <p>Again, ground conditions preclude a definitive assessment of potential signs of bomb damage, although two circular ground indentations – possibly bomb craters - are visible, highlighted in Annex N6.</p>
---	---

WWII-era aerial photography for the site area was obtained from the National Monuments Record Office (Historic England). This photography provides a record of the potential composition of the site during the war, as well as its condition immediately following the war (see **Annex N**).

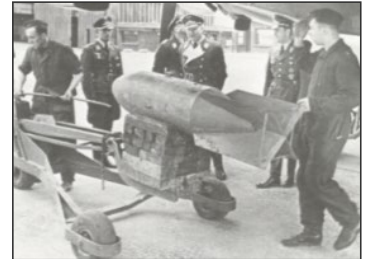
SC 500kg High Explosive Bomb

Bomb Weight	480-520kg (1,058-1,146lb)
Explosive Weight	250-260kg (551-573lb)
Fuze Type	Electrical impact/mechanical time delay fuze
Bomb Dimensions	1957 x 640mm (77 x 25.2in)
Body Diameter	470mm (18.5in)
Use	Against fixed airfield installations, hangars, assembly halls, flyovers, underpasses, high-rise buildings and below-ground installations.
Remarks	40/60 or 50/50 Amotol TNT, Trialene. Bombs recovered with Trialene filling have cylindrical paper-wrapped pellets, 1-15/16in. in length and diameter.
