Preliminary Risk Assessment & Geo-Environmental Assessment

651 - 664 Ajax Avenue, Slough Trading Estate

Presented to Slough Trading Estate Limited

Issued: June 2021

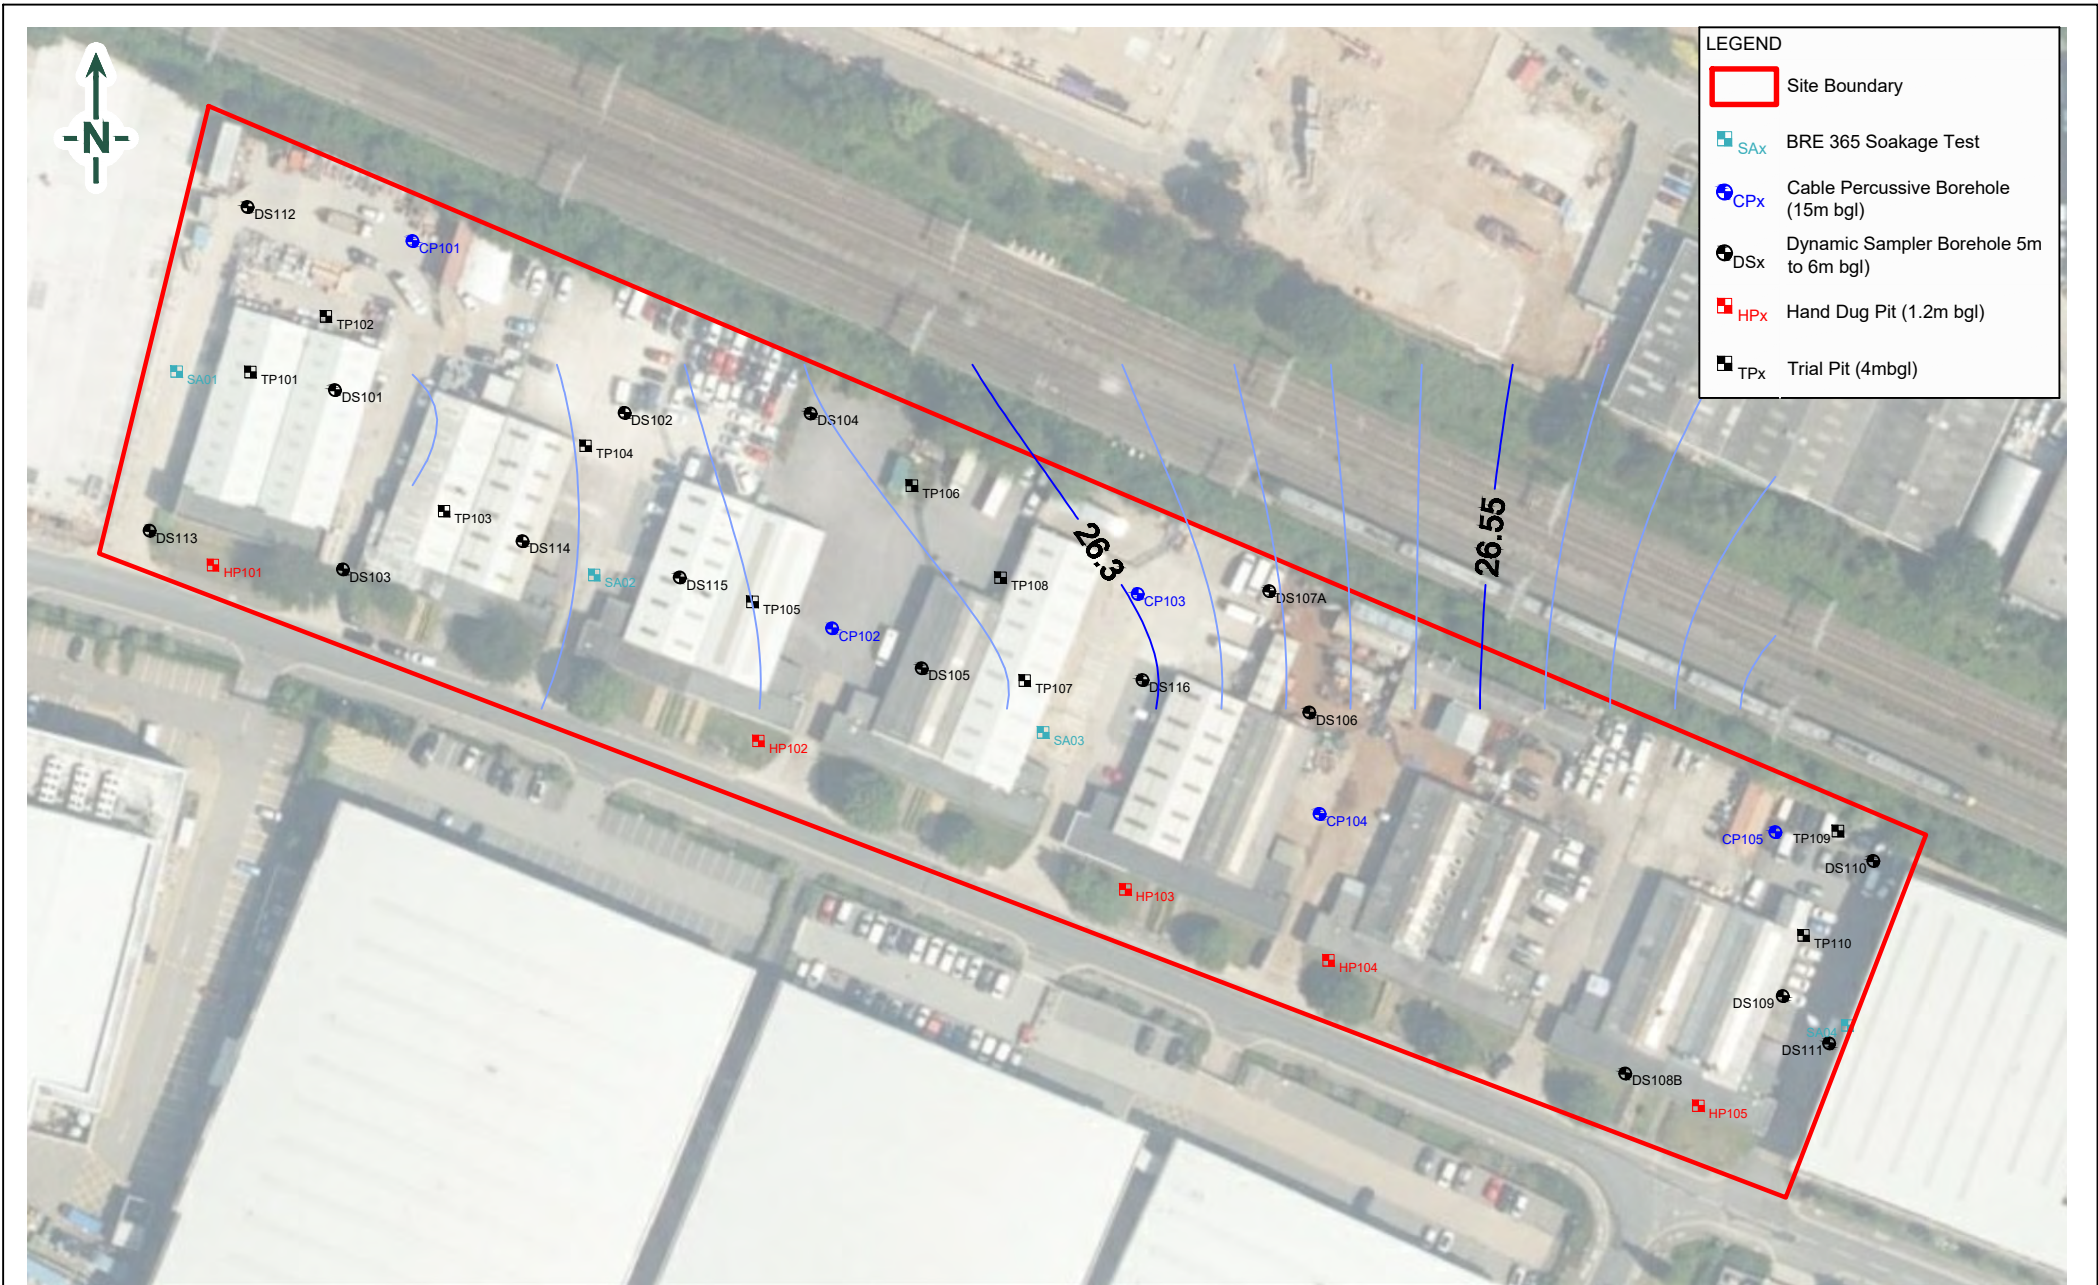
Figure 6 – Interpolated Groundwater Plots

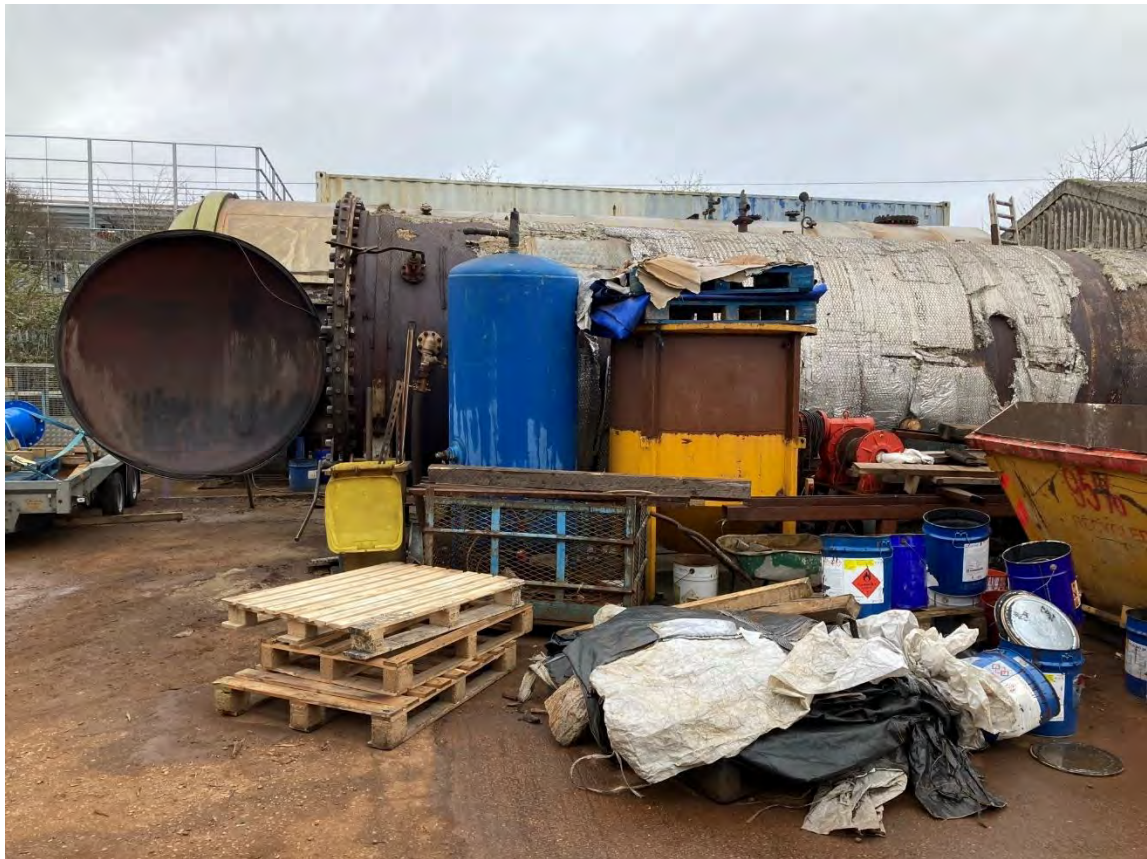
Photograph 12 – Wooden pallets, empty chemical drums and large ‘cookers’ stored to the rear of 660 Ajax Avenue
