ENVIRONMENTAL PERMIT APPLICATION

AMAZON DATA SERVICES UK LIMITED, LON2
DATA CENTRE, SLOUGH

Site Condition Report

SLR Ref: 410.11808.00001
Version No: Final
October 2021

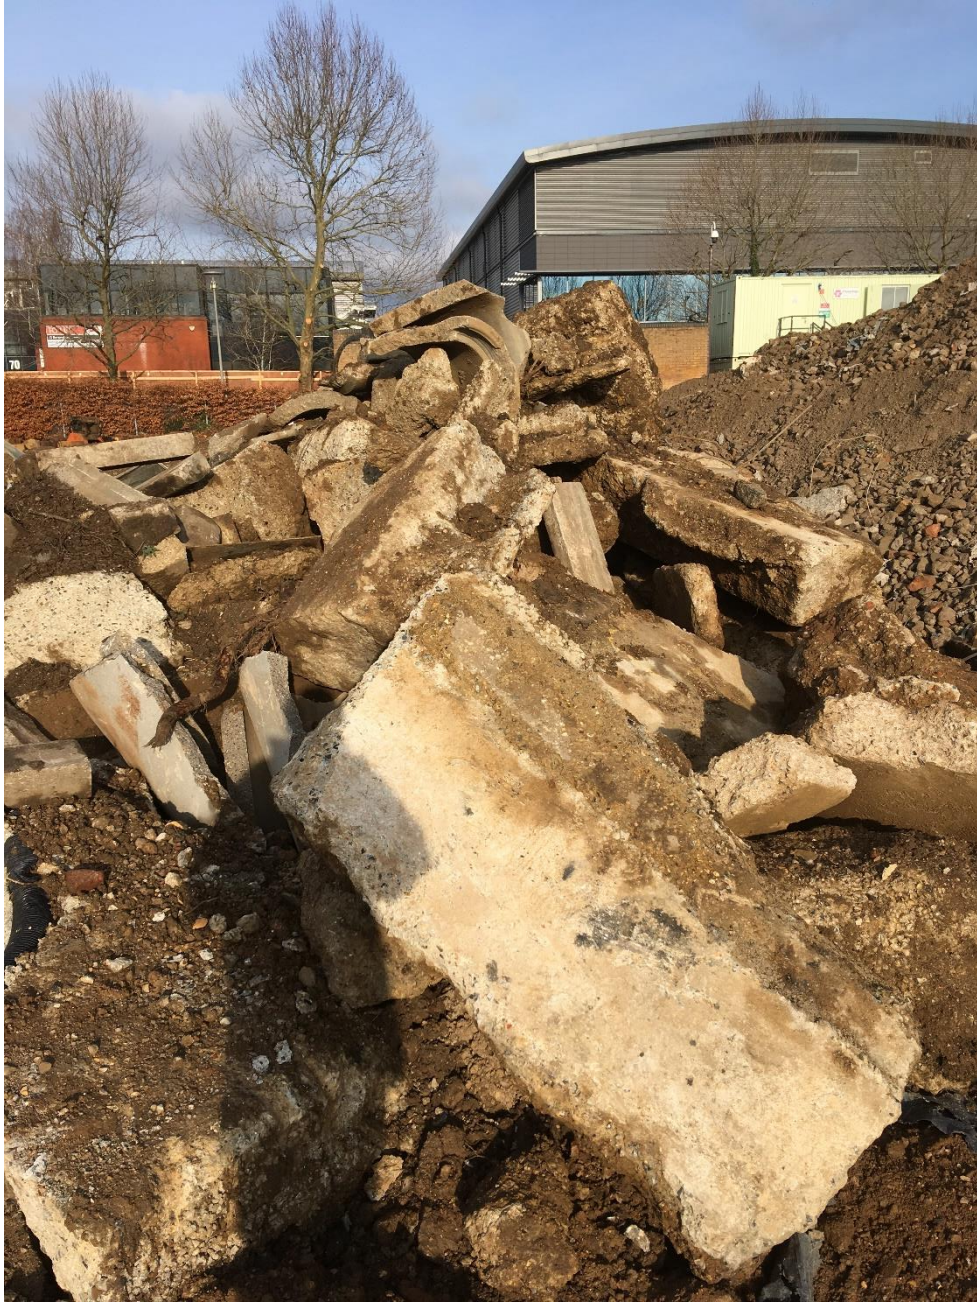
Photograph 13 – Asphalt/ concrete material from demolition

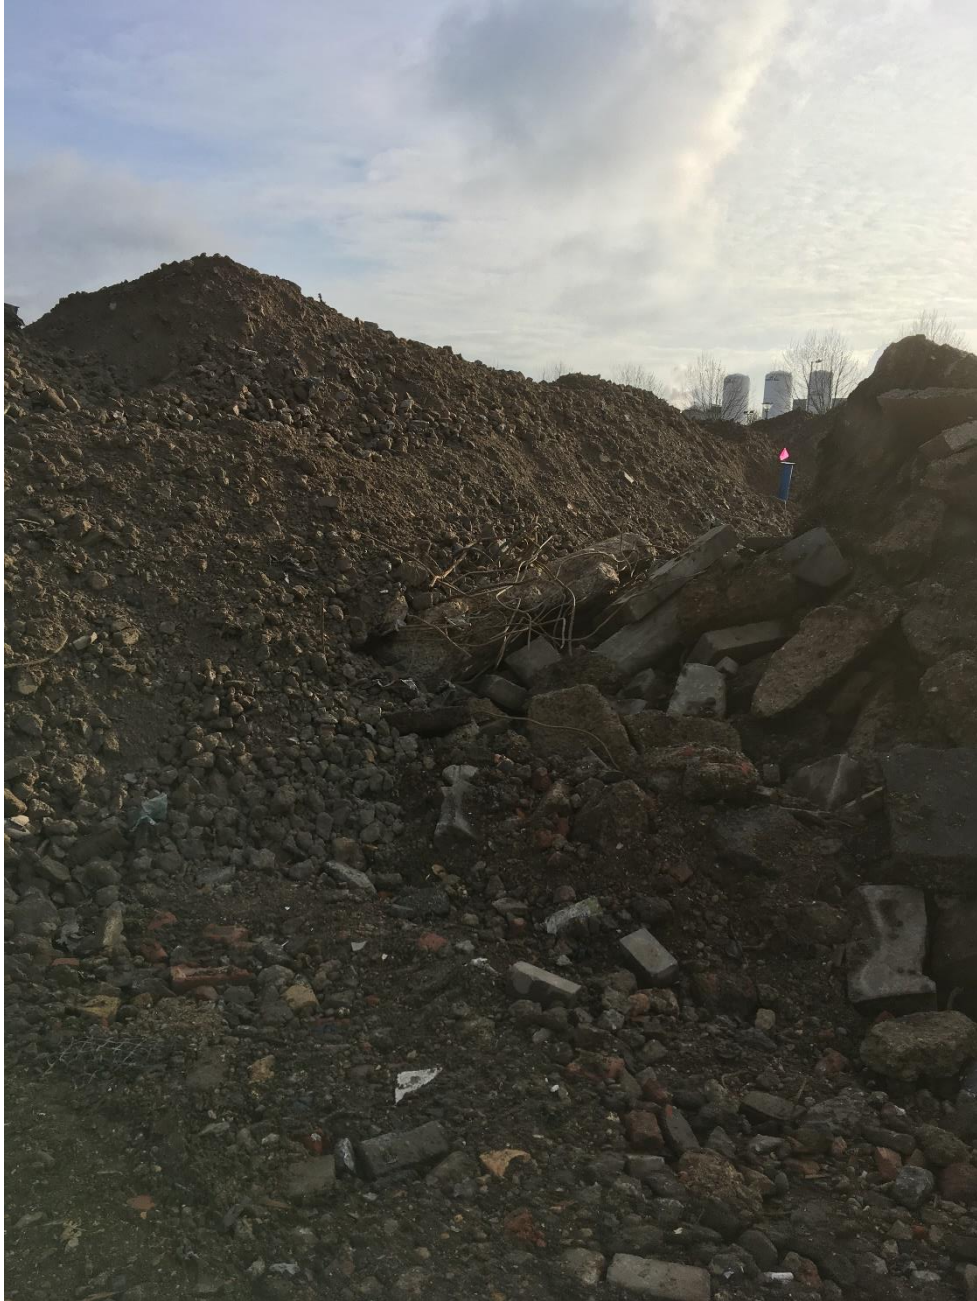
Photograph 14 – Large concrete foundations from demolition
