| Project name | Wroughton Closed Landfill | | |
| Title | Summary Controlled Waters Risk Assessment | | |
| Document reference | 12248-HYD-XX-XX-TN-GE-1001 | Status / Revision | S2 P01 |
| Client | The Hills Group Ltd. | | |

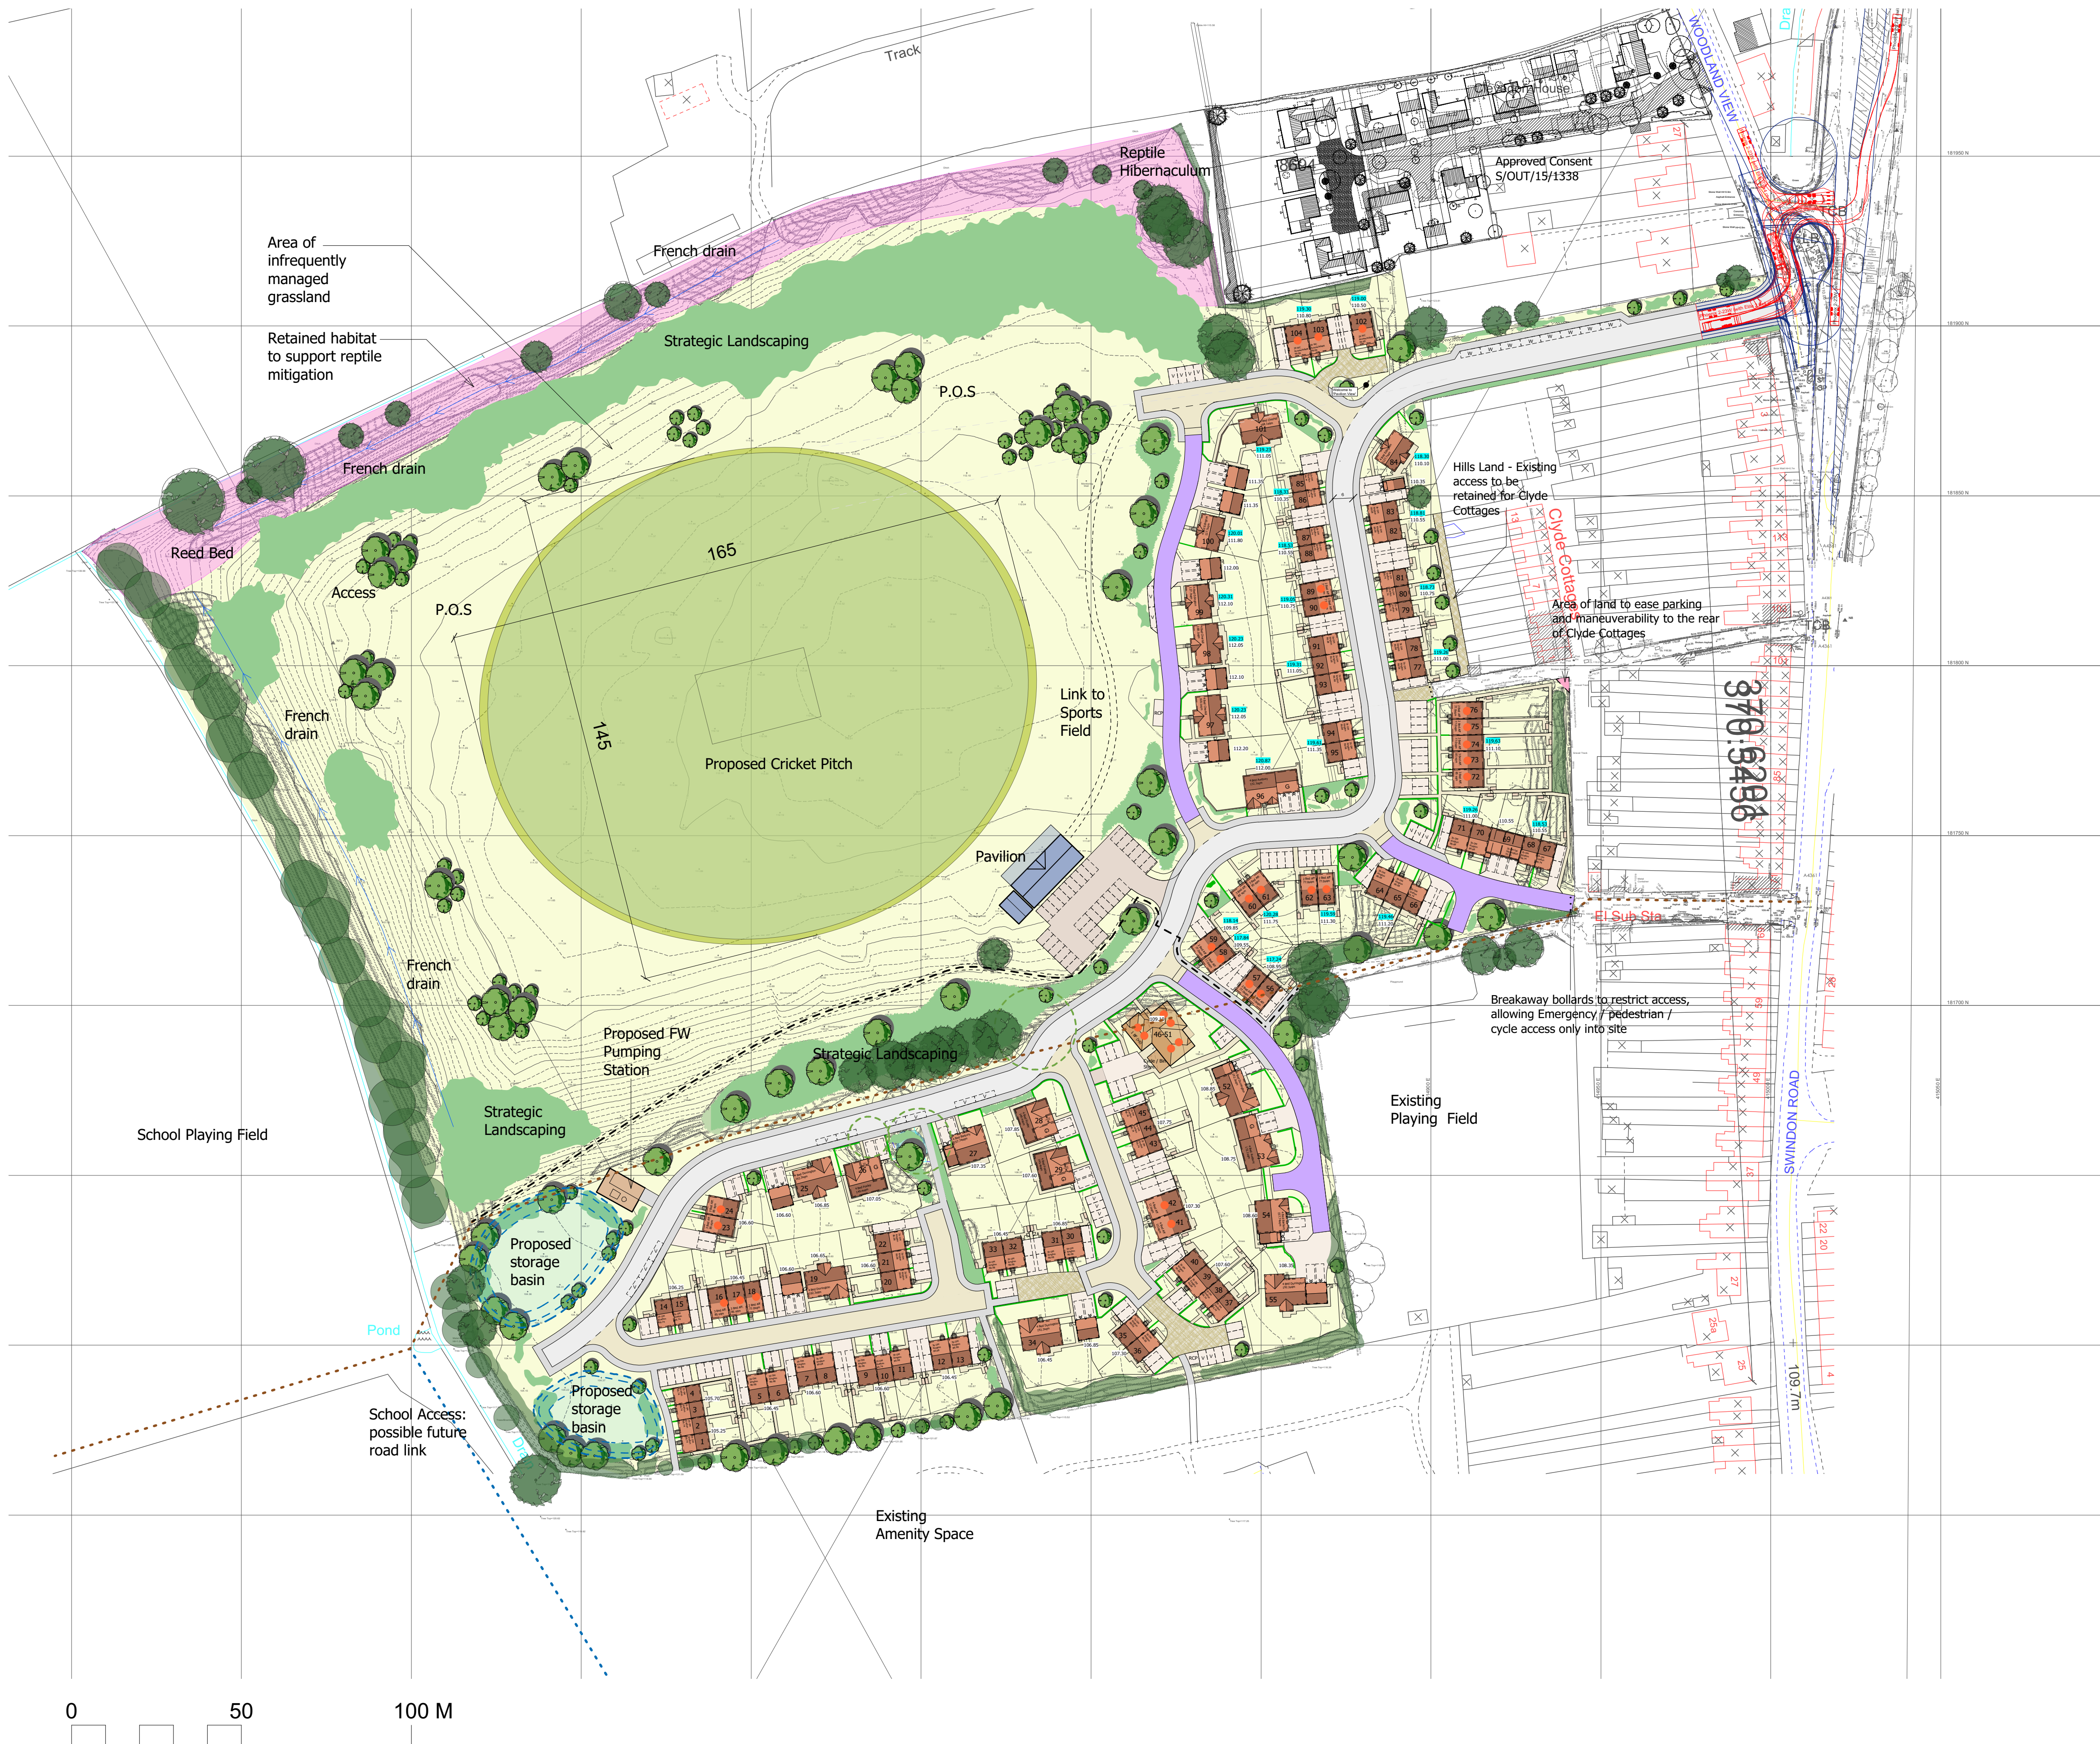
DWG NO: P1-01

The proposed development is presented on the Proposed Site Layout Plan (Ref: 50467 P1-01 [Rev L], dated 4 February 2022) in Annex A and comprises residential housing, public open space (POS), including a cricket pitch and a pavilion, supporting infrastructure and a new access road off the A4361 Swindon Road to the east.
