## Airfield Quarry

Proposed sand and gravel extraction and restoration

# Hydrogeological Risk Assessment

Final Report

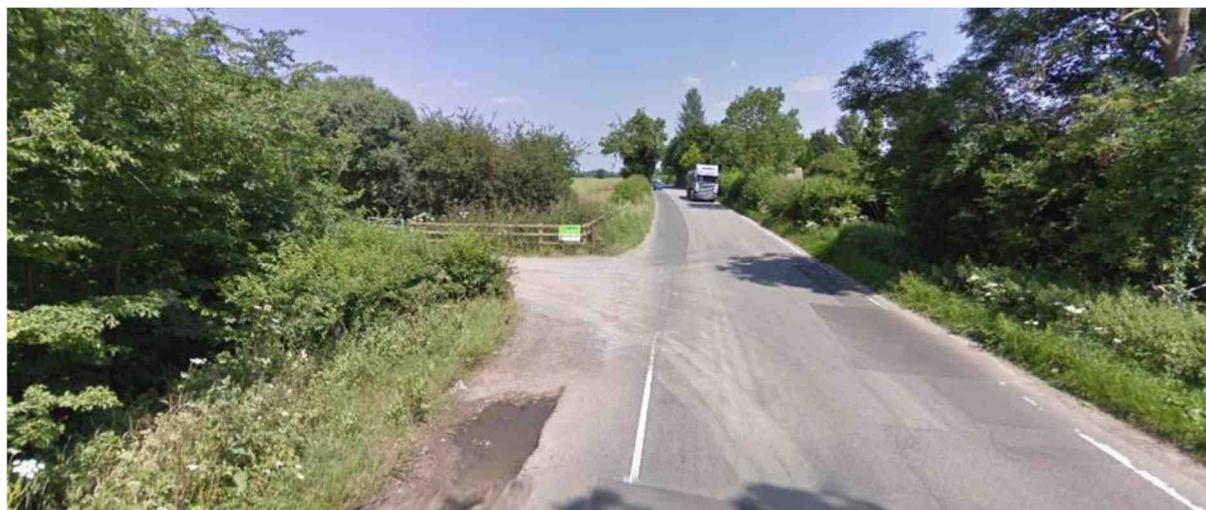
- Clarification on whether the existing access in to the site from the C124 via Oak Road – see pictures below was considered as a possible entrance for the proposed site as the road is wider, relatively straight, with good visibility and no watercourse to cross. It is also within Gloucestershire County Boundary which would make them the sole authority for the application.

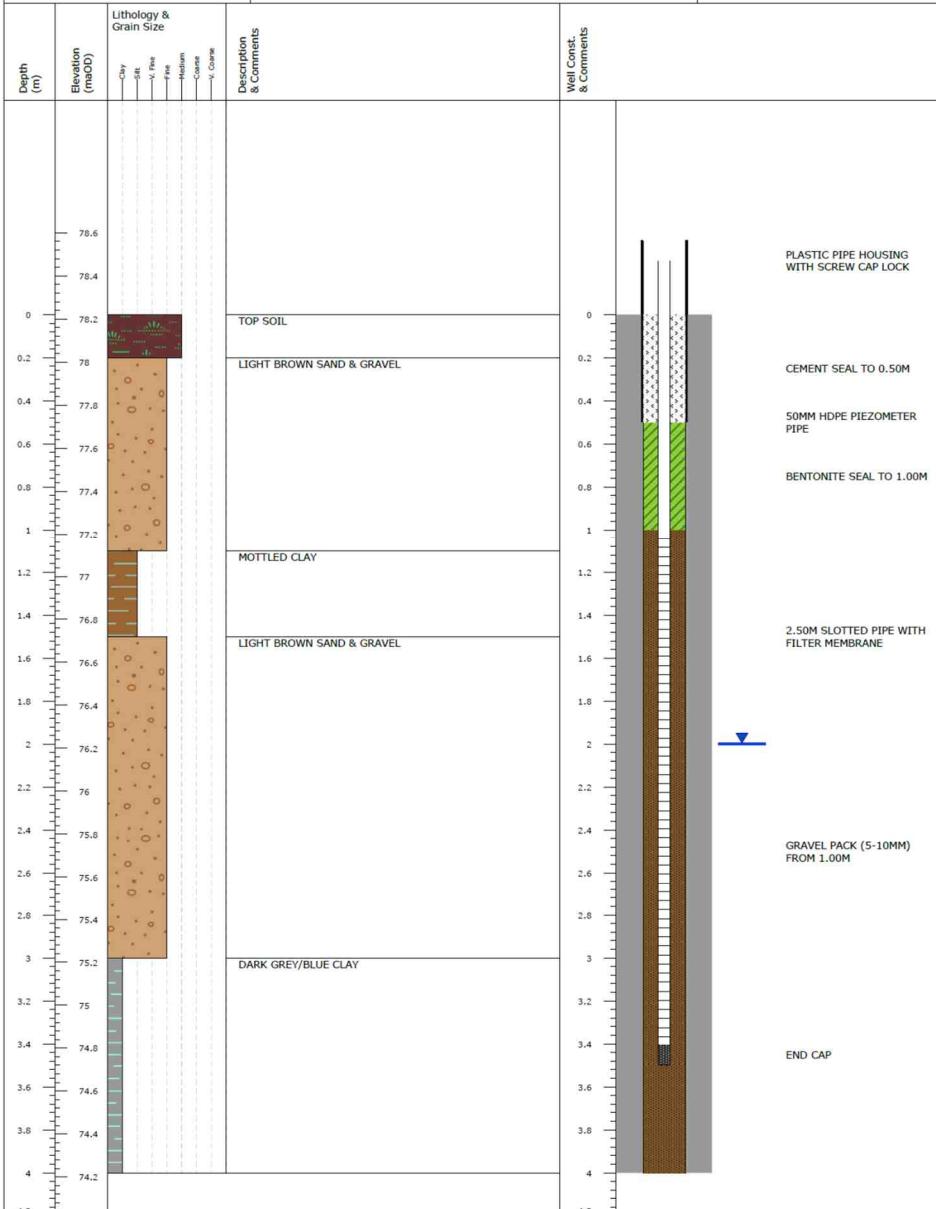
**Hole No:** P1\_18  
**Sheet:** 1 of 1  
**Eastings:** 412393  
**Northings:** 196626  
**Inc/Ori:** 90 / 0  
**Depth (m):** 4  
**Security Cover Elevation (maOD):** 78.56

**Project:** Welcome Trust  
**Site:** Airfield Quarry  
**Job No:** BCL/PI/0219/001  
**Logged By:** Gavinder Meetcia  
**Drill Rig:** B40  
**Drilling Started:** 24 September 2018  
**Drilling Finished:** 25 September 2018

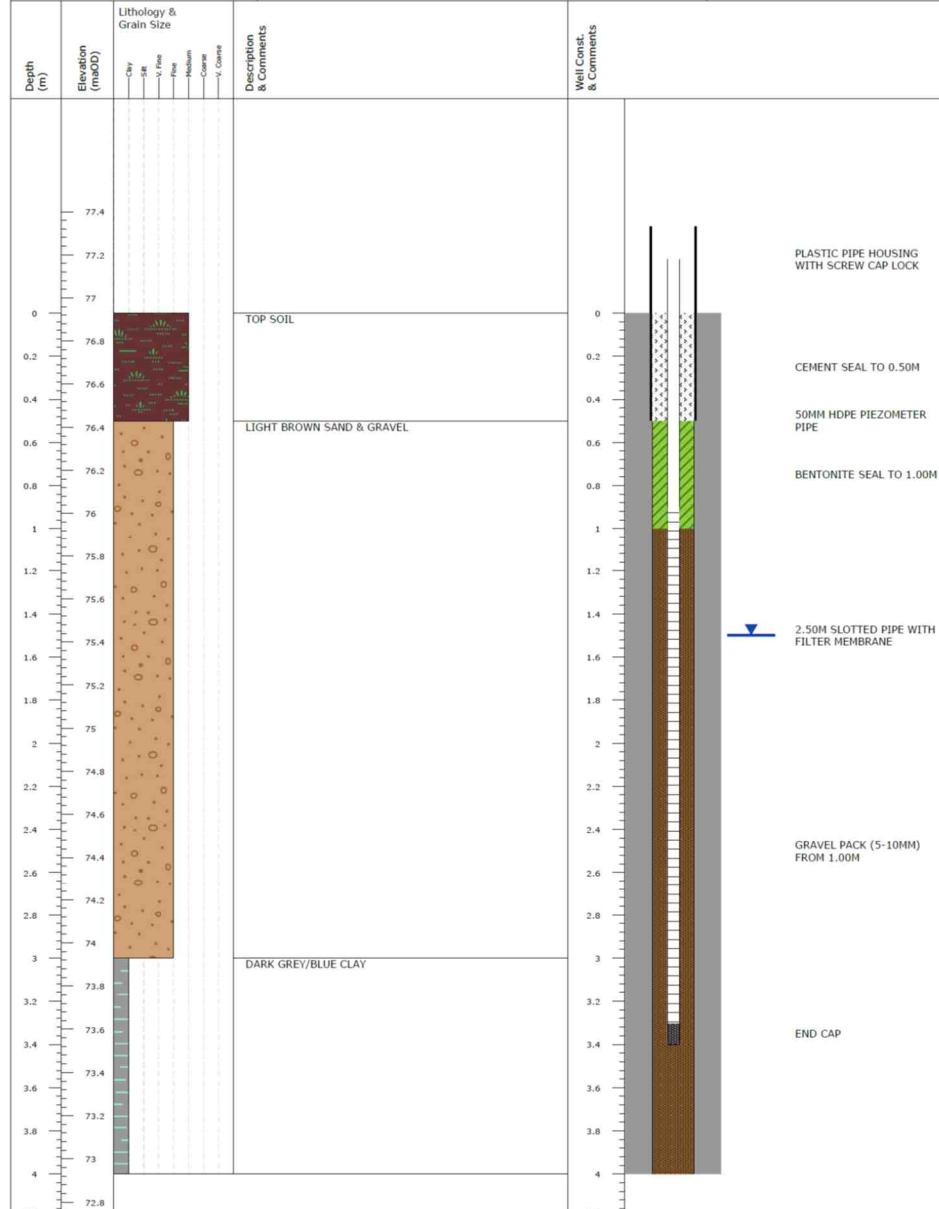
**Hole No:** P2\_18  
**Sheet:** 1 of 1  
**Eastings:** 412540  
**Northings:** 196301  
**Inc/Ori:** 90 / 0  
**Depth (m):** 4  
**Security Cover Elevation (maOD):** 77.33

**Project:** Welcome Trust  
**Site:** Airfield Quarry  
**Job No:** BCL/PI/0219/001  
**Logged By:** Gavinder Meetcia  
**Drill Rig:** B40  
**Drilling Started:** 24 September 2018  
**Drilling Finished:** 25 September 2018
