**Site Investigation for the Wastefront Development
at the Port of Sunderland**

PHASE 2 GROUND INVESTIGATION ON LAND AT HUDSON DOCK EAST, PORT OF SUNDERLAND

3899OR02/January 2021

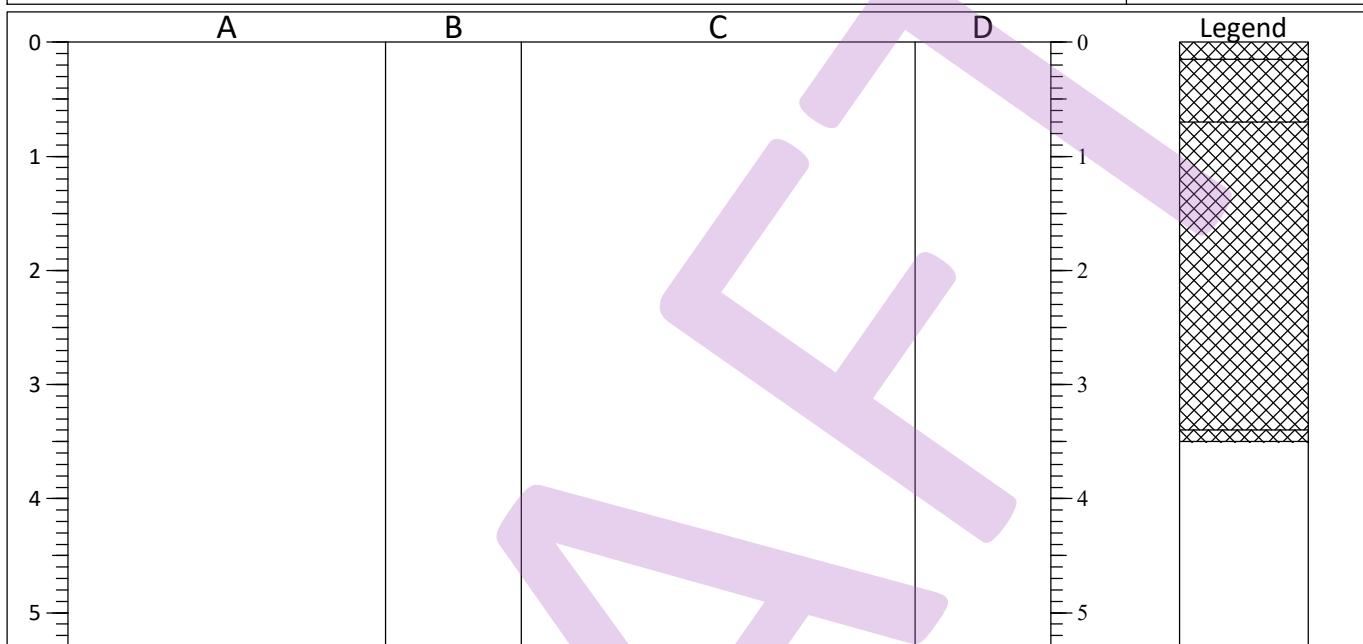
STRATA			SAMPLES & TESTS		
Depth	No	DESCRIPTION	Depth	No	Remarks/Tests
0.00-0.15		MADE GROUND: Light brown clayey slightly gravelly fine to coarse SAND. Gravel is fine to medium angular to subangular of sandstone and concrete.	0.10	E	PID: <0.1

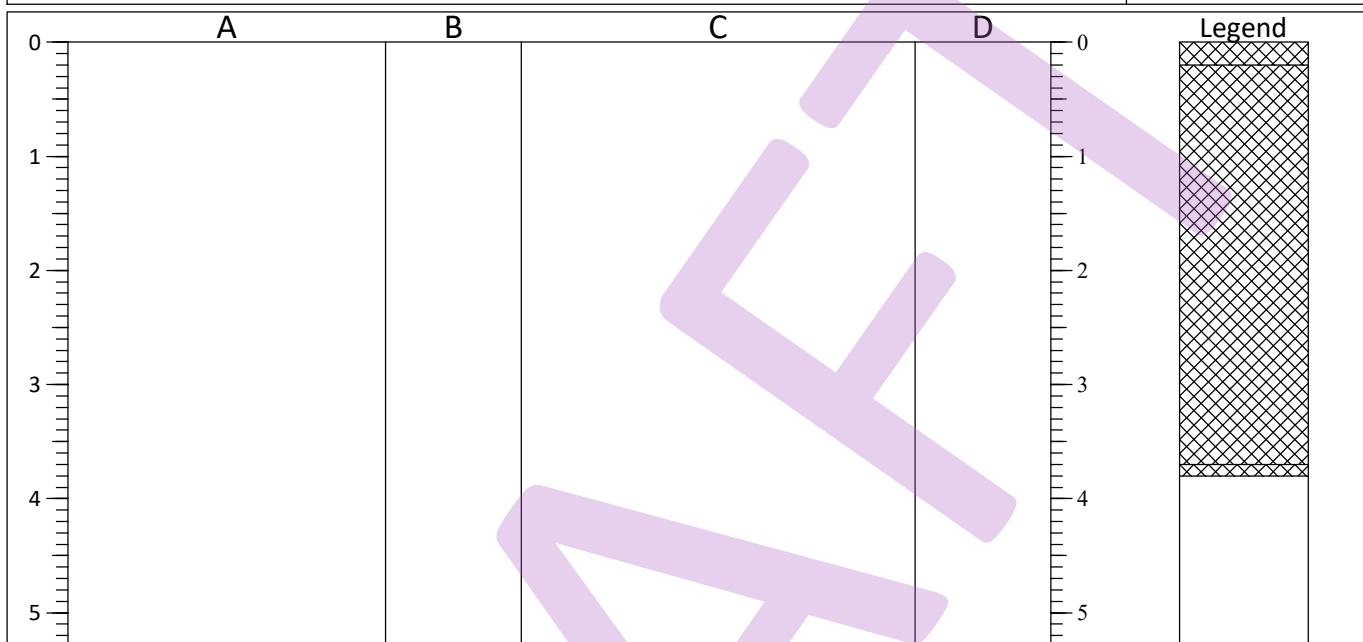
Project GESI Wastefront, Sunderland				TRIAL PIT No TP02
Job No 3899	Date 30-11-12	Ground Level (m) 5.33	Co-ordinates () E 441,319.2 N 556,854.6	
Contractor Patterson Plant Hire				Sheet 1 of 1

STRATA			SAMPLES & TESTS		
Depth	No	DESCRIPTION	Depth	No	Remarks/Tests
0.00-0.20		MADE GROUND: Light brown clayey slightly gravelly fine to coarse SAND. Gravel is fine to medium angular to subangular of sandstone clinker dolomite and concrete. Low cobble content of angular masonry.	0.10	E	PID: <0.1

0.20-3.70		MADE GROUND: Dark brown to black gravelly fine to coarse SAND. Gravel is fine to coarse angular to subangular of brick slag dolomite glass. 0.40 Low cobble content of whole bricks. 0.70 Moderate cobble content of subangular to subrounded slag. Gravels include bottles teapots wire and metallic objects.	0.25	E	PID: 0.5

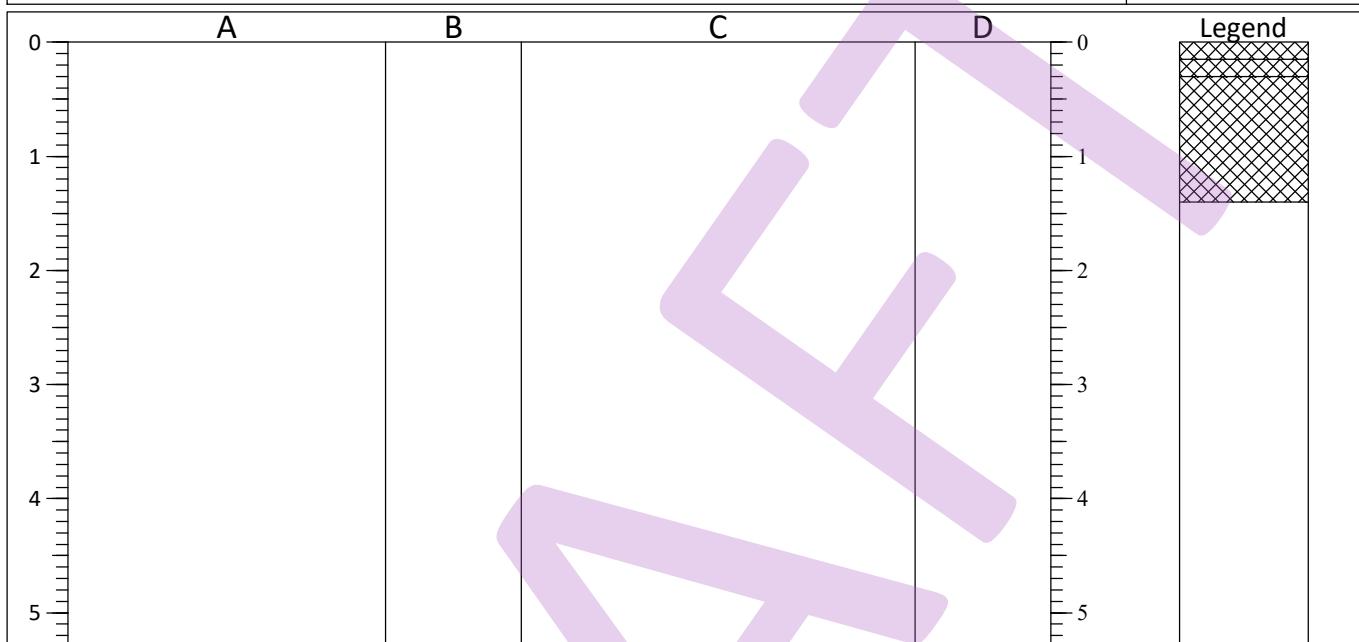
STRATA			SAMPLES & TESTS		
Depth	No	Description	Depth	No	Remarks/Tests
0.00-0.15		MADE GROUND: Dark grey gravelly fine to coarse SAND. Gravel is fine to medium angular to subangular of concrete slag and dolomite.	0.10	E	PID: 0.1
0.15-0.30		MADE GROUND: Grey reinforced concrete.	0.35	E	PID: <0.1
0.30-1.40		MADE GROUND: Light brown to light grey sandy gravelly COBBLES of angular concrete and masonry. Gravel is fine to coarse angular of concrete and brick.	0.60	E	PID: 0.1
1.40		End of excavation on concrete obstruction.	1.20	E	PID: <0.1

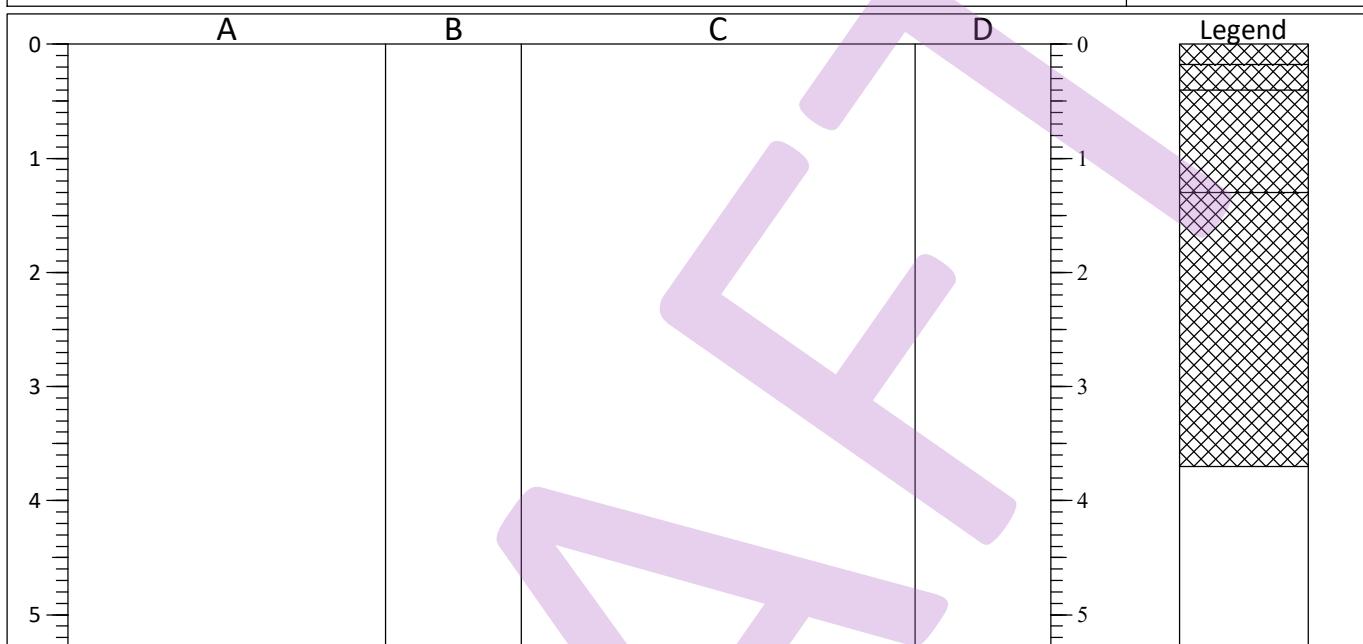
STRATA			SAMPLES & TESTS		
Depth	No	DESCRIPTION	Depth	No	Remarks/Tests
0.00-0.18		MADE GROUND: Reinforced concrete	0.20	E	PID: <0.1
0.18-0.40		MADE GROUND: Light brown clayey gravelly fine to coarse SAND. Gravel is fine to medium of concrete and sandstone.	0.80	E	PID: <0.1

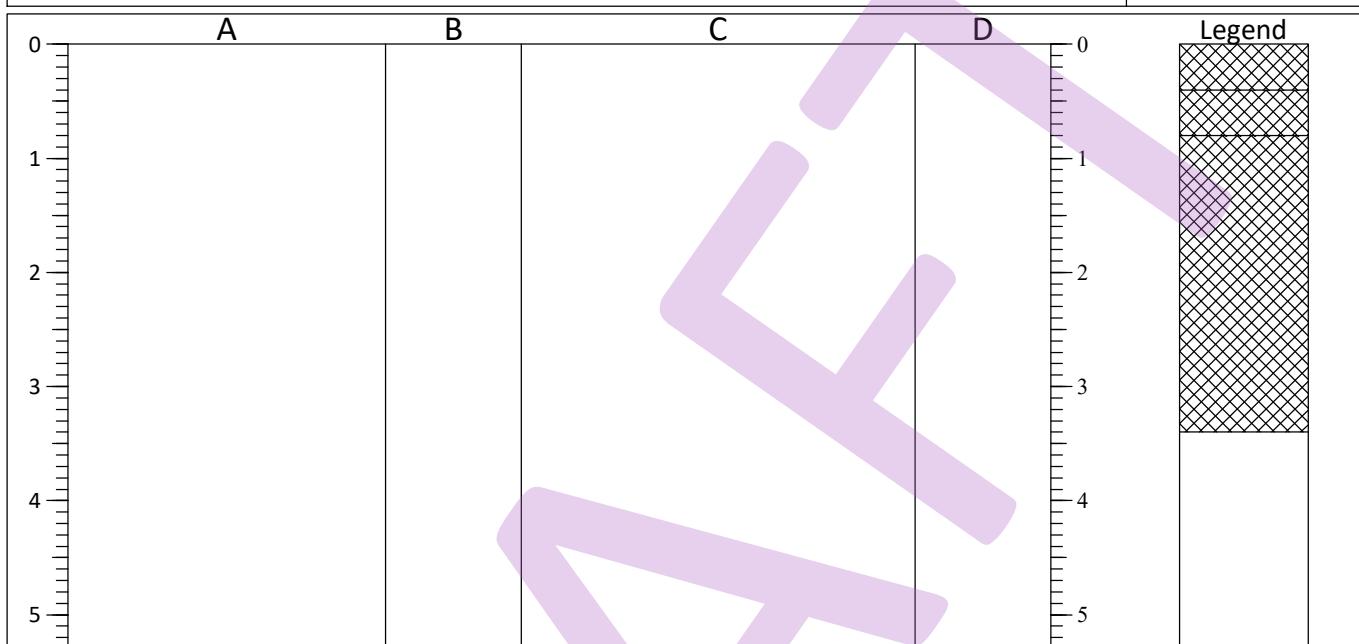
STRATA			SAMPLES & TESTS		
Depth	No	DESCRIPTION	Depth	No	Remarks/Tests
0.00-0.40		MADE GROUND: Dark brown to black sandy fine to medium subangular to subrounded GRAVEL of dolomite.	0.20	E	PID: 0.1
0.40-0.80		MADE GROUND: Dark brown to black gravelly medium to coarse SAND. Gravel is fine to medium of subangular to subrounded dolomite.	0.60	E	PID: <0.1
0.80-3.40		MADE GROUND: Light brown to light yellow slightly gravelly fine to coarse SAND. Gravel is fine to coarse of subangular dolomite. Low cobble content of subangular to rounded dolomite.	0.90	E	PID: 0.1
		2.00 Occasional subangular boulders of weathered dolomite.	1.50	D	
		2.40 Occasional grey lenses.			
3.40		End of excavation. Eastern wall of pit collapsing.

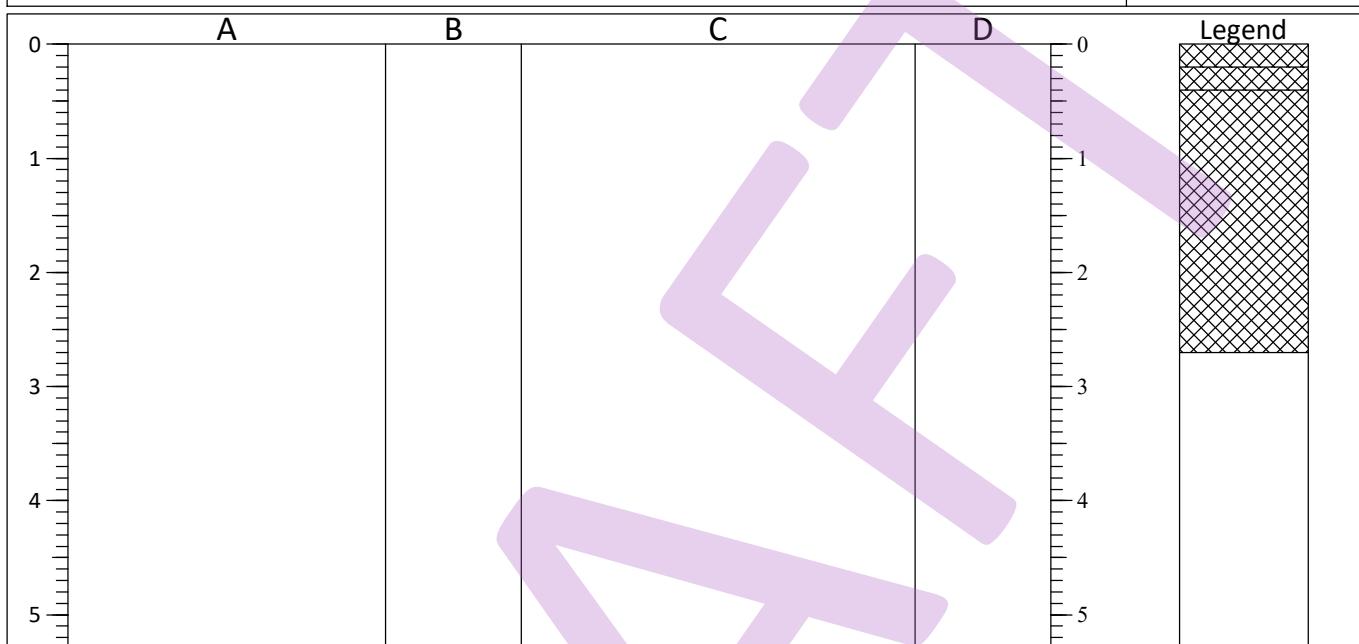
STRATA			SAMPLES & TESTS		
Depth	No	DESCRIPTION	Depth	No	Remarks/Tests
0.00-0.20		MADE GROUND: Dark grey sandy fine to medium angular to subangular GRAVEL of dolomite and sandstone.	0.10	E	PID: <0.1
0.20-0.40		0.20 Geotextile membrane.	0.30	E	PID: 0.1
0.40-2.70		MADE GROUND: Dark grey gravelly medium to coarse SAND. Gravel is fine to medium angular to subangular of dolomite and sandstone.	0.60	E	PID: <0.1
		MADE GROUND: Light to dark grey sandy fine to coarse angular to subangular GRAVEL of brick and concrete. Moderate cobble content of whole bricks concrete and sandstone. Occasional wood and metal fragments throughout.	1.20	D	
		1.80 Low cobble content of subrounded to rounded sandstone with dolomite and occasional whole bricks.	1.60	E	PID: <0.1
2.70		End of excavation. Eastern wall of pit collapsing.

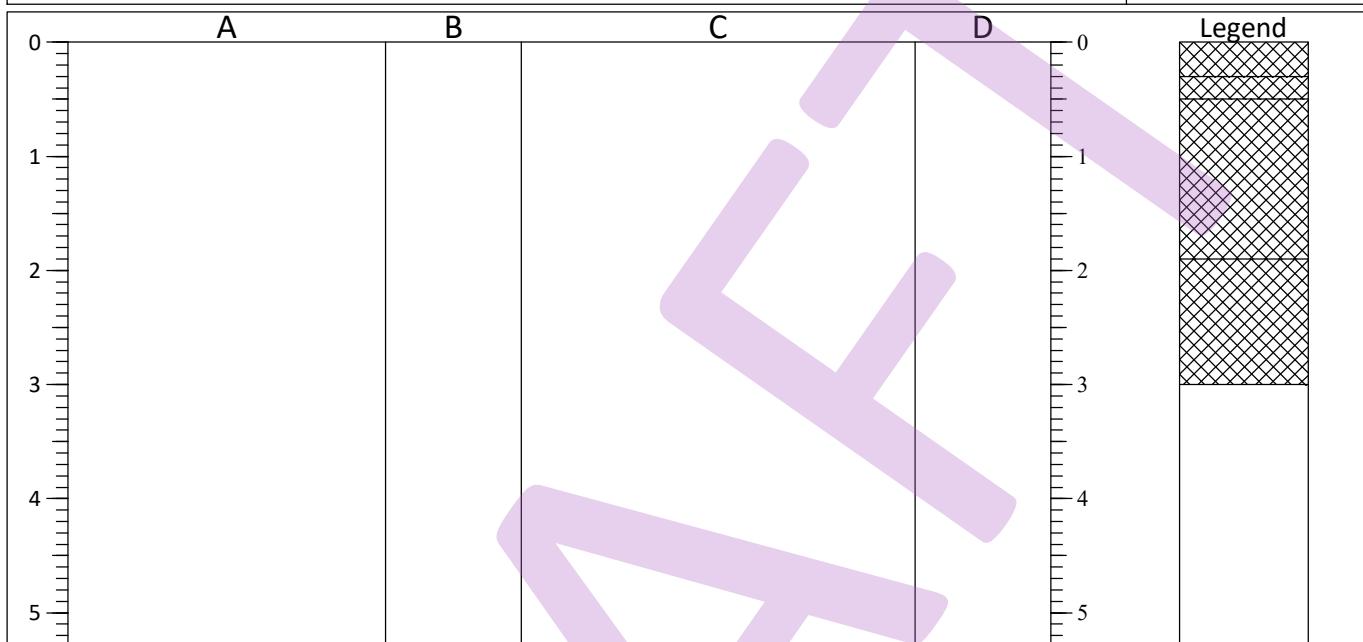
STRATA			SAMPLES & TESTS		
Depth	No	DESCRIPTION	Depth	No	Remarks/Tests
0.00-0.30		MADE GROUND: Dark grey sandy fine to medium angular to subangular GRAVEL of dolomite and sandstone.	0.20	E	PID: 0.1
0.30-0.50		0.30 Geotextile membrane.	0.40	E	
0.50-1.90		MADE GROUND: Dark grey gravelly medium to coarse SAND. Gravel is fine to medium angular to subangular of dolomite and sandstone.			
		MADE GROUND: Light to dark grey sandy fine to coarse subangular GRAVEL of brick and concrete. Moderate cobble content of whole bricks concrete and sandstone.			
1.90-3.00		1.80 - 1.90 Abundant whole bricks MADE GROUND: Light to dark grey clayey sandy fine to medium angular to subangular GRAVEL of brick concrete and sandstone.	2.00	E	PID: 0.1
3.00		End of excavation.

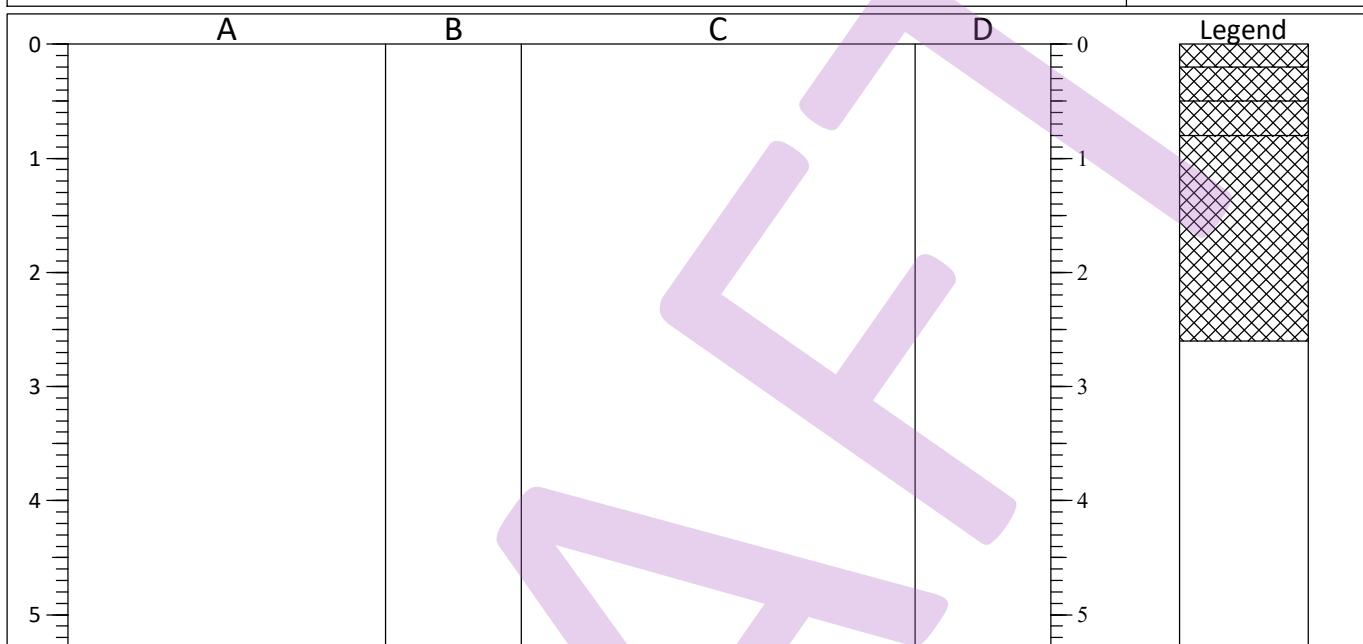
Project GESI Wastefront, Sunderland				TRIAL PIT No TP11
Job No 3899	Date 01-12-12	Ground Level (m) 5.00	Co-ordinates () E 441,403.1 N 556,818.7	
Contractor Patterson Plant Hire				Sheet 1 of 1

STRATA			SAMPLES & TESTS		
Depth	No	DESCRIPTION	Depth	No	Remarks/Tests
0.00-0.20		MADE GROUND: Dark grey sandy fine to medium angular to subangular GRAVEL of dolomite and sandstone.	0.10	E	PID: 0.1

0.20-0.50		0.20 Geotextile membrane.	0.30	E	
0.50-0.80		MADE GROUND: Dark grey gravelly medium to coarse SAND. Gravel is fine to medium angular to subangular of dolomite and sandstone.	0.50	E	PID: <0.1

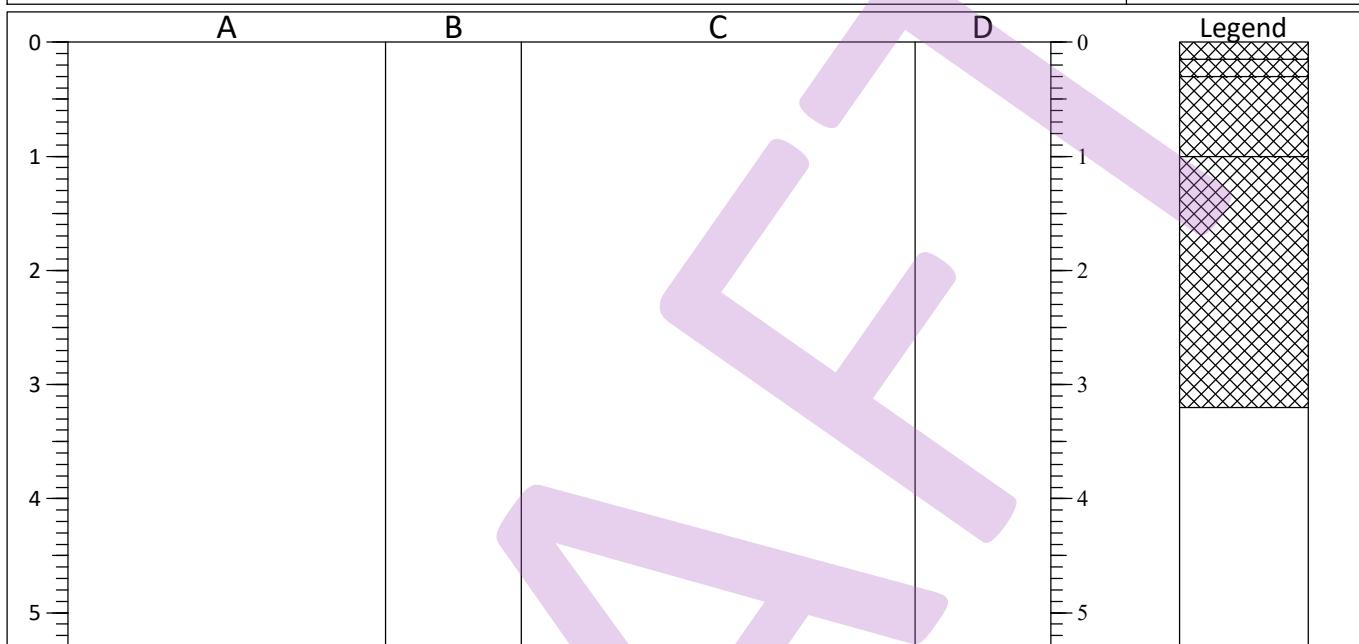
STRATA			SAMPLES & TESTS		
Depth	No	DESCRIPTION	Depth	No	Remarks/Tests
0.00-0.15		MADE GROUND: Dark grey sandy fine to medium angular to subangular GRAVEL of dolomite and sandstone.	0.20	E	PID: 0.1
0.15-0.30		0.15 Geotextile membrane.	0.40	E	PID: 0.2
0.30-1.00		MADE GROUND: Dark grey sandy fine to medium angular GRAVEL of dolomite and sandstone.			
1.00-3.20		MADE GROUND: Dark grey gravelly medium to coarse SAND. Gravel is fine to medium angular bricks and blocks with subangular of dolomite and sandstone. 0.60 Metal wire in east of the pit.	1.20	E	PID: <0.1
		MADE GROUND: Brick red slightly sandy gravelly COBBLES of whole bricks. Gravels are fine to coarse angular of brick with rare asphalt.	2.00	D	
3.20		End of excavation.

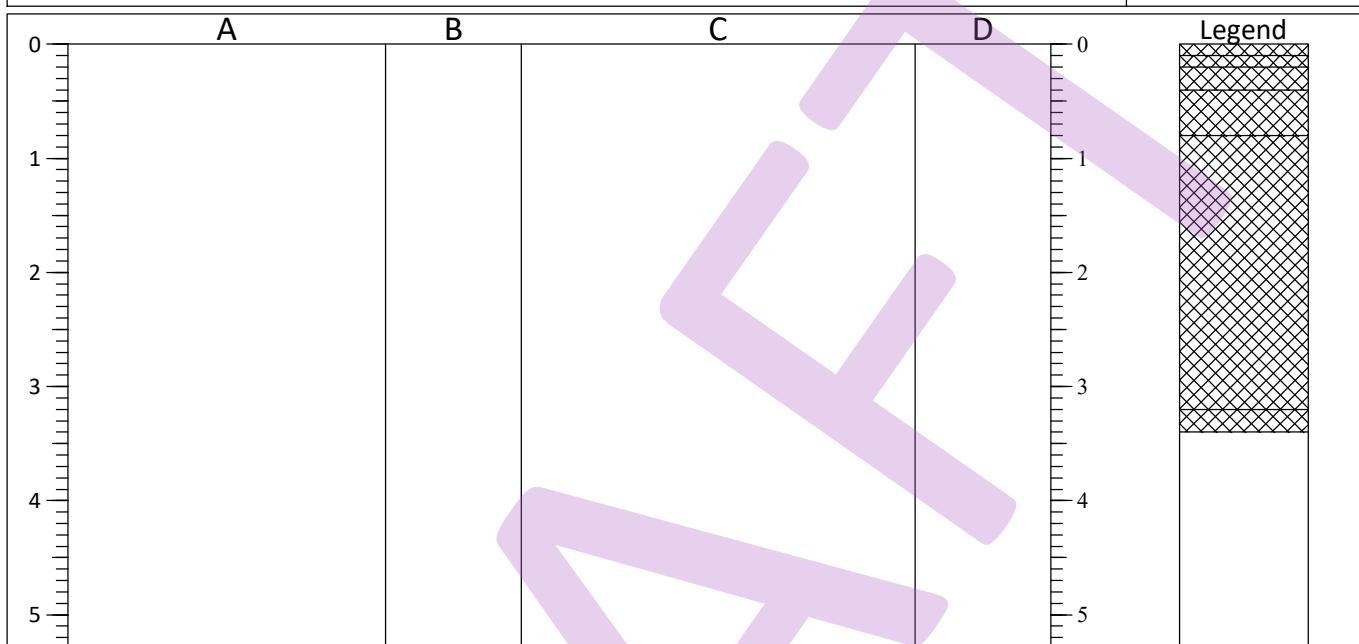
Project GESI Wastefront, Sunderland				TRIAL PIT No TP14
Job No 3899	Date 01-12-12	Ground Level (m) 5.04	Co-ordinates () E 441,362.0 N 556,804.2	
Contractor Patterson Plant Hire				Sheet 1 of 1

STRATA			SAMPLES & TESTS		
Depth	No	DESCRIPTION	Depth	No	Remarks/Tests
0.00-0.10		MADE GROUND: Dark grey sandy fine to medium angular to subangular GRAVEL of dolomite and sandstone.	0.15	E	PID: 0.1

0.10-0.20		0.10 Geotextile membrane.	0.30	E	PID: 0.2
0.20-0.40		MADE GROUND: Light brown gravelly fine to coarse SAND. Gravel is fine to medium angular to subangular of dolomite.	0.50	E	PID: <0.1

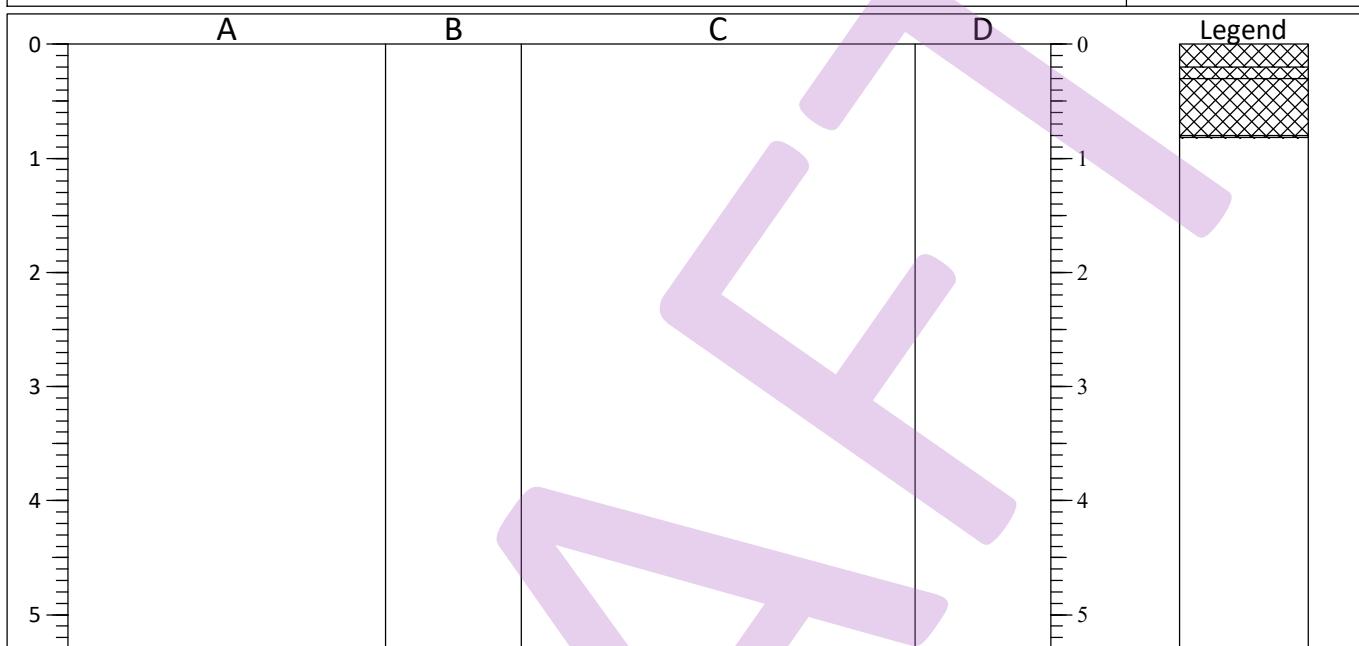
STRATA			SAMPLES & TESTS		
Depth	No	DESCRIPTION	Depth	No	Remarks/Tests
0.00-0.20		MADE GROUND: Light brown gravelly fine to coarse SAND. Gravel is fine to medium angular to subangular of dolomite.	0.10	E	0.1
0.20-0.30		0.20 Geotextile Membrane	0.25	E	0.1
0.30-0.80		MADE GROUND: Dark grey sandy fine to medium angular to subangular GRAVEL of dolomite and sandstone.	0.40	E	<0.1
0.80-0.82	0.82	MADE GROUND: Dark brown to reddish brown sandy GRAVEL of angular to subangular brick and block work dolomite and sandstone. Low cobble content of whole bricks and occasional lenses of dolomite subbase. 0.60 Low boulder content of masonry. Concrete slab End of excavation on concrete slab	0.80	B

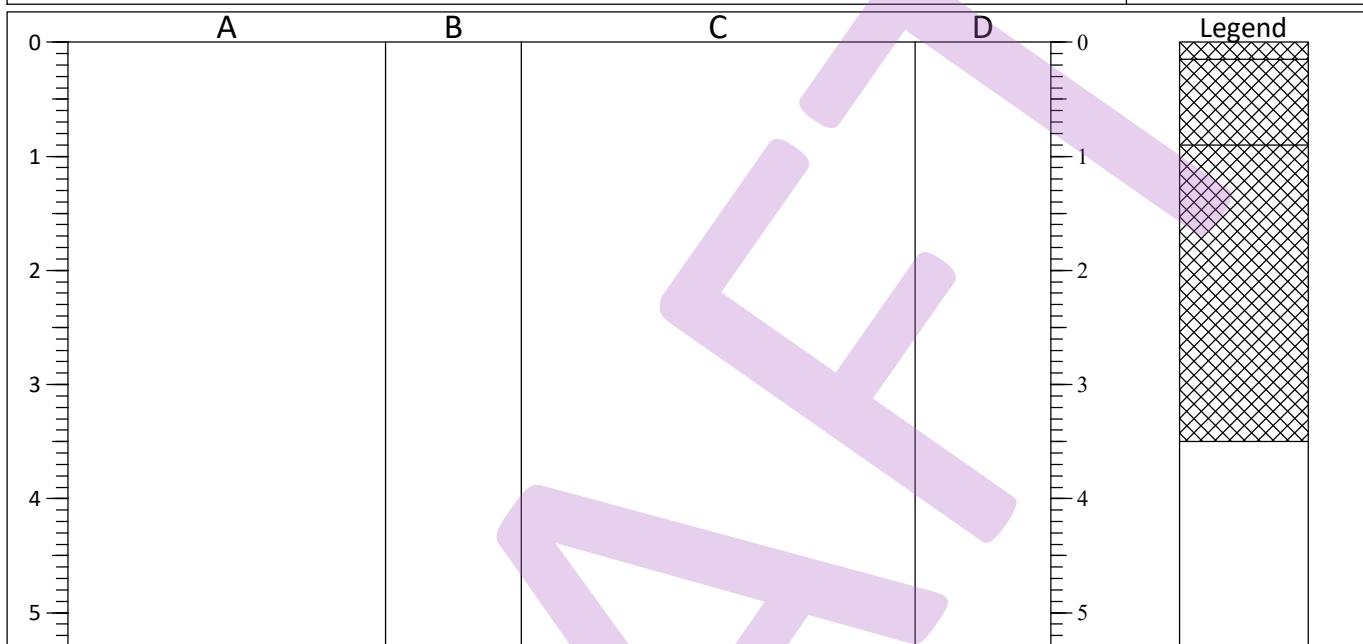
STRATA			SAMPLES & TESTS		
Depth	No	DESCRIPTION	Depth	No	Remarks/Tests
0.00-0.15		MADE GROUND: Dark grey sandy fine to medium angular to subangular GRAVEL of dolomite and sandstone.	0.10	E	0.1
0.15-0.90		0.15 Geotextile Membrane	0.40	E	1.5
0.90-3.50		MADE GROUND: Black fine to medium angular to subangular GRAVEL of dolomite. Slight hydrocarbon odour.	0.90	B	
		MADE GROUND: Dark grey sandy cobbly fine to coarse SAND. Gravel is fine to coarse subangular to subrounded of brick sandstone concrete ceramic and bottles. Low cobble content of whole bricks.	1.00	E	27
		2.00 Hydrocarbon odour. Coarse gravel of glass and bottles.	2.00	E	33
3.50		3.40 Very strong hydrocarbon odour with oily groundwater with slight iridescence encountered in base of hole. End of excavation on collapse of side walls	3.30	W

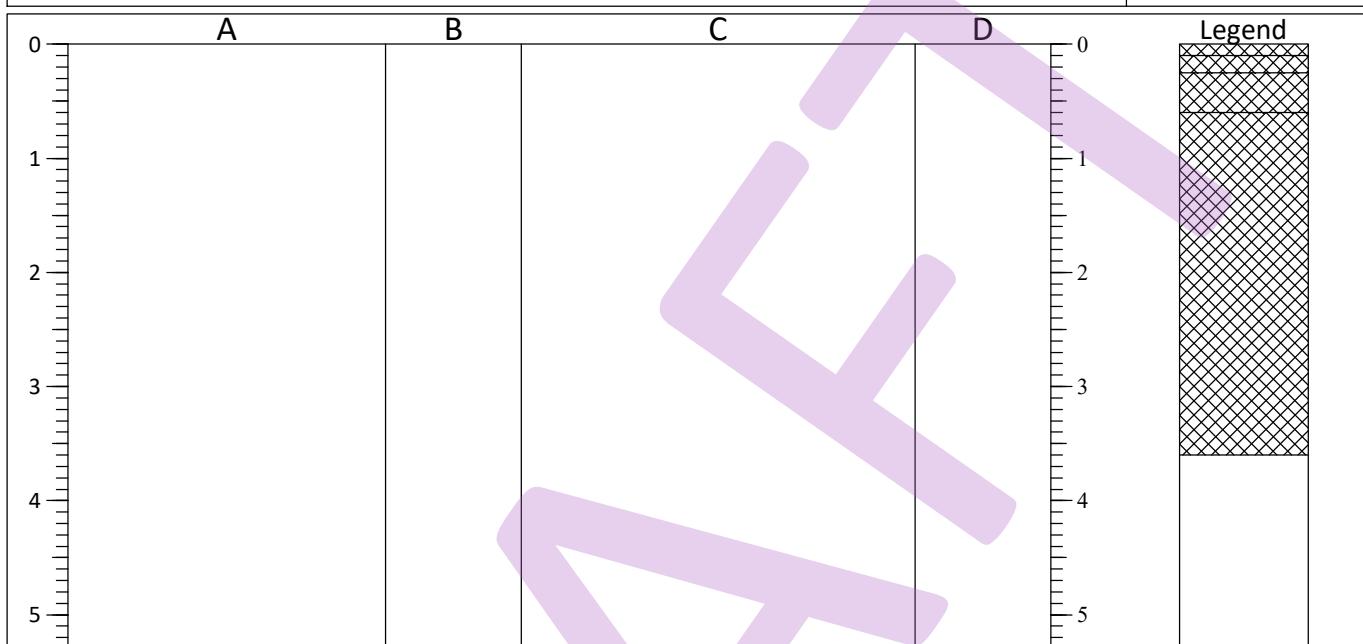
Project GESI Wastefront, Sunderland				TRIAL PIT No TP17
Job No 3899	Date 02-12-20	Ground Level (m) 5.25	Co-ordinates () E 441,338.2 N 556,920.2	
Contractor Patterson Plant Hire				Sheet 1 of 1

STRATA			SAMPLES & TESTS		
Depth	No	DESCRIPTION	Depth	No	Remarks/Tests
0.00-0.10		MADE GROUND: Dark grey sandy fine to medium angular to subangular GRAVEL of dolomite and sandstone.	0.30	E	0.1

0.10-0.25		0.10 Geotextile Membrane	0.60	E	0.2
0.25-0.60		MADE GROUND: Light brown gravelly fine to coarse SAND. Gravel is fine to medium angular to subangular of dolomite.	1.20	B

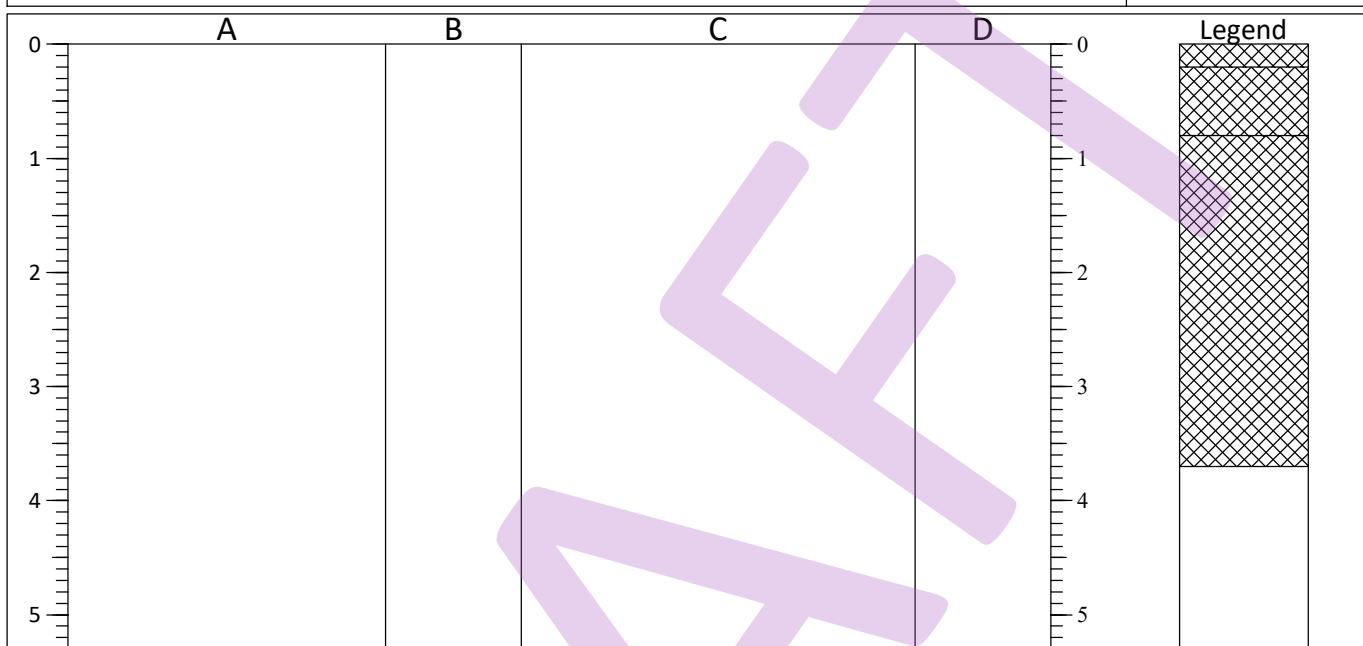
STRATA			SAMPLES & TESTS		
Depth	No	DESCRIPTION	Depth	No	Remarks/Tests
0.00-0.20		MADE GROUND: Light brown gravelly fine to coarse SAND. Gravel is fine to medium angular to subangular of dolomite.	0.10	E	<0.1
0.20-0.80		0.20 Geotextile Membrane	0.40	E	0.1
0.80-3.70		MADE GROUND: Dark grey sandy fine to medium angular to subangular GRAVEL of dolomite and sandstone.	0.90	E	<0.1
		MADE GROUND: Light brown to black gravelly fine to coarse SAND. Gravel is fine to coarse angular brick dolomite sandstone concrete glass bottles and occasional ceramics.	1.00	B	
		1.00 Becomes black	2.00	E	<0.1
		1.20 - 1.30 Abundant ceramics			
		2.40 Cobbles of subrounded to rounded weathered dolomite.			
		3.20 - 3.70 Abundant cobbles of brick tile slate and wood.	3.20	E	<0.1
3.70		End of excavation

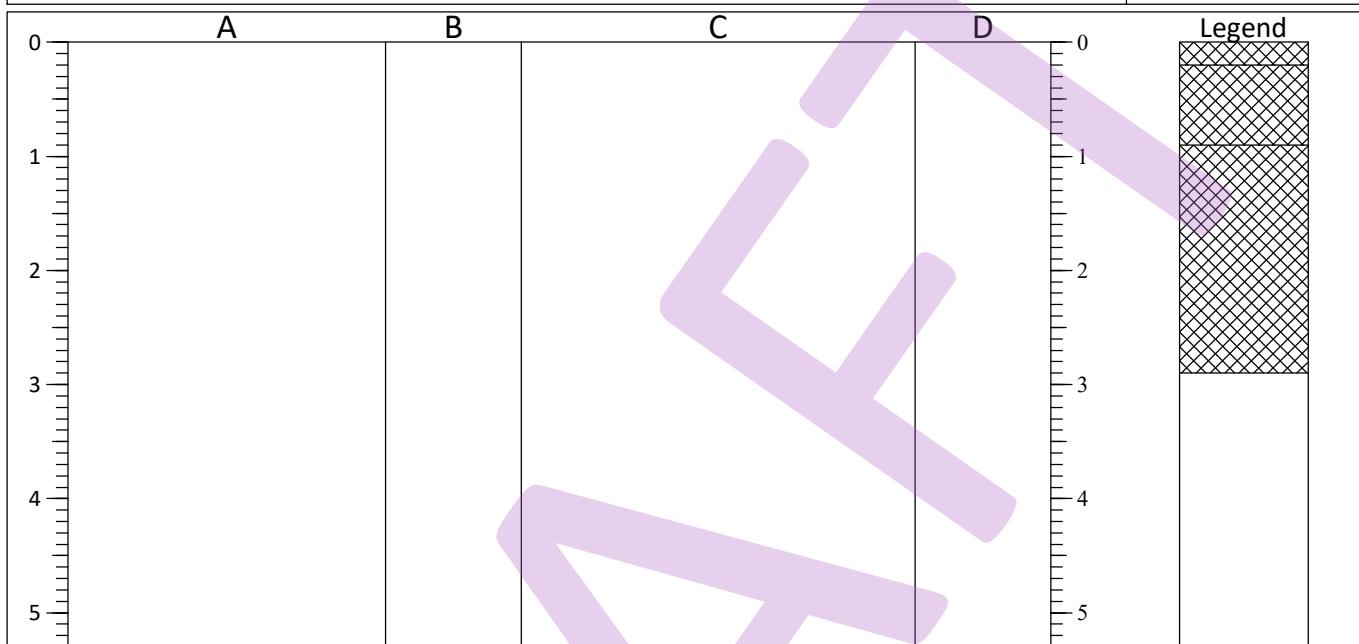
STRATA			SAMPLES & TESTS		
Depth	No	DESCRIPTION	Depth	No	Remarks/Tests
0.00-0.20		MADE GROUND: Dark grey sandy fine to medium angular to subangular GRAVEL of dolomite and sandstone.	0.30	E	
0.20-0.90		MADE GROUND: Grey to reddish brown gravelly medium to coarse SAND. Gravel is fine to coarse angular to subangular of brick.			
0.90-2.90		0.40 Becomes dark grey to dark brown. 0.50 Low cobble content of whole bricks and cobbles of masonry. MADE GROUND: Black GRAVEL of fine to medium angular to subangular to subrounded slag chert and dolomite.	1.50	E	
		2.00 Collapse from east and west of pit.			
		2.50 Collapse from south of pit.			
2.90		End of excavation

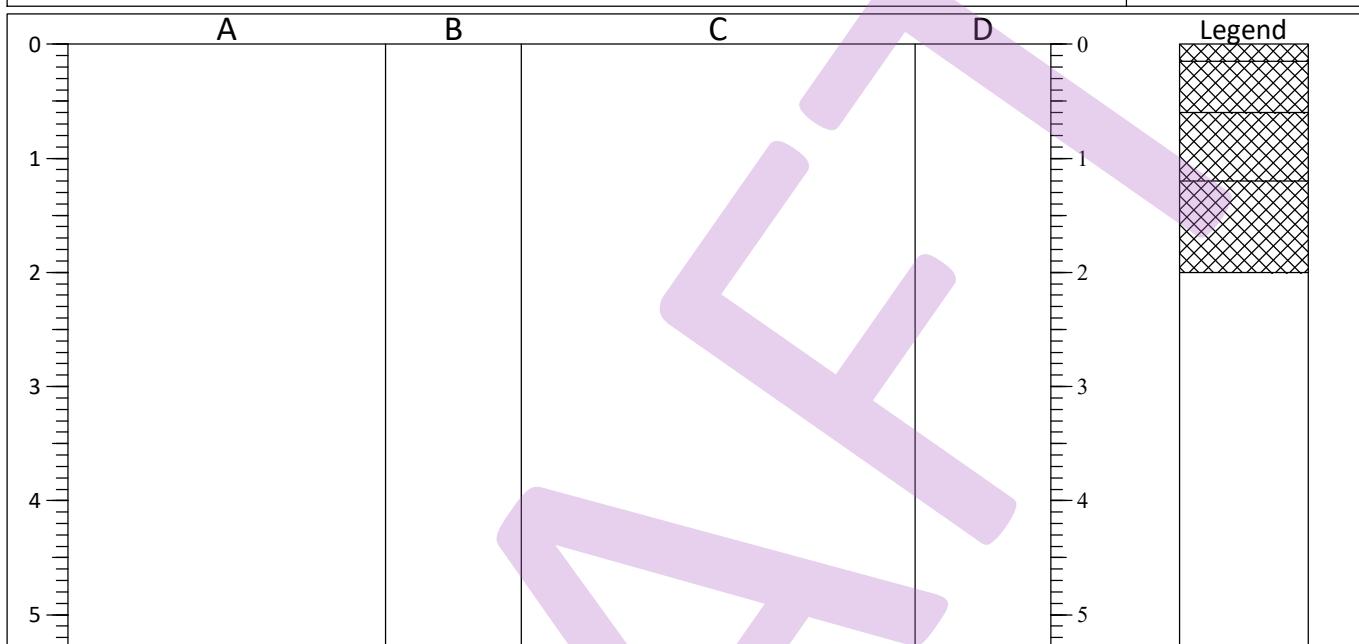
STRATA			SAMPLES & TESTS		
Depth	No	DESCRIPTION	Depth	No	Remarks/Tests
0.00-0.15		MADE GROUND: Black asphalt.			
0.15-0.60		MADE GROUND: Black gravelly medium to coarse SAND. Gravel is angular to subangular fine to medium of limestone and concrete. Low cobble content of masonry and concrete.	0.40	D	
0.60-1.20		MADE GROUND: Brown gravelly medium to coarse SAND. Gravel is fine to coarse surrounded to rounded of sandstone and chert.	0.40	E	0.2
1.20-2.00		0.70-0.05 m thick concrete slab in the south of the trial pit	1.00	D	
		MADE GROUND: Black gravelly medium to coarse SAND. Gravel is fine to coarse surrounded to rounded of sandstone and chert and coarse angular dolomite.	1.00	E	0.3
2.00		Trial Pit Terminated on concrete slab	1.60	E	<0.1

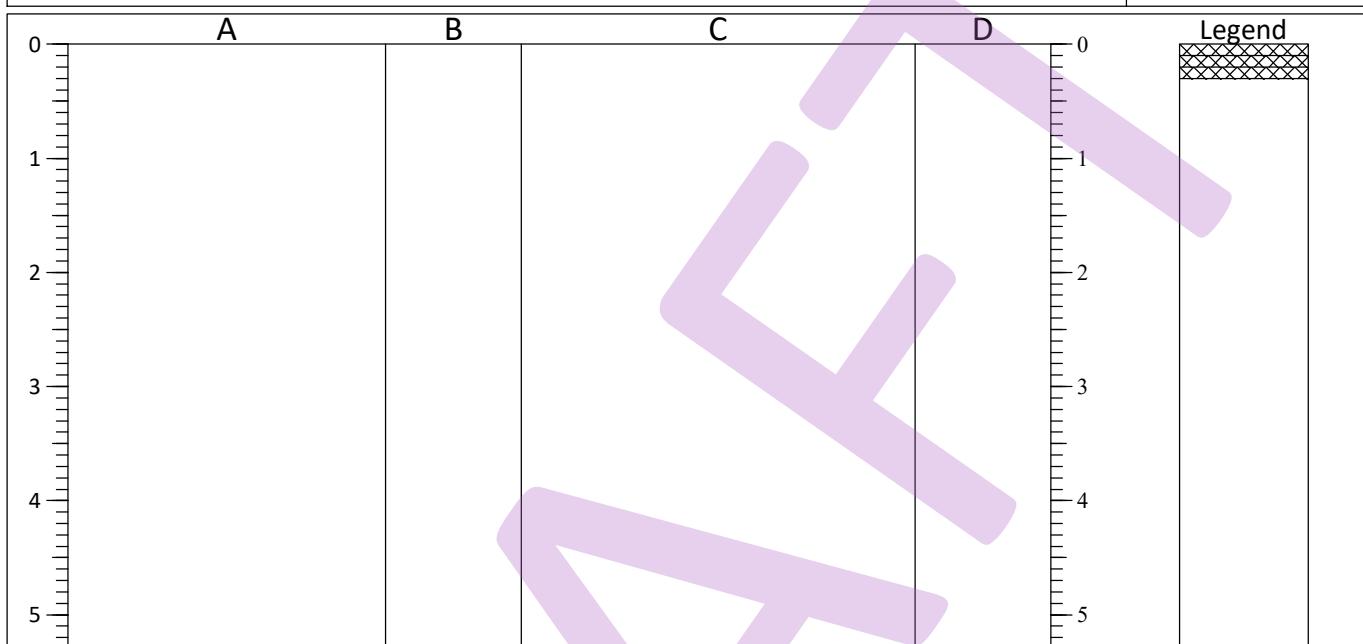
STRATA			SAMPLES & TESTS		
Depth	No	DESCRIPTION	Depth	No	Remarks/Tests
0.00-0.10		MADE GROUND: Grey gravelly fine to coarse SAND. Gravel is fine to medium angular to subangular of dolomite and sandstone.	0.15	E	0.2
0.10-0.20		MADE GROUND: Light brown sandy GRAVEL of fine to medium subangular dolomite,			
0.20-0.30		MADE GROUND: Brown gravelly medium to coarse SAND. Gravel is fine to coarse surrounded to rounded of sandstone and chert and coarse angular dolomite.			
0.30		0.20 Steel rail in the north of the trial pit. Trial Pit Terminated on buried sleepers

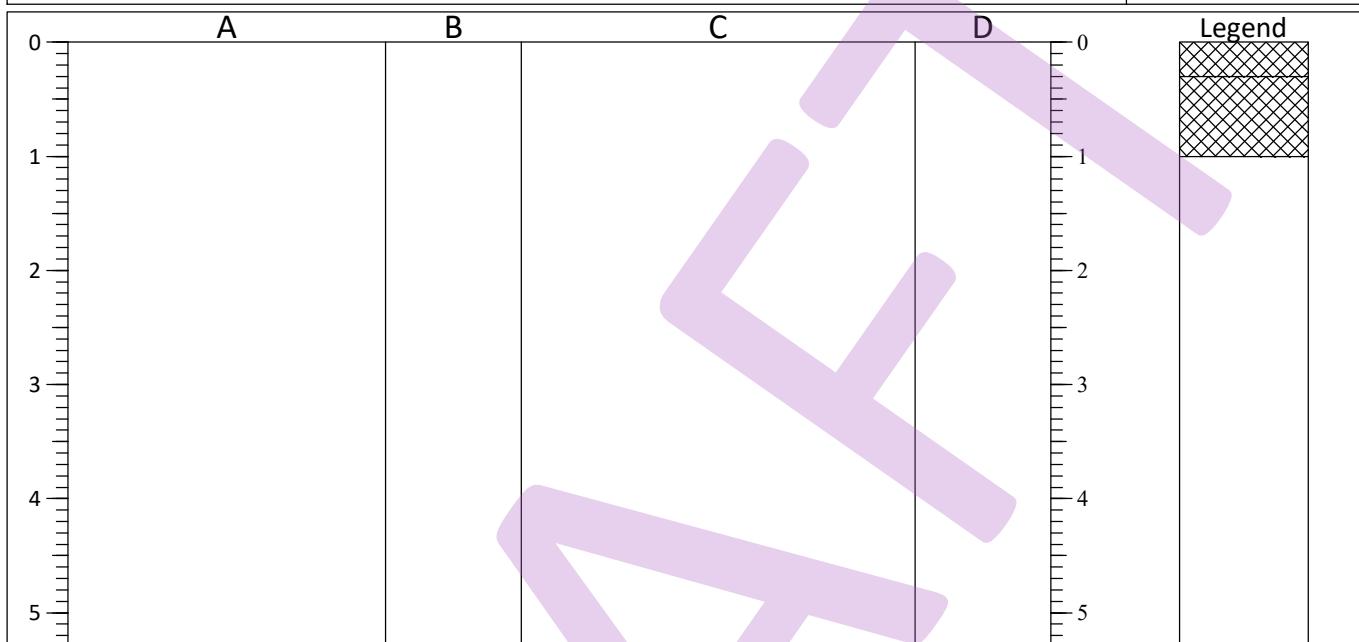
STRATA			SAMPLES & TESTS		
Depth	No	DESCRIPTION	Depth	No	Remarks/Tests
0.00-0.30		MADE GROUND: Grey gravelly fine to coarse SAND. Gravel is fine to medium angular to subangular of dolomite and sandstone.	0.20	E	<0.1
0.30-1.00		MADE GROUND: Brown gravelly medium to coarse SAND. Gravel is fine to coarse surrounded to rounded of sandstone and chert and coarse angular dolomite. Low cobble content of angular whole bricks. Occasional of glass and wood.	0.50	E	0.3
1.00		0.50 Broken lengths of steel rail in the centre of the pit. Trial Pit Terminated on concrete slab

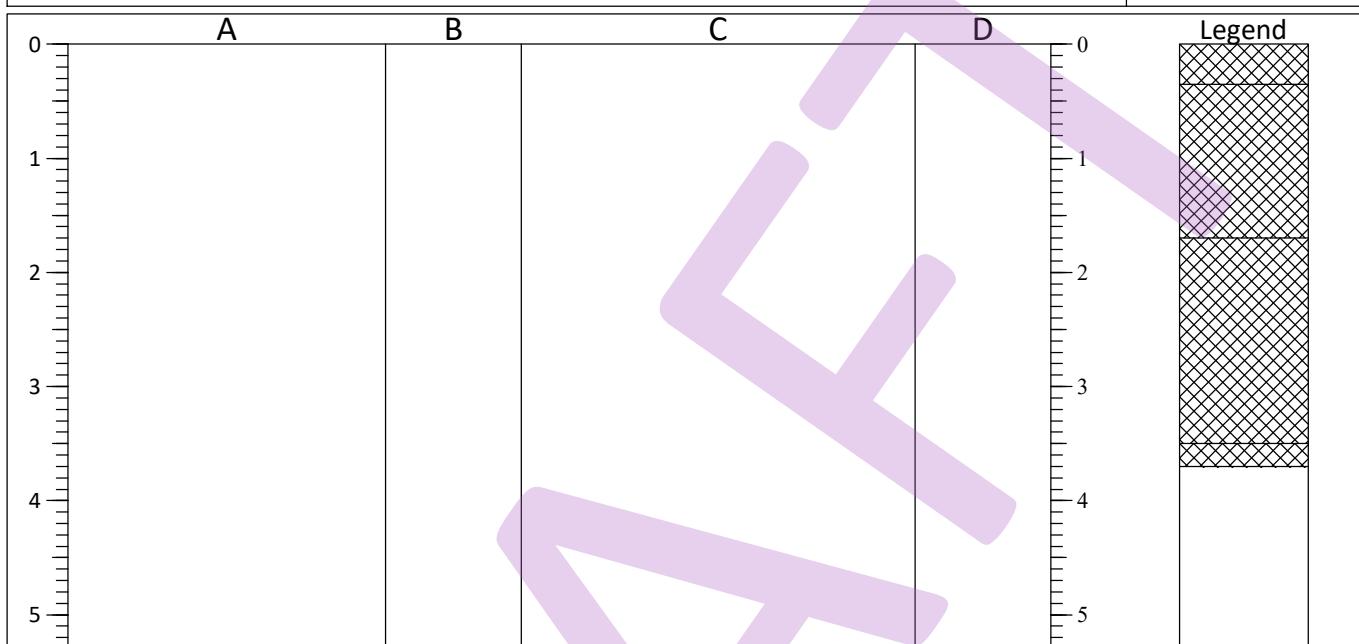
Project GESI Wastefront, Sunderland				TRIAL PIT No TP30
Job No 3899	Date 15-12-20	Ground Level (m) 5.30	Co-ordinates () E 441,260.5 N 556,832.2	
Contractor Patterson Plant Hire				Sheet 1 of 1

STRATA			SAMPLES & TESTS		
Depth	No	DESCRIPTION	Depth	No	Remarks/Tests
0.00-0.35		MADE GROUND: Black to grey sandy cobbly fine to coarse GRAVEL of angular to subangular slag. Low cobble content of angular slag.	0.20	E	0.2
0.35-1.70		MADE GROUND: Light brown sandy fine to medium angular to subangular GRAVEL of dolomite and sandstone. 0.60 Becomes light brown 0.80 Slight hydrocarbon odour	0.80	E	0.3
1.70-3.50		MADE GROUND: Very soft brown to grey sandy gravelly CLAY. Gravel is fine to medium of sandstone.	1.70	E	0.2
3.50-3.70 3.70		MADE GROUND: Grey very clayey slightly gravelly SAND. Gravel is fine to coarse surrounded to rounded of concrete glass and wood. Excavation terminated on collapse of north and southern wall.	3.50	E	5.9

AGS3 UK TP NEW TP LOGS.GPJ AGS3 ALL.GDT 28/12/21	Shoring/Support: Stability: Unstable from 3.5 m		GENERAL REMARKS Slight hydrocarbon odour at 1.0 m bgl. No groundwater encountered. PID value in ppm.
All dimensions in metres Scale 1:66.25	Client DTA Engineering	Method/ Plant Used JCB 3CX	Logged By JD

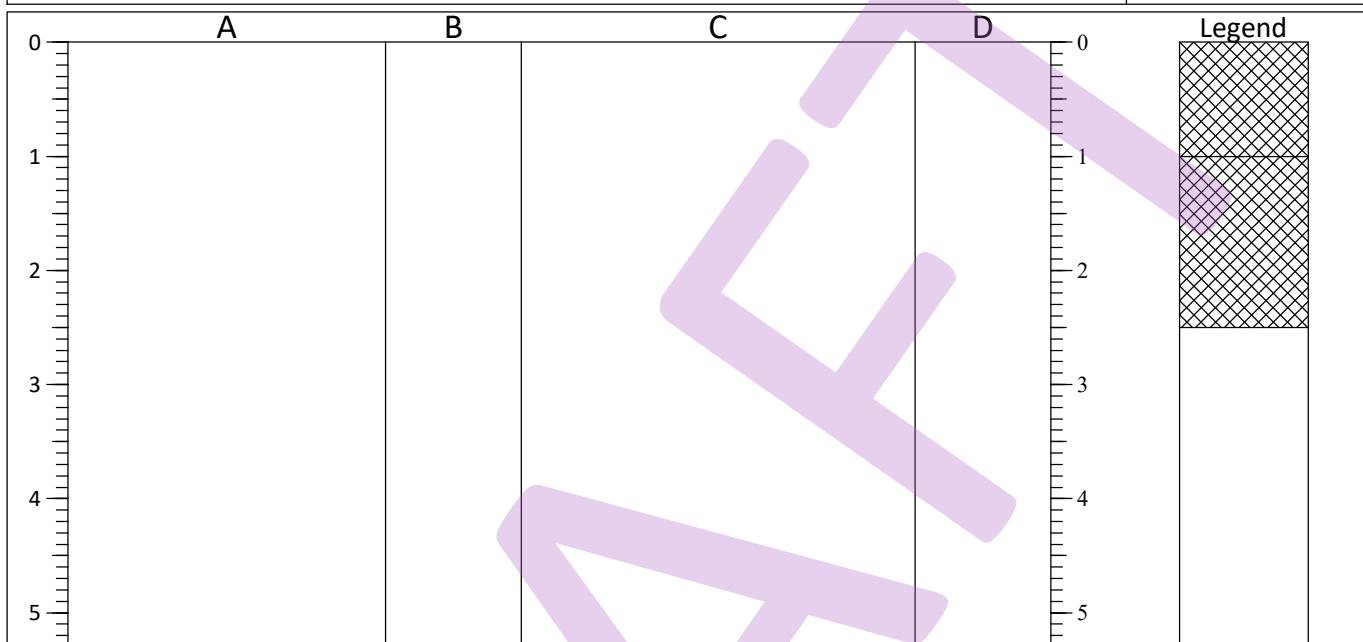
STRATA			SAMPLES & TESTS		
Depth	No	DESCRIPTION	Depth	No	Remarks/Tests
0.00-1.00		MADE GROUND: Grass over dark brown and black very sandy fine to coarse angular to rounded GRAVEL of concrete brick mudstone and sandstone with ashy sand and a high cobble content of concrete. With angular boulders of concrete.	0.20 0.50-0.80 0.50 0.90 1.00-1.20 1.20	E B CBR E B E	31%
1.00-2.50		MADE GROUND: Soft to firm brown sandy very clayey GRAVEL. Gravel is fine to coarse subangular to subrounded of concrete brick sandstone mudstone and dolomite. With occasional plastic bags whole bricks and cobbles and boulders of concrete with rebar. 1.50 Metal bar 1.80 Becomes less clayey.		B	
2.50		End of trial pit - instability and hard digging with concrete and rebar.		2.00

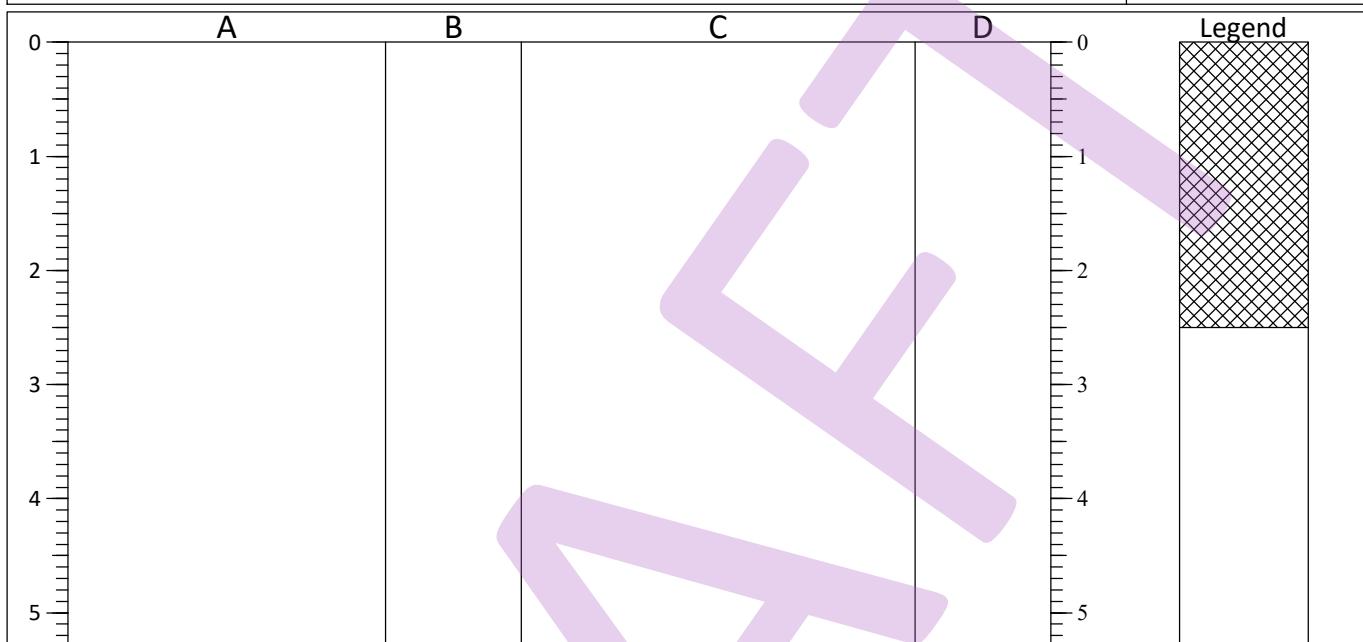
STRATA			SAMPLES & TESTS		
Depth	No	DESCRIPTION	Depth	No	Remarks/Tests
0.00-2.50		MADE GROUND: Greyish brown clayey sandy fine to coarse angular to subrounded GRAVEL of sandstone limestone brick concrete and mudstone with plastic sheeting ceramic and occasional whole bricks. 0.70 Frequent whole bricks. 1.00 Large concrete boulders. (0.8 X 1.0 m)	0.30 0.50 0.50 1.00 1.00	E CBR B E B	19%
2.50		End of trial pit due to collapse and hard digging.	2.00	B
