**Site Investigation for the Wastefront Development
at the Port of Sunderland**

PHASE 2 GROUND INVESTIGATION ON LAND AT HUDSON DOCK EAST, PORT OF SUNDERLAND

3899OR02/January 2021

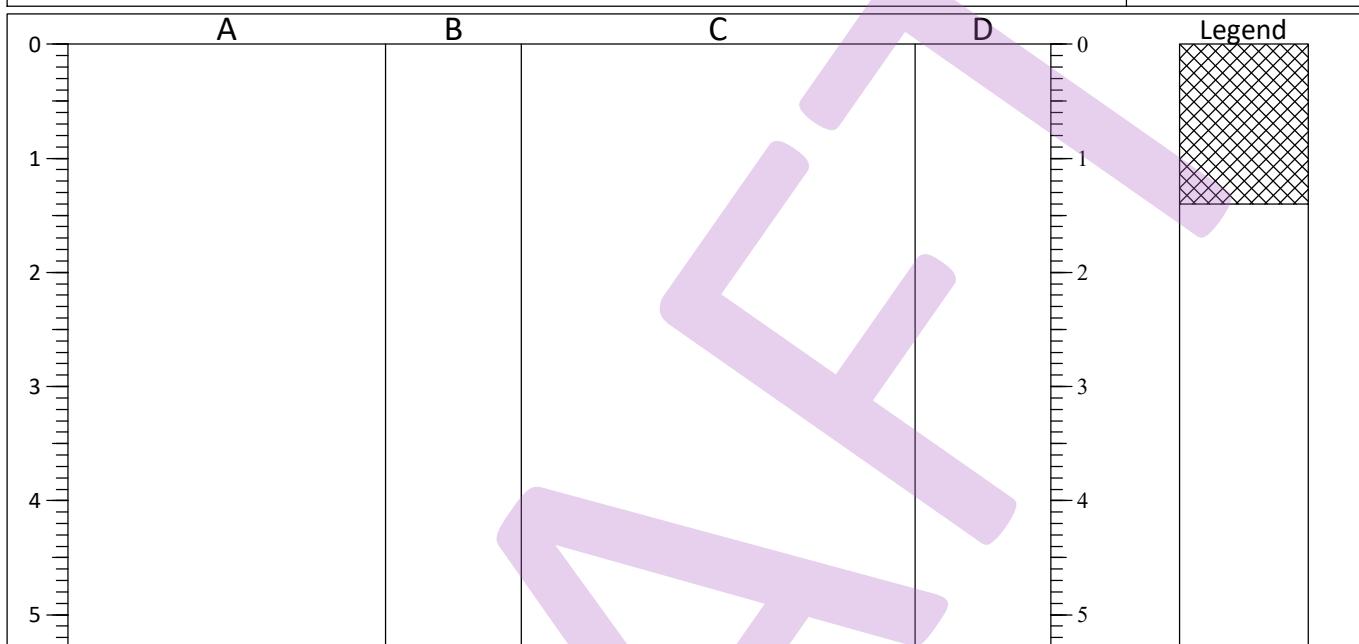
STRATA			SAMPLES & TESTS		
Depth	No	DESCRIPTION	Depth	No	Remarks/Tests
0.00-1.40		MADE GROUND: Waterlogged grass over brown slightly ashy sandy fine to coarse angular to subangular GRAVEL of brick concrete dolomite and mudstone with a high cobble content of brick and concrete. With occasional concrete slabs/boulders max 1 x 1.5 m and 0.2 m thick.	0.50	E	
1.40		End of trial pit due to instability and many boulders.	0.50	B	
			1.00	E	
			1.00	B
