CASTLE HILL QUARRY

**APPLICATION FOR WASTE RECOVERY
PERMIT**

Stability Risk Assessment Report

GEC JOB NO: GE230291204

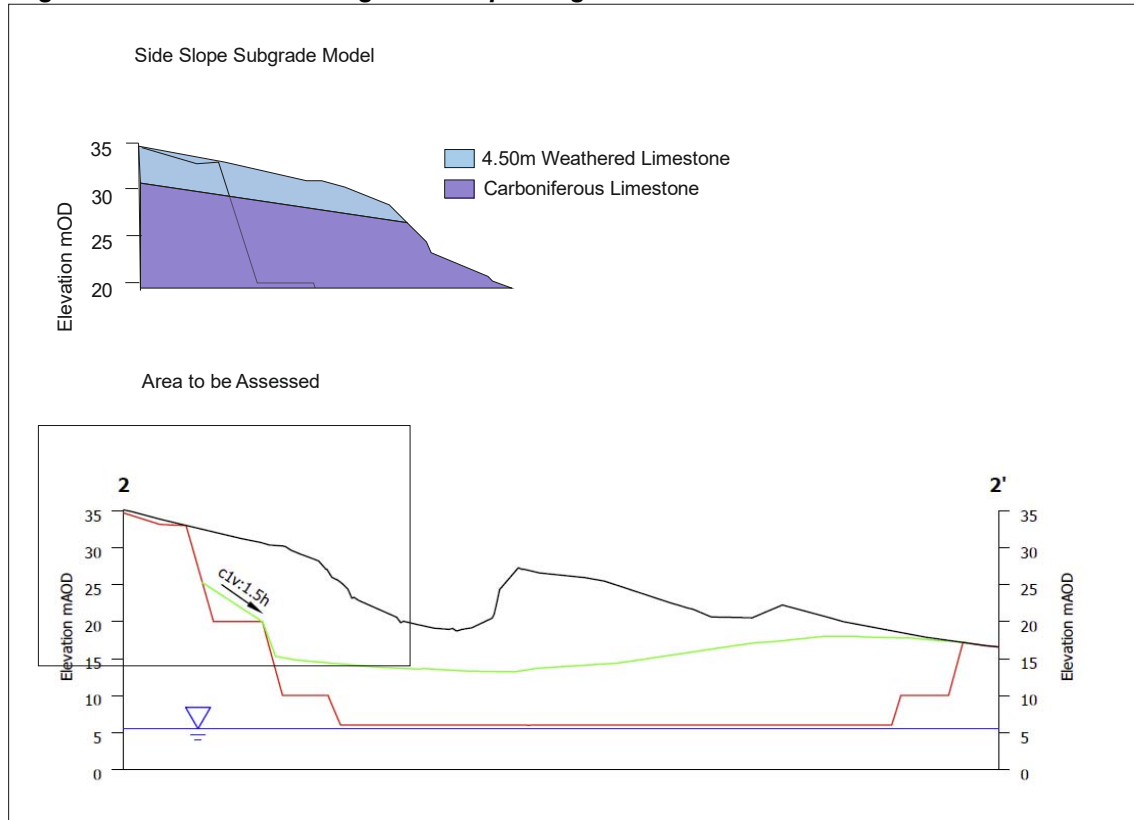
Figure SRA4 Section through side slope subgrade

- 1.3 The side slope subgrade model will comprise the Carboniferous Limestone Supergroup comprising massive bioclastic / micritic limestone. However, local boreholes have shown there to be potentially up to 4.50m of weathered limestone likely comprising rubbly material above the massive limestone beds.
- 1.4 Based on information supplied by the Client the highest side slope will be approximately 29m with a benched batter angle of 45° (1H : 1V). This represents an average across the slope as some of the massive limestones of the Carboniferous Limestone Supergroup will stand near vertically.
- 1.5 Dewatering will maintain groundwater 0.50m below the base of the extraction void at 5.50mOD and therefore will not act to destabilise the side slope subgrade.
- 1.6 A Geological cross section, compiled from information supplied by the Client, is presented as Figure SRA4 overleaf.

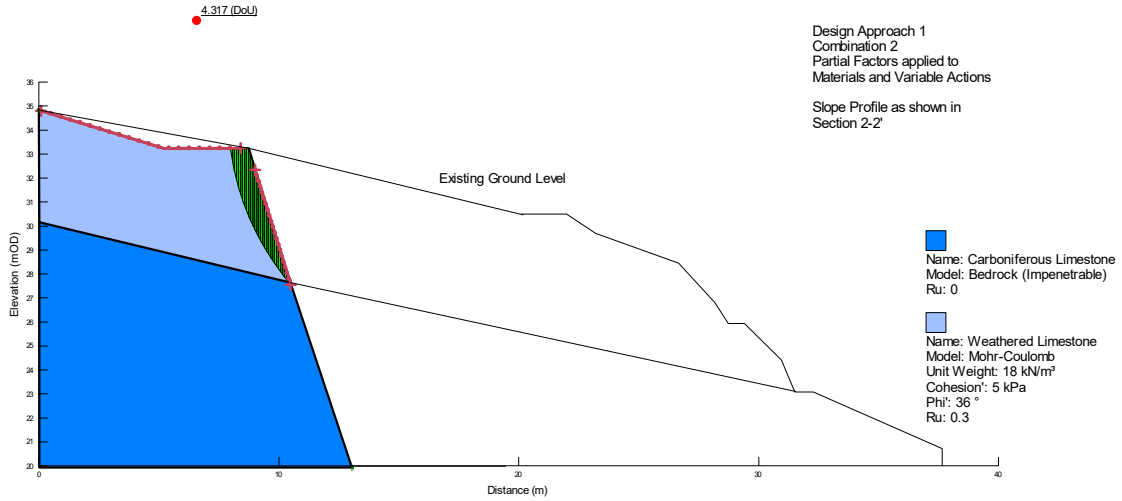
Design Approach 1
 Combination 2
 Partial Factors applied to
 Materials and Variable Actions

Slope Profile as shown in
 Section 2-2'

2.30 The results of the side slope subgrade stability analyses are shown in Table SRA7 and the SlopeW worksheets presented in Appendix 1.

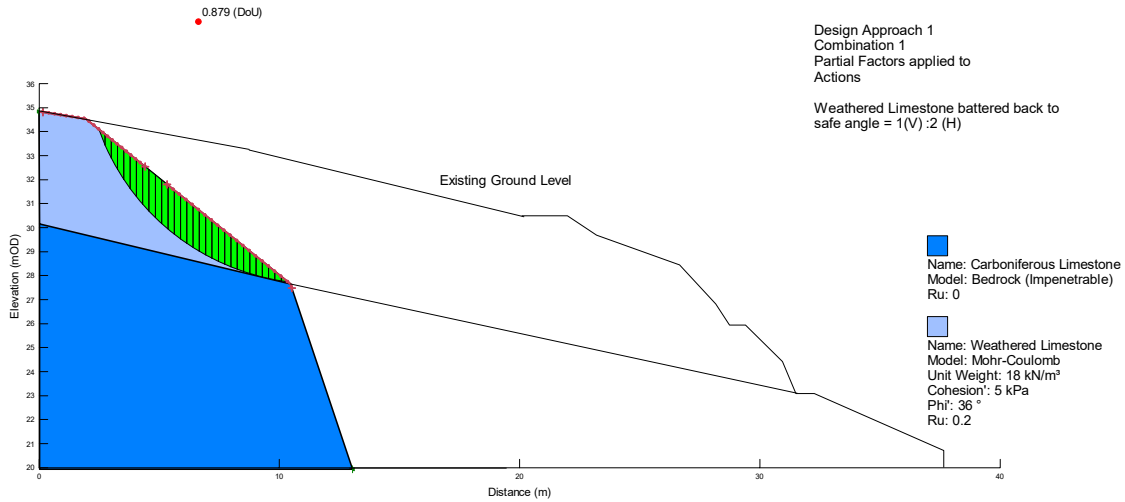
Side Slope Subgrade - SSG2

Design Approach 1
 Combination 1
 Partial Factors applied to
 Actions

Weathered Limestone battered back to
 safe angle = 1(V) : 2 (H)

- 2.48 The side slope stability analysis has shown that provided the side slope subgrade batter does not exceed 1(v) : 2 (h) in the weathered limestone, the side slope subgrade will remain stable under all foreseeable conditions.

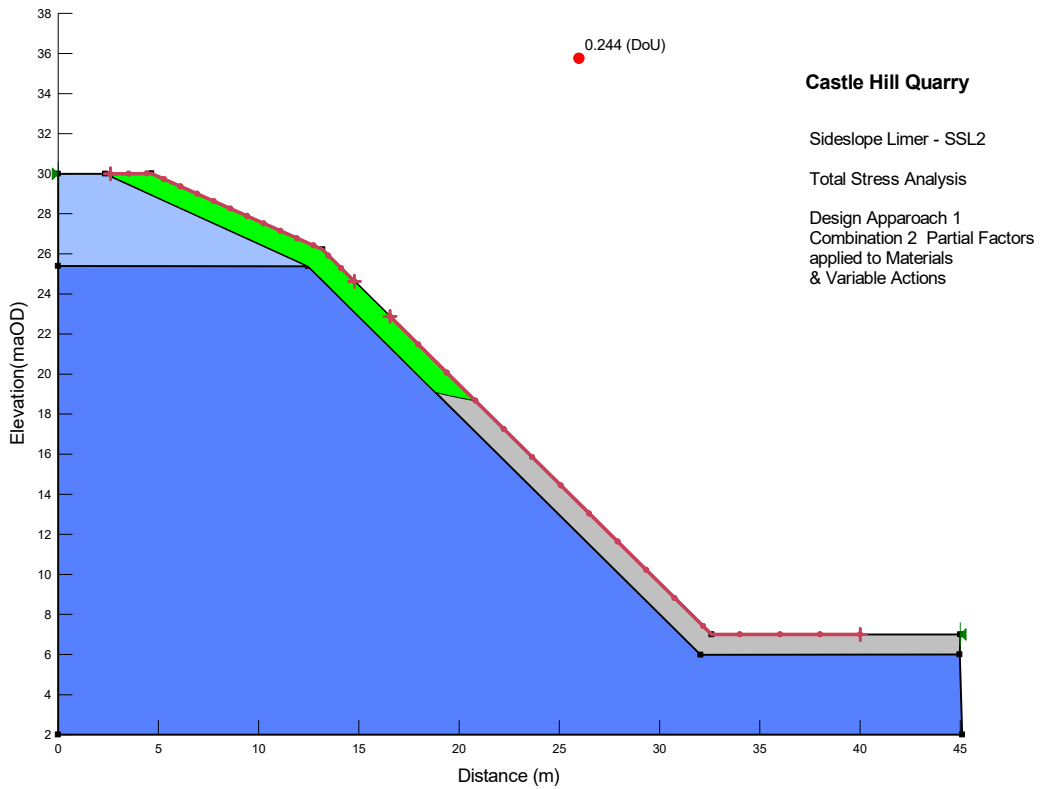
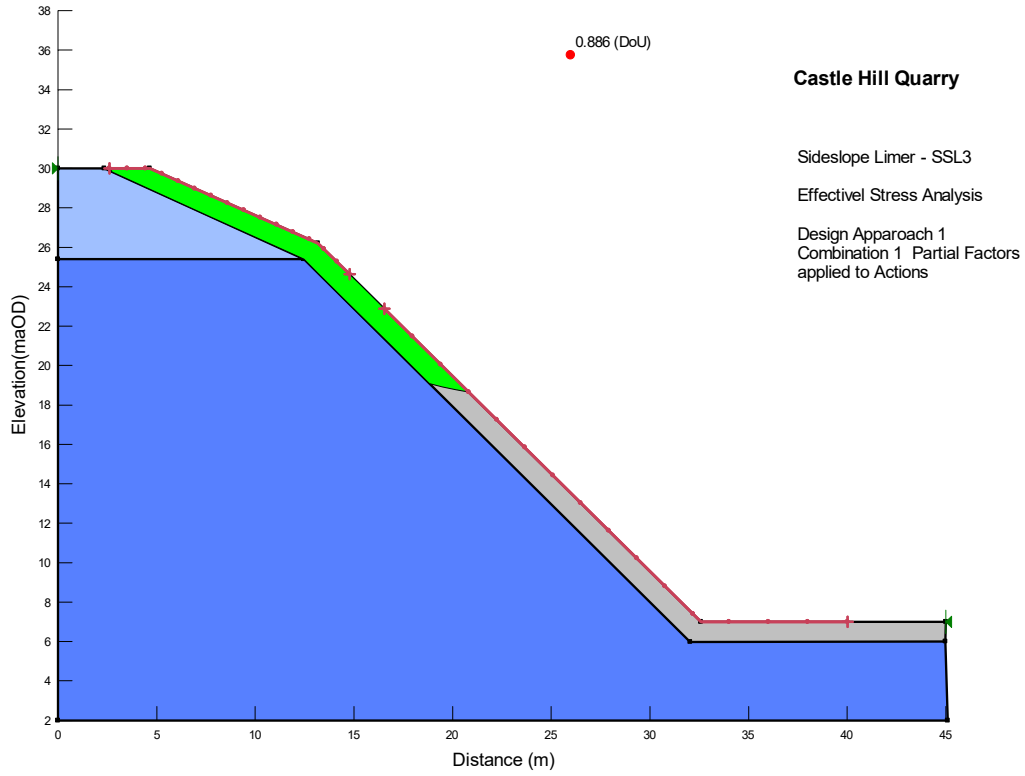
SlopeW Worksheets - Side Liner & Terminal Bund Stability

Run	File Name	Characteristic Shear Strength		Degree of Utilisation		Liner Thickness (m)	Notes
		c	ϕ	C1	C2		
Rotational Failure Entirely within Side Slope Liner							
01	SSL1	50	0	0.26	/	1.00	Total stress
02	SSL2			0.24			
03	SSL3	5	25	0.89	/	1.00	Full effective stress conditions
04	SSL4			0.99			
05	SSL5	5	25	/	0.25	1.00	5m lift buttressed with inert waste

- 2.49 For the purposes of this stability assessment, initially the full height of the side slope liner has been modelled.
- 2.50 The 1.00m thick side slope liner has been analysed and shown to be stable in the short term under total stress conditions with a maximum degree of utilisation of 0.36 being returned under Combination 1 factoring.

- 2.51 If left unsupported in the long-term such that fully drained effective stress conditions are achieved the liner remains stable albeit with a degree of utilisation of 0.99 under Combination 2 factoring. Therefore, it is recommended that the liner is placed in advance of the inert waste placement and not left unsupported for long periods without buttressing with inert waste.(SLL5).

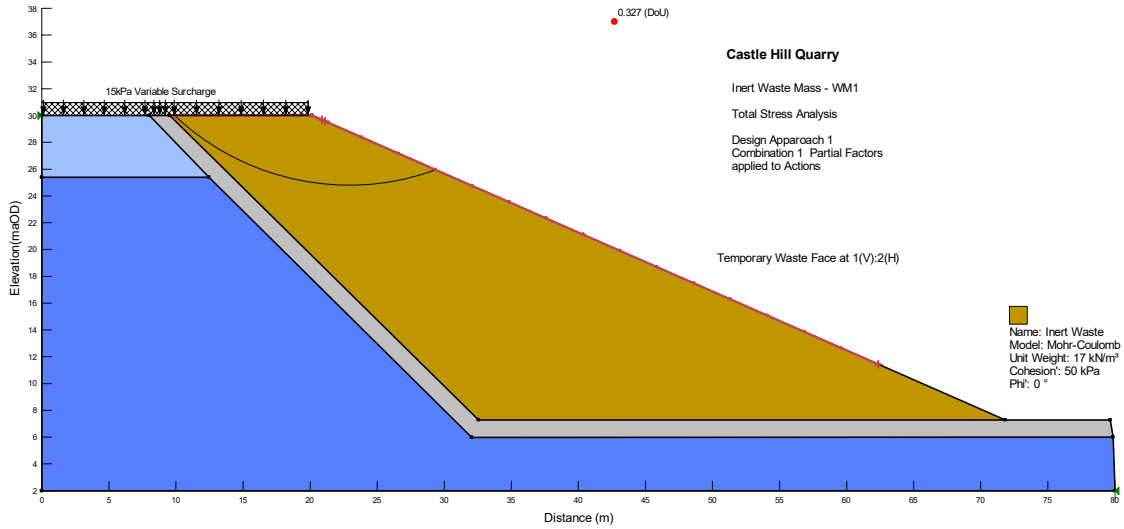
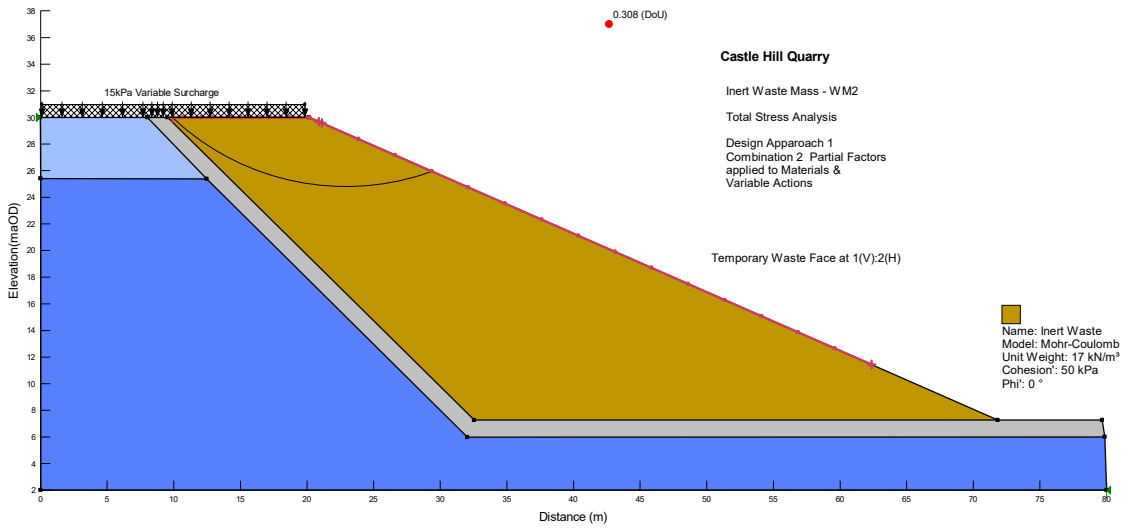
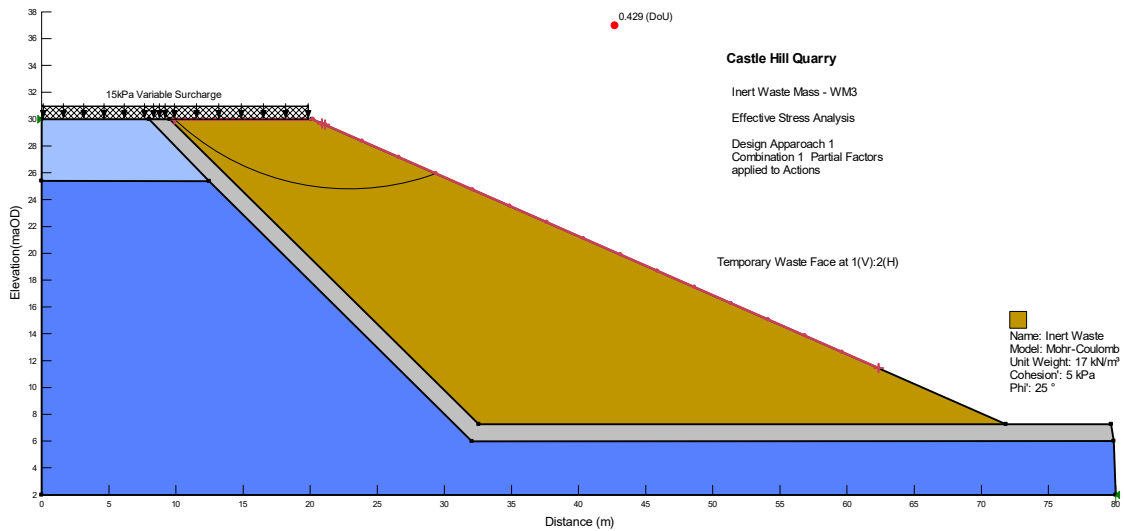
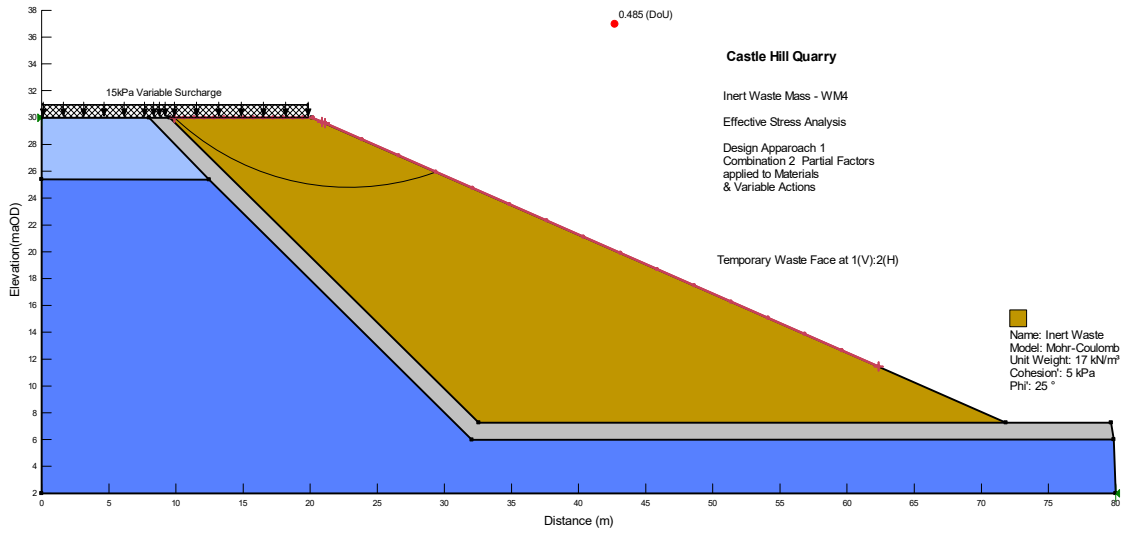
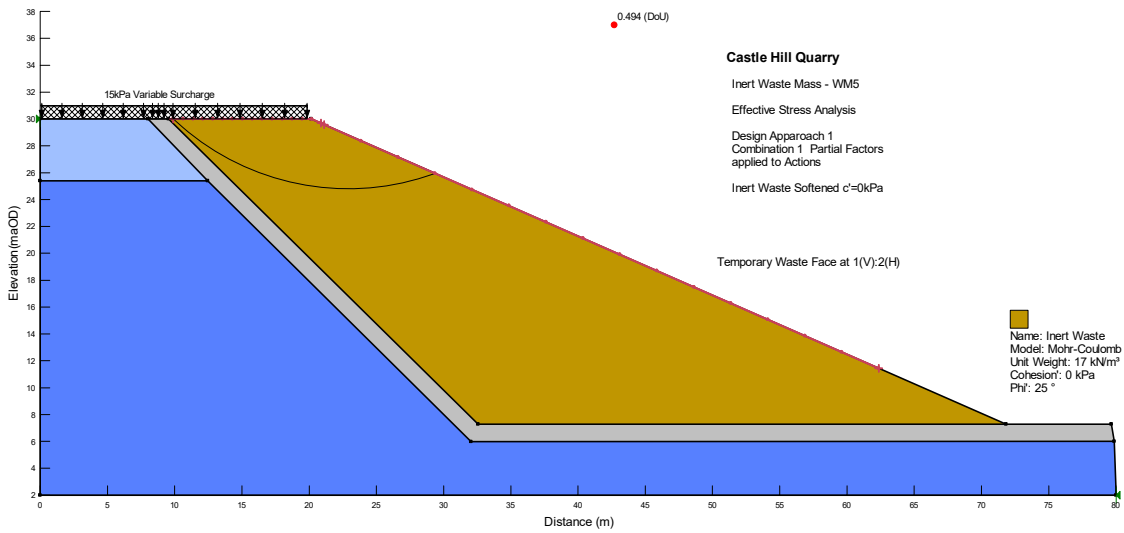
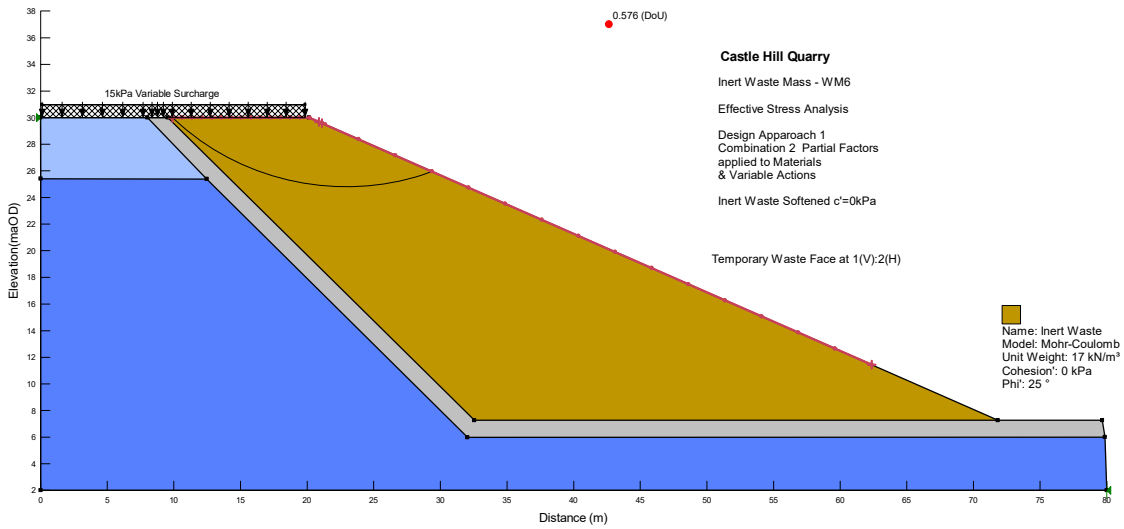
SlopeW Worksheets – Waste Mass

Run	File Name	Waste Strength	Leachate Condition	Degree of Utilization		Notes	
				C1	C2		
1	WM1	Total	Dry	0.33	/	Total Stress	
2	WM2			/	0.31		
3	WM3	Effective	Dry	0.43	/	Effective Stress	
4	WM4			/	0.49		
5	WM5		Saturated		0.49	/	Cohesion = 0kN/m ²
6	WM6				/	0.58

- 2.54 The stability of the inert waste face was analysed using the computer programme SLOPE/W to calculate the degree of utilisation of the restoring forces to prevent failure through the waste body for a range of circular failure surfaces using Morgenstern and Price's method.
- 2.55 The waste slope has a Degree of Utilisation of <1.00 (<100%) for both short term total stress conditions and long term effective stress conditions.
- 2.56 The waste slope continues to have a Degree of Utilisation of < 1.00 even when the material becomes fully softened and the value of the cohesion intercept reduces from 5kN/m² to 0kN/m².
- 2.57 It is concluded that a 1(v) : 2(h) waste slope will be stable for the range of conditions anticipated.
