| PROJECT | Chilmington Green<br>Ashford, Kent | | CLIENT | Hodson Developments | | | |
| TITLE | River Beult Monitoring October 2023 | | REFERENCE | 22074-SVY-TN-01 | | C01 | |

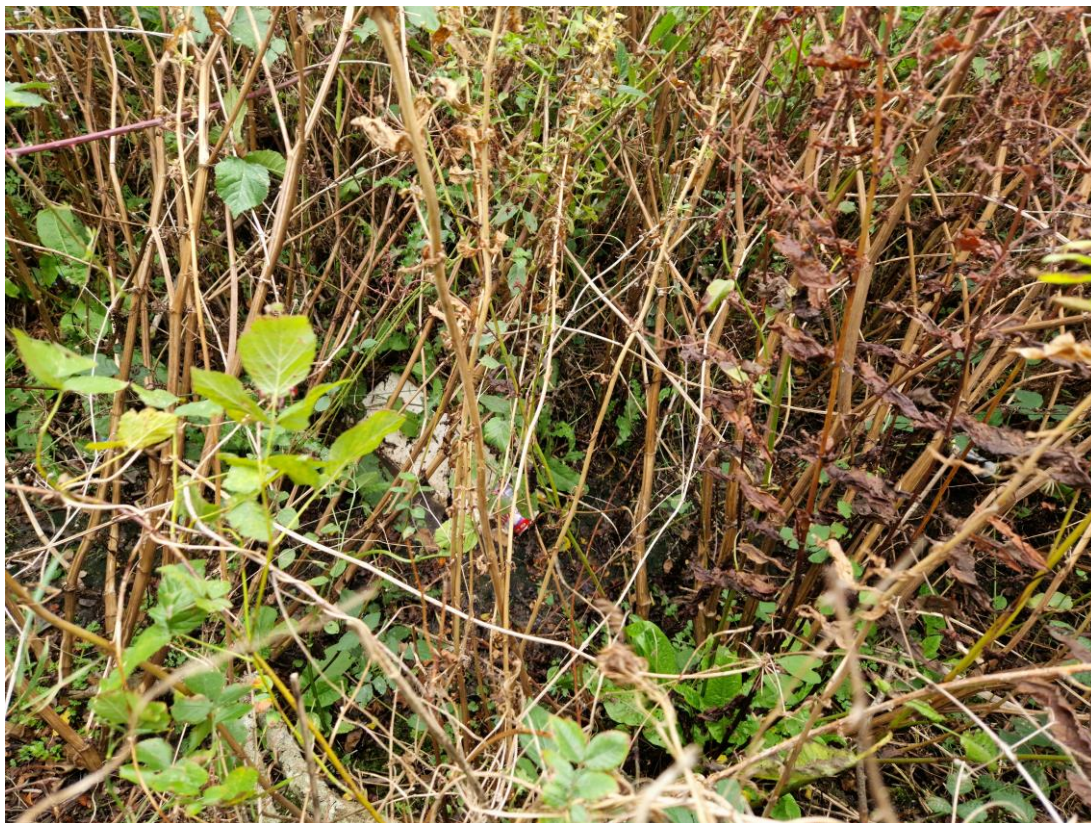
- 2.1 Water Environment attended site on 13<sup>th</sup> October 2023. General weather conditions during the visit were dry and overcast but had been preceded by heavy overnight rains. Water was not present at site 1, and therefore no measurements or samples were taken. All other sites have flowing water present and the following measurements and samples were taken.
- 2.2 Pictures of the sites and conditions can be found in Appendix B.

Site 1: Dry roadside ditch

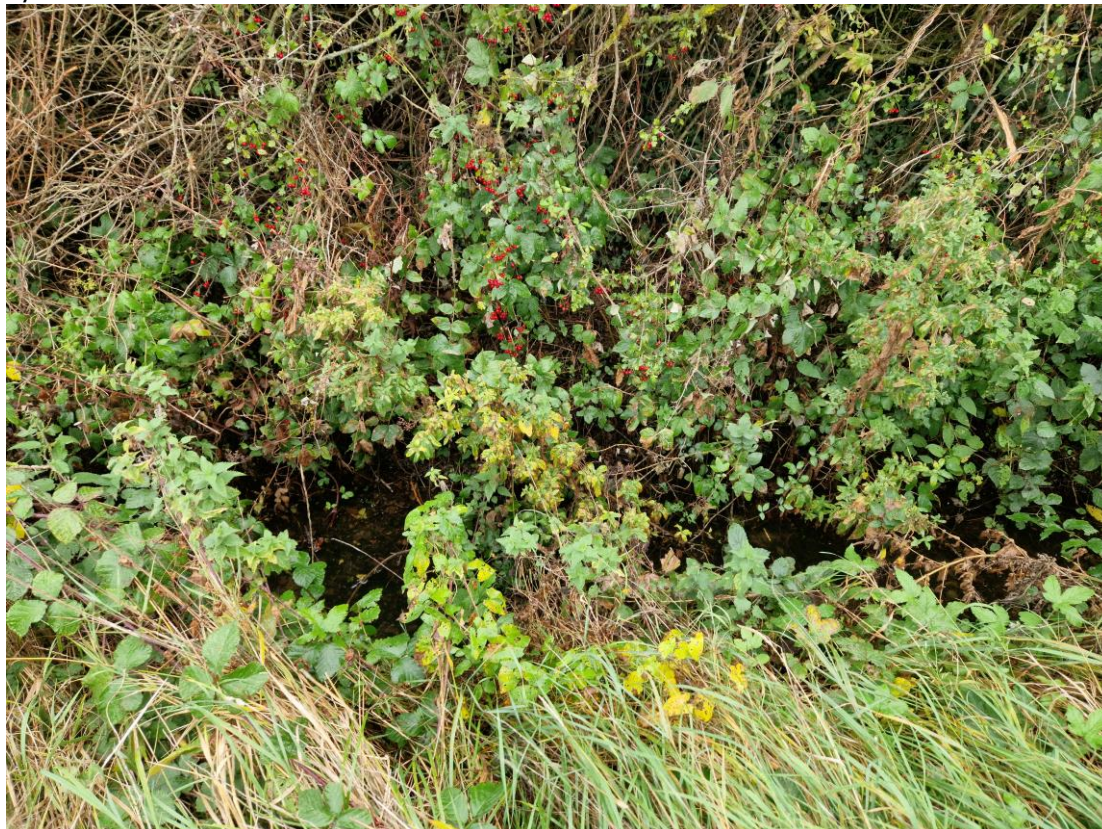
- 3.1 Whilst recording flow, the depth of the river channel was recorded. Site 1 was recorded as dry, site 2 had the shallowest channel (0.1 m) and site 5 had the deepest (0.7 m). A general observation is that the river channel gradually got wider and deeper from site 1 to 5 which was expected.
- 3.2 Site 5 was showed the greatest depth and width, however, the water was generally very slow moving and the flow meter recorded negative results in some cases, showing that there are other flow dynamics such as eddies present.
- 3.3 The table below summarises the flow and discharge recorded at each site, however, further data can be found in Appendix C.
- 3.4 Site 2-5 have either no detected or very low flow. Using the flow profiles from onsite monitoring, the discharge ( $\text{m}^3/\text{s}$ ) has been calculated and displayed in Table 1.

Site 2: Stream next to field hedge row

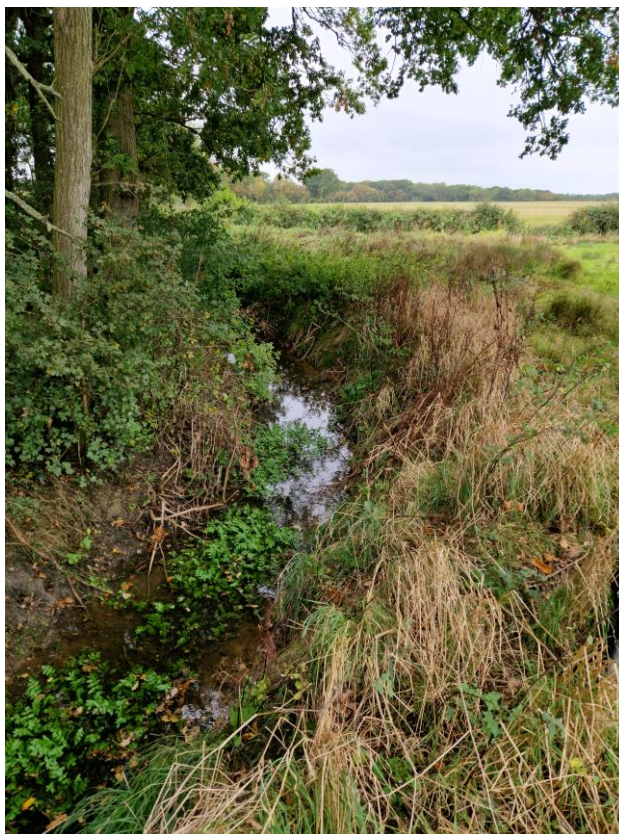
Site 3: Stream prior to joining adjacent River Beult tributary.

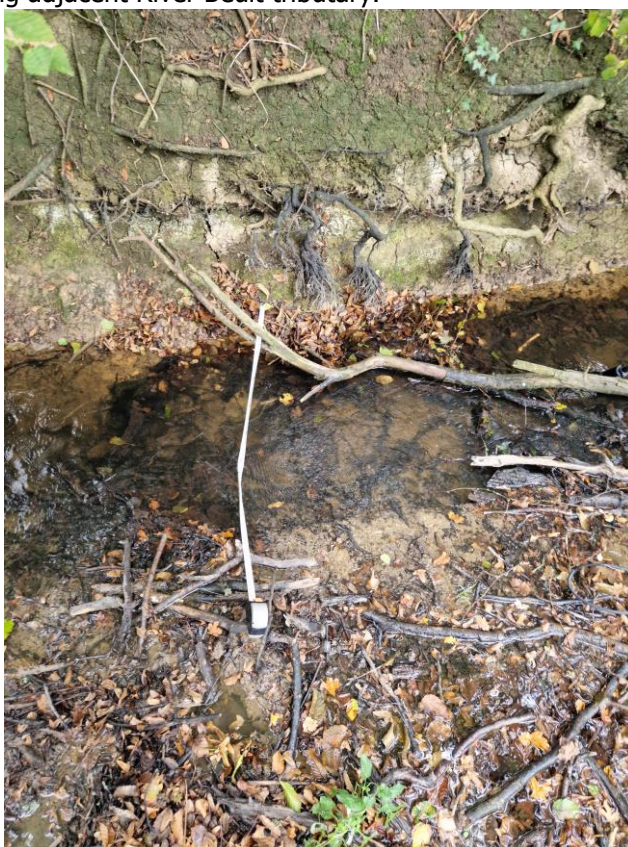
Site 4: Upper River Beult near Bethersdon Road

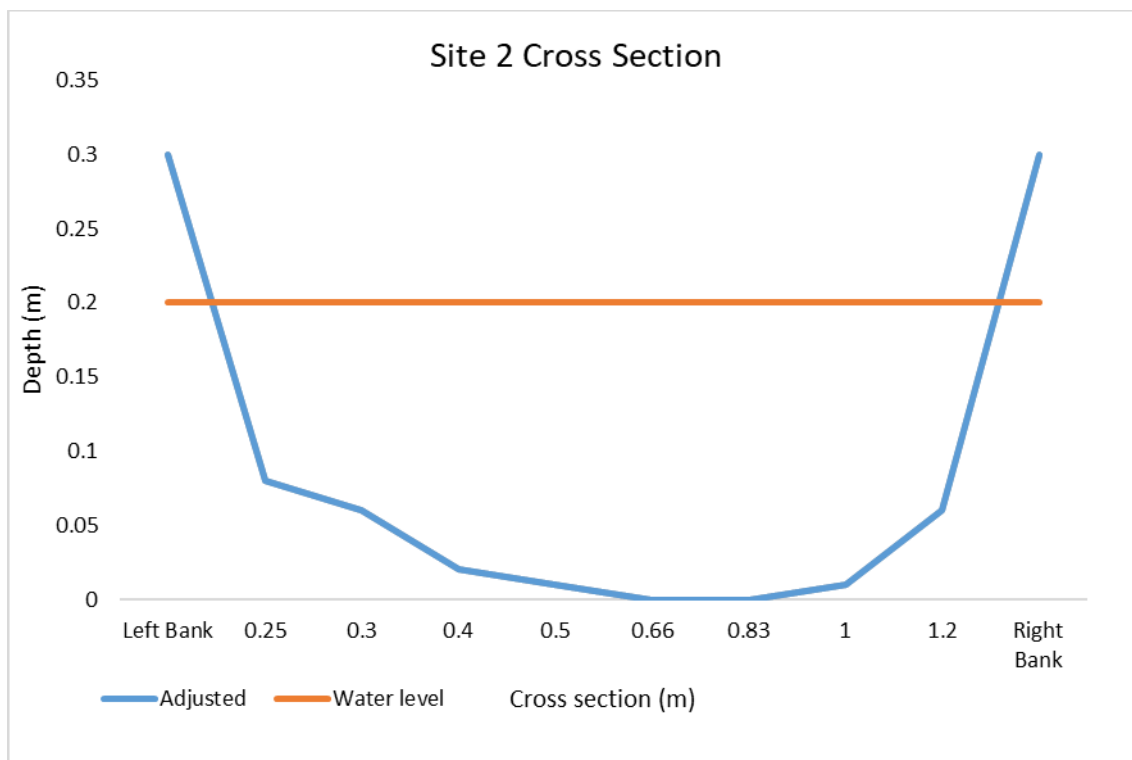
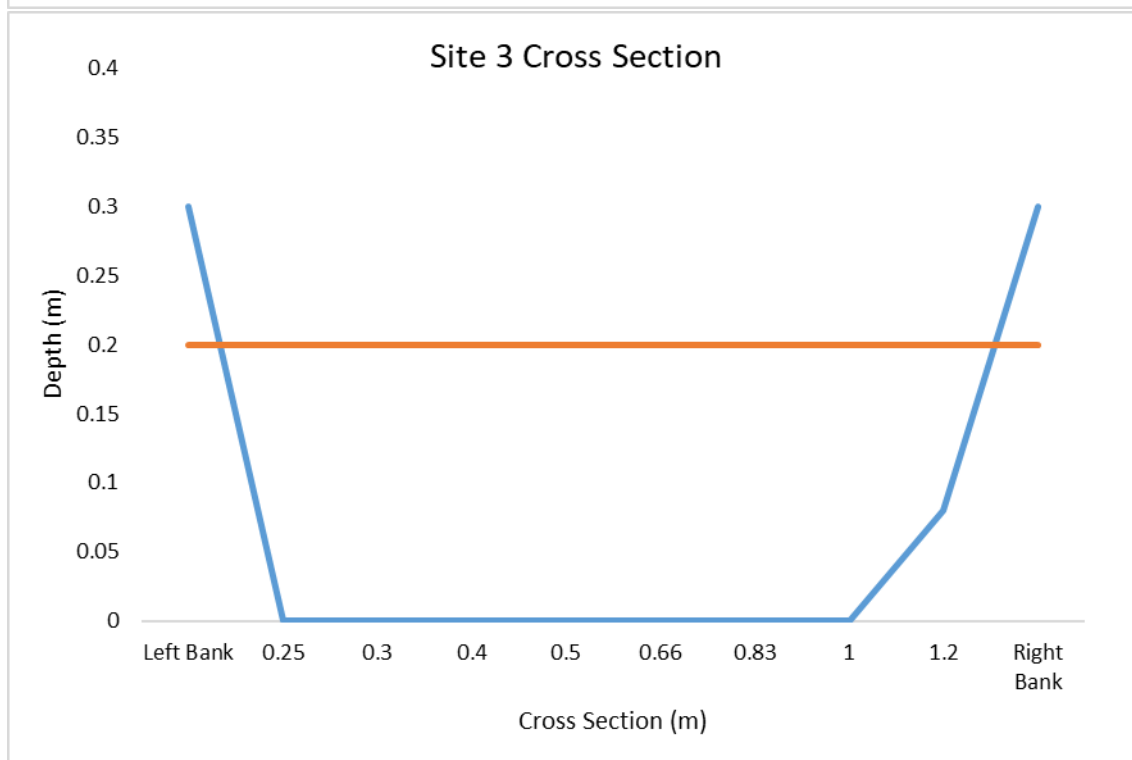
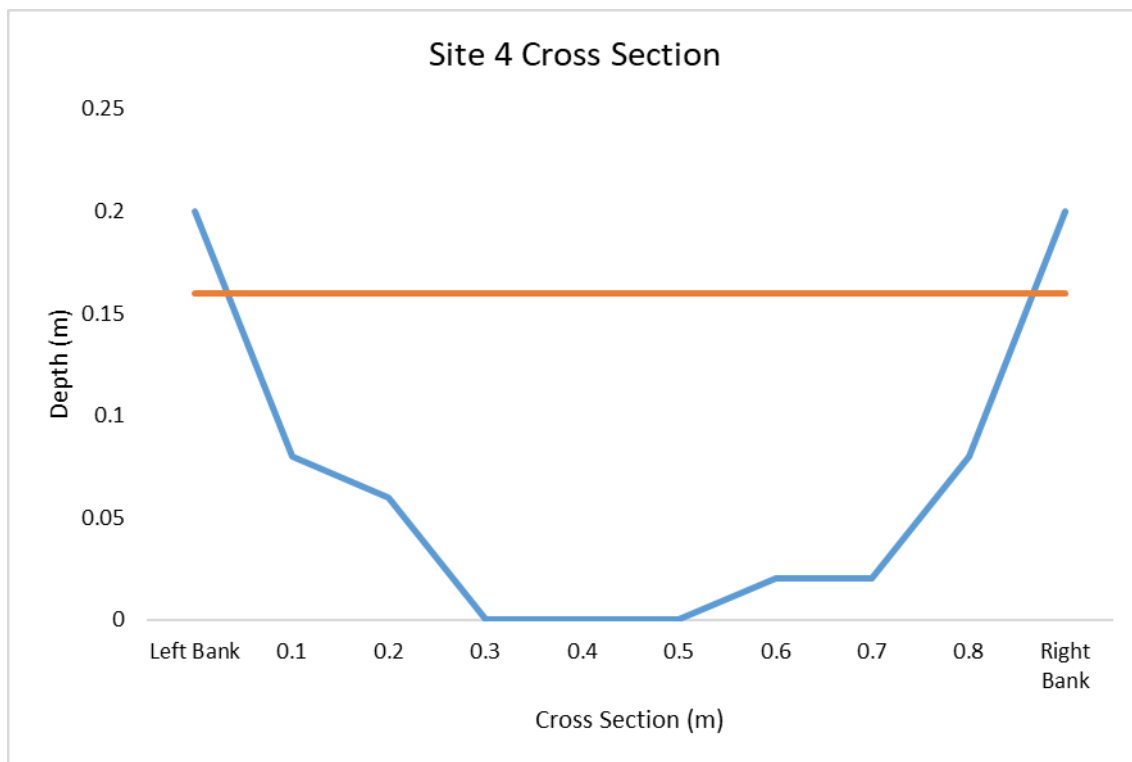
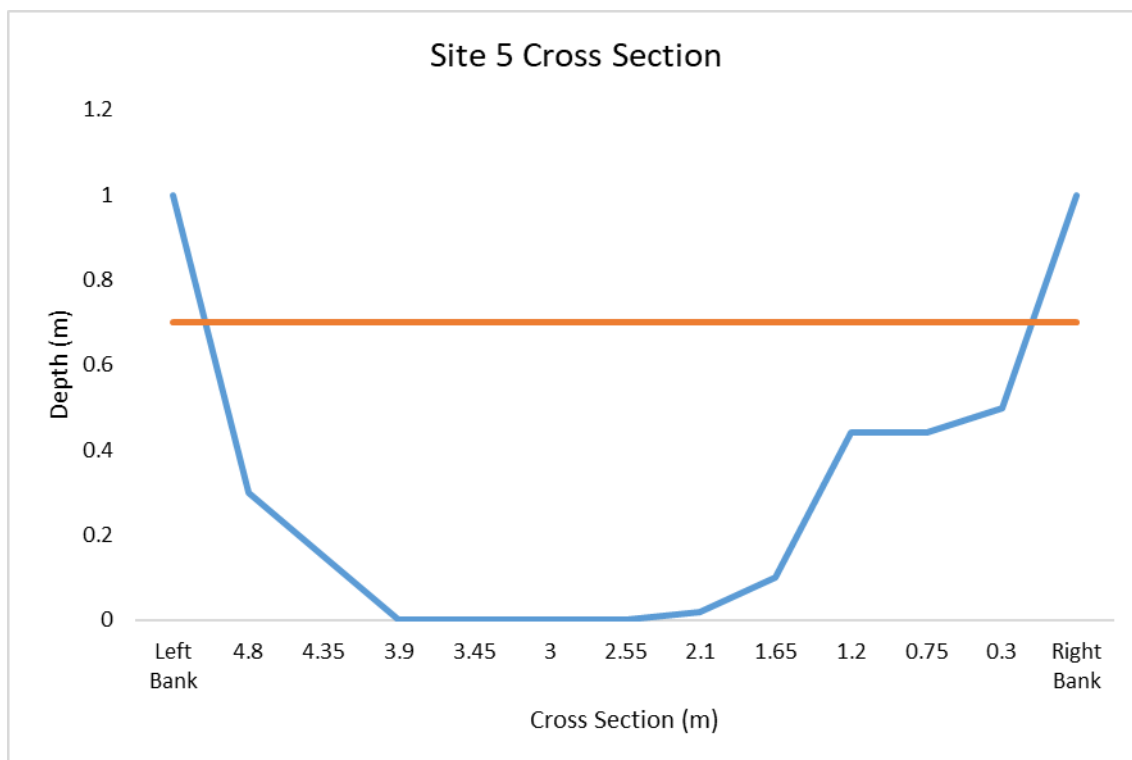
## **Appendix C: River Cross section profiles**

- 2.3 A SonTek Flowtracker 2 was inserted into the river at multiple locations across the width of the river to give a range of flow across the river profile. Flow, discharge and depth was determined at each transect point to calculate an overall stream profile and discharge rate. The number of transects and measurements taken at each site vary depending on river width, but a minimum of 5 was taken for each site.
- 2.4 Schematics and river profiles at each monitoring point, with flow recordings at each position are attached in Appendix C.
