# Appendix A. Engineering Geology Desk Study

# **Proposed extension to Linhay Hill Quarry**

Engineering Geology Desk Study

E&JW Glendinning Ltd.

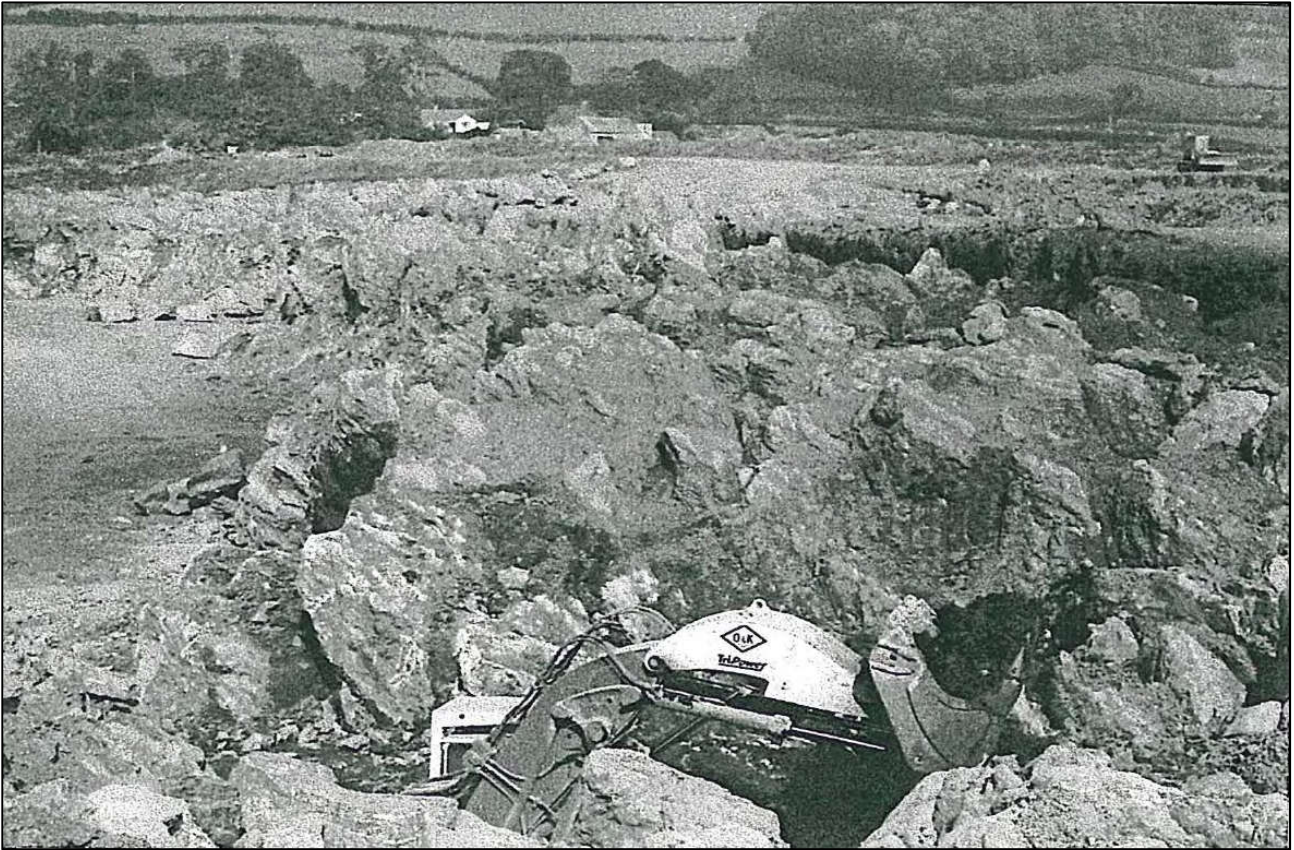
**Figure 2-10** Photograph showing the northeastern area of excavation at Linhay Hill Quarry with the irregular karstic rockhead after the overburden has been stripped off. The overburden comprised superficial clays and the infill of karst features. A mechanical excavator is shown in the foreground, providing a sense of scale [2].
