# **THE ALSTON EXTENSION TO LINHAY QUARRY, ASHBURTON, DEVON.**

## **SITE INVESTIGATION & DESIGN REPORT**

**Sandybed Geological Services**

**January 2016**

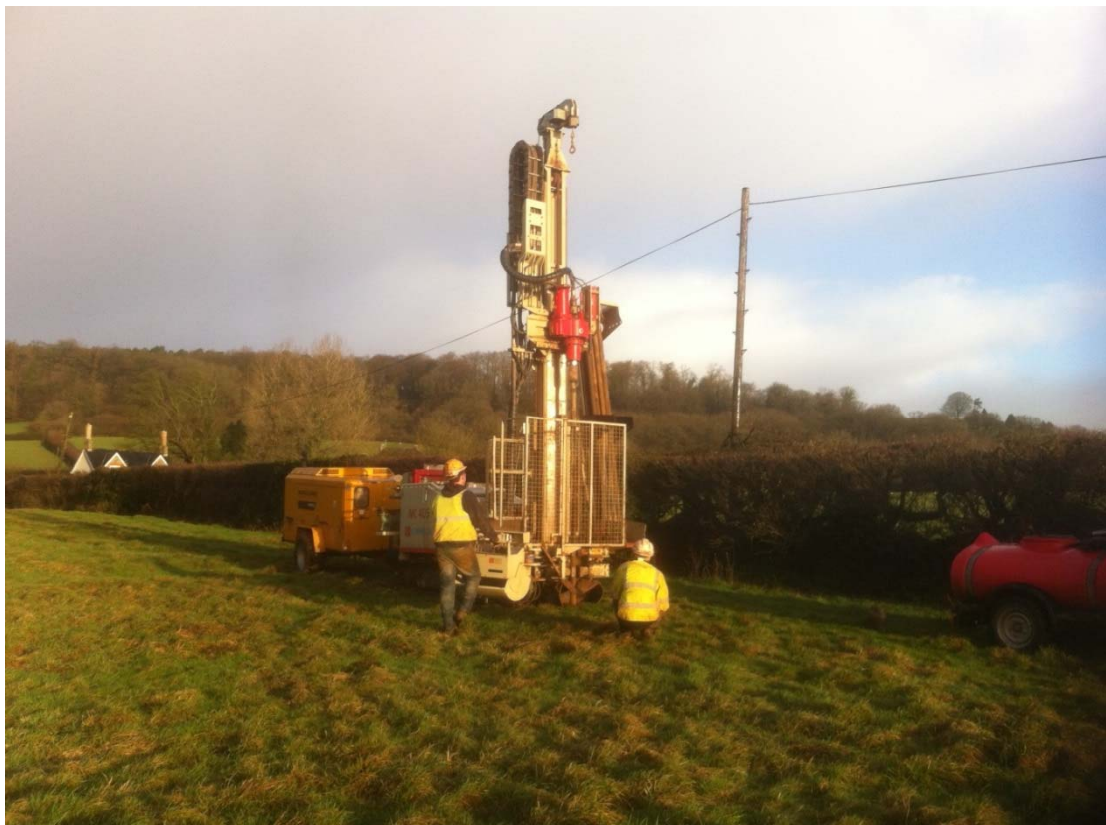
Drilling to prove limestone at Alston - Jan 2015

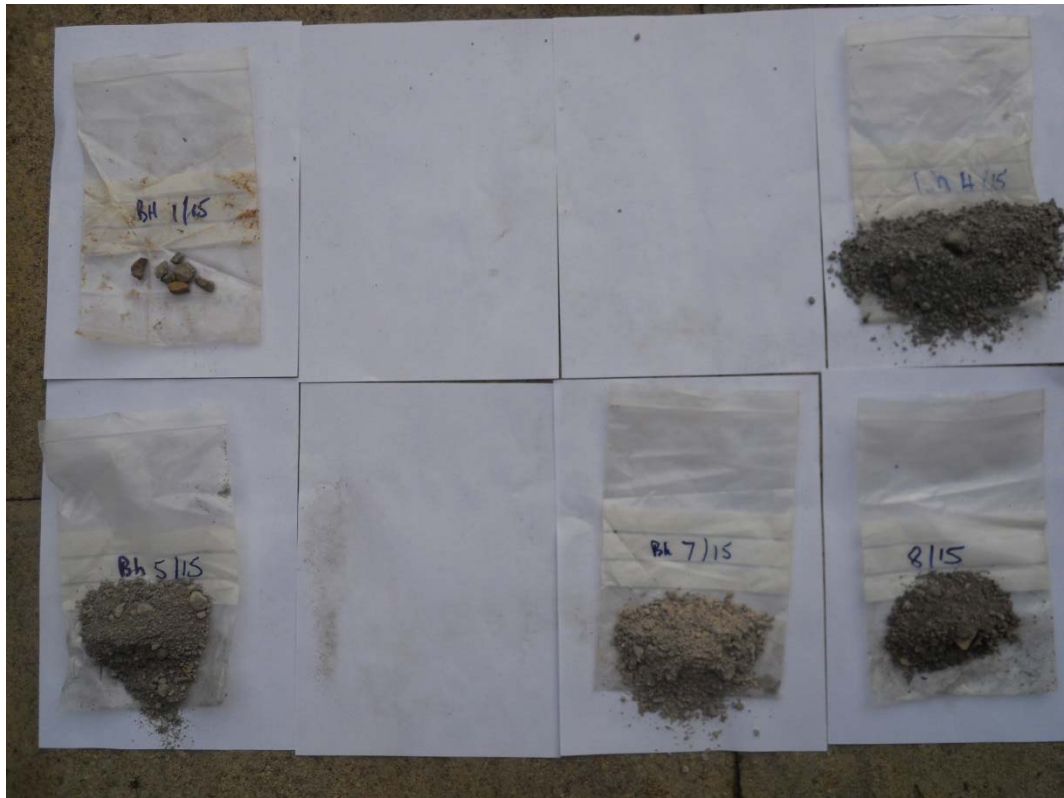
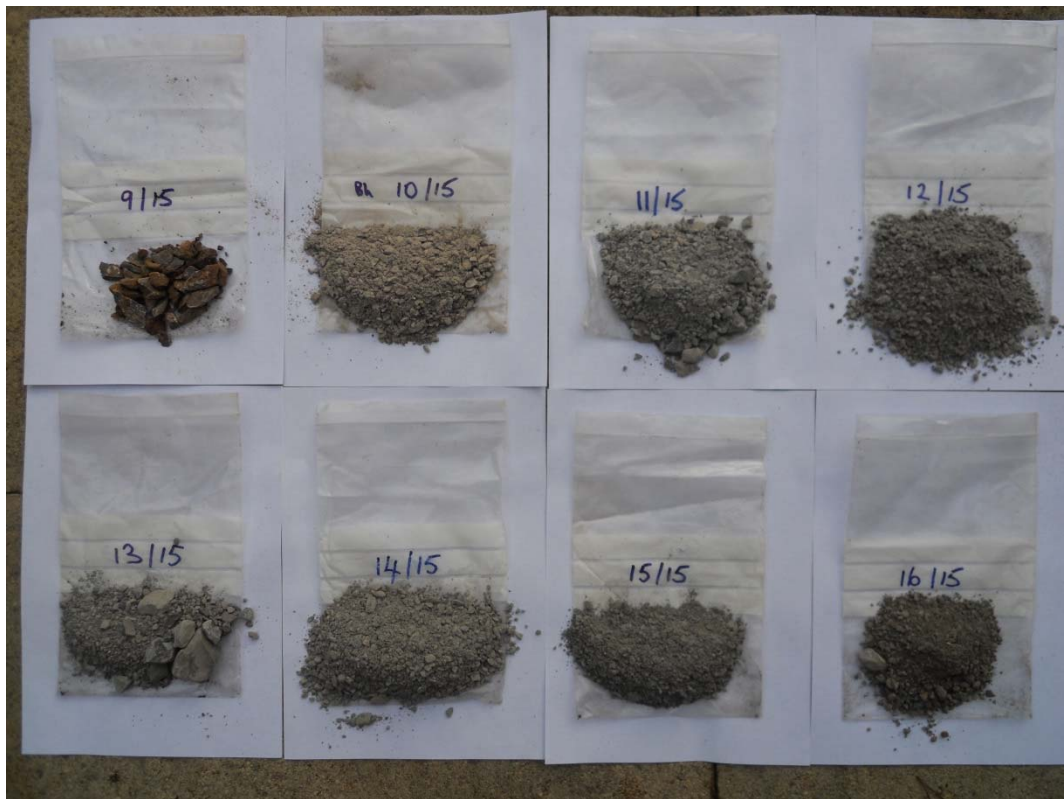
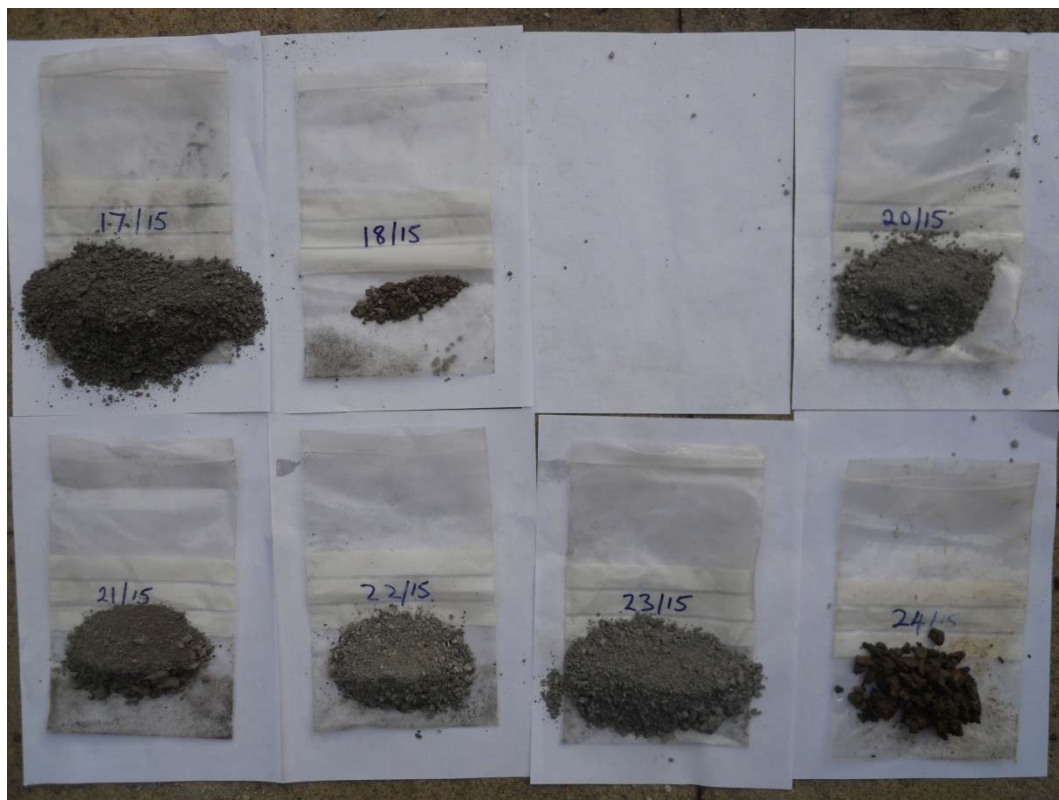
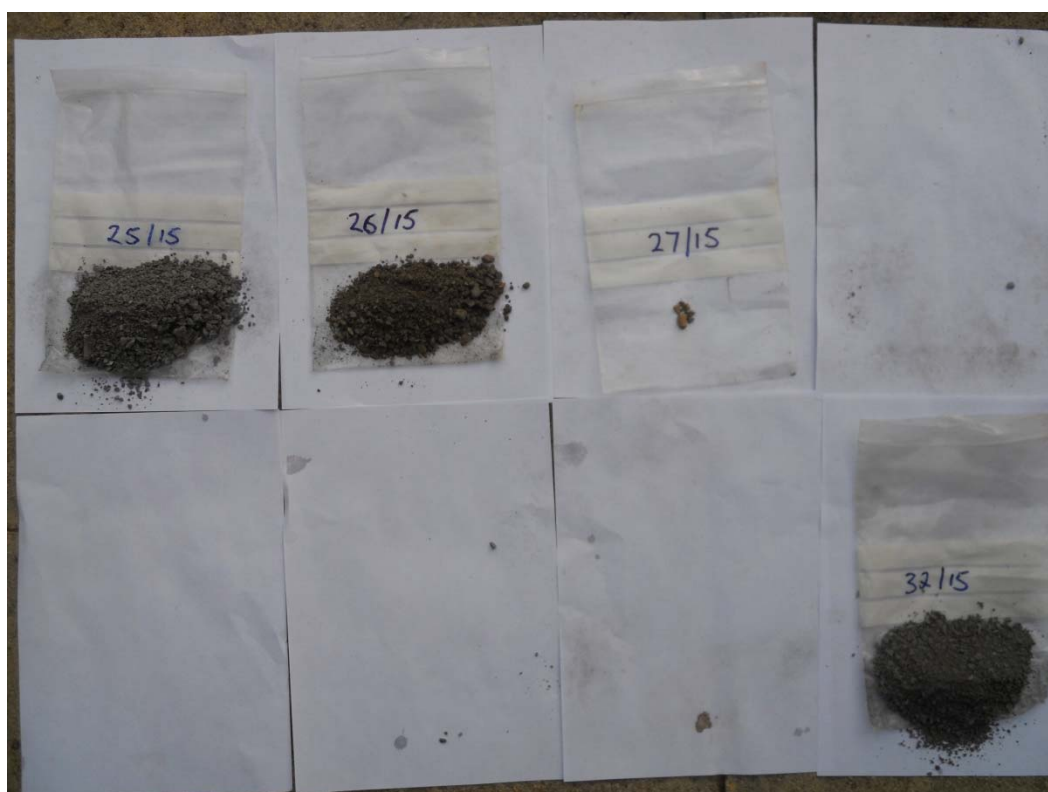
## **Appendix 2. Photographs of Samples**

Samples of drilling cuttings were taken where the air flush returned dust and chippings to the surface. In all cases, drilling progress and the quality of the flush returns indicated very strong fresh blue limestone. Importantly no weathered or brown rock was observed. In a number of holes, voids, fissures and clay filled fissures / voids were encountered. This is considered normal in a karstic landscape. Indeed, the resistivity survey indicated several circular features with increased clay content which appear to be sinkholes. The drilling confirmed this in a number of cases. Photographs of the samples recovered are attached in Appendix 2. All samples were tested with dilute acid to prove limestone.

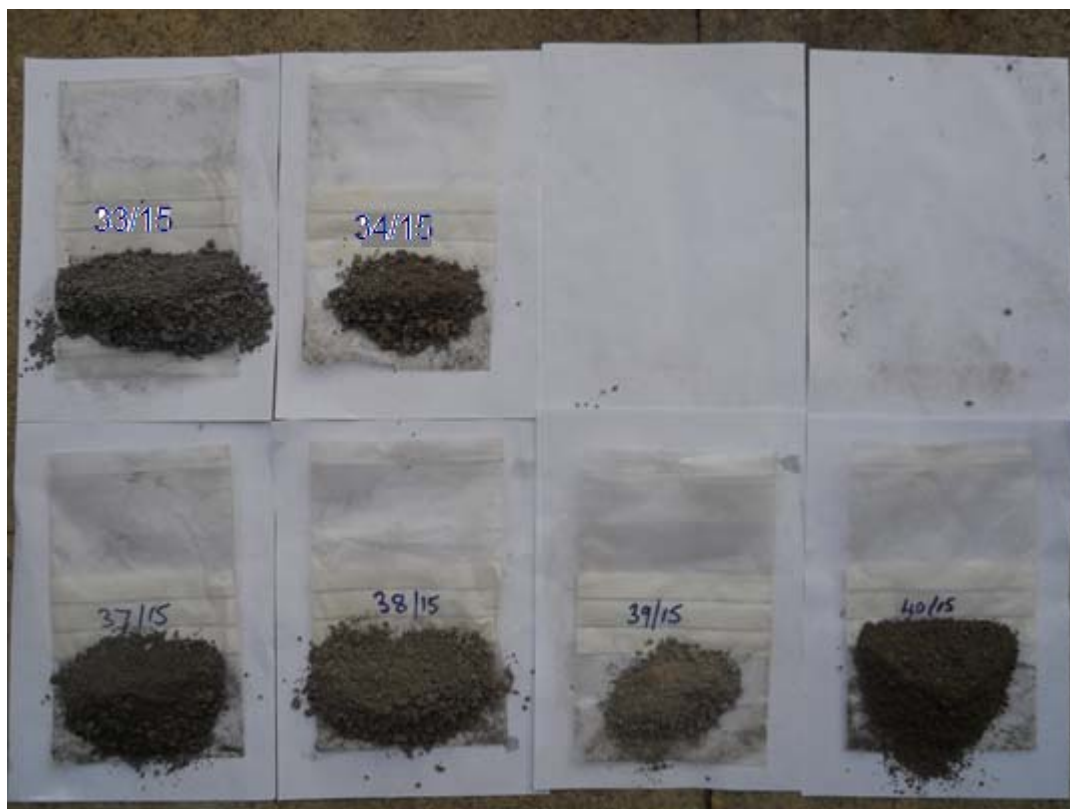
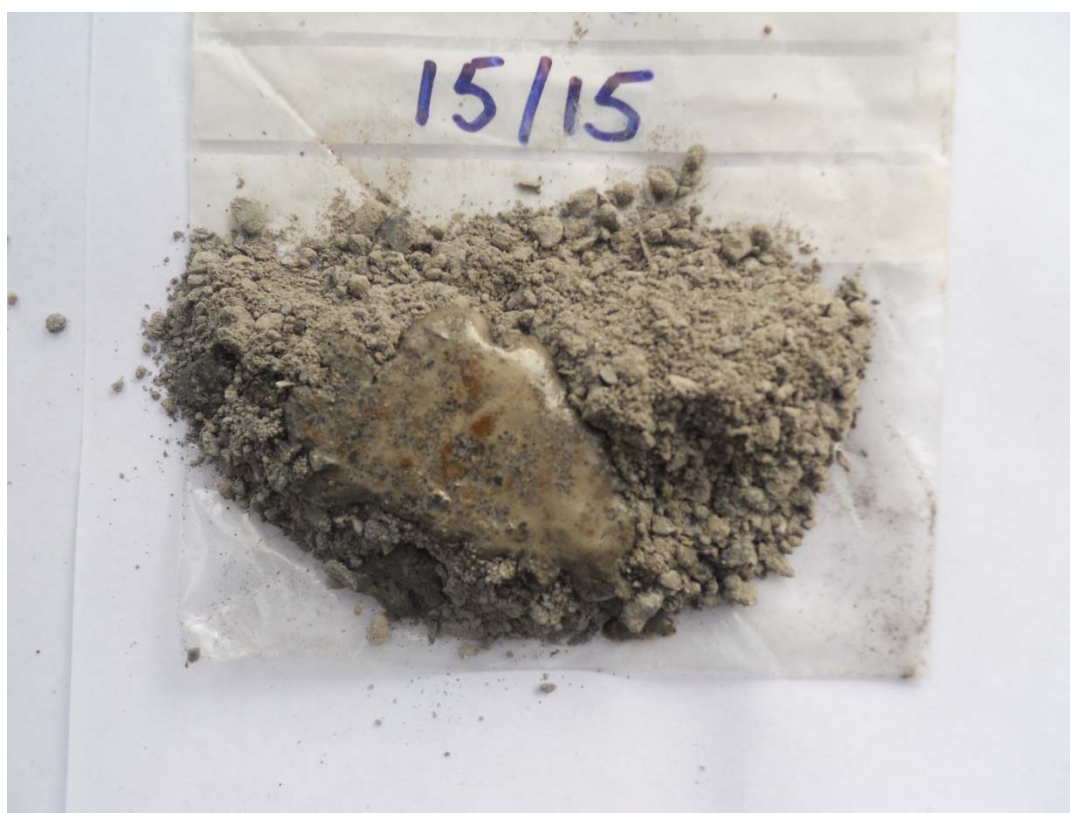
**Below:** Reaction with dilute acid

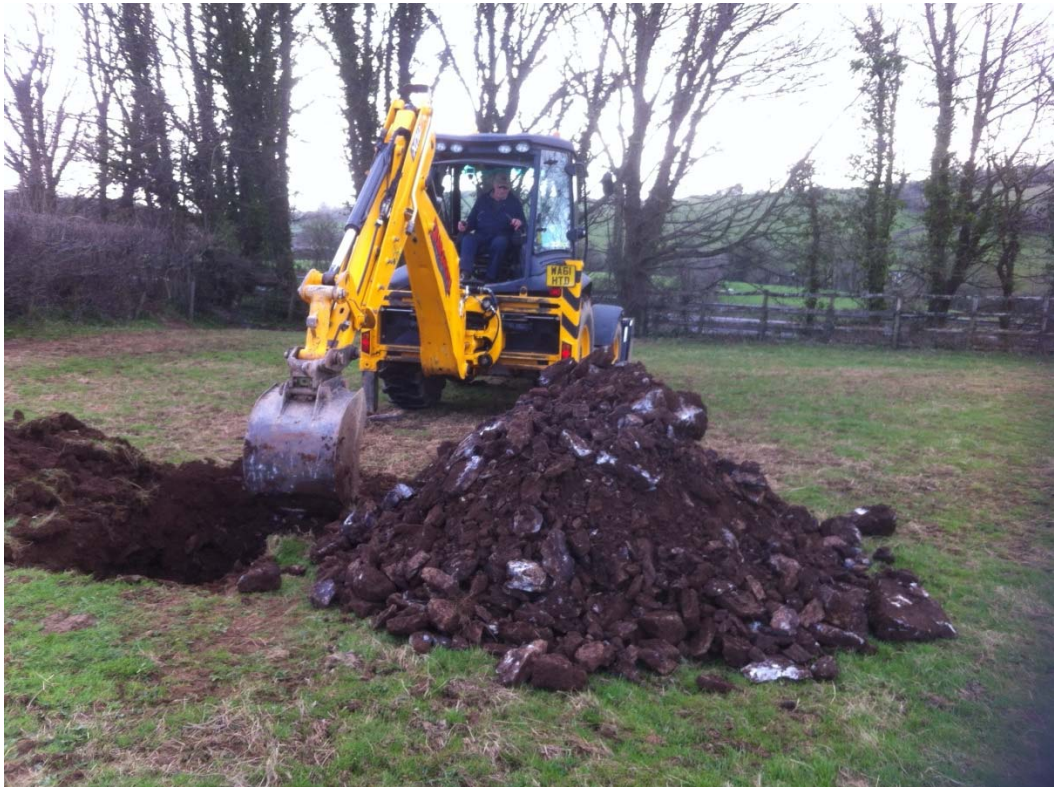
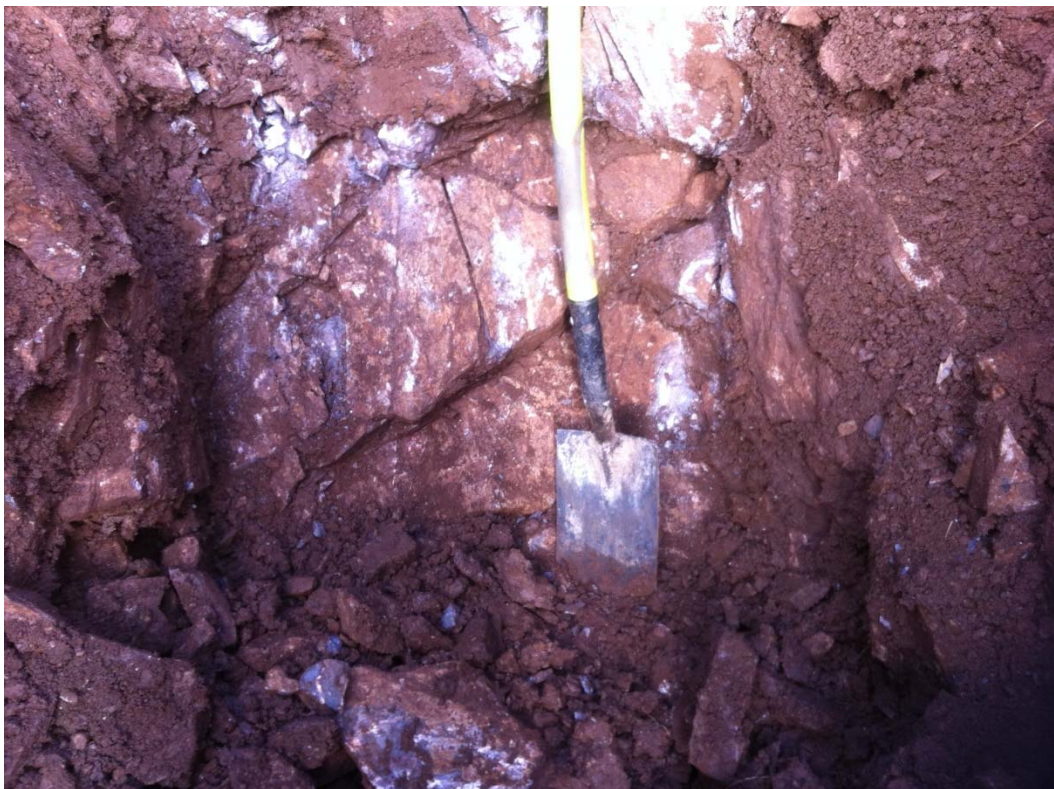
**Above:** JCB excavating Trial Pit N0.1. Below: Bedding exposed in Trial Pit No.1.

On 1<sup>st</sup> April 2105, a trial pitting exercise was undertaken to verify the strike and dip of the strata in the Alston extension area (See Appendix 4). Trial pit No.1 was excavated on the site of Borehole 9/15 and exposed 0.4 metres top soil overlying 1.9 metres limestone brash (mainly clay bound strong fresh limestone cobbles). At the north side of the pit the bedding was exposed and measured.

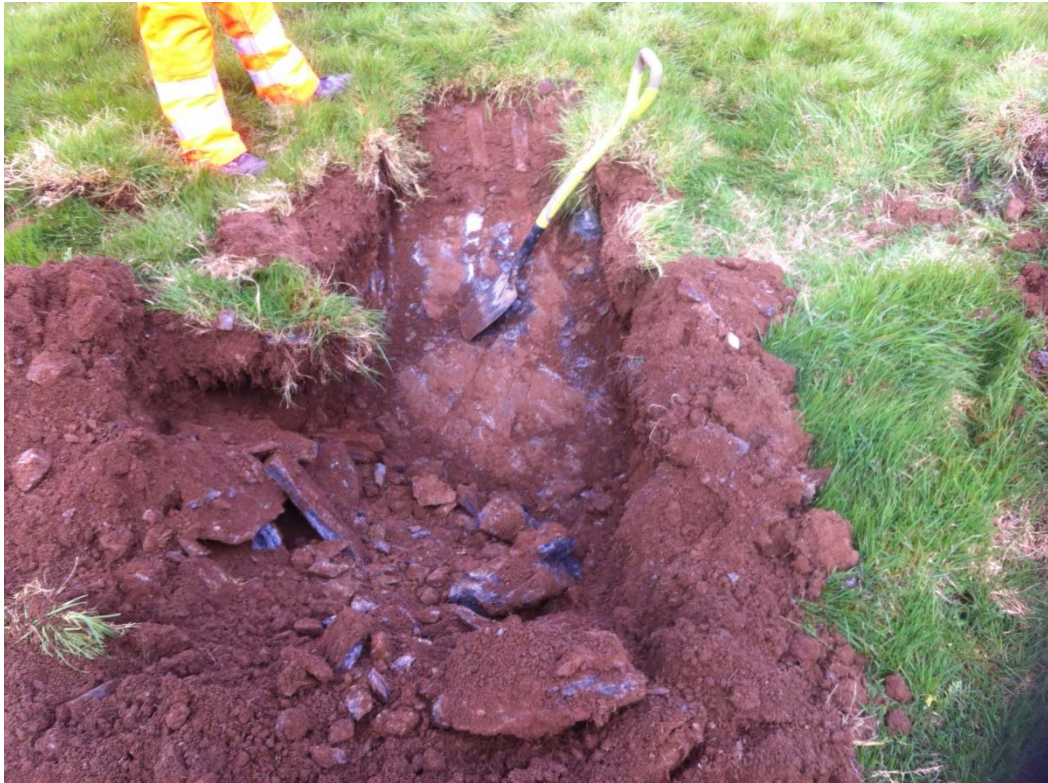
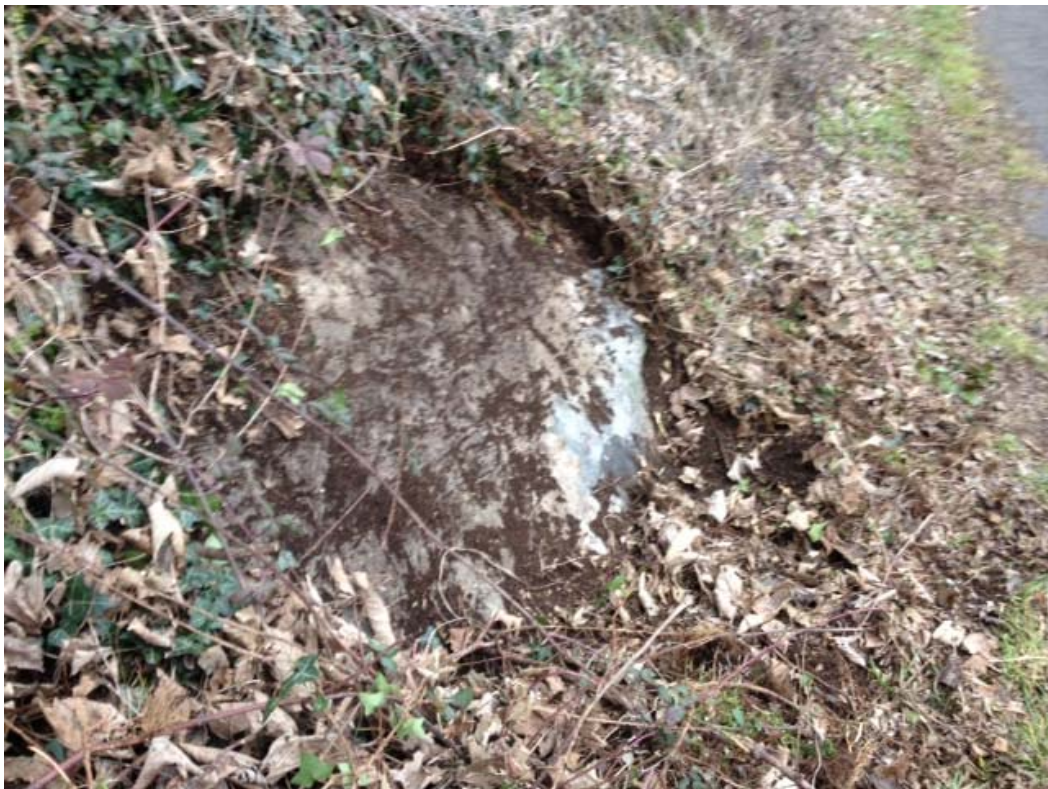
**Above:** Trial Pit 2 – Bedding exposed in pit. **Below:** Bedding exposed on A38 roadside, east of planned extension

Trial pit No.2 was excavated on the site of Borehole 4/15 and exposed 0.3 metres topsoil overlying 0.8 fresh strong limestone. At the north side of the pit the bedding was exposed and measured.

A small limestone exposure was also measured on the northern side of the A38 roadside cutting c.50 metres east of the proposed extension. The assumed bedding was measure for dip and strike.
