Hallenbeagle Transfer Station and Material Recycling Facility

Site Condition Report

September 2023

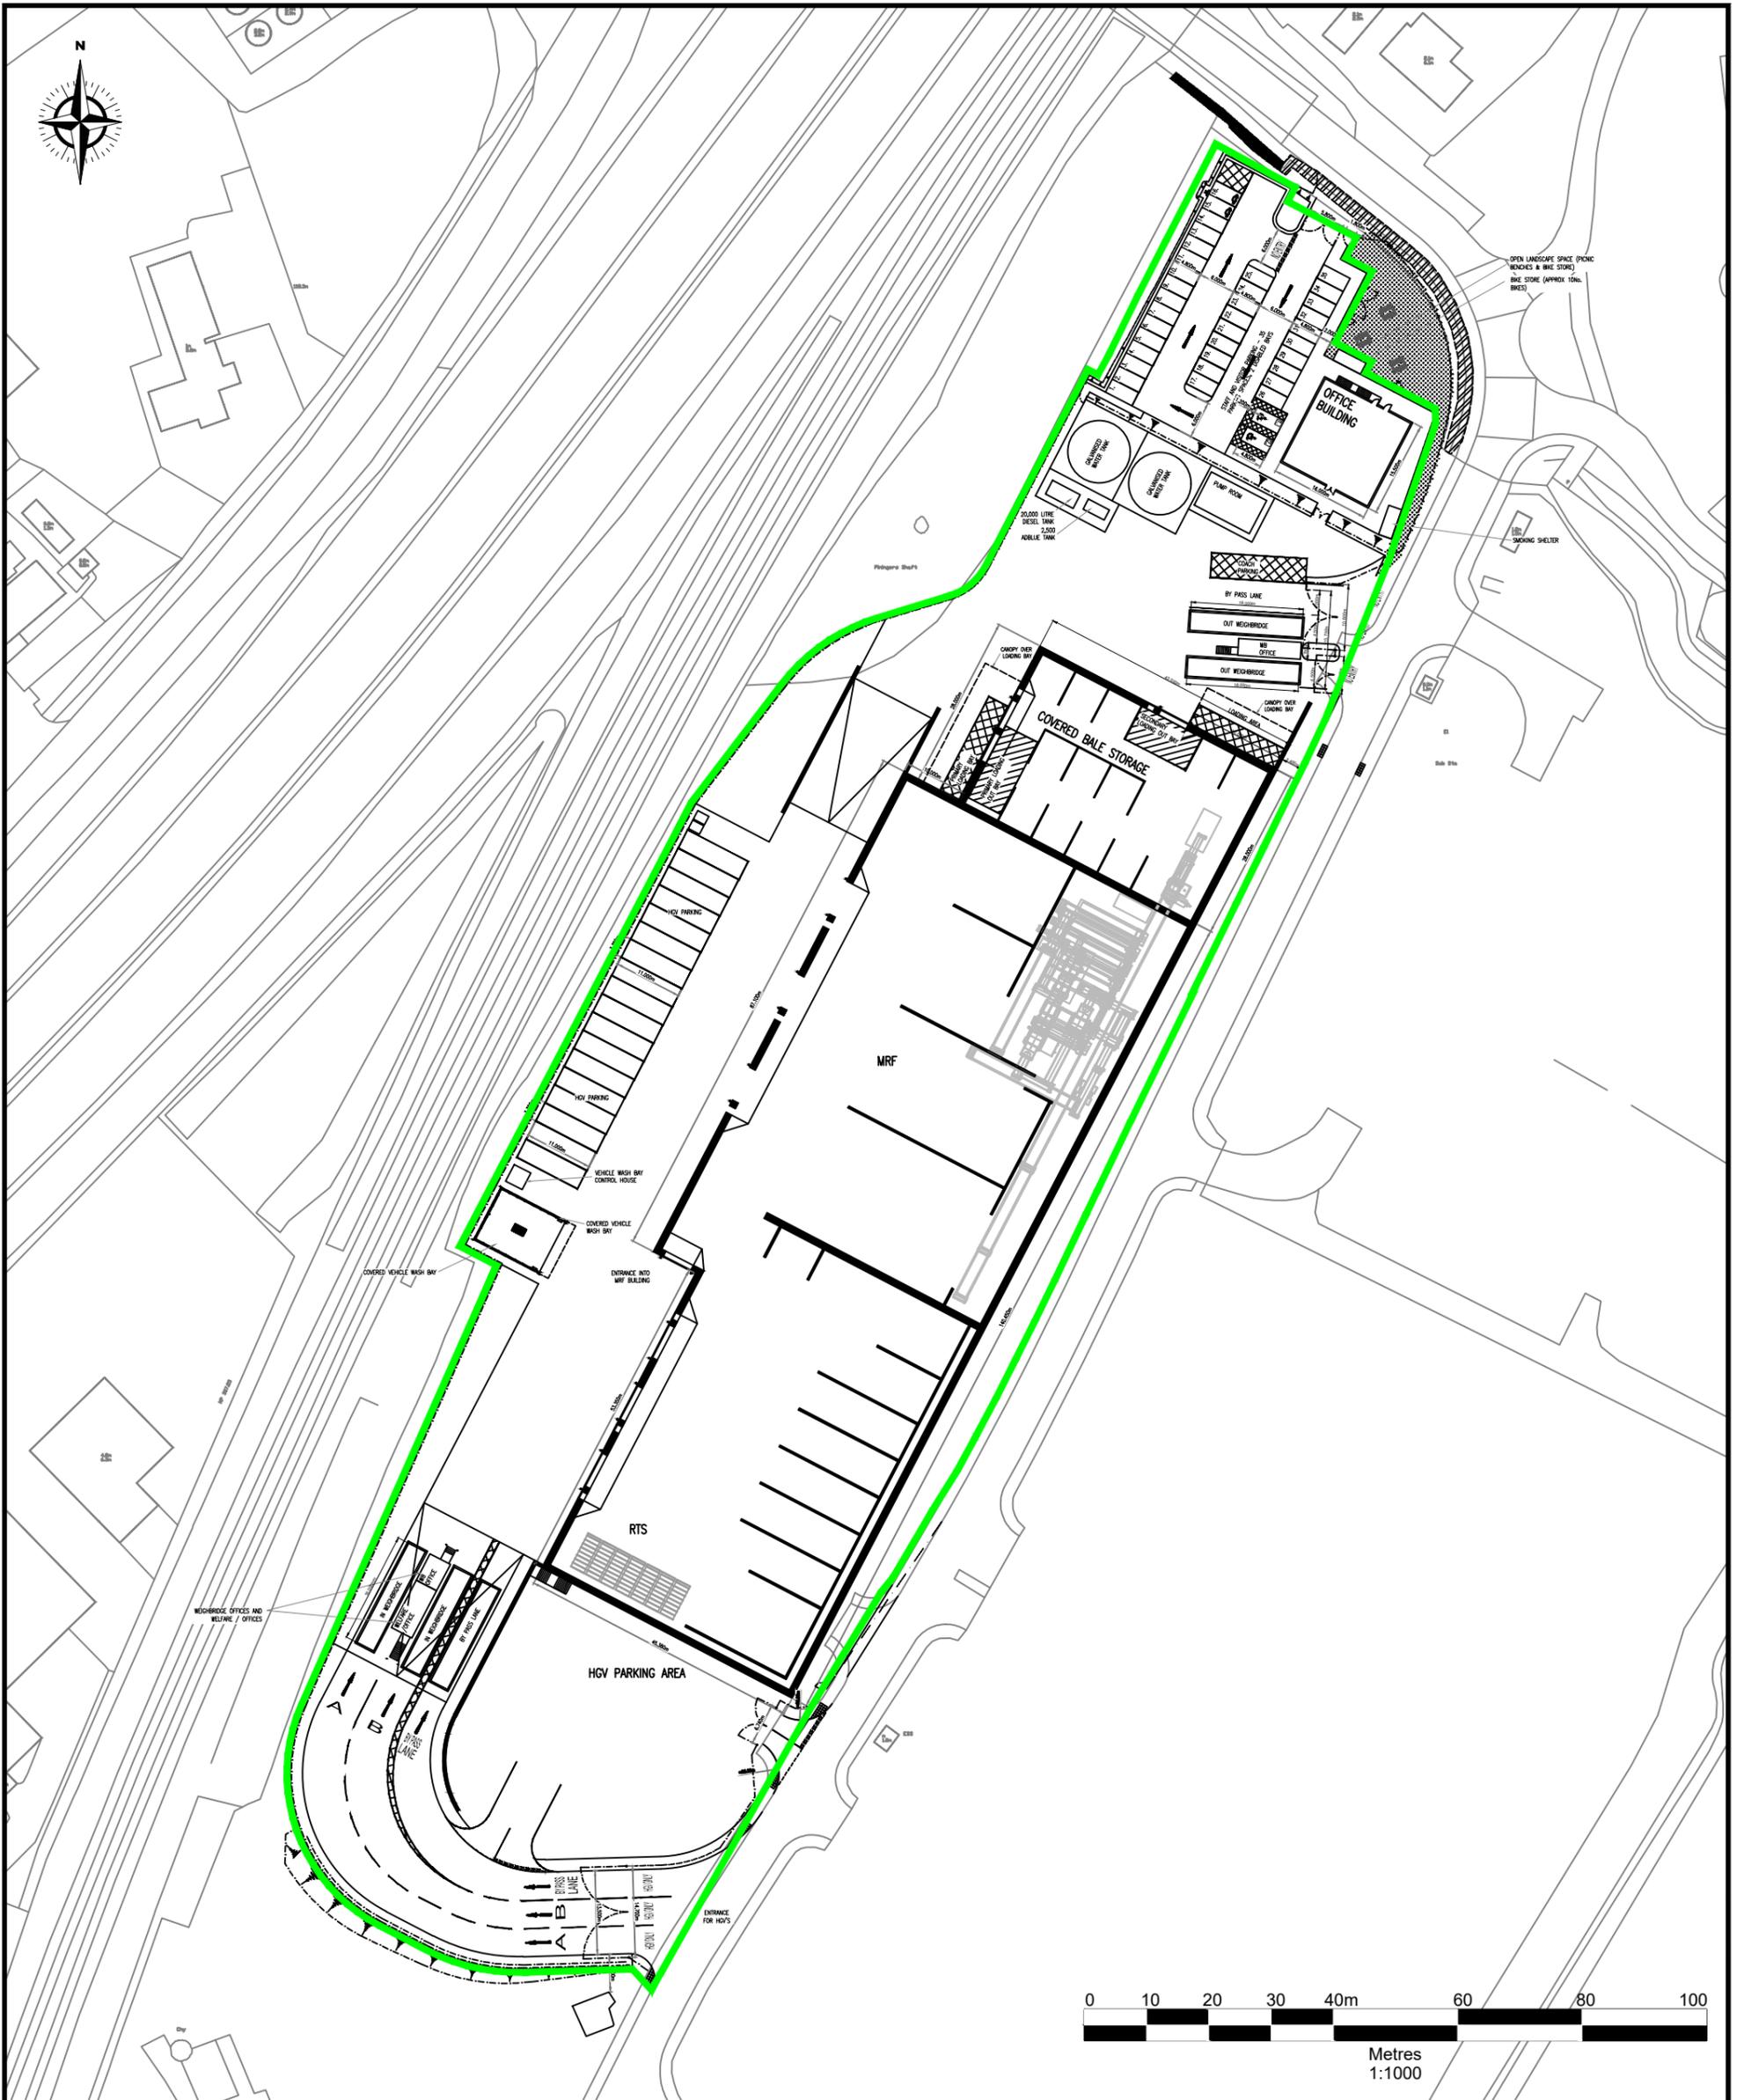
Site Permit Boundary

Name of Applicant:	SUEZ Recycling and Recovery UK Ltd
Activity Address:	Cornwall Business Park, Hallenbeagle, Scorrier, Redruth, Cornwall, TR16 5EN
National Grid Reference:	SW 72700 44778
Document reference and dates for Site Condition Report at Permit Application and Surrender:	This report is prepared and submitted in support of the development of Hallenbeagle Transfer Station and Material Recycling Facility application. September 2023.
Document references for site plans (including location and boundaries):	Figure 1 – Site Permit Boundary
