APPENDIX G
SITE RECONNAISSANCE PHOTOGRAPHS

Hallenbeagle Phase 2 Geo-environmental Site Investigation

SUEZ Recycling and Recovery UK Ltd

Hallenbeagle

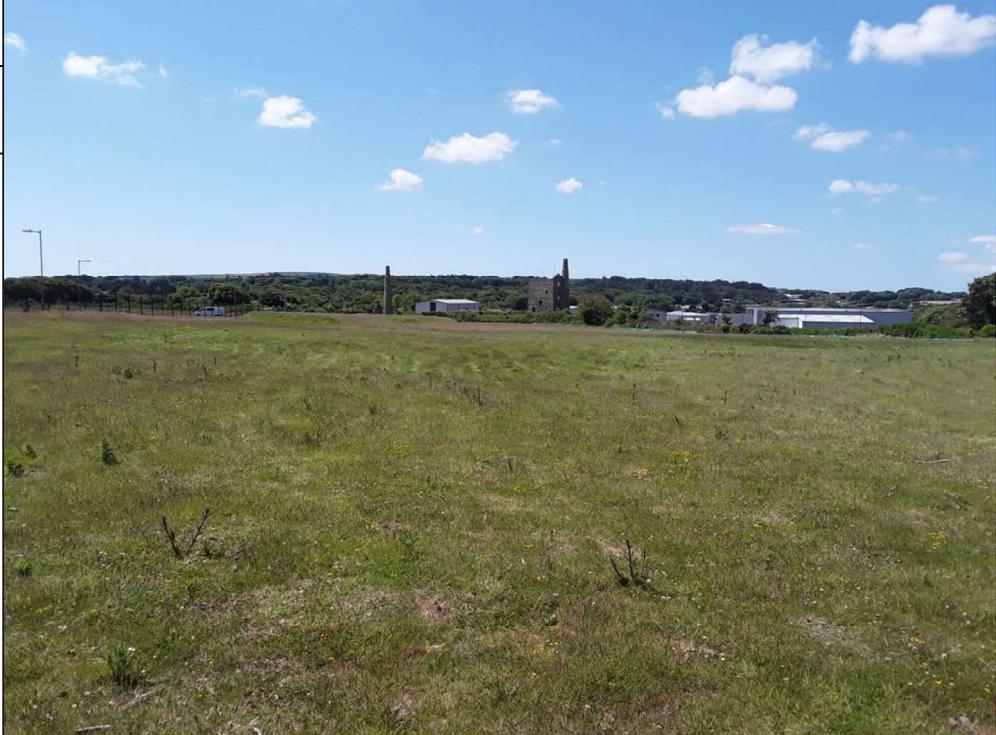
<p>Photo No. 1</p>

<p>Date: 20/06/22</p>	
<p>Facing south west towards original Cornish Engine houses /chimneys. Eastern boundary marked by a metal fence.</p>

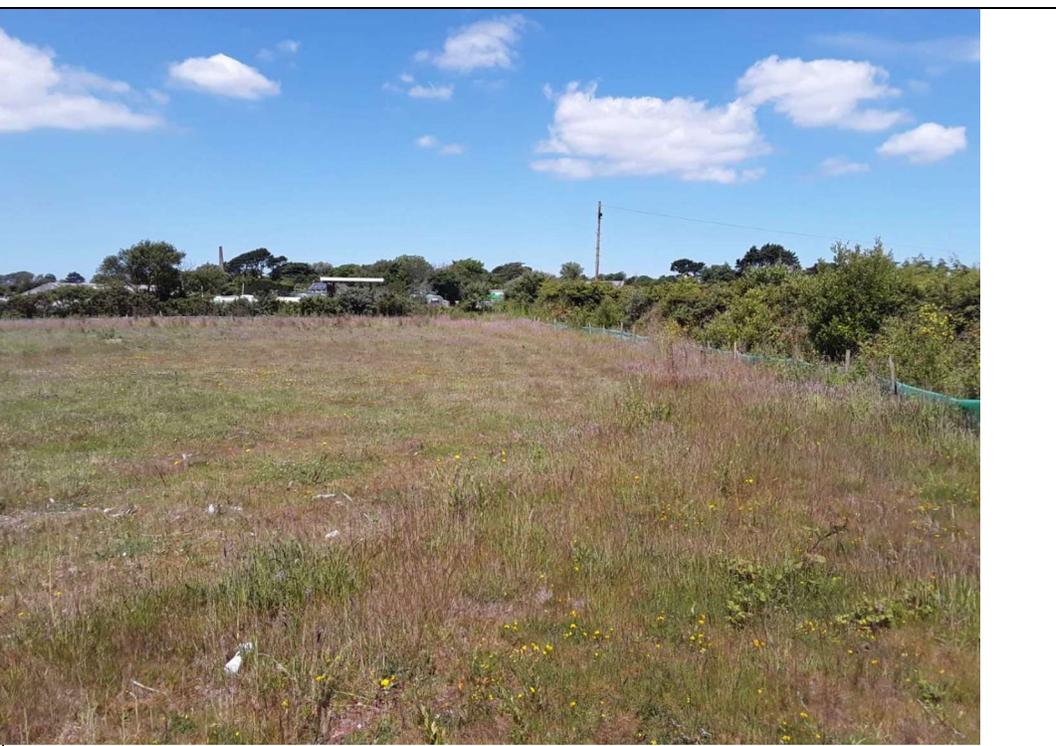
<p>Photo No. 4</p>

<p>Date: 20/06/22</p>	
<p>Facing north west towards the railway, A30 and commercial properties beyond.</p> <p>Railway line significantly lower than site level.</p> <p>Cornish hedge and protective barrier.</p>

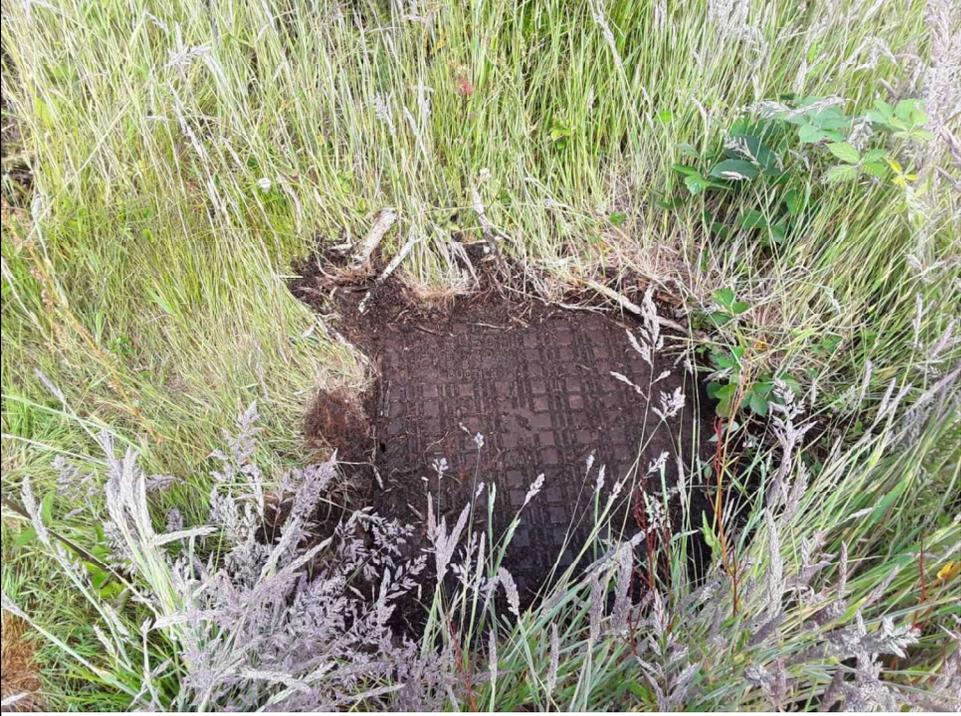
Photo No. 5

Date: 20/06/22	
Manhole in north west corner.

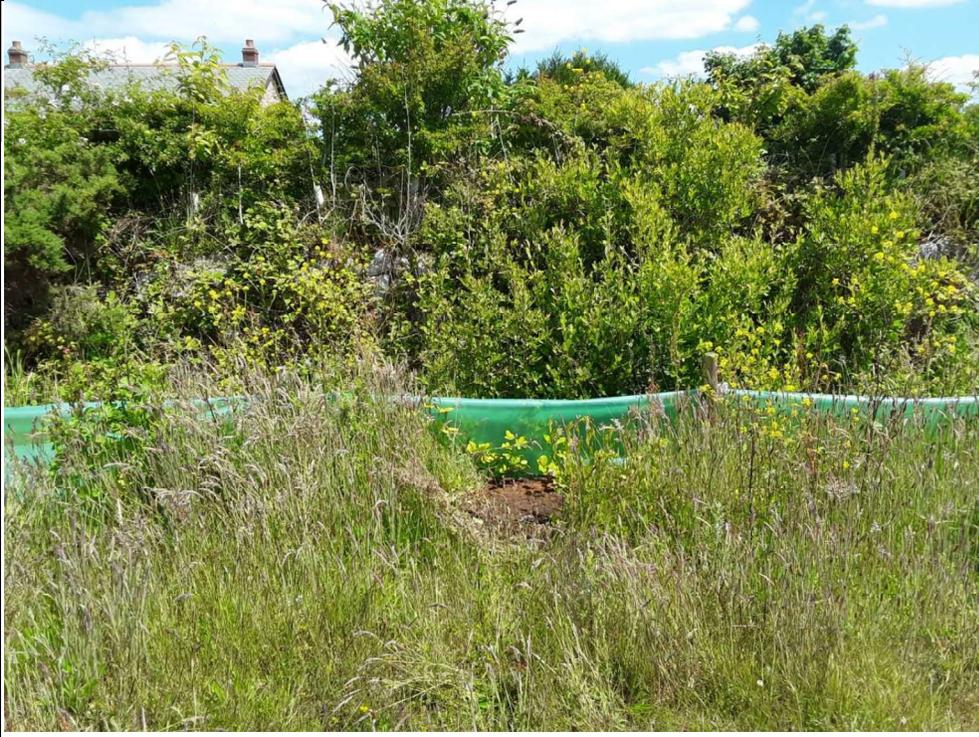
Photo No. 6

Date: 20/06/22	
Manhole on northern boundary (approximately in line with house across the road).

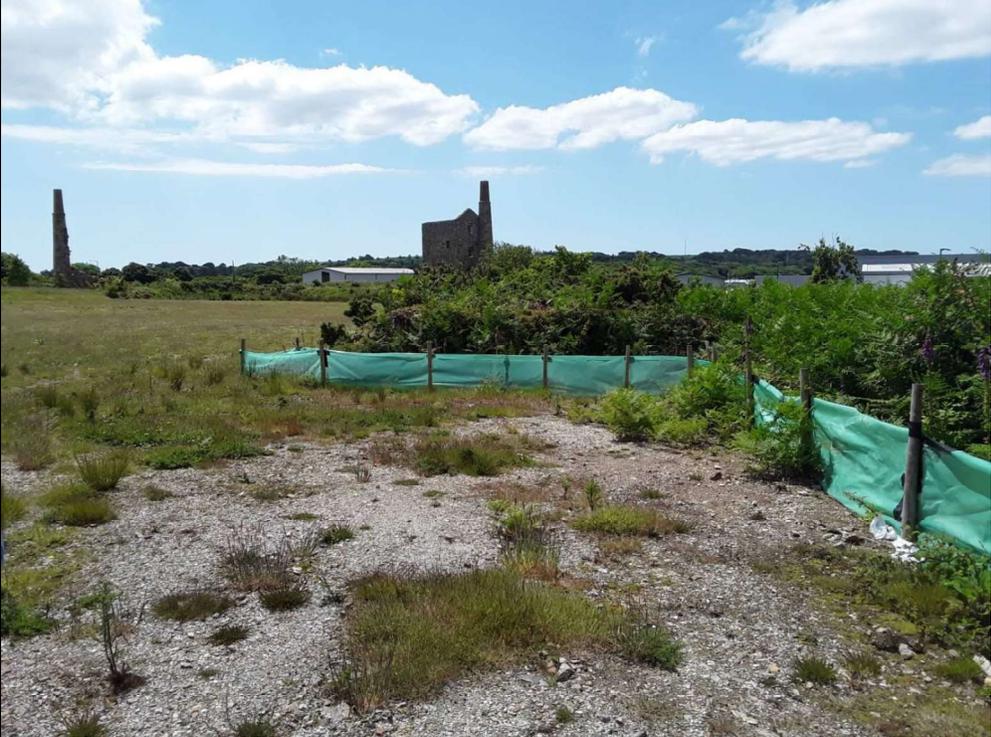
<p>Photo No. 8</p>

<p>Date: 20/06/22</p>	
<p>Facing south west towards the Cornish Engine Houses /chimneys from approximately half along the western boundary. Barrier and Cornish hedges extend slightly inwards.</p>

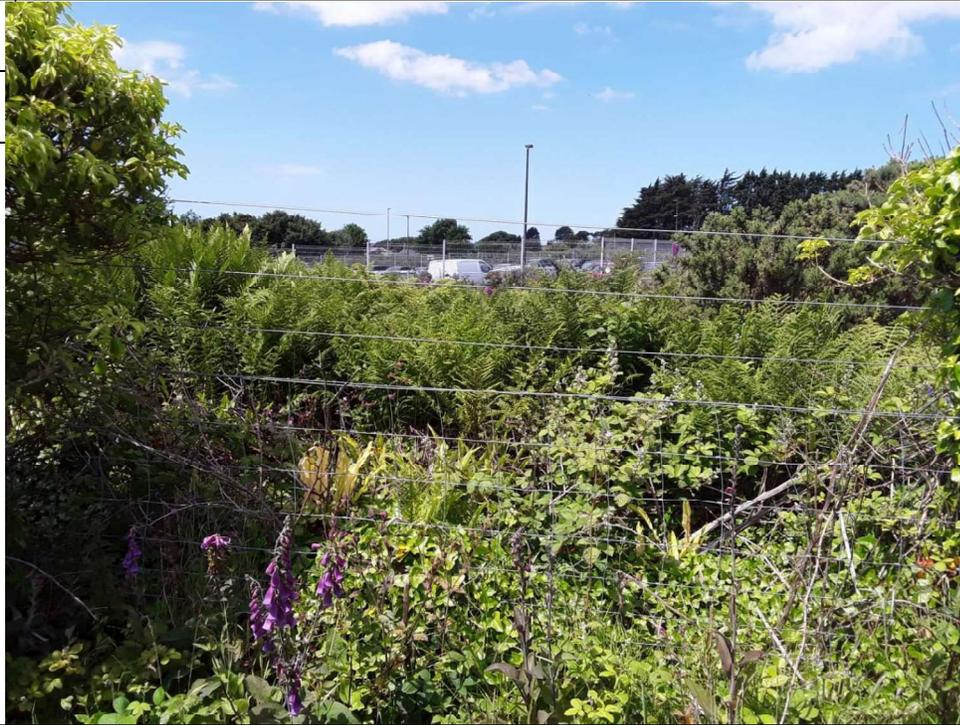
Southern end
of site along
the railway
boundary.

Site is nearly
level with the
railway.

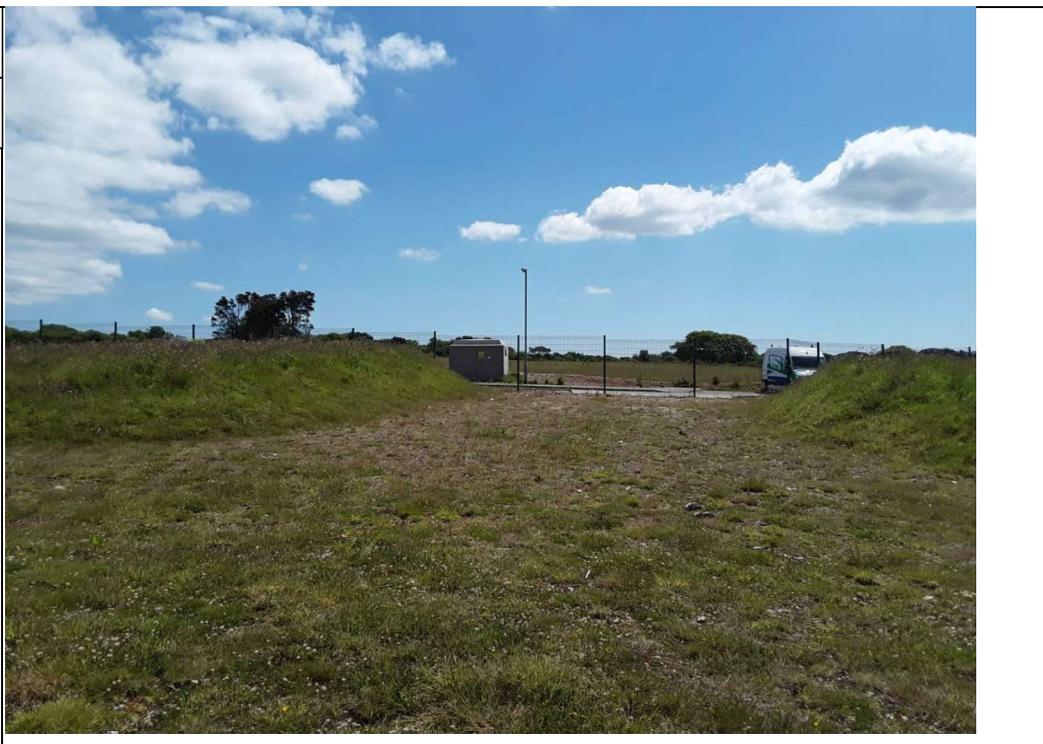
<p>Photo No. 12</p>

<p>Date: 20/06/22</p>	
<p>Substation located adjacent to site towards the south east.</p> <p>Stockpiles observed between 1.0 - 2.0 m high.</p>

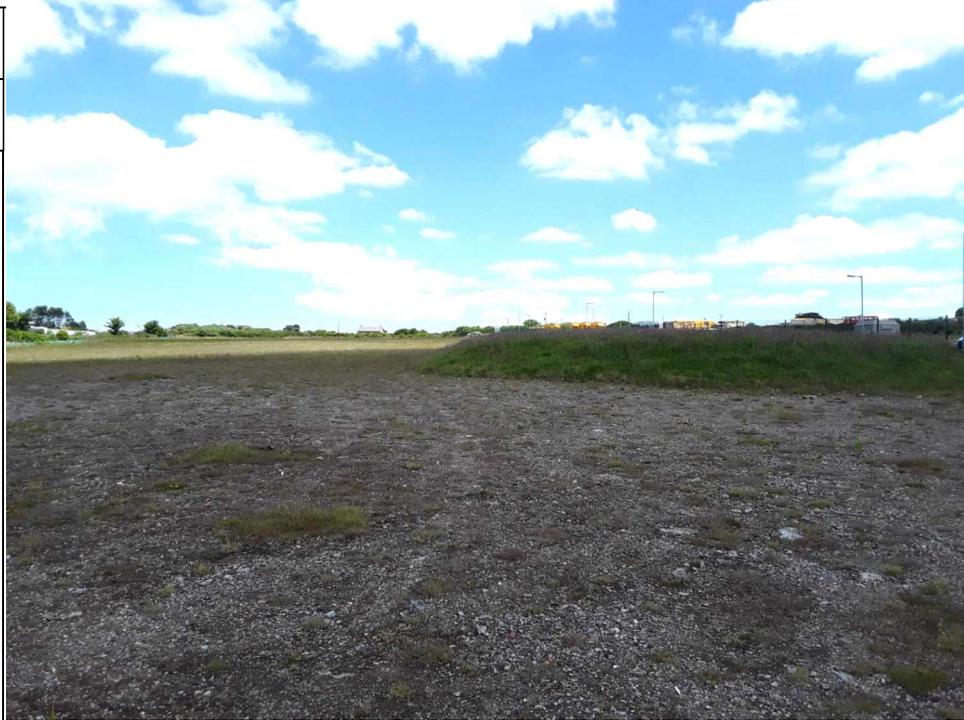
Photo No.
13Date:
20/06/22Facing north
across the
stockpiles (in
the southern
end of site).

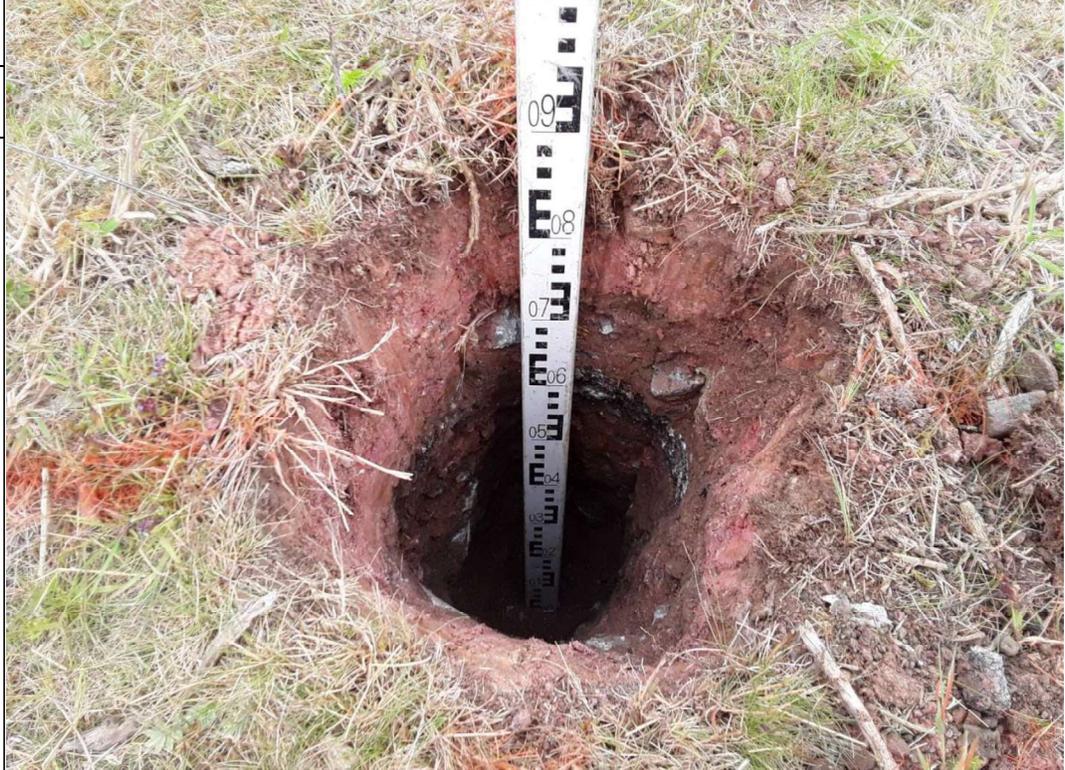
Photo No. 1

A photograph showing a borehole (BH1) in reddish-brown soil. A measuring tape is placed vertically in the hole, showing a depth of approximately 0.45 meters. The surrounding area is covered with dry grass and some green vegetation.
Date: 06/07/22	
BH1	
Photo No. 2

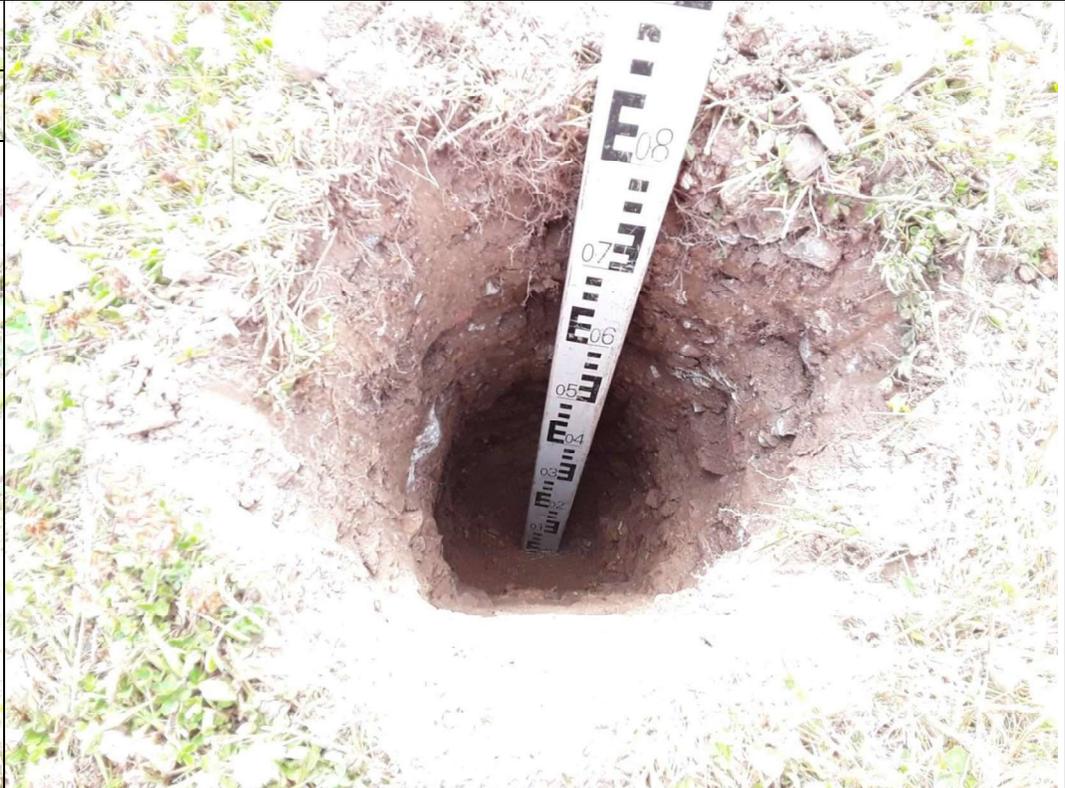
A photograph showing a borehole (BH2) in reddish-brown soil. A measuring tape is placed vertically in the hole, showing a depth of approximately 0.45 meters. The surrounding area is covered with dry grass and some green vegetation.
Date: 06/07/22	
BH2

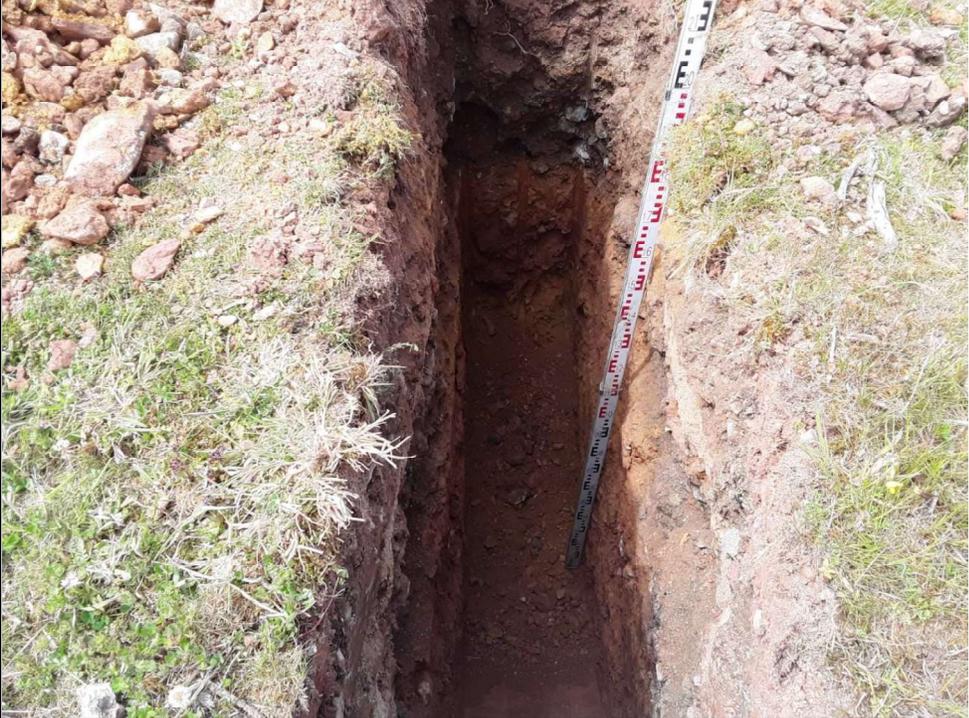
Photo No. 7

A photograph showing a vertical soil profile. A measuring tape is placed vertically on the right side of the profile for scale. The soil is reddish-brown and appears to be composed of various layers. The top of the profile is covered with sparse vegetation and small rocks.
Date: 04/07/22	
TP01B

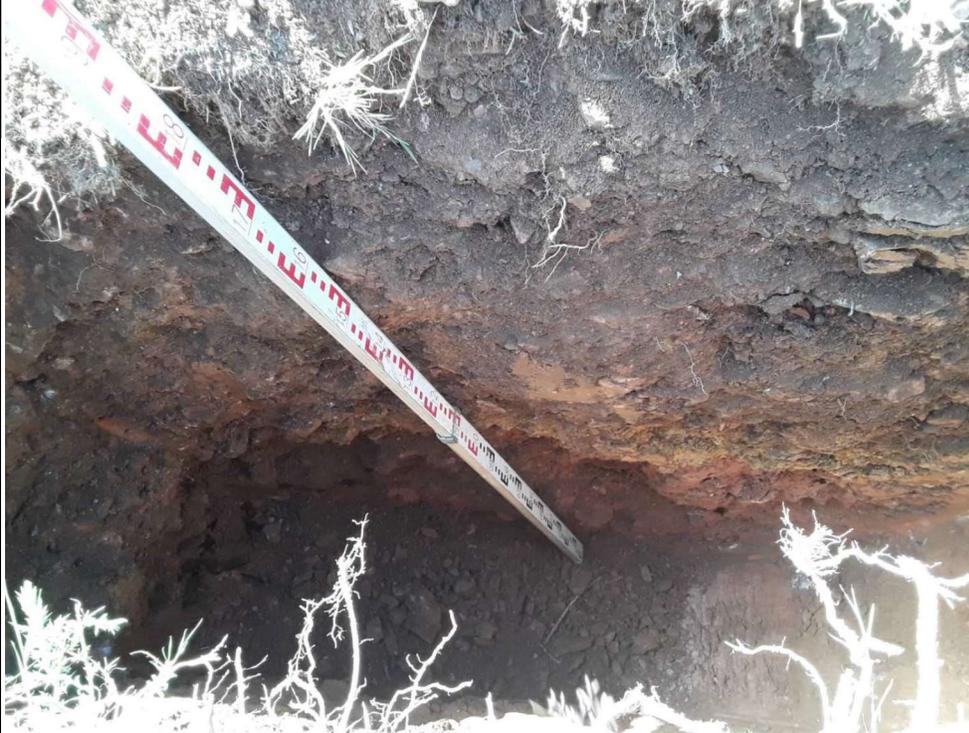
Photo No. 8

A photograph showing a vertical soil profile. A measuring tape is placed vertically on the left side of the profile for scale. The soil is dark brown and appears to be composed of various layers. The top of the profile is covered with sparse vegetation and small rocks.
Date: 04/07/22	
TP02

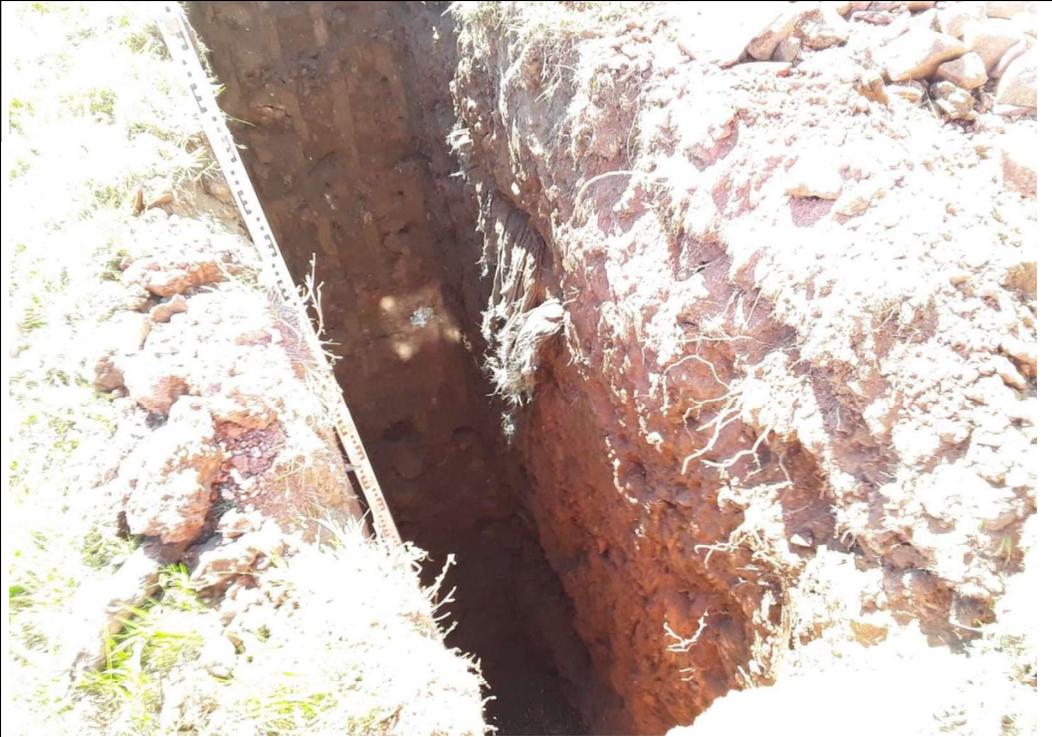
A photograph showing a vertical soil profile. A measuring tape is placed vertically against the left side of the profile for scale. The soil is reddish-brown and appears to be composed of sand and small rocks. The profile is about 1.5 meters deep.
Date: 11/07/22	
TP17
