**Environmental Setting and Site  
Design Report**

**Nansmerrow Farm**

Waste Recovery Permit  
Application

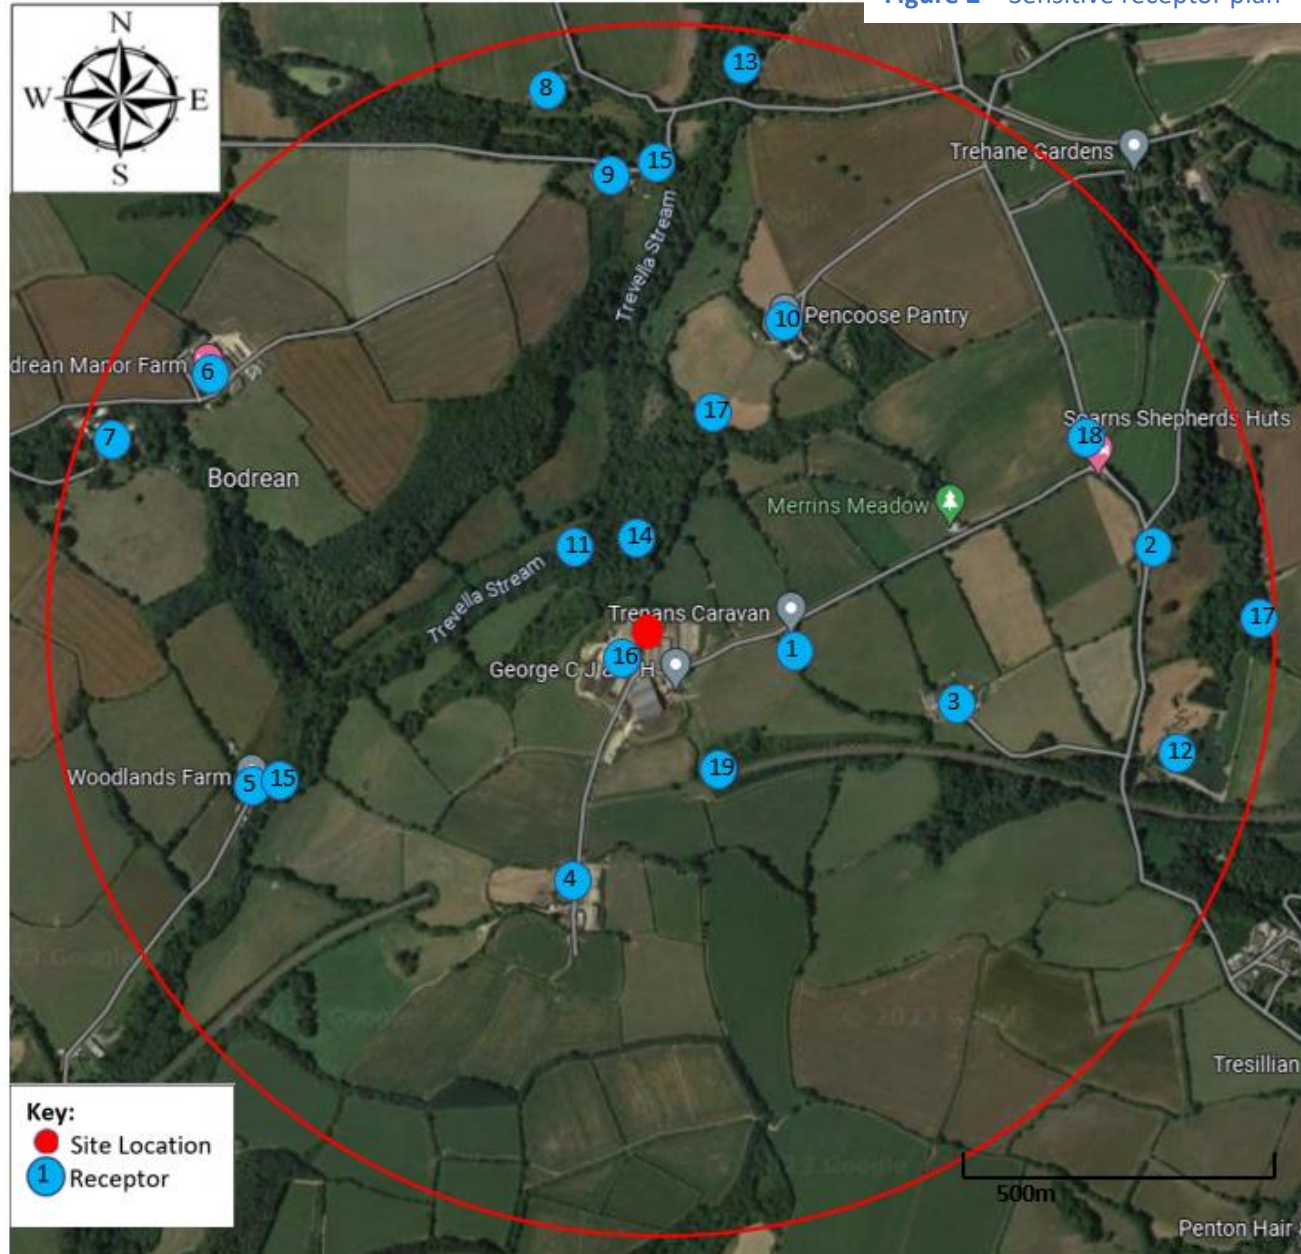
Figure 2 – Sensitive receptor plan

2.4.2 MTS Environmental have undertaken an assessment of the site context to identify all receptors within a 1000m range from the site. Receptors are shown on Figure 2 with the red circle indicating the 1000m threshold area. Table 1 shows all the receptors, respective distance from the centre of the site and direction from the site.

ID	Receptor
<b>Residential</b>	
1	Trenans Caravan
2	Venton Berron
3	Tresournes
4	Polperrow Farm
5	Woodlands Farm
6	Bodrean Manor
7	The Coach House
8	Milltown Cottage
9	Cottages
10	Pencoose Pantry
<b>Designated Land and Waterways</b>	
11	Trevella Stream
12	Waterbody
13	Ancient Woodland
14	Priority Habitat Inventory (PHI) – Deciduous Woodland
15	PHI – Traditional Orchards
<b>Public Rights of Way</b>	
16	Public Byway
17	Public Footpath
<b>Infrastructure/utilities</b>	
18	Unclassified Public Highway
19	The Cornish Main Line (train)

2.4.3 Nineteen receptors have been identified and listed in Table 1, five of which are considered high sensitivity receptors based on their nature and vicinity to the site (highlighted bold in Table 1): Trenans Caravan (Receptor 1), Tresournes (Receptor 3), Polperrow Farm (Receptor 4), Trevella Stream (Receptor 11) and the Public Byway (Receptor 16). The remaining receptors are low sensitivity receptors.
