**Industrial Emissions Directive –
Hayle Waste Water Treatment
Works (WWTW)**

Site Condition Report – H5

September 2022

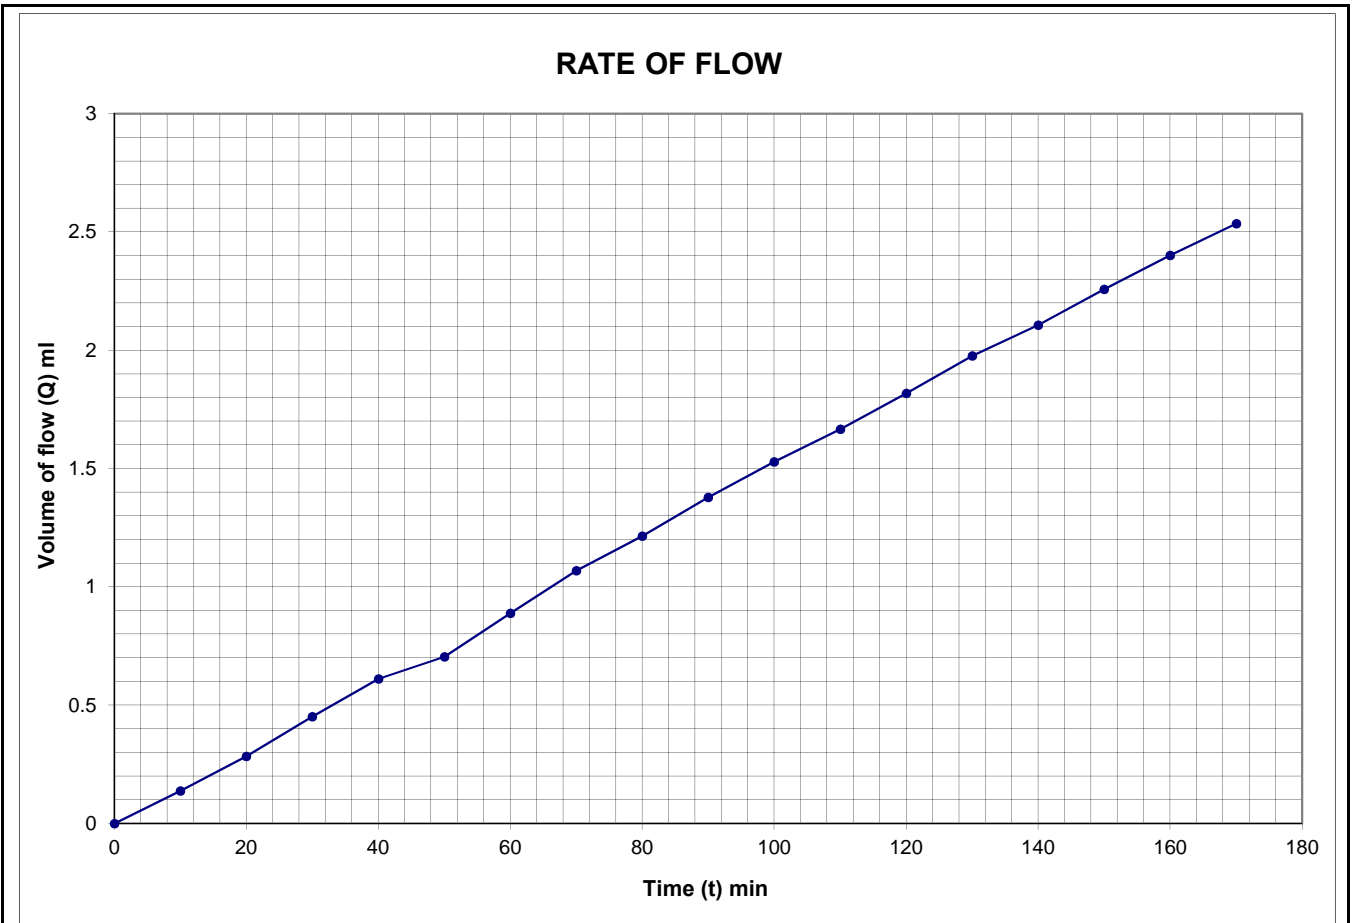
CLIENT	SOUTH WEST WATER	BH/TP No.	BH02
SITE	HAYLE SEWAGE TREATMENT WORKS	SAMPLE No./TYPE	12UT
		SAMPLE DEPTH (m)	5.20-5.65
DESCRIPTION	Greyish brown slightly sandy clayey SILT	SPECIMEN DEPTH (m)	5.50-5.60

Initial	Final	
Cell pressure	(kPa)	385	Length	(mm)	107	106
Inlet pressure (top)	(kPa)	355	Diameter	(mm)	102	100
Outlet pressure (base)	(kPa)	325	Moisture content	(%)	45.9	39.7
Pressure difference	(kPa)	30	Bulk density	(Mg/m ³)	1.77	1.76
Mean effective stress	(kPa)	45	Dry density	(Mg/m ³)	1.22	1.26

From graph, mean flow rate (Q) (ml/min) 0.0150

Two selected samples were subsampled to provide specimens which had their permeability determined in the triaxial cell [Part 6:6]. The specimens were of nominal sizes of 100mm in diameter by 100mm in height. The specimens were installed in the cell and were saturated by increments of cell pressure and back pressure applied alternatively. The specimen was then consolidated to the required effective stress and then subjected to a pressure difference to cause water to flow downward through the specimen. The permeability was determined once steady state conditions were achieved, i.e. the flow of water into the specimen equals the flow of water out.

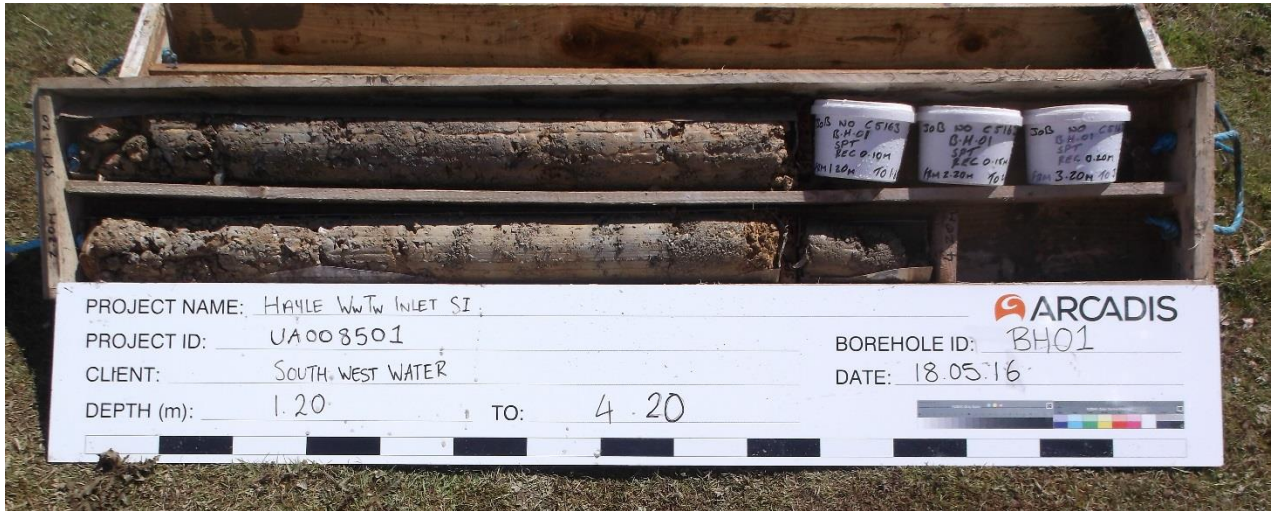
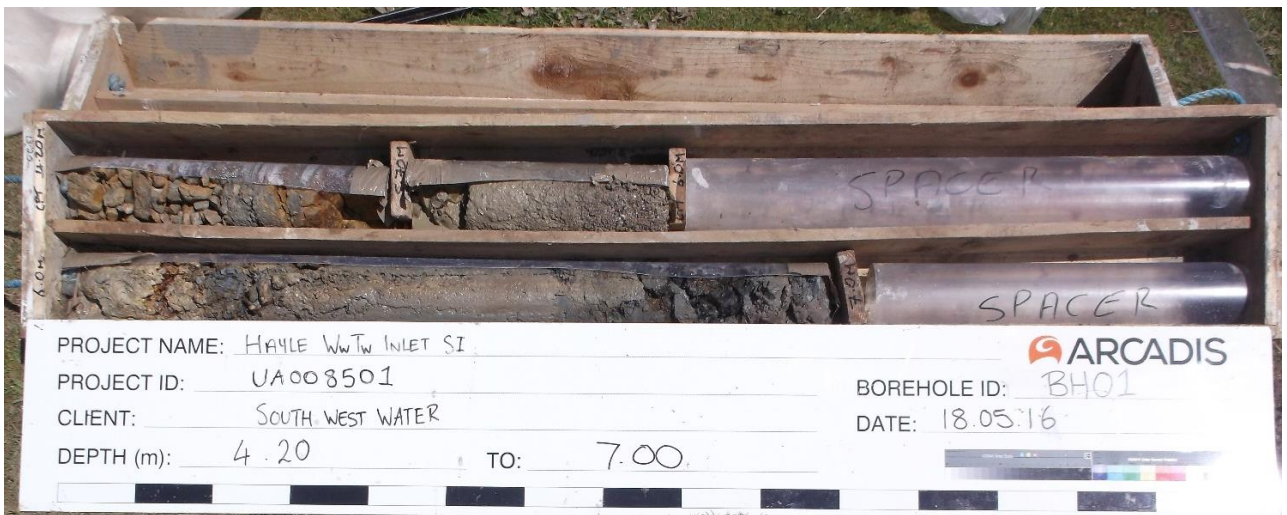
Figure 1
1.20 – 4.20 m

Project Hayle Inlet WwTw					Exploratory Hole ID BH01
Job No UA008501	Date 18/05/2016	round Level (mAOD) 10.71	Easting (OS) 154613.60	Northing (OS) 35816.96	Sheet Page 1 of 5
Contractor

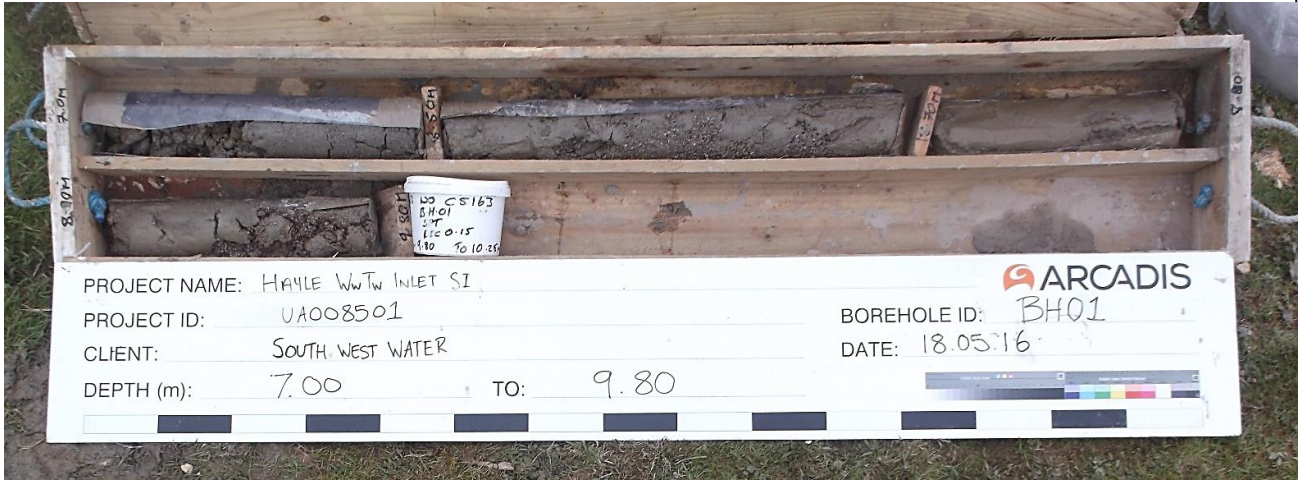
Figure 1
7.0 – 9.8 m

Project Hayle Inlet WwTw					Exploratory Hole ID BH01
Job No UA008501	Date 18/05/2016	round Level (mAOD) 10.71	Easting (OS) 154613.60	Northing (OS) 35816.96	
Contractor					Sheet Page 2 of 5

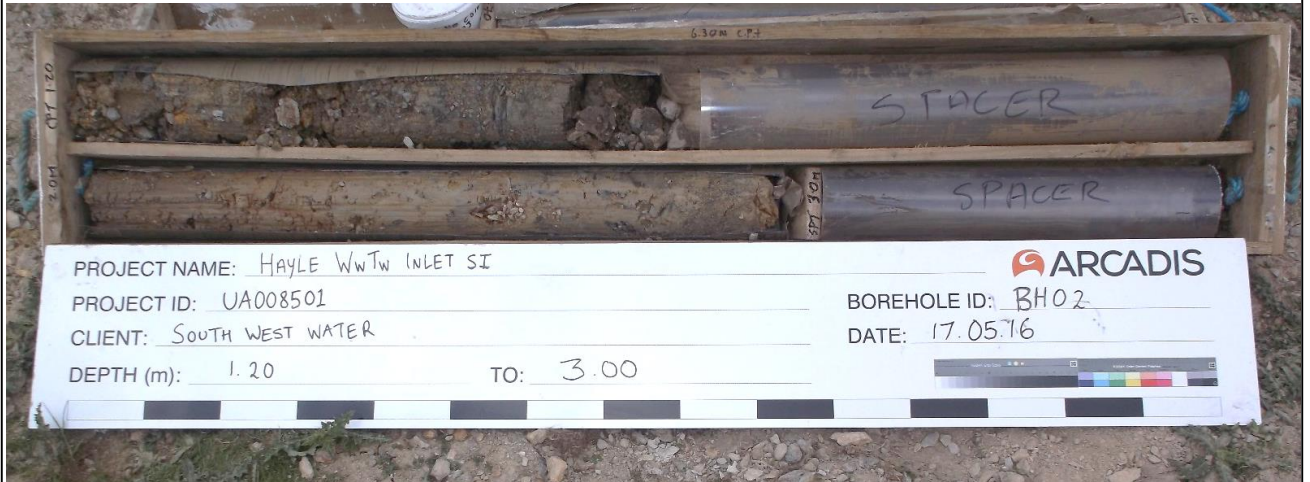
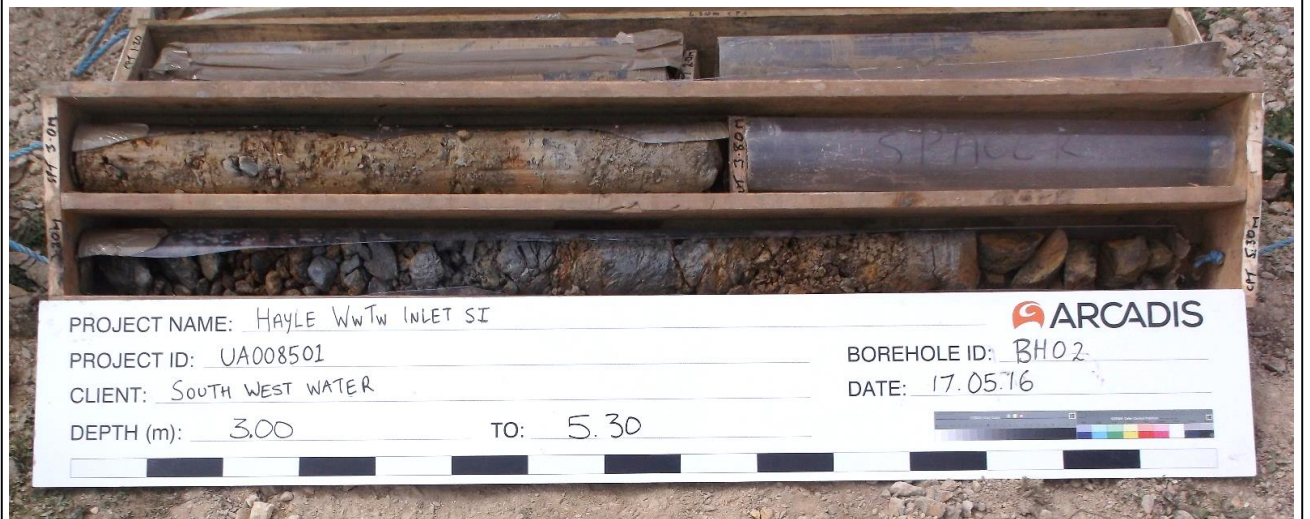
Figure 1
1.20 – 3.00 m

Project Hayle Inlet WwTw					Exploratory Hole ID BH02
Job No UA008501	Date 17/05/2016	round Level (mAOD) 10.65	Easting (OS) 154610.10	Northing (OS) 35808.35	
Contractor					Sheet Page 3 of 5

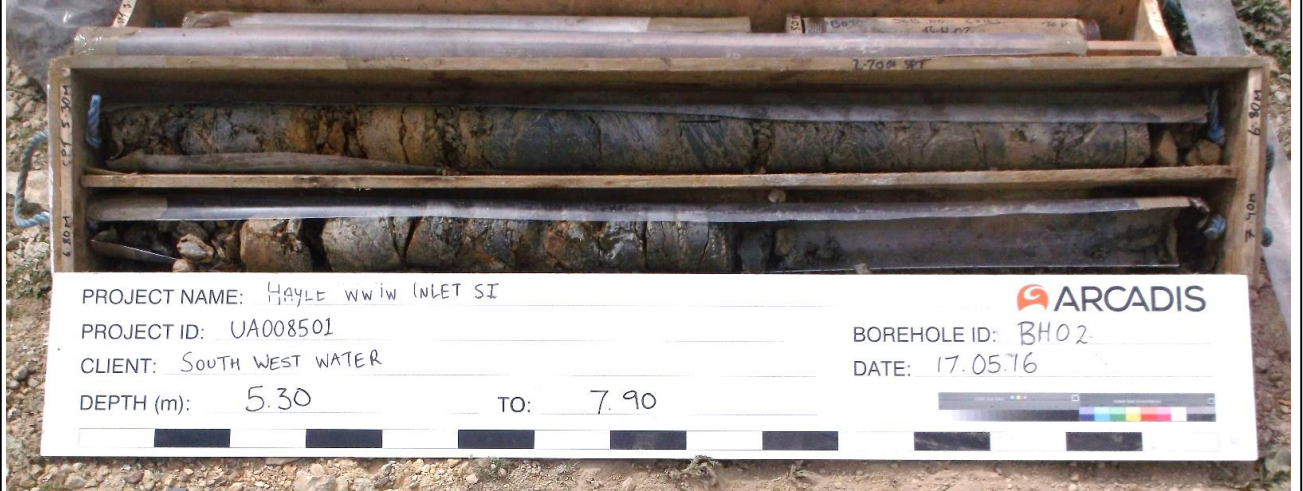
Figure 1
5.30 – 7.90 m

Project Hayle Inlet WwTw					Exploratory Hole ID BH02
Job No UA008501	Date 17/05/2016	round Level (mAOD) 10.65	Easting (OS) 154610.10	Northing (OS) 35808.35	
Contractor					Sheet Page 4 of 5

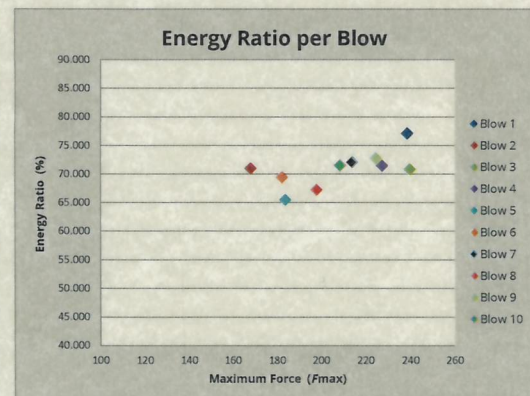
Fig. B.1 and B.2 BS EN ISO 22476-3 : 2005 + A1 : 2011

Diameter: $d_r = 0.052\text{m}$
 Length of the instrumented rod: 0.558m
 Area: $A = 11.61\text{cm}^2$
 Modulus: $E_a = 206843\text{MPa}$

$E_{\text{meas}} = 0.336\text{ kN-m}$
 $E_{\text{theor}} = 0.473\text{ kN-m}$
