Net Zero Teesside Project

High Pressure Compression Plant
Directly Associated Activity Application

Appendix B - Application Site Report

26 May 2022

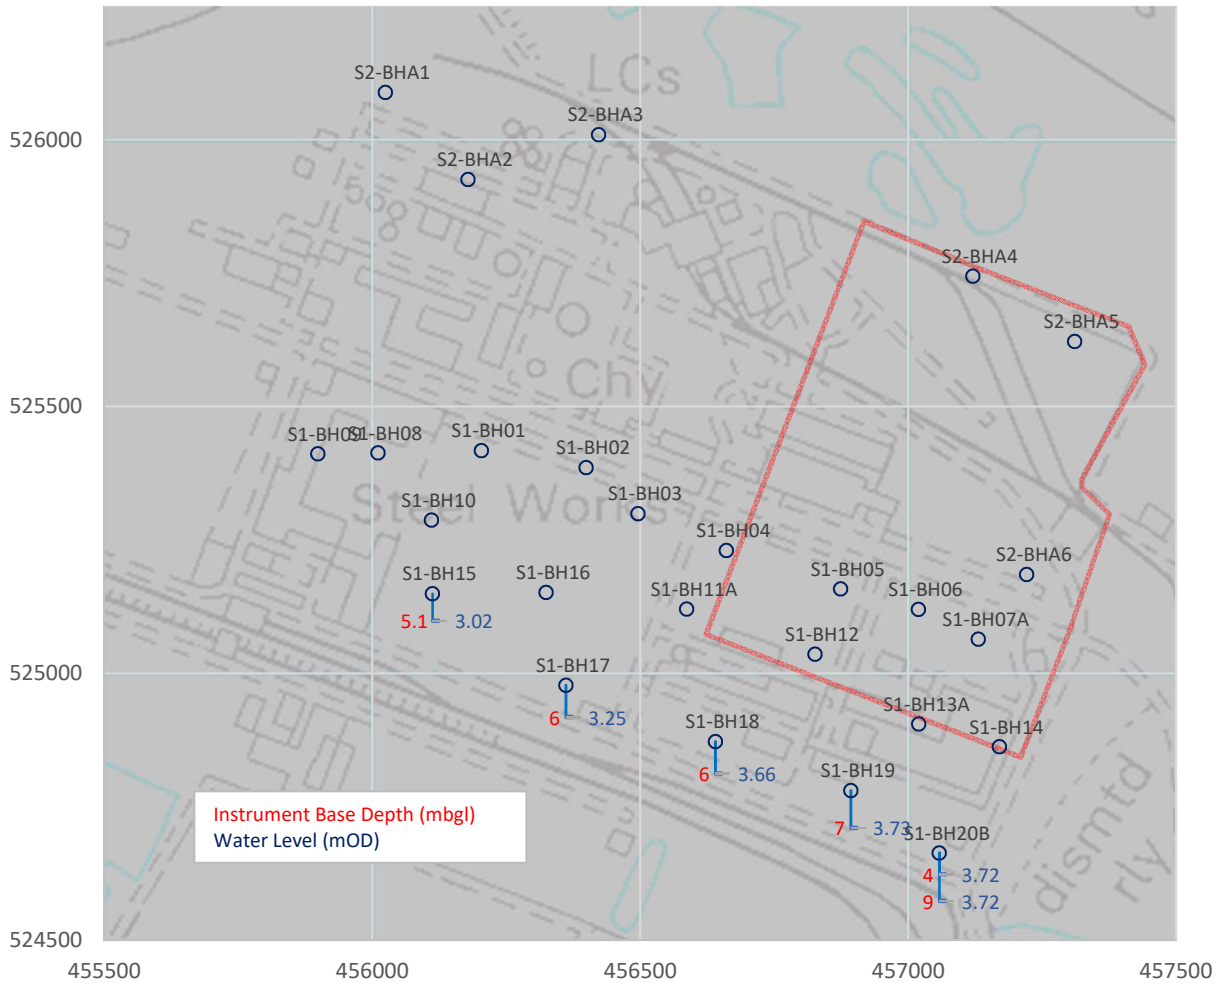
**Teesside Net Carbon Zero - Water Elevation (mAOD)
against Instrument Base Depth (mbgl)
November 2017**

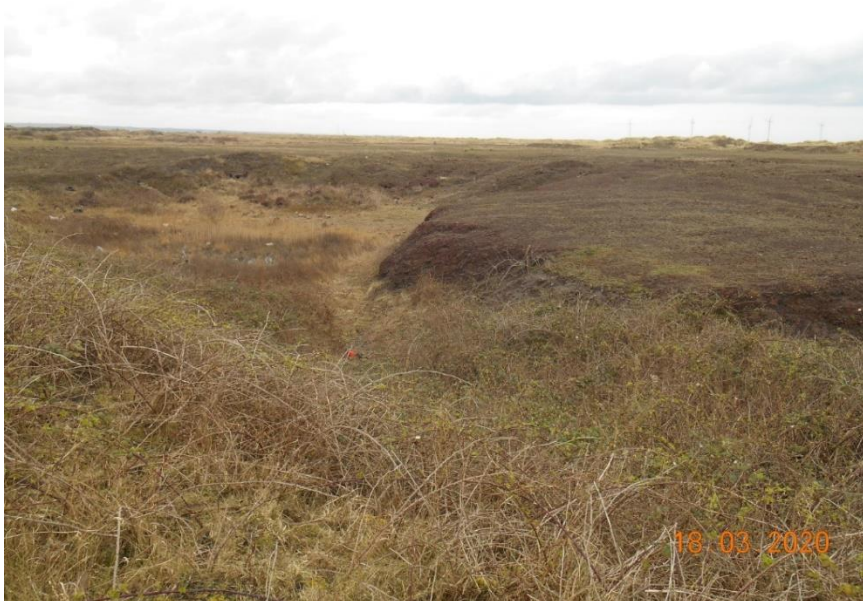
Plates 1, 2 and 3 show areas of steel slag waste, most likely placed during the operation of the Redcar Iron and Steelworks (present between 1929 and 1973) tipped immediately north of the Site across the proposed Onshore CO₂ corridor. These areas of slag extend north to Blown Sands deposits of the natural beach sand and dune habitats, although these areas are also most likely underlain with man-made materials placed between 1856 and 1894, associated with early land reclamation and construction of defences from the North Sea.

Plate 1 – View looking north east showing areas of steel blast furnace waste slag with the existing offshore windfarm visible in the distance.

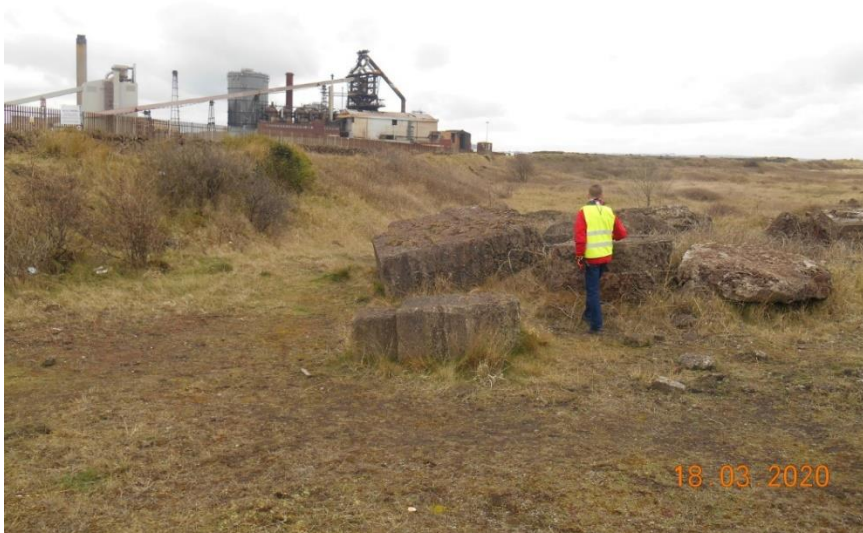
It was noted that there are localised areas of spoil comprising large discarded fused slag and old concrete foundations from previous industrial development across this area, see Plate 3.

Plate 3 – View looking south west showing large concrete blocks thought to be foundations from previous land use within the Main Teesworks Site shown on the foreground, and the former blast furnace on the right-hand side of the photograph which is outside and adjacent to the east boundary of the site.

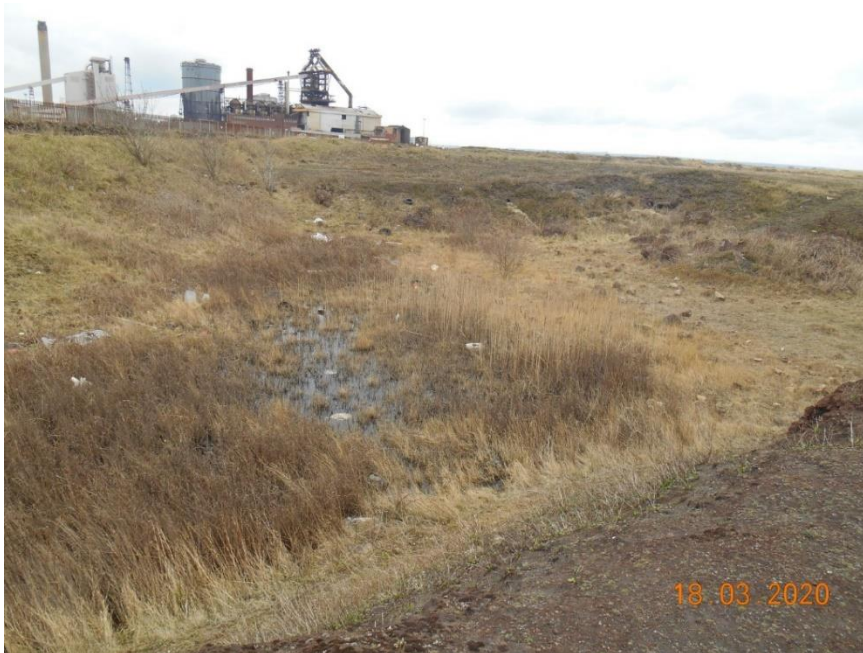
Sites were generally dry or marshy, see Plate 4. These ponded areas are shown as different sizes over different dates of OS mapping, suggesting they are influenced by seasonal rainfall.

Plate 4 – View looking south west within the Onshore CO₂ corridor showing marshy pond areas north east of the Main Teesworks Site.

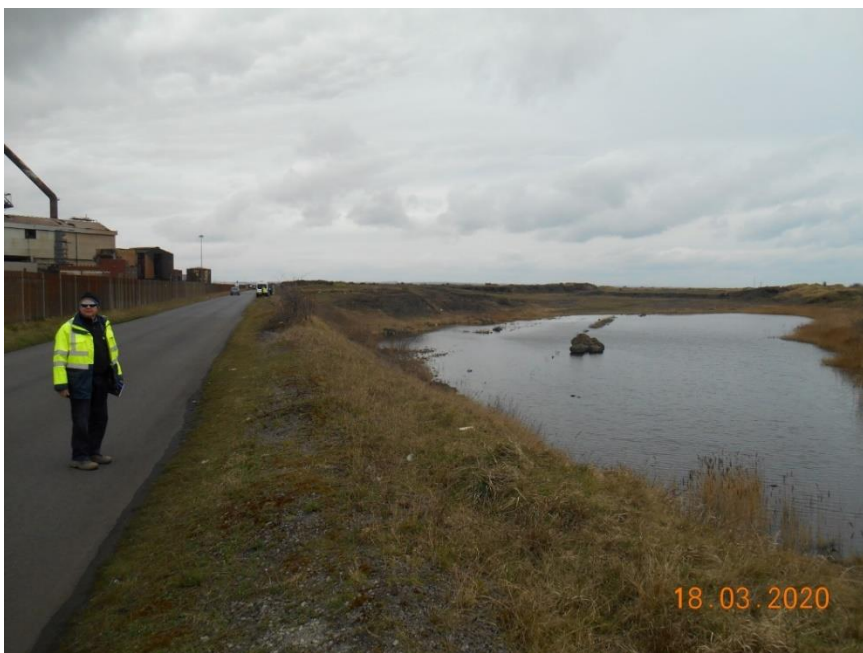
A larger and more permanent pond is present north of the unnamed road adjacent to the north west corner of the of the Main Teesworks Site. The bunded areas around the pond are formed of Made Ground primarily comprising waste slag materials from the former Redcar Iron and Steel Works, shown on Plate 5 below.

Plate 5 – View looking north west along unnamed road and permanent pond.

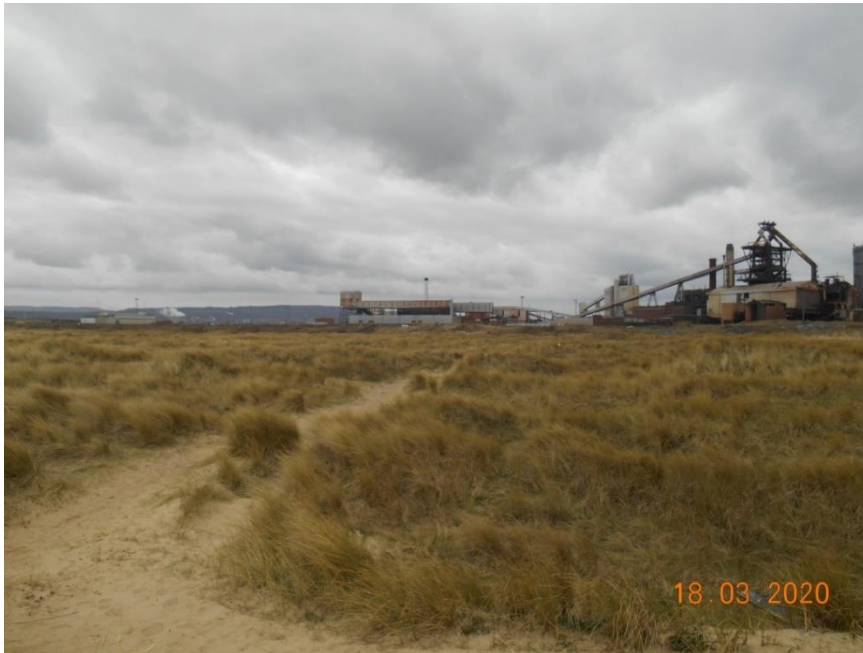
Plate 6 – View looking south southwest showing the dune habitat in the area of the proposed CO₂ corridor showing the proposed Main Teesworks Site in the background.

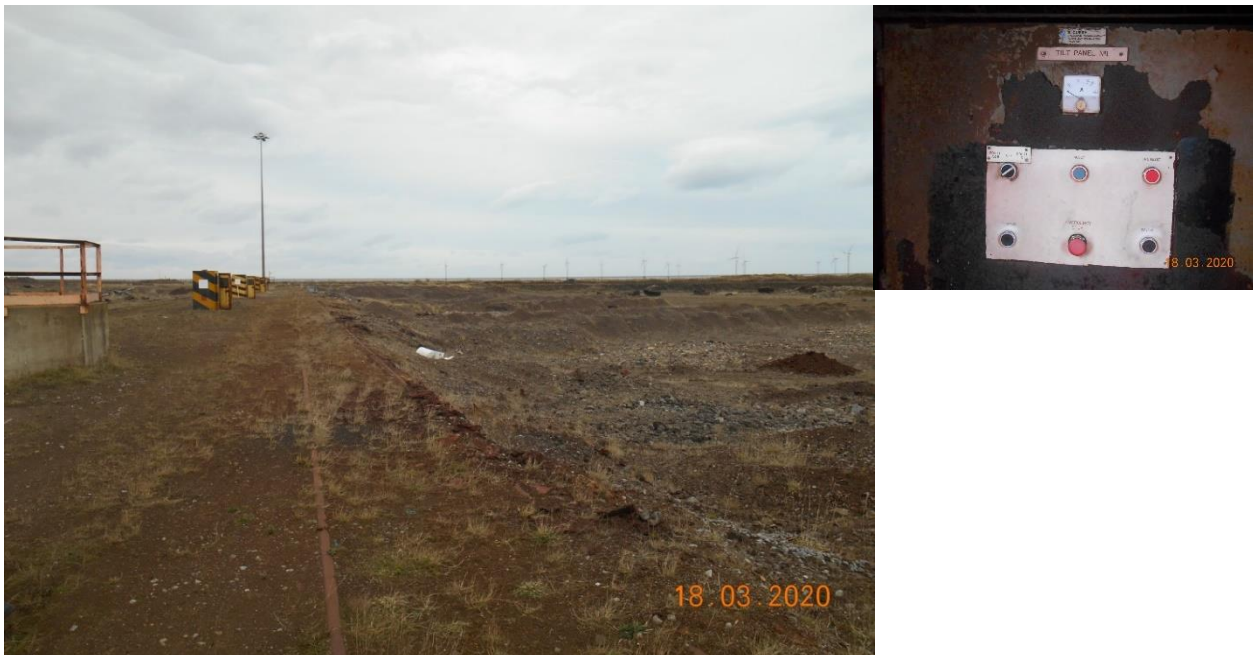
Land in the north portion of the Main Teesworks Site comprises wasteland, former rail sidings, hardstanding and land previously used as a 'steel ponding' area. The whole of the north east corner of the proposed Main Teesworks Site is occupied by an area of former 'steel ponds'. Historically, when problems were encountered during steel production or where excess iron was produced that was unable to be processed by the Basic Oxygen Furnace Steelmaking (BOS) Plant, this molten iron was transported to this area and tilted as a 'torpedo' to 'pond'. The iron was then fractured and recycled back to the blast furnace. It is reported that there were a series of nine 'ponds' which covered an area of 8,000m² with a capacity to hold 60,000t of iron. It is understood the pond areas were also used for the disposal of waste products from the Blast Furnace although the type of wastes are not known. The steel 'pond' area is shown on Plates 7 to 9.

Plate 7 – View looking north west along the alignment of the steel torpedo 'pond area'. The tilt operation booths are seen yellow/black on the left hand left-hand side of the photograph (see insert showing Tilt Panel to the right), with running rails for the tippers shown on the edge of the 'pond' areas.

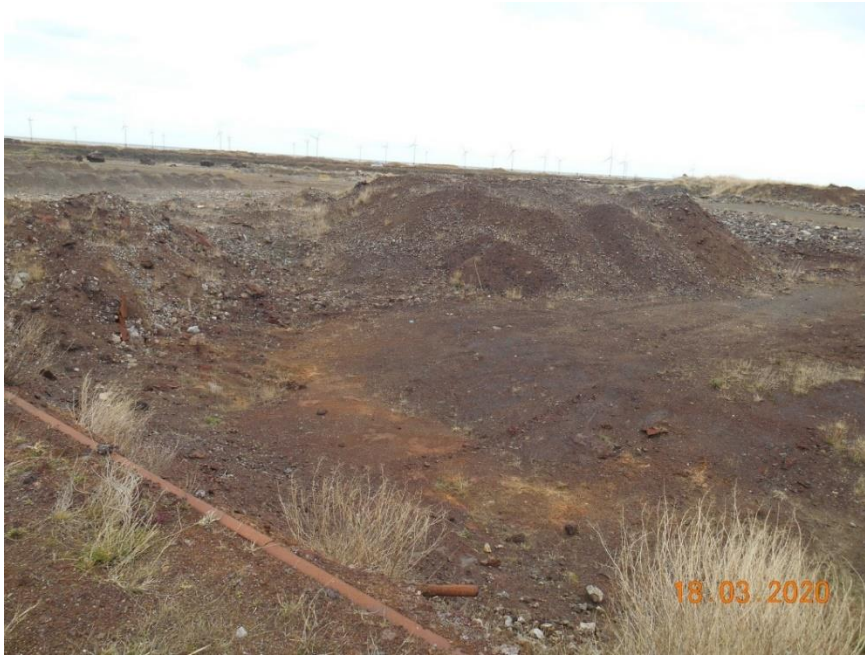
The former 'pond' area is now covered in various spoil heaps of blast furnace slag and crushed concrete, with metal detritus varying in size typical of gravel, cobbles and boulders across the area, see Plate 8. It was noted that there is no or little vegetation present across the former ponds. Land immediately south and south west of the 'ponds' was generally vegetated with grasses and included very large blocks of waste iron assumed to be associated with the practise of tipping of molten iron as described above, see Plate 9 for a typical 'block' observed.

Plate 8 - View looking north showing typical spoil heaps of iron slag waste material.

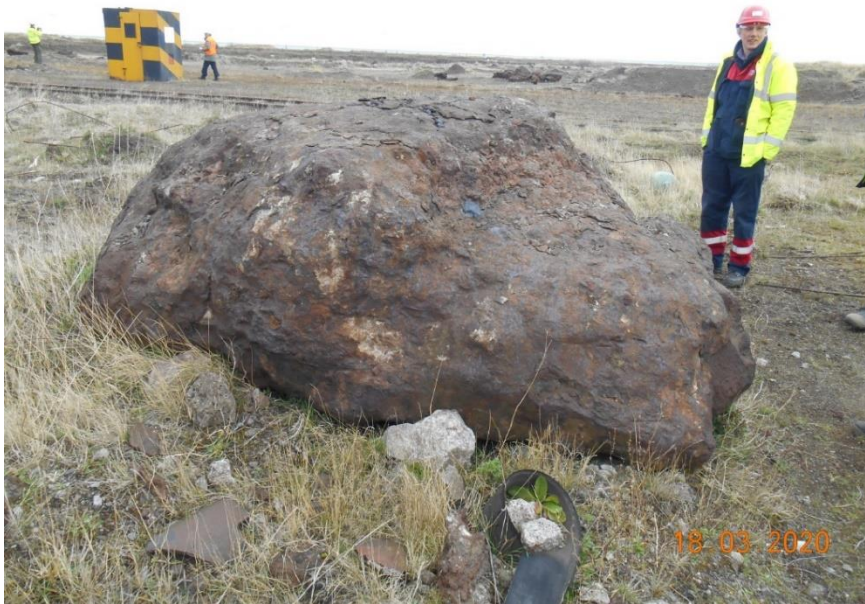
Plate 9 - Typical example of waste iron blocks discarded across land south of the torpedo pond area. Estimated size 5.0 X 5.0 X 1.5m.

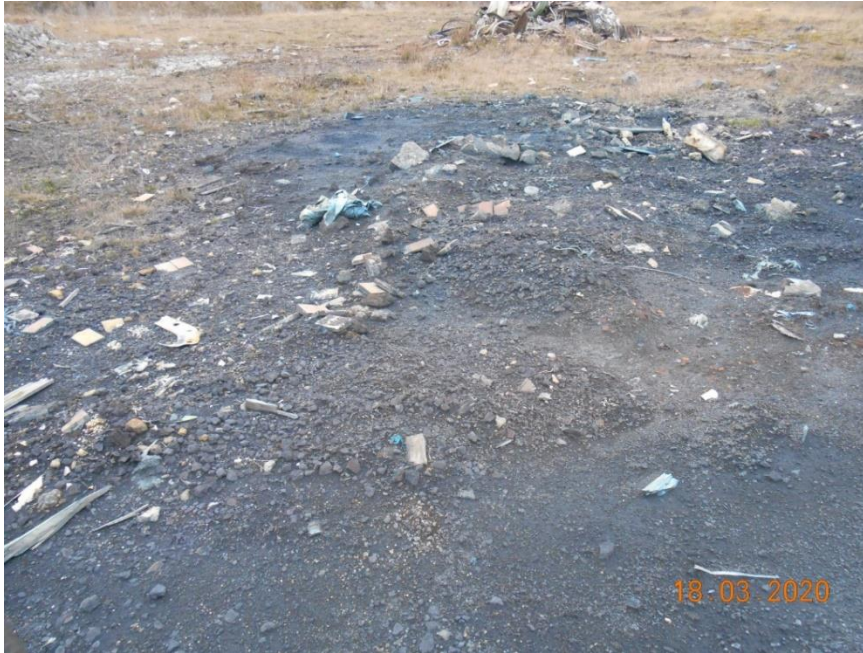
gasification (gas works) processors and also with coke works and manufacturing of coke for steelmaking. However, neither of these of these industries are recorded on historical OS mapping to have been present on the Site, with former Redcar Coke Ovens (RCO) and coke stocking area located some 200m to the west northwest. Therefore, the source of this contamination is unknown. However, groundwater monitoring data from previous ground investigations by others has identified cyanide contamination within groundwater in this area, so the source and extent of contamination should be determined by ground investigation.

Plate 10 – Surface soils discoloured blue typical of cyanide contamination.

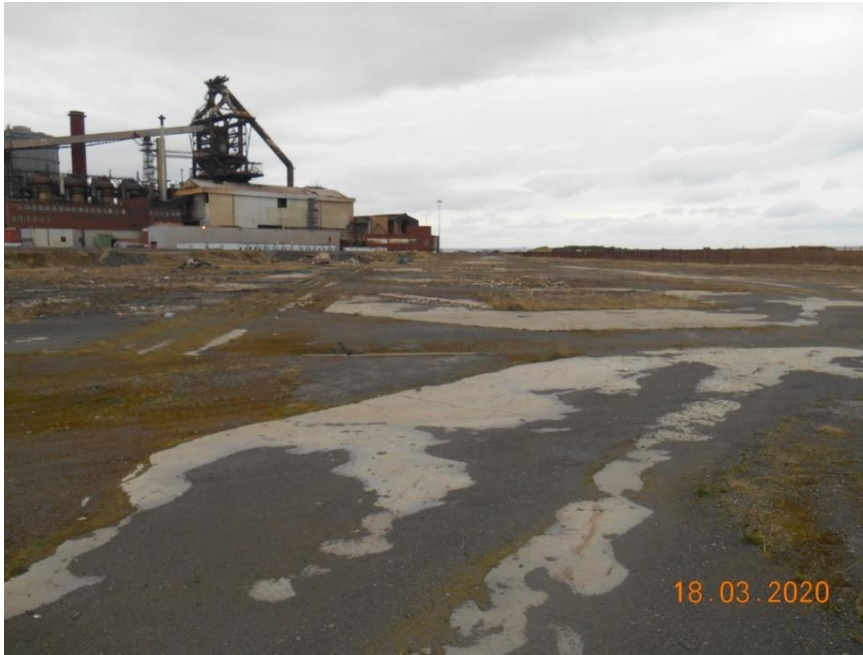
The second area of interest comprises hardstanding and remnants of four hexagonal areas of hardstanding understood to be foundation bases located in the north east corner of the proposed Main Teesworks Site, see Plate 11. These footings are thought to possibly be a result of the initial intention to build a further 2 blast furnaces (outside, and to the north west of the proposed site boundary shown on the left hand side of the photograph) which were subsequently never constructed. It is understood the initial production forecast for the existing plant was originally intended to be three times the actual production capacity, but was scaled down due to economic demand at that time. The circular foundations do not include concrete within the centre as it is understood this would have housed a low collection point required as part of the production process.

Plate 11 - View looking west- north west showing remnant foundations and hardstanding.

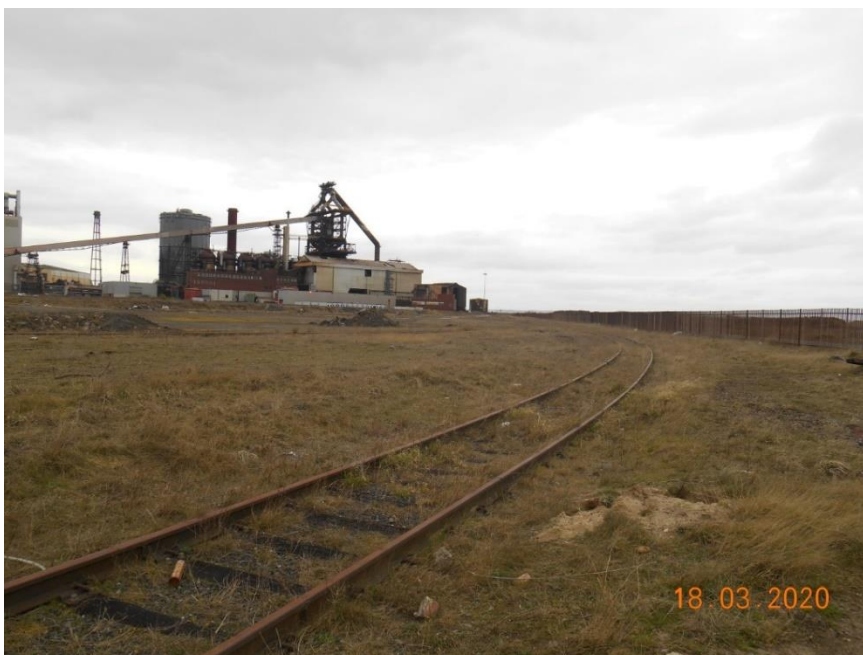
A rail siding is present running along the north boundary of the proposed Main Teesworks Site running from the blast furnaces to the west-north-west trending east southeast towards the steel 'pond' area, see Plate 12. This forms part of the Hot Metal Route railway, which was used to transport the liquid metal in the Torpedo ladles to the BOS plant located approximately 7km to the south (within the wider SSI site). This route also links to numerous other rail lines associated with the various processes that took place on Site.

Plate 12 - Rail siding running along the north boundary of the Teesworks Site.

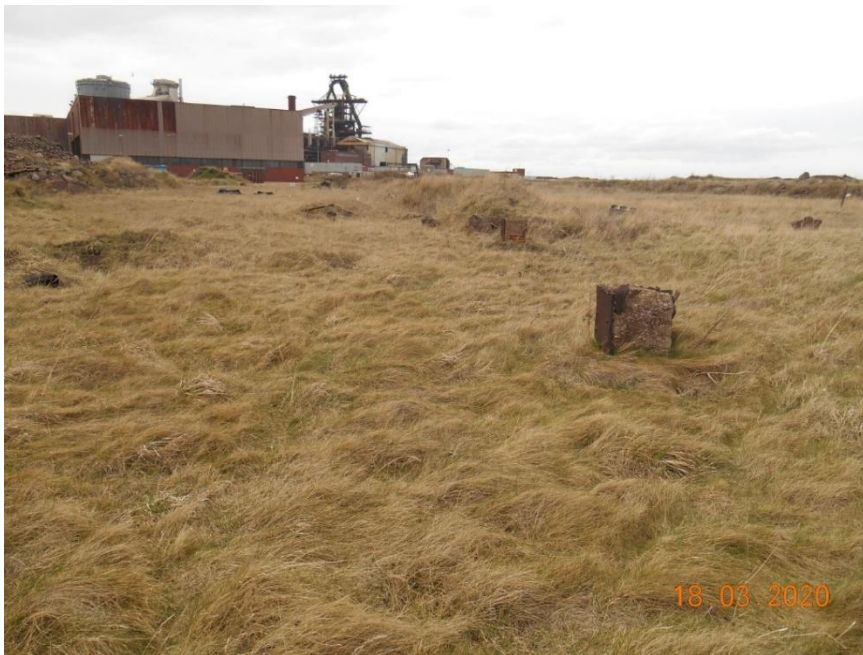
Plate 15 – View looking north west showing cut-down structure stanchions along the alignment of the former Redcar Steel and Iron works Steel Plant building.

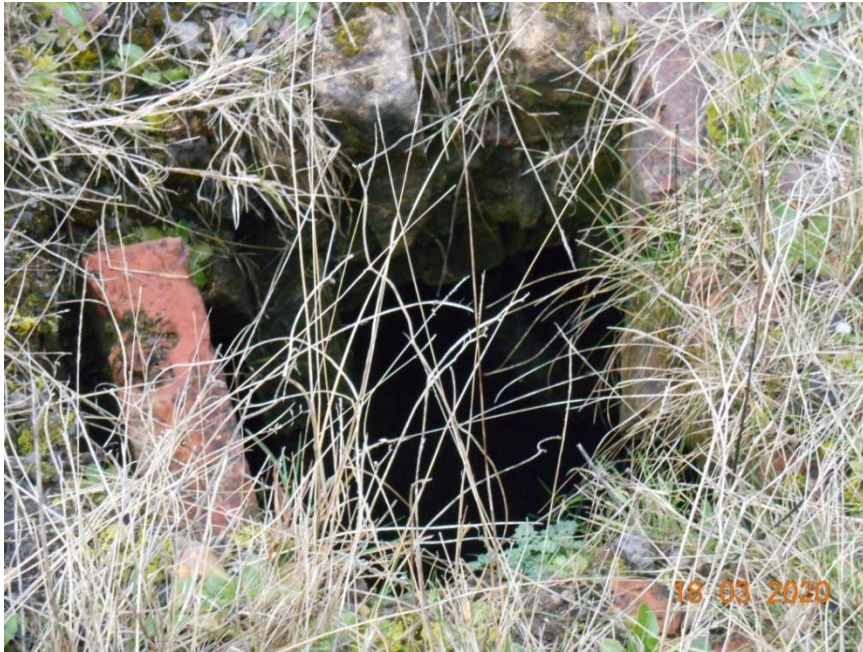
The area of open ground east of the Blast Furnace Stockhouse (see Plate 13) is known to be underlain by a number of buried structures, caverns and brick-lined tunnels, these within the area of Herras fencing shown in the centre of the photograph. These predate the existing SSI plant layout and are most likely associated with the earlier former Redcar Iron and Steelworks site (present on site from 1929 to 1973). The buried structures and tunnels may be associated with steel melting hearths and ventilation tunnels with anecdotal evidence suggesting there were ten steel melting hearths on the site, although these are not shown on any historical OS mapping. The

Plate 16 - Surface expression of buried structures and tunnels.

merits of undertaking geophysical investigations including Ground Penetrating Radar (GPR) and/or Resistivity techniques was discussed on site as a suitable for a Phase 1 investigation to aid determination of the location, direction and extent of these across this area. Access into the fenced areas was not permitted during the site walkover due to The CDM Regulations (2015) and Health and Safety restrictions, however there is little visible surface expression of these features as shown in Plate 16.

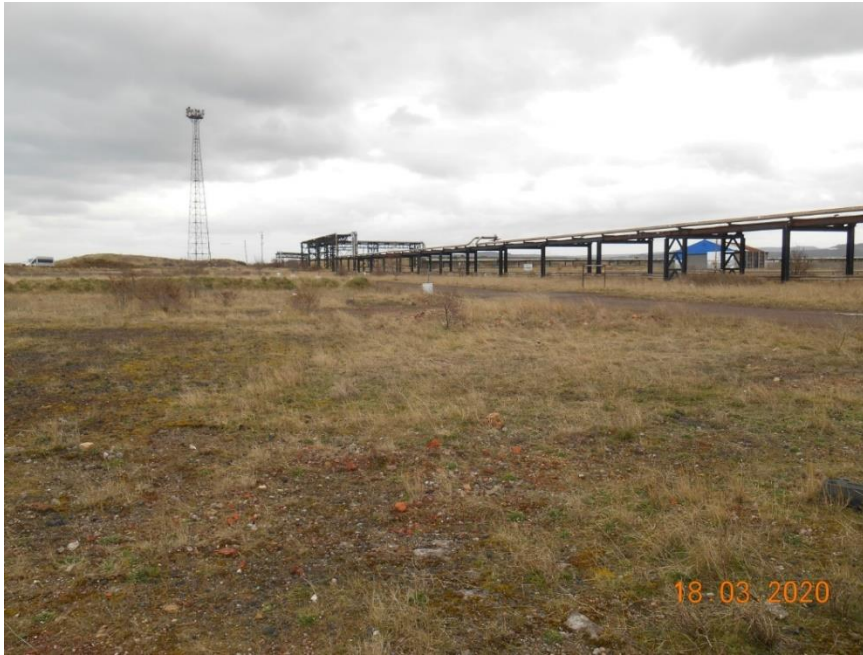
The south part of the central area is delineated by an overhead network of pipelines and a further internal access road. From discussion on site the overhead network carries a number of different materials for the industrial processes undertaken and include but not limited to fuel oils and the Cog Oven Gas (COG) main that is piped to South Bank from the coke ovens west and outside of the Site boundary, see Plate 17.

Plate 17 – View looking east south-east showing overhead COG and fuel oil pipelines. The RDL Stores building and associated canteen are located in the north east corner of the central area adjacent to the east boundary of the Site boundary, see Plate 18. It is reported that historically there may have been some storage tanks (contents unknown) west of the structures associated with stores.

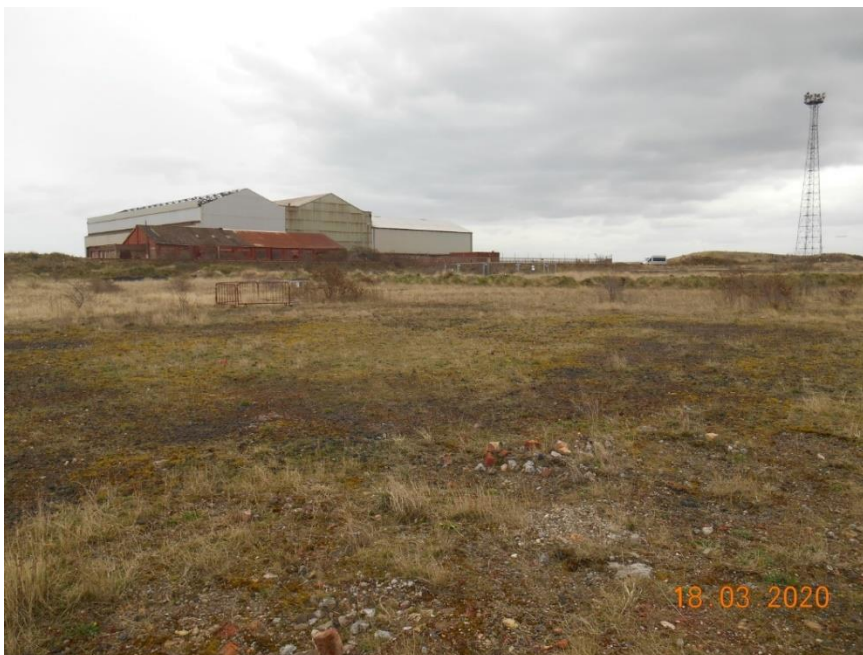
Plate 18 – View looking north east showing RDL Stores and Canteen. A lighting column is visible on the right hand side of the photograph, with others

present elsewhere across the site. In some areas the columns have been removed and foundations are present at ground surface.

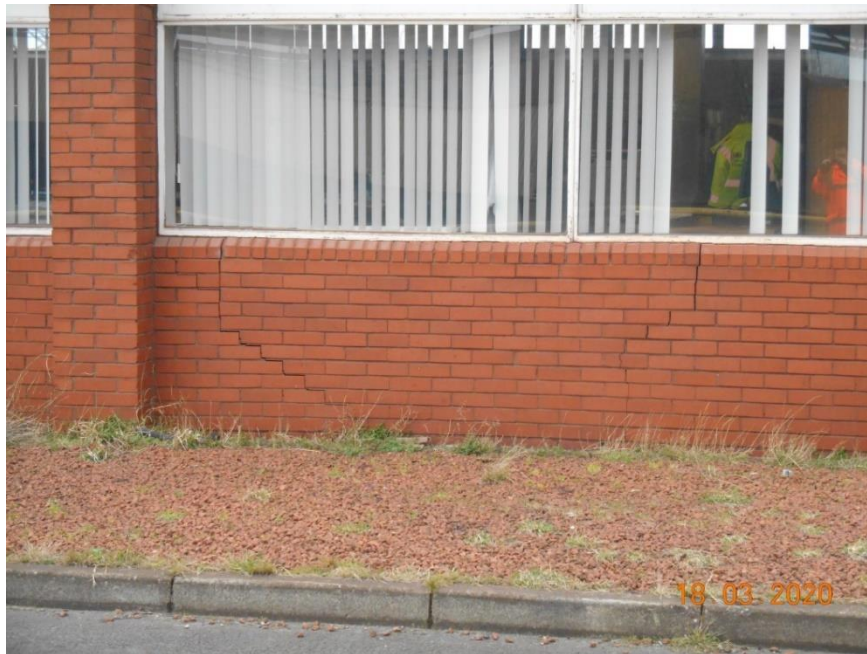
The structures in this area are of brick construction. Waste slag material is present widely across the whole site, with evidence of the expansive nature of this material visible through structure deformation and cracking in the walls of these buildings. Plate 19 shows the STSC offices and Plate 20 shows the Pellet Tunnel building.

Plate 19 – View looking north showing structure deformation and cracking on the STSC office building.

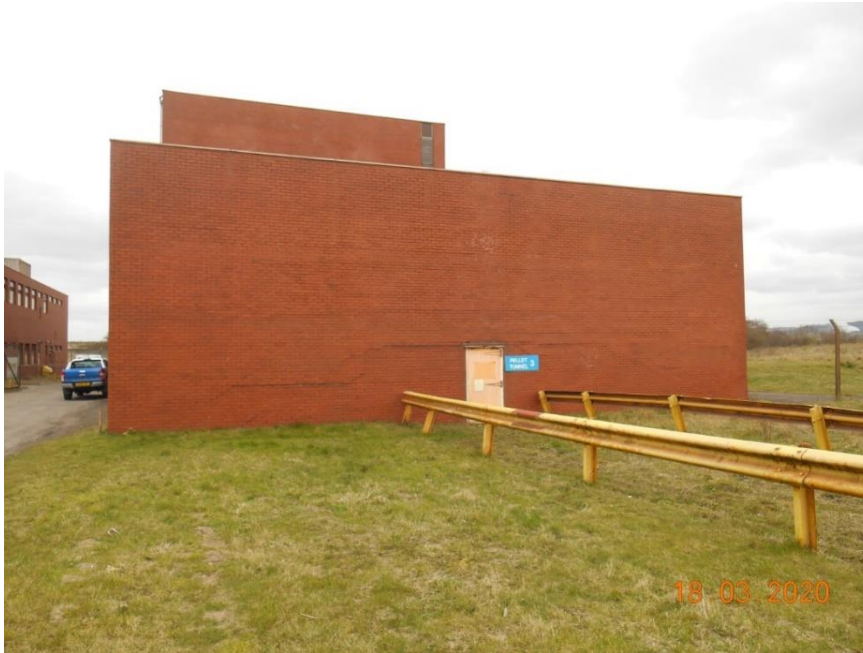
Plate 20 – View looking west showing deformation across the Pellet Tunnel building. It is noted that the extent and direction of the tunnels are not known at the time of this report issue, however STSC have indicated that these records should be available for release. The barriers leading to the structure again delineate the corridor of buried underground services and high voltage cables.

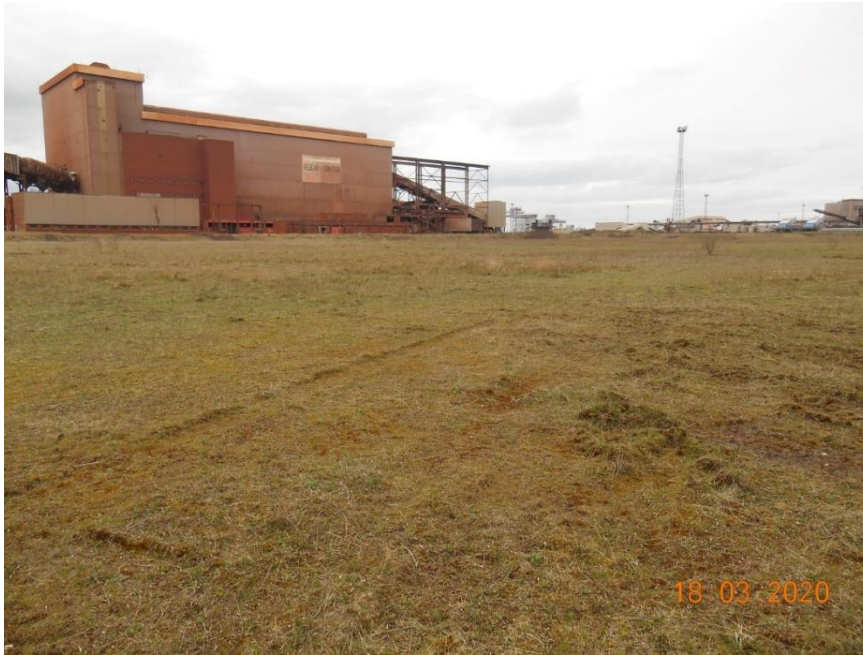
The area to the west of the office buildings comprises open vegetated soft landscaping bounded to the north by overhead equipment and the Blast Furnace Stockhouse, the Sinter Plant to the south, with conveyors and associated services to the east. The Sinter Plant is shown on Plate 21. The STSC representative described sinter to comprises small, irregular nodule shaped agglomerates of iron ore fines, limestone and coke which was used as a feedstock for the blast furnace.

Plate 21 - View looking south west showing the Sinter Plant adjacent to the south boundary of the proposed site.

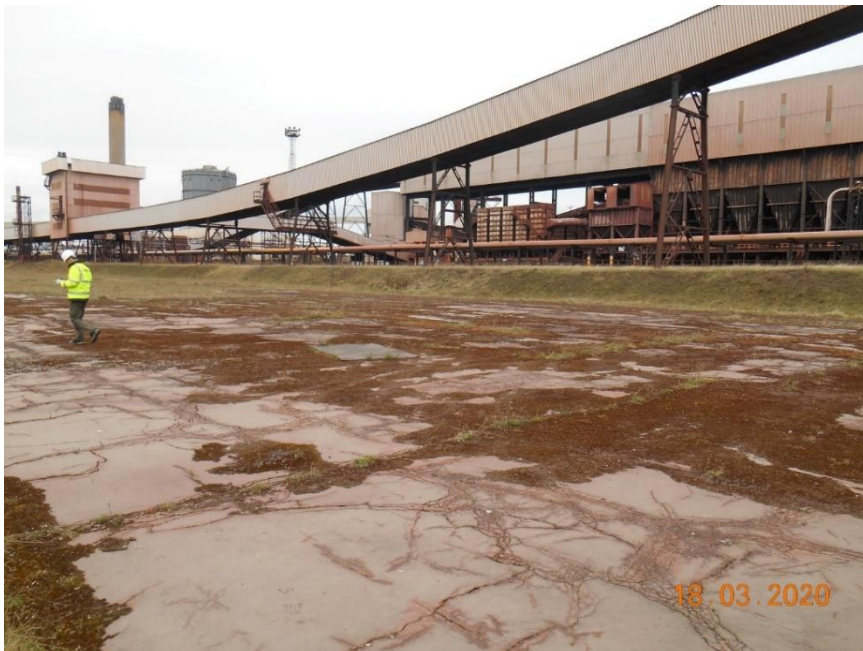
The north portion of this part of the Site is bounded by the Blast Furnace Stockhouse. An area of remnant hardstanding is present across this area, see Plate 22. It is understood that it was originally intended to construct three sinter plants across this area, however due to economic conditions and demand only one of these was constructed, with this relic hardstanding possibly associated with this.

Plate 22 – View looking north west showing area of remnant hardstanding and the Blast Furnace Stockhouse.

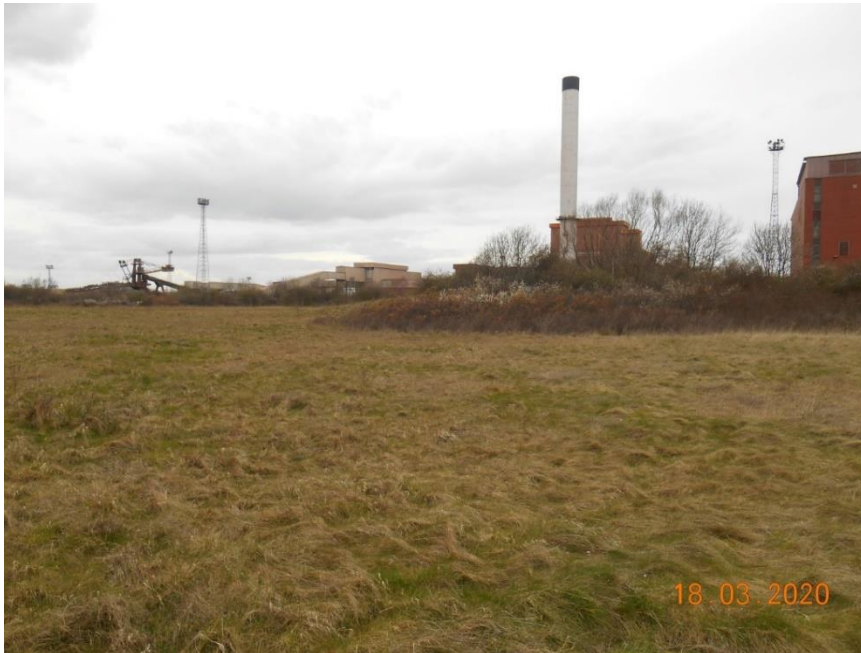
Land to the east of the STSC offices generally comprise areas of grassland and an area of remnant hardstanding. The south east corner of this part of the Site was historically occupied by a Pellet Plant demolished in the 1980s, see Plate 23.

Plate 23 – View looking south west. The Pellet Plant was located across the grassland shown on the left hand side of the photograph. There is no visible surface evidence of the former structure. The chimney stack shown in the background is associated with the Sinter Plant and is located adjacent to, but outside of, the Teesworks southern site boundary.

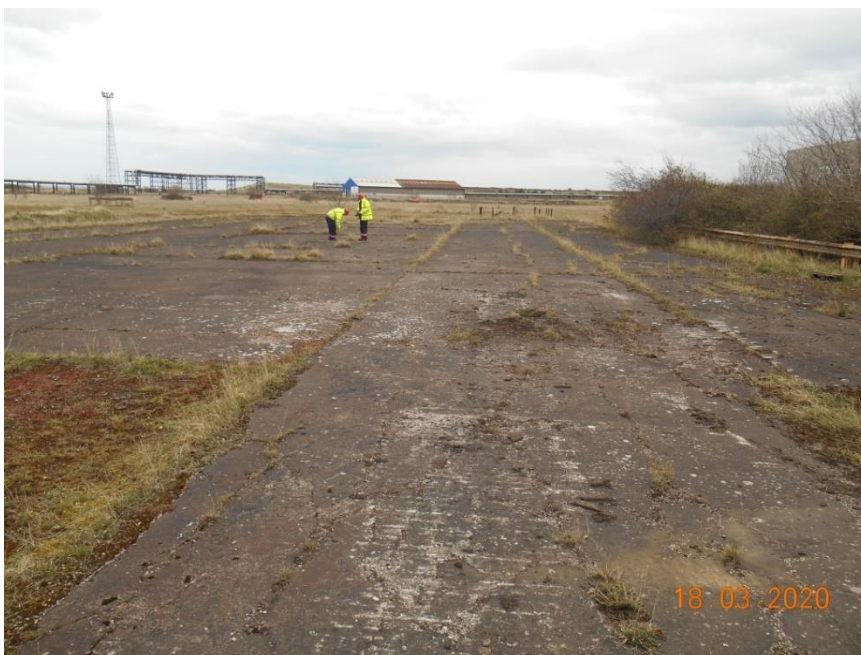
Plate 24 – View looking east southeast showing a hardstanding area. It was noted that the hardstanding surface is ‘wavy’ and cracked, again providing

evidence of heave inferred to have resulted from the presence of expansive slag materials below this area.

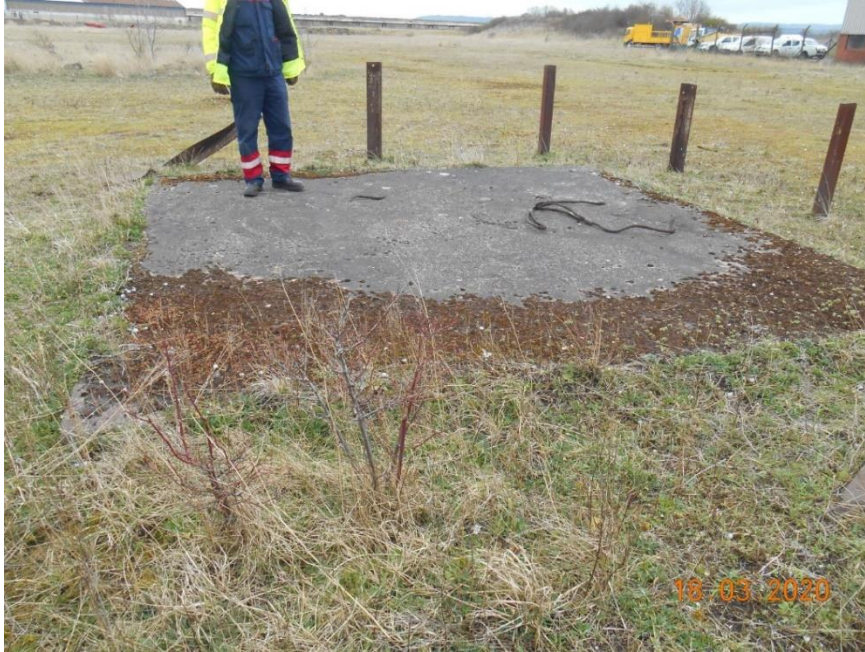
Further localised foundation bases were visible across this area, thought to be associated with former lighting columns, see Plate 25.

Plate 25 - View looking east southeast showing foundation base.

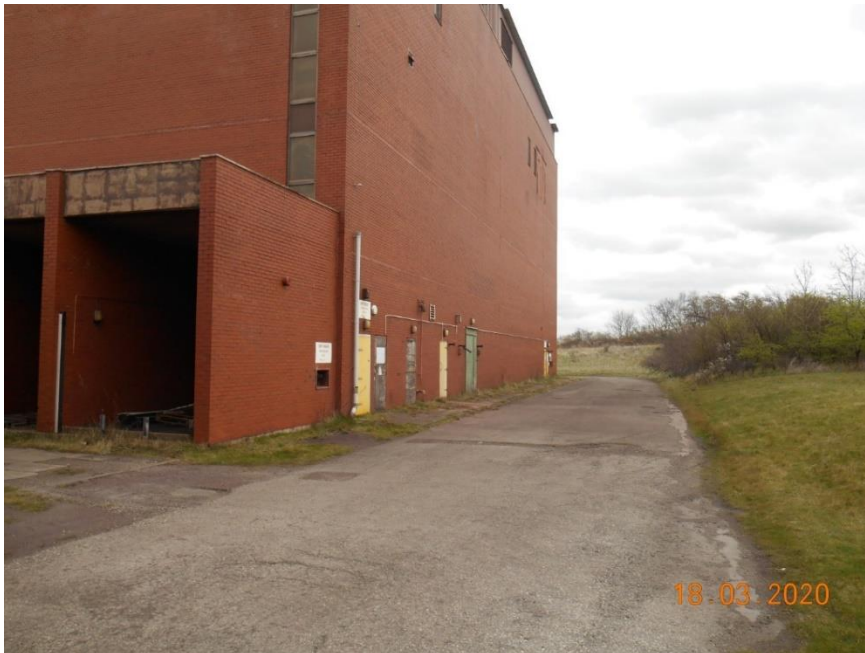
There are some large brick construction maintenance works present close to the south boundary of the Teesworks Site, see Plate 26.

Plate 26 – View looking east southeast showing a brick construction maintenance building.

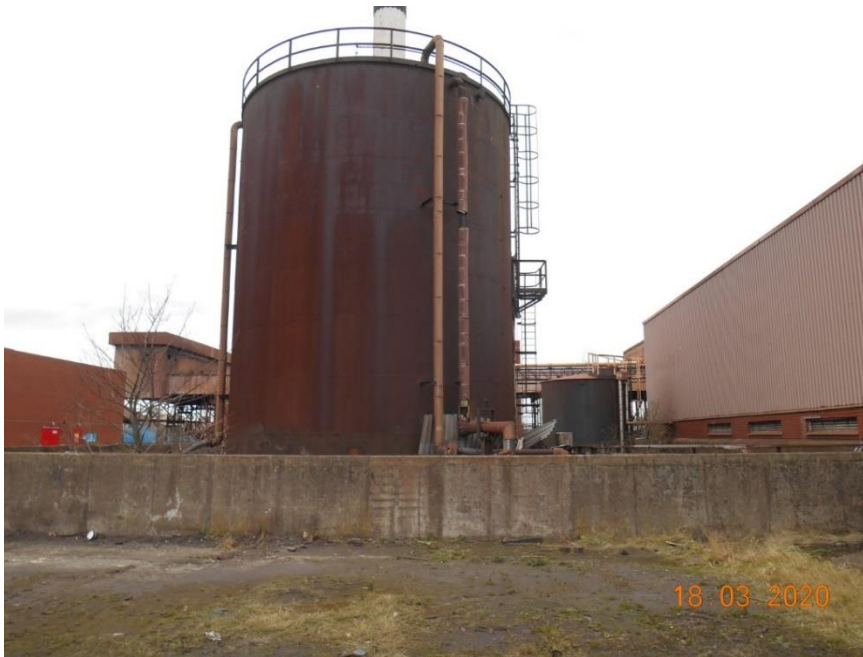
located adjacent to, but outside of the proposed south boundary of the Teesworks Site. The tank is located within a concrete bund which appeared to be of sound construction. The site representative from STSC confirmed that the tank was removed from service prior to SSI purchase of the site but was not fully emptied. It was noted that pipe cladding insulation materials were fibrous in nature and may represent an asbestos risk, see Plate 28. This would need to be established through testing although it is noted that the tanks will most likely be demolished as part of the STSC site clearance works.

Plate 27 – View looking west northwest showing diesel tank and surrounding concrete bund wall.

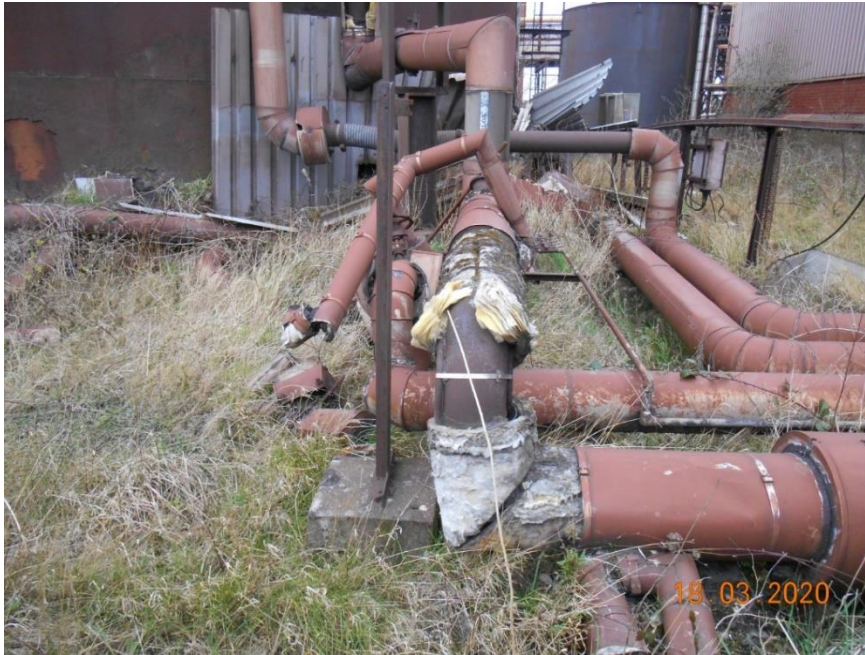
Plate 28 – Diesel tank connections and fibrous pipe lagging.
