Site Condition Report

Substantial Permit Variation

Project No.: SOL_26_P042_FUJ

Document Details	
Document title	Site Condition Report
Document subtitle	Substantial Permit Variation
Project No.	SOL_26_P042_FUJ
Date	31 st March 2026
Version	QMS_7.5.38_TEM – Template – Report Long Form – New Style (Perm) v3
Author	Michael Sylvester, Steve Butler
Client Name	Fujifilm Diosynth Biotechnologies UK Limited

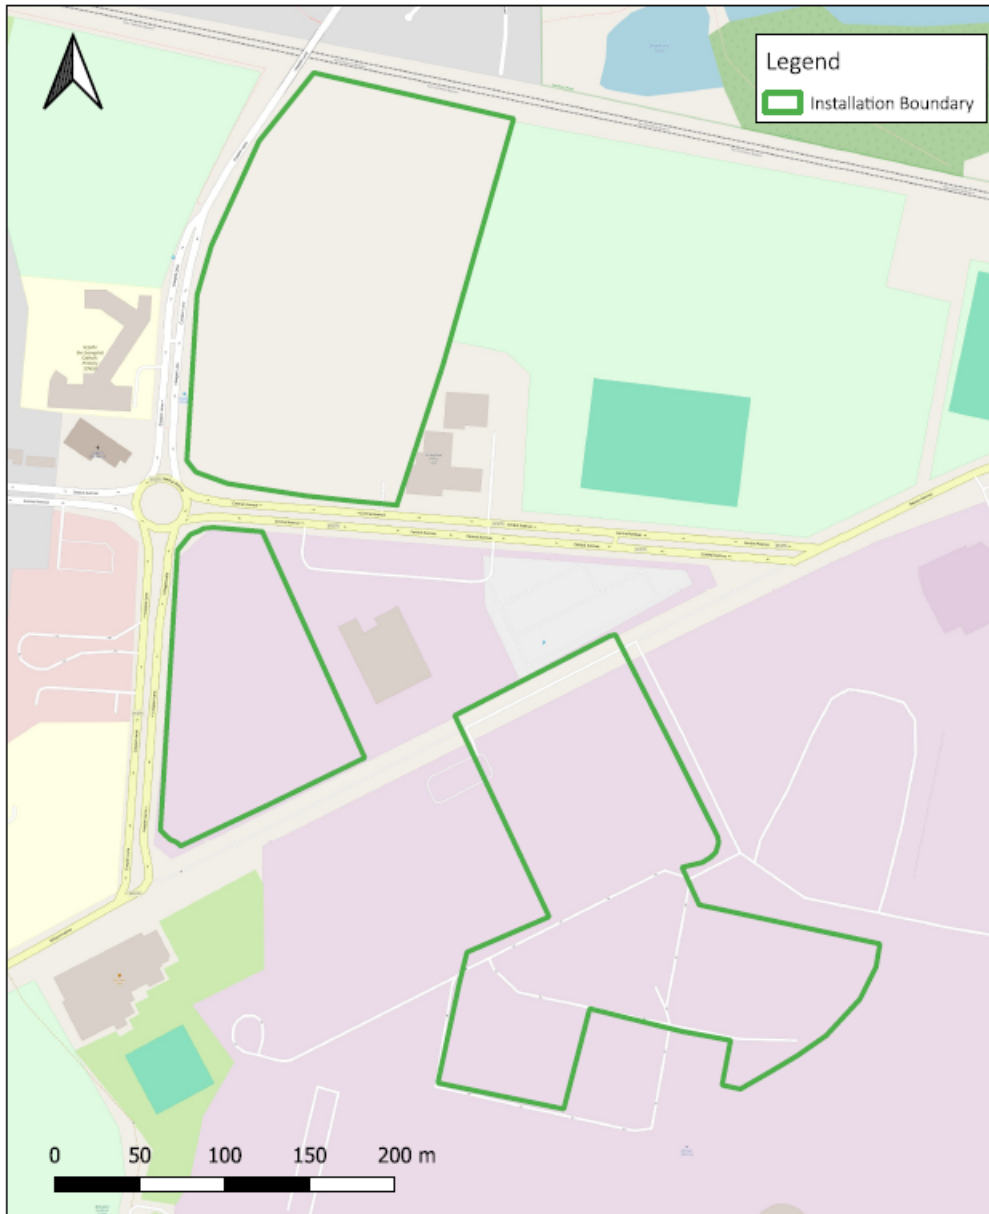
Figure 1-1 –Proposed Permit Boundary

The proposed variation application requires additional land and therefore changes the permitted installation boundary i.e. needs to be extended to include Borealis and BIC-UK (**Figure 1-1**).

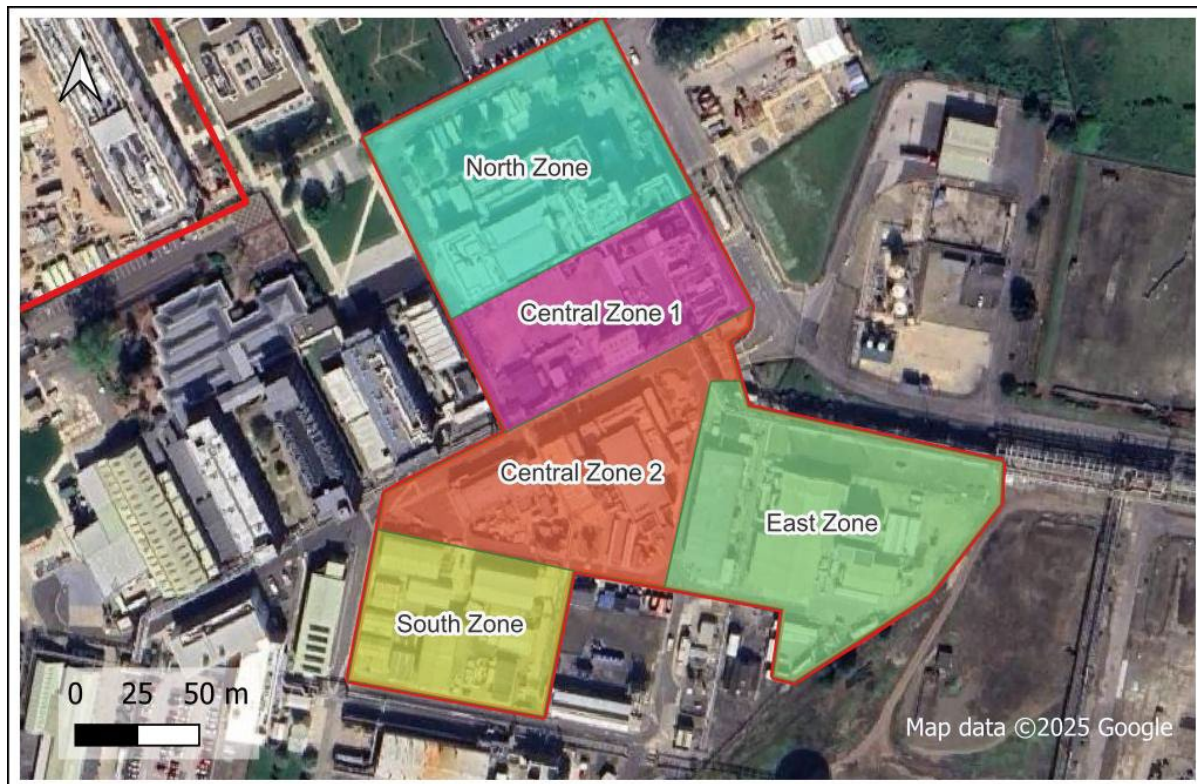
Figure 3-7 – Historical Site Zoning

For this report, the recent history of the Chilton Site has been divided into five zones (Figure 3-7).

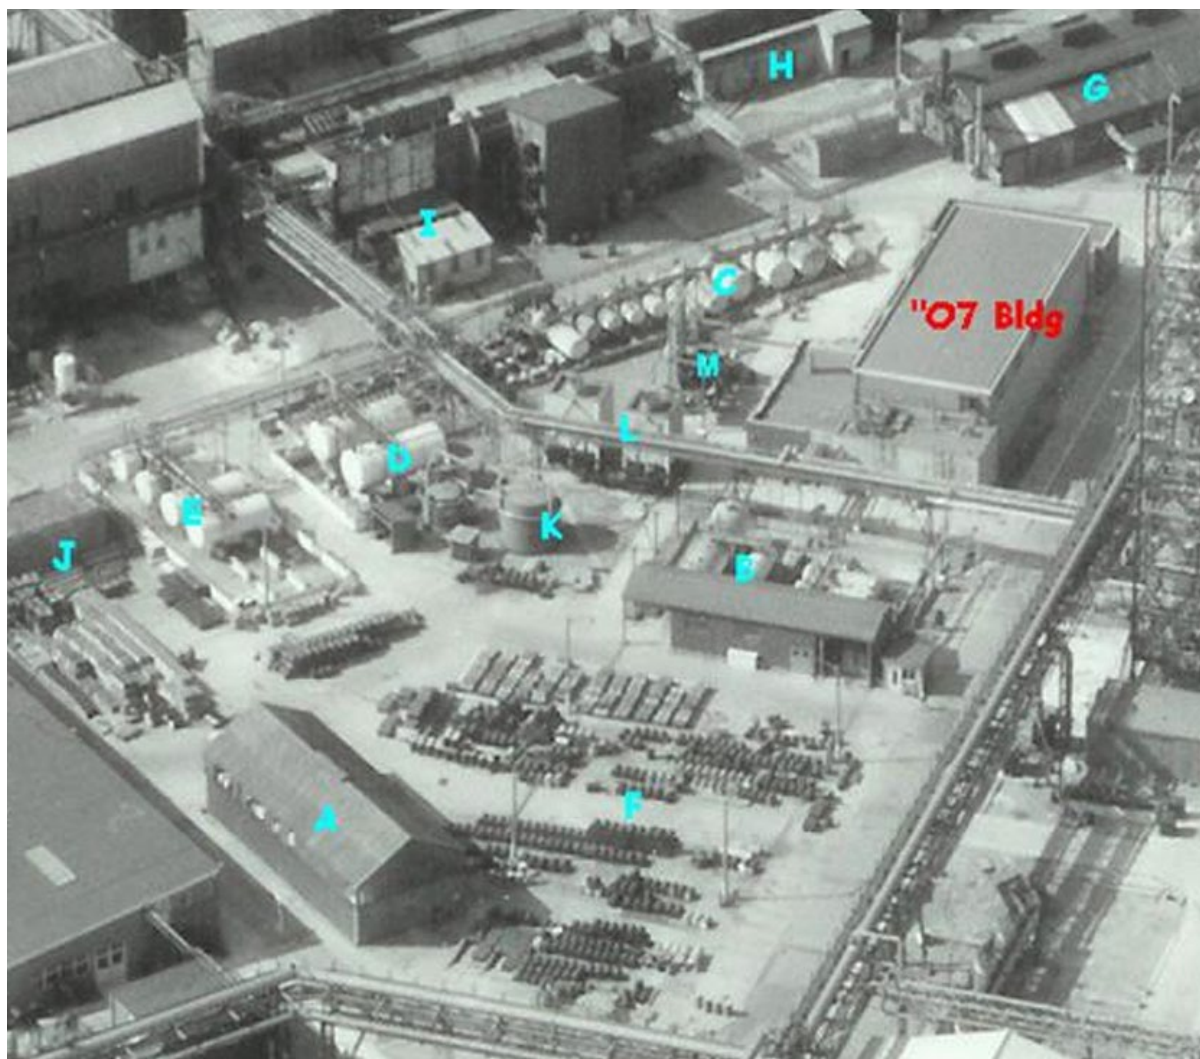
Figure 3-8 – Central Zone (2), circa 1972

The buildings and areas identified in **Figure 3-8** are summarised in **Table 3-4**.
