Phase 2: Site Investigation

Fujifilm Synthonia Site, Billingham

PHASE 2 SITE INVESTIGATION REPORT

FUJIFILM SYNTHONIA SITE, BILLINGHAM

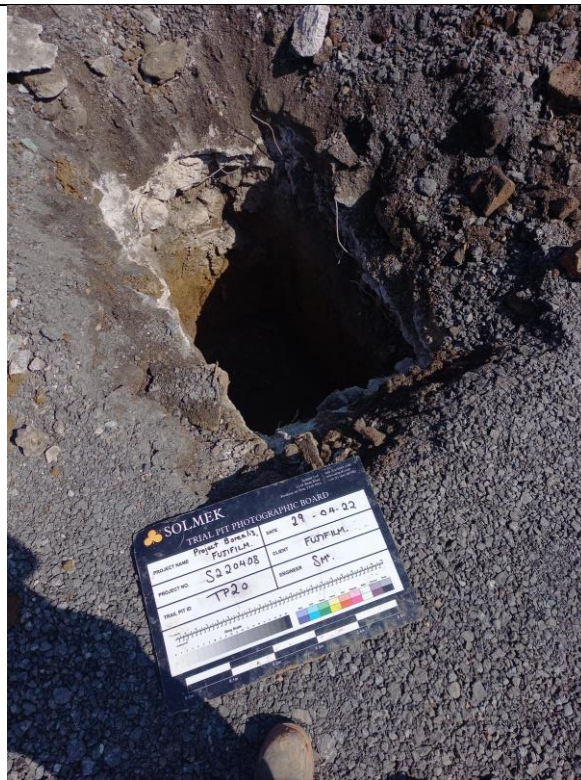
Figure 31: TP20.

Soluble sulphates (potentially aggressive to foundation concrete) were recorded between <10 and 1700mg/l. None of the samples were elevated above levels affecting human health, however two samples (TP02 & TP20) exceeded the BRE Special Digest 1 500mg/l limit for the sulphate classification of concrete.

The levels of contaminants across the site are generally low with exceedances noted within just one of the 20no samples, for dibenz(ah)anthracene within TP20 (0.20-0.30m).

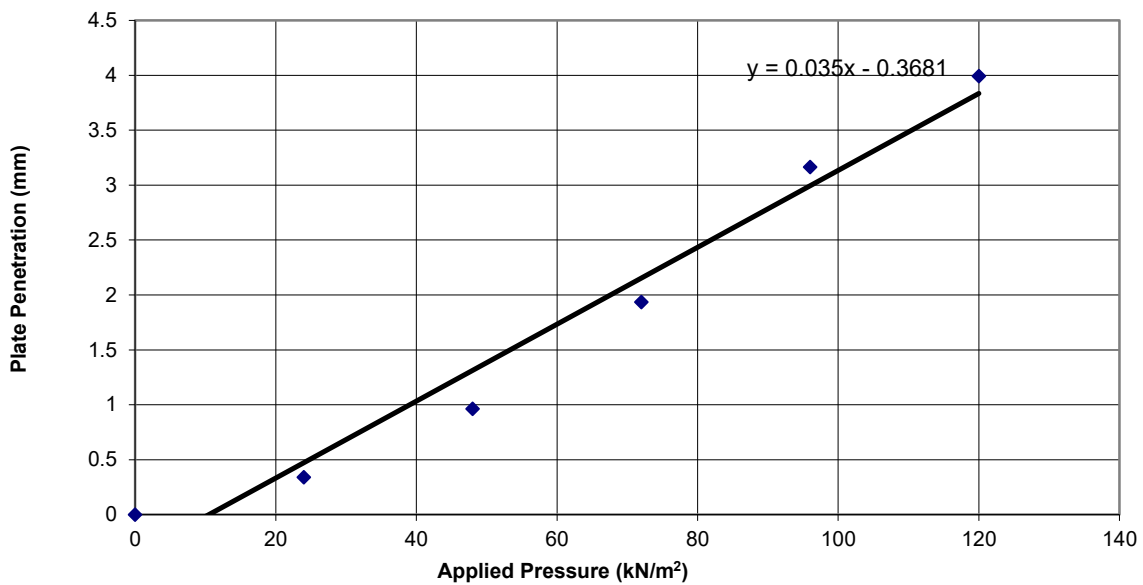
PLATE BEARING TEST		Date:	10/05/2022
Project Number:	S220408	Test No:	PBT11 TP11
Project Name:	Project Borealis, Fujifilm	Test Level:	0.30mbgl
Test Method: BS 1377 : Part 9 : 1990 (Incremental Method)		Weather:	Warm and Clear
Plate Diameter:	0.455 m	Load Applied:	120 kPa
Kentledge Type:	8.5T JCB 3CX	Remarks:	Firm light brown CLAY

Pressure (kN/m ²)	Plate Penetration (mm)
Initial	0	0
Stage 1	24	0.34
Stage 2	48	0.97
Stage 3	72	1.94
Stage 4	96	3.17
Stage 5	120	4.00
Stage 6		
Stage 7		
Stage 8
