Phase 2: Site Investigation

MF6 Building, Fujifilm

PHASE 2 SITE INVESTIGATION REPORT

MF6 BUILDING, FUJIFILM

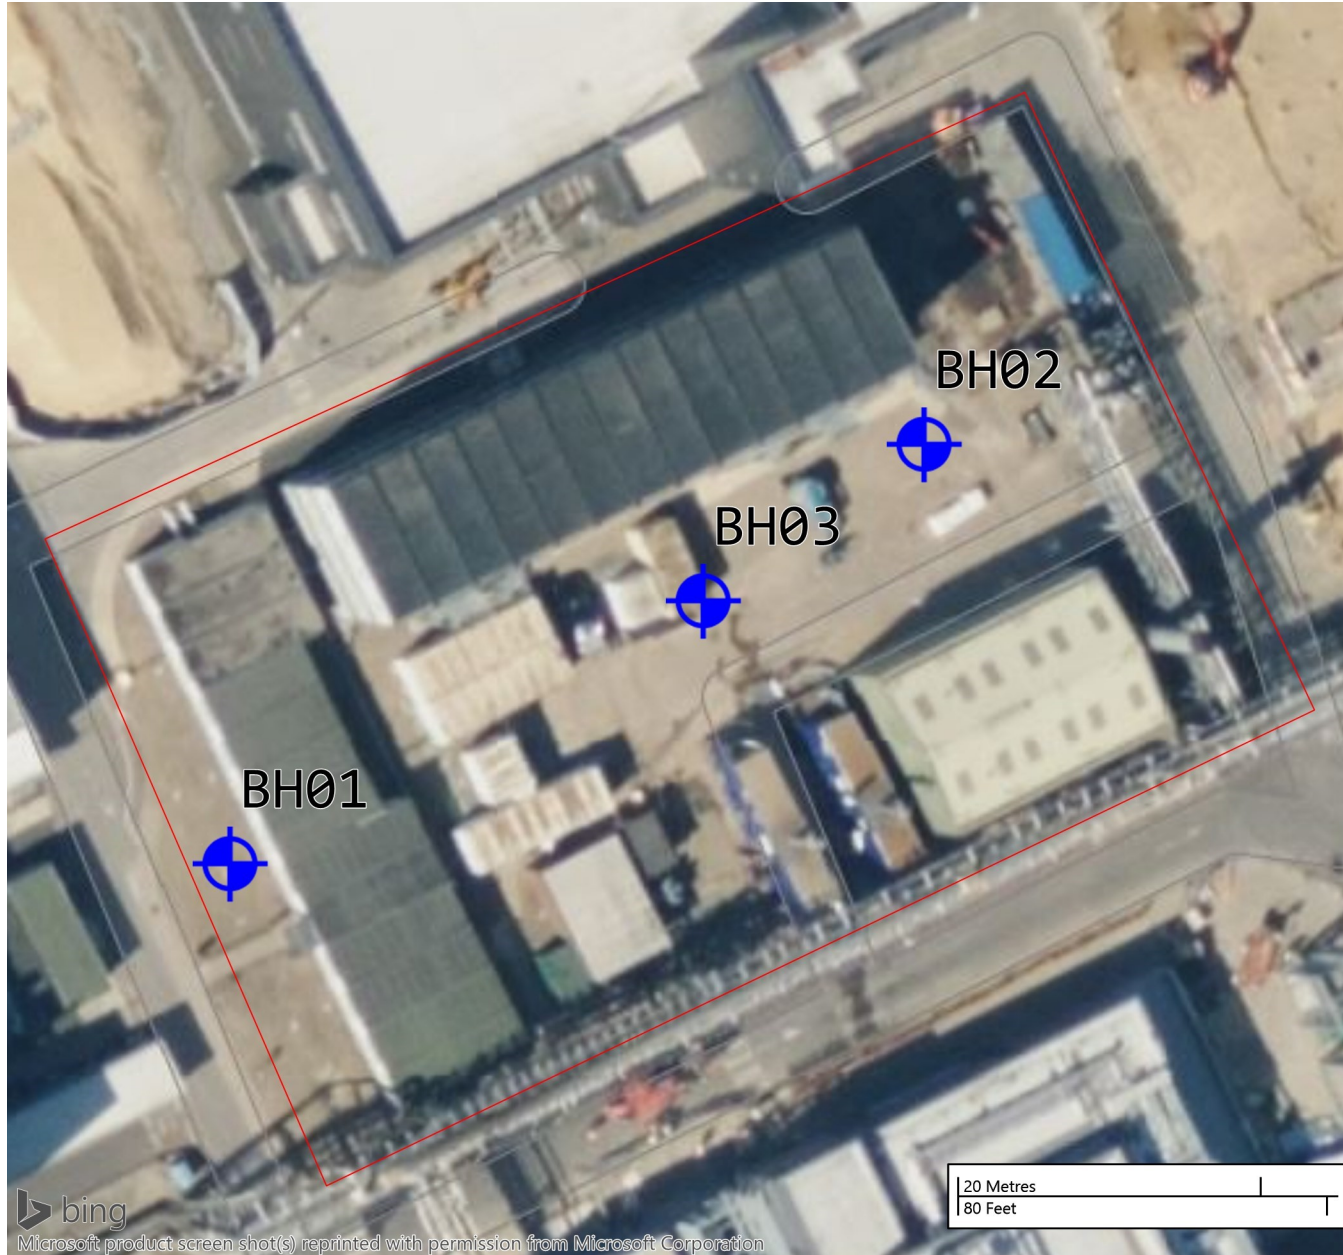
Descriptions of the strata encountered in the boreholes together with details of sampling and groundwater are presented in Appendix B of this report. A plan showing the location of the boreholes can be found in Appendix A (Figure 2).
