Geo-Environmental and Geotechnical Ground Investigation Report – Tees Valley ERF Site

Grangetown Prairie, Redcar, TS10 5QW

27/11/2020

Tees Valley EfW

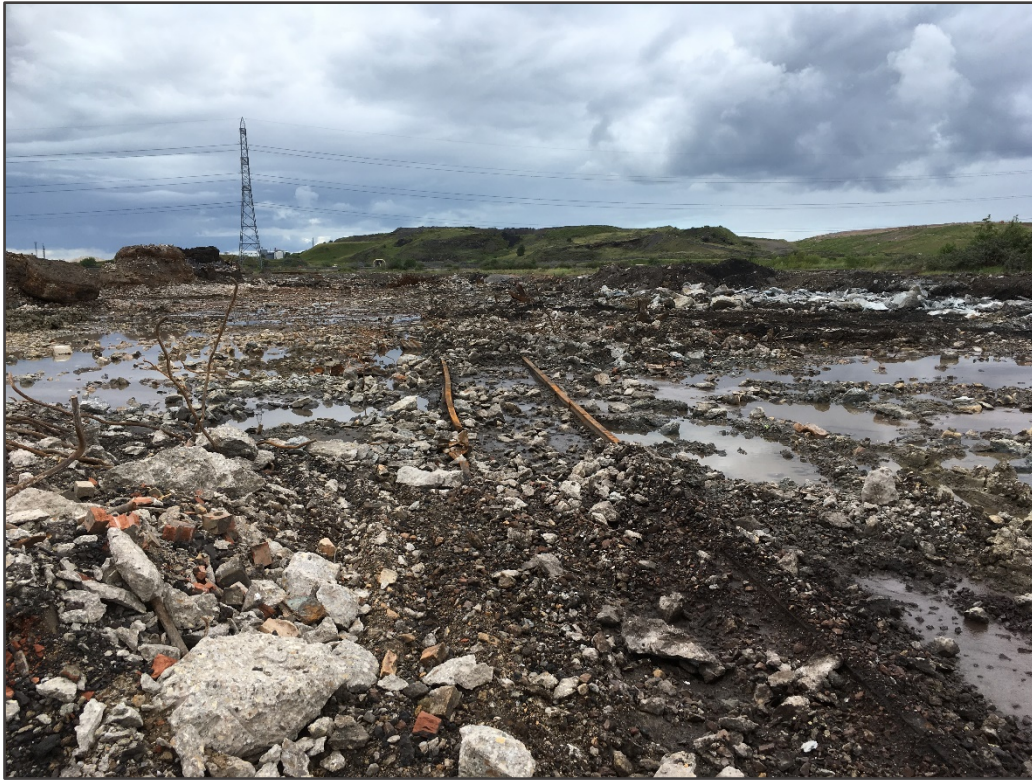
Slide 1: View looking north, taken from around the centre-southwest of the site. The photograph shows a particularly significant area of excavated material, exposing previous structures lying below the previous ground level. An old tram line, as well as large blast furnace foundations can be noted in this location.

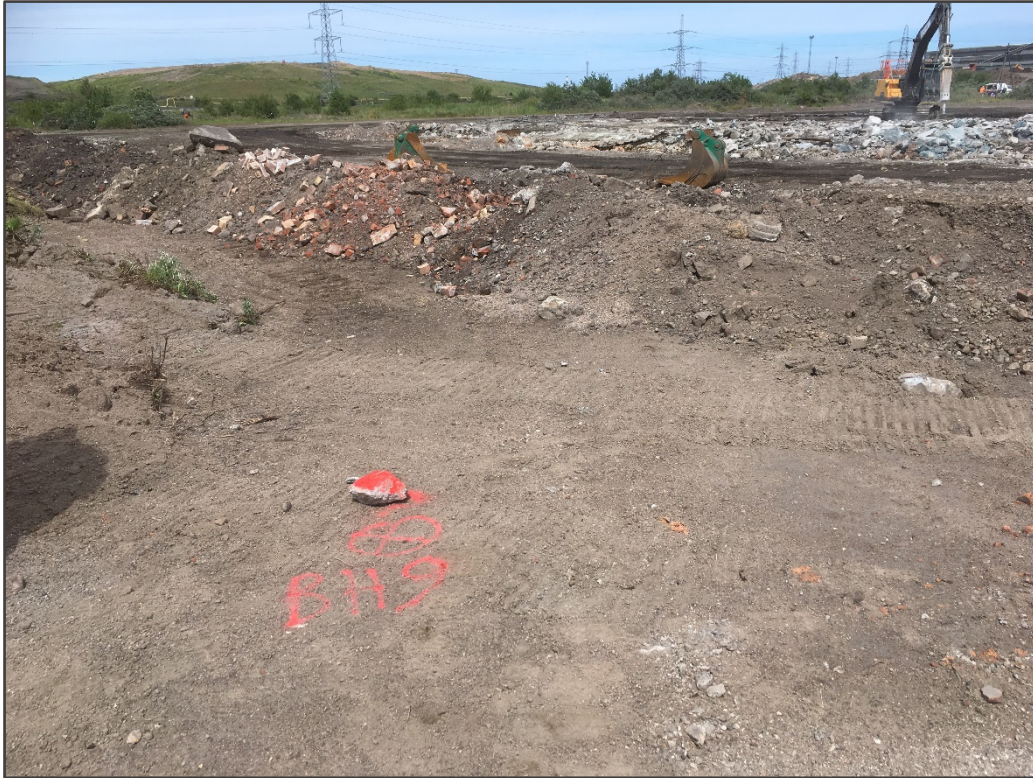
Slide 2: View looking northeast, taken from the original location of BH9. The photograph shows the demolition of large underground concrete structures in the upper right hand corner, with aforementioned areas of vegetation beyond.

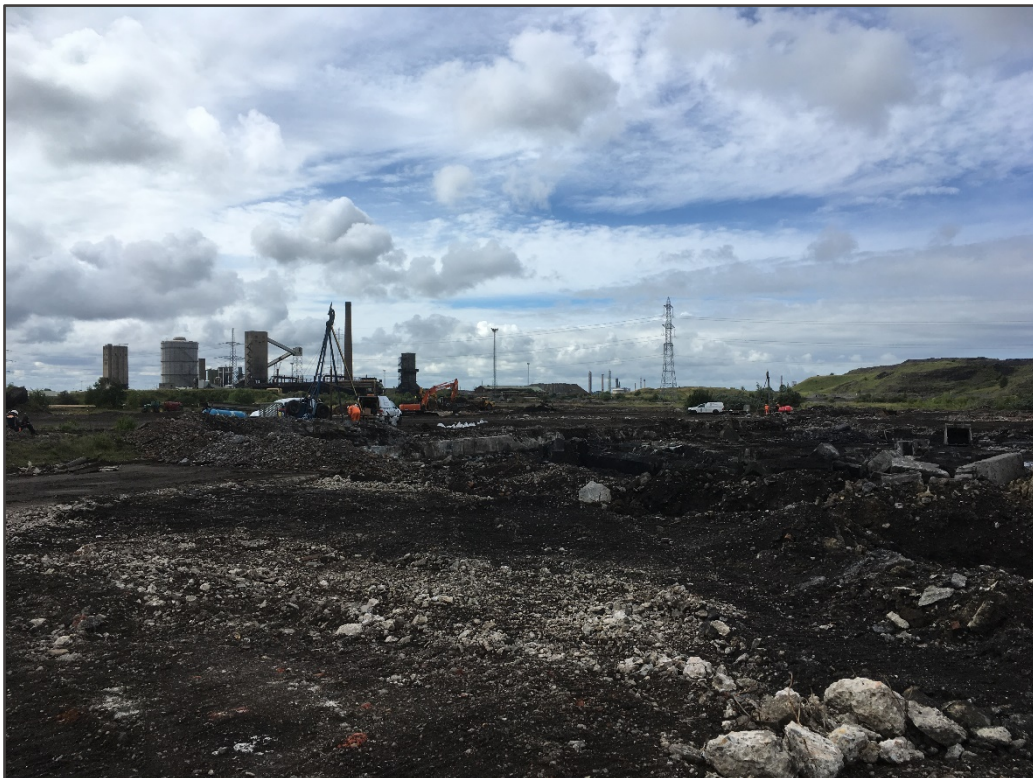
Slide 3: View looking northwest from the southeast of the site. The photograph shows a large excavation in the centre-south of the site, as well as drilling of BH12 (left of the photograph) and BH9 (right of the photograph).

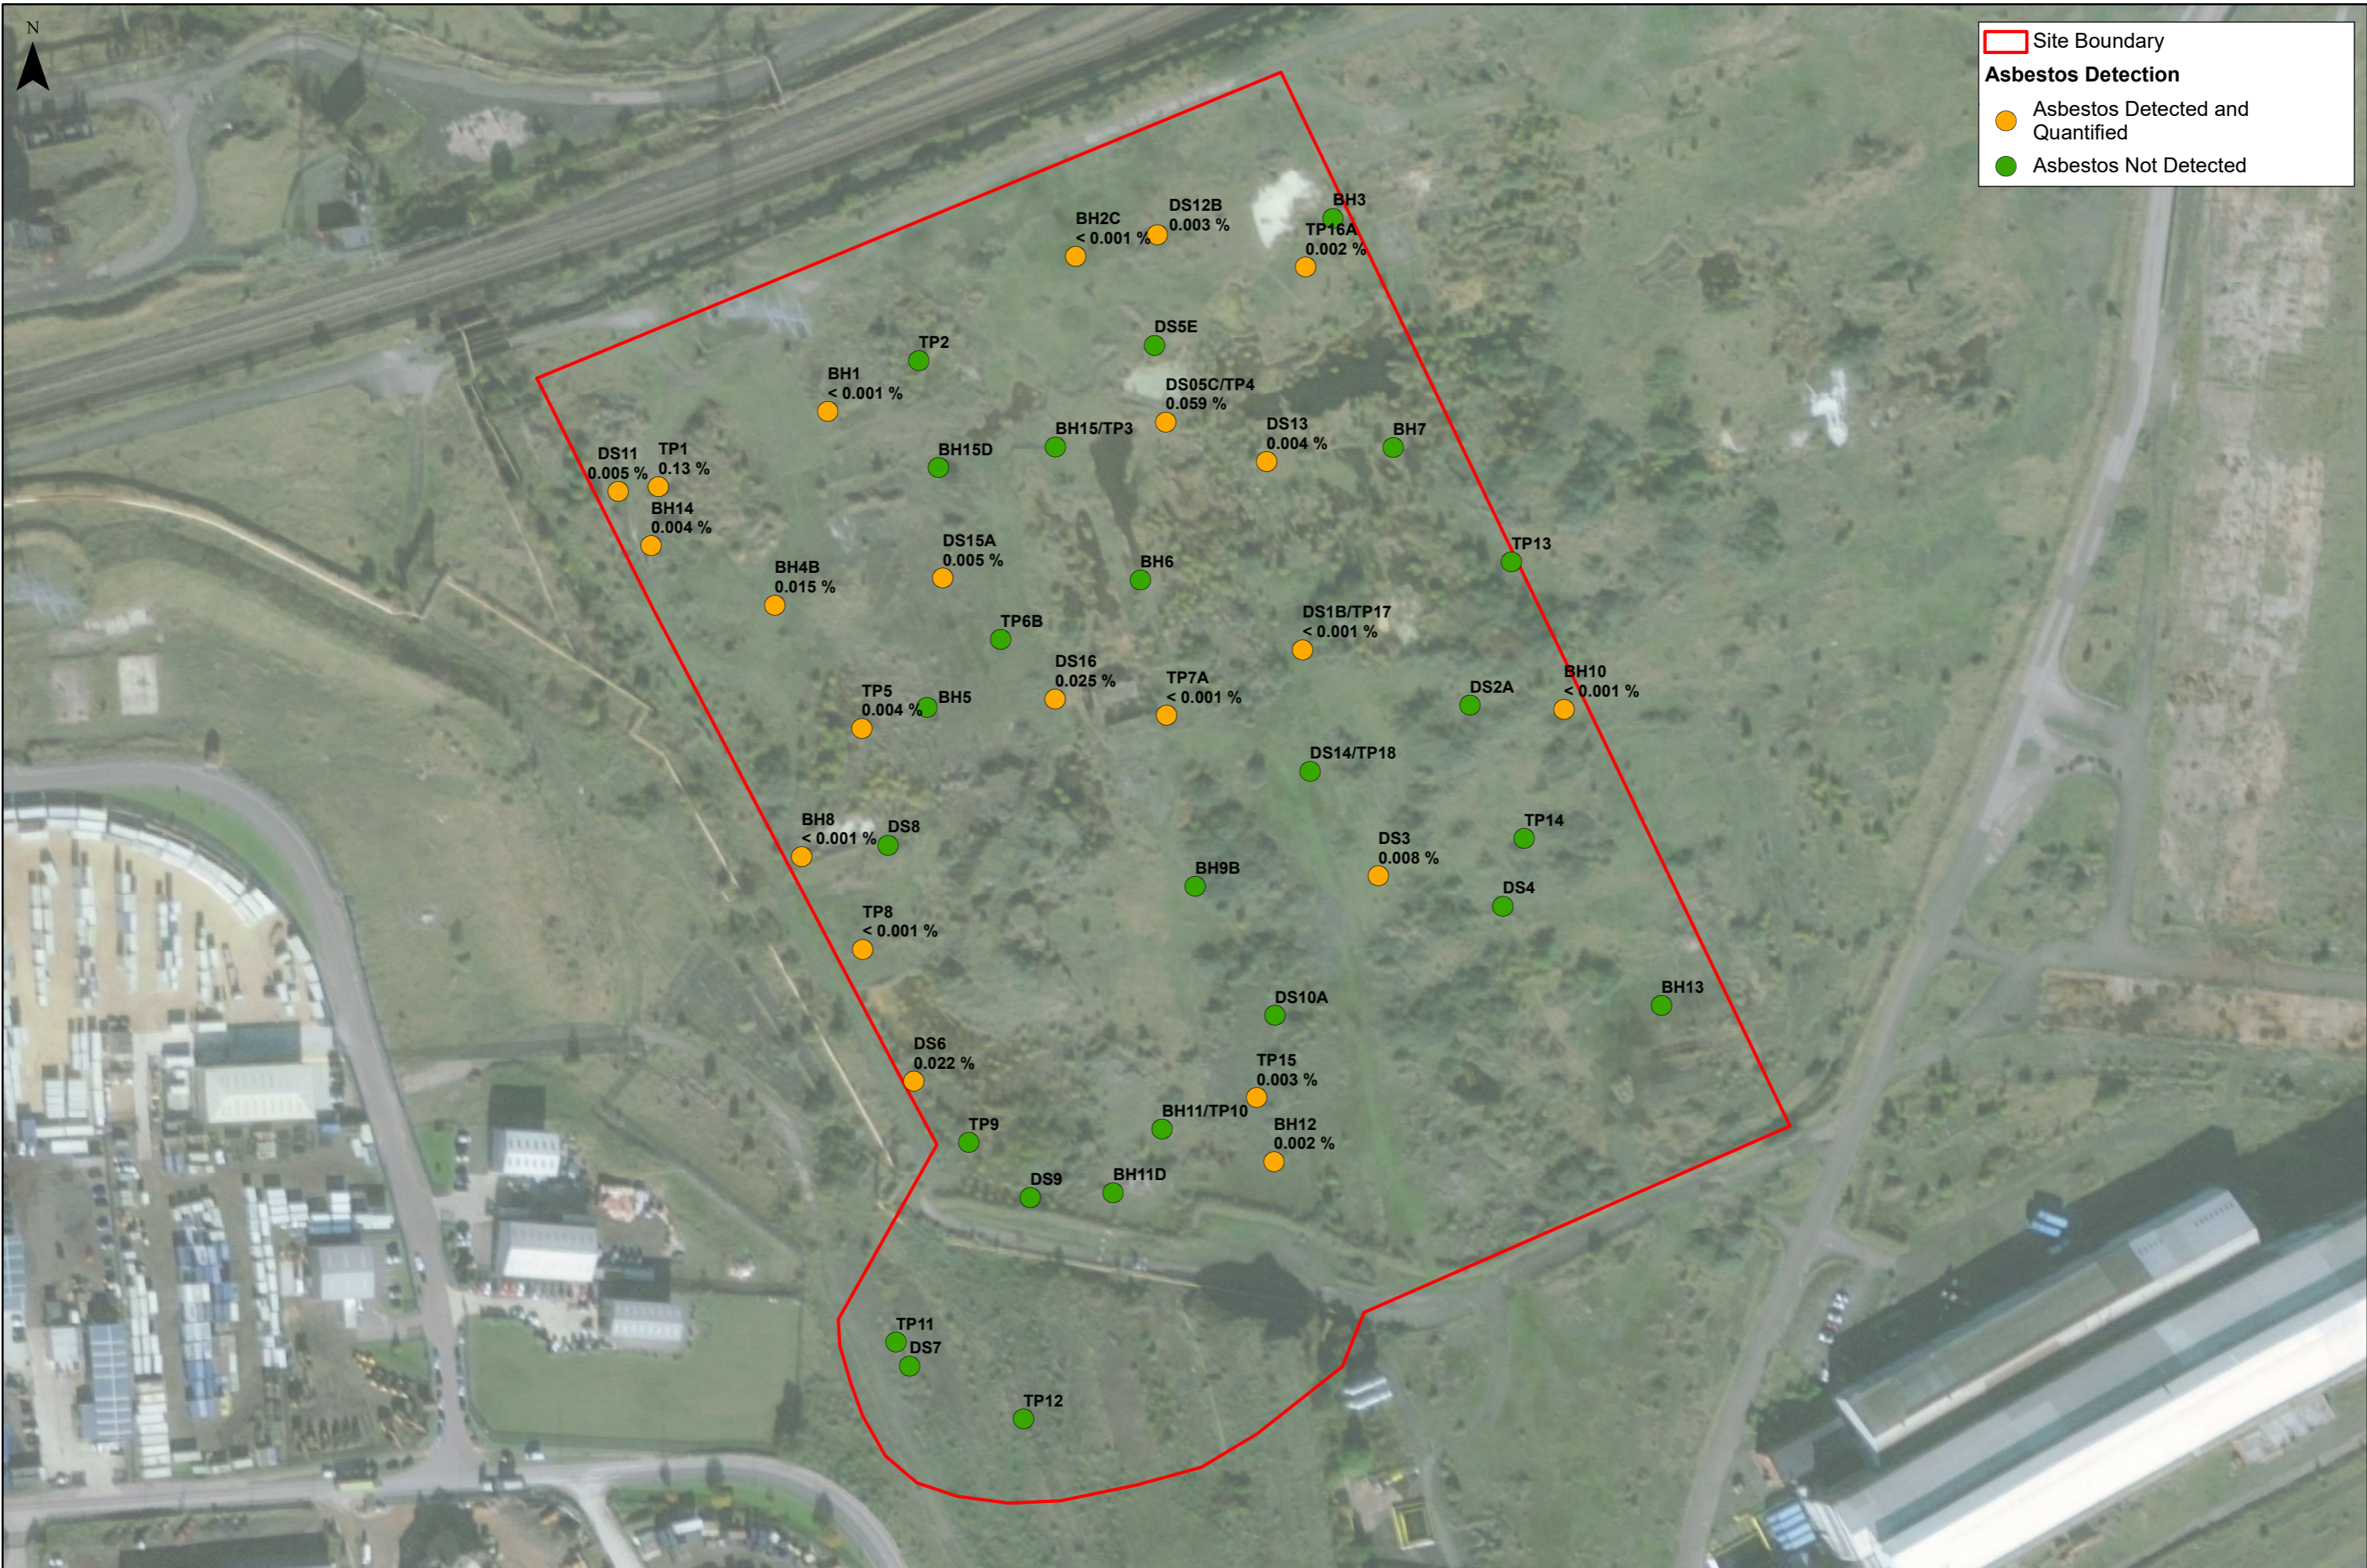
Figure 3 - Asbestos Detection – Made Ground

Tees Valley ERF Site
Soil Sample Survey Results
Asbestos Detection - Made Ground

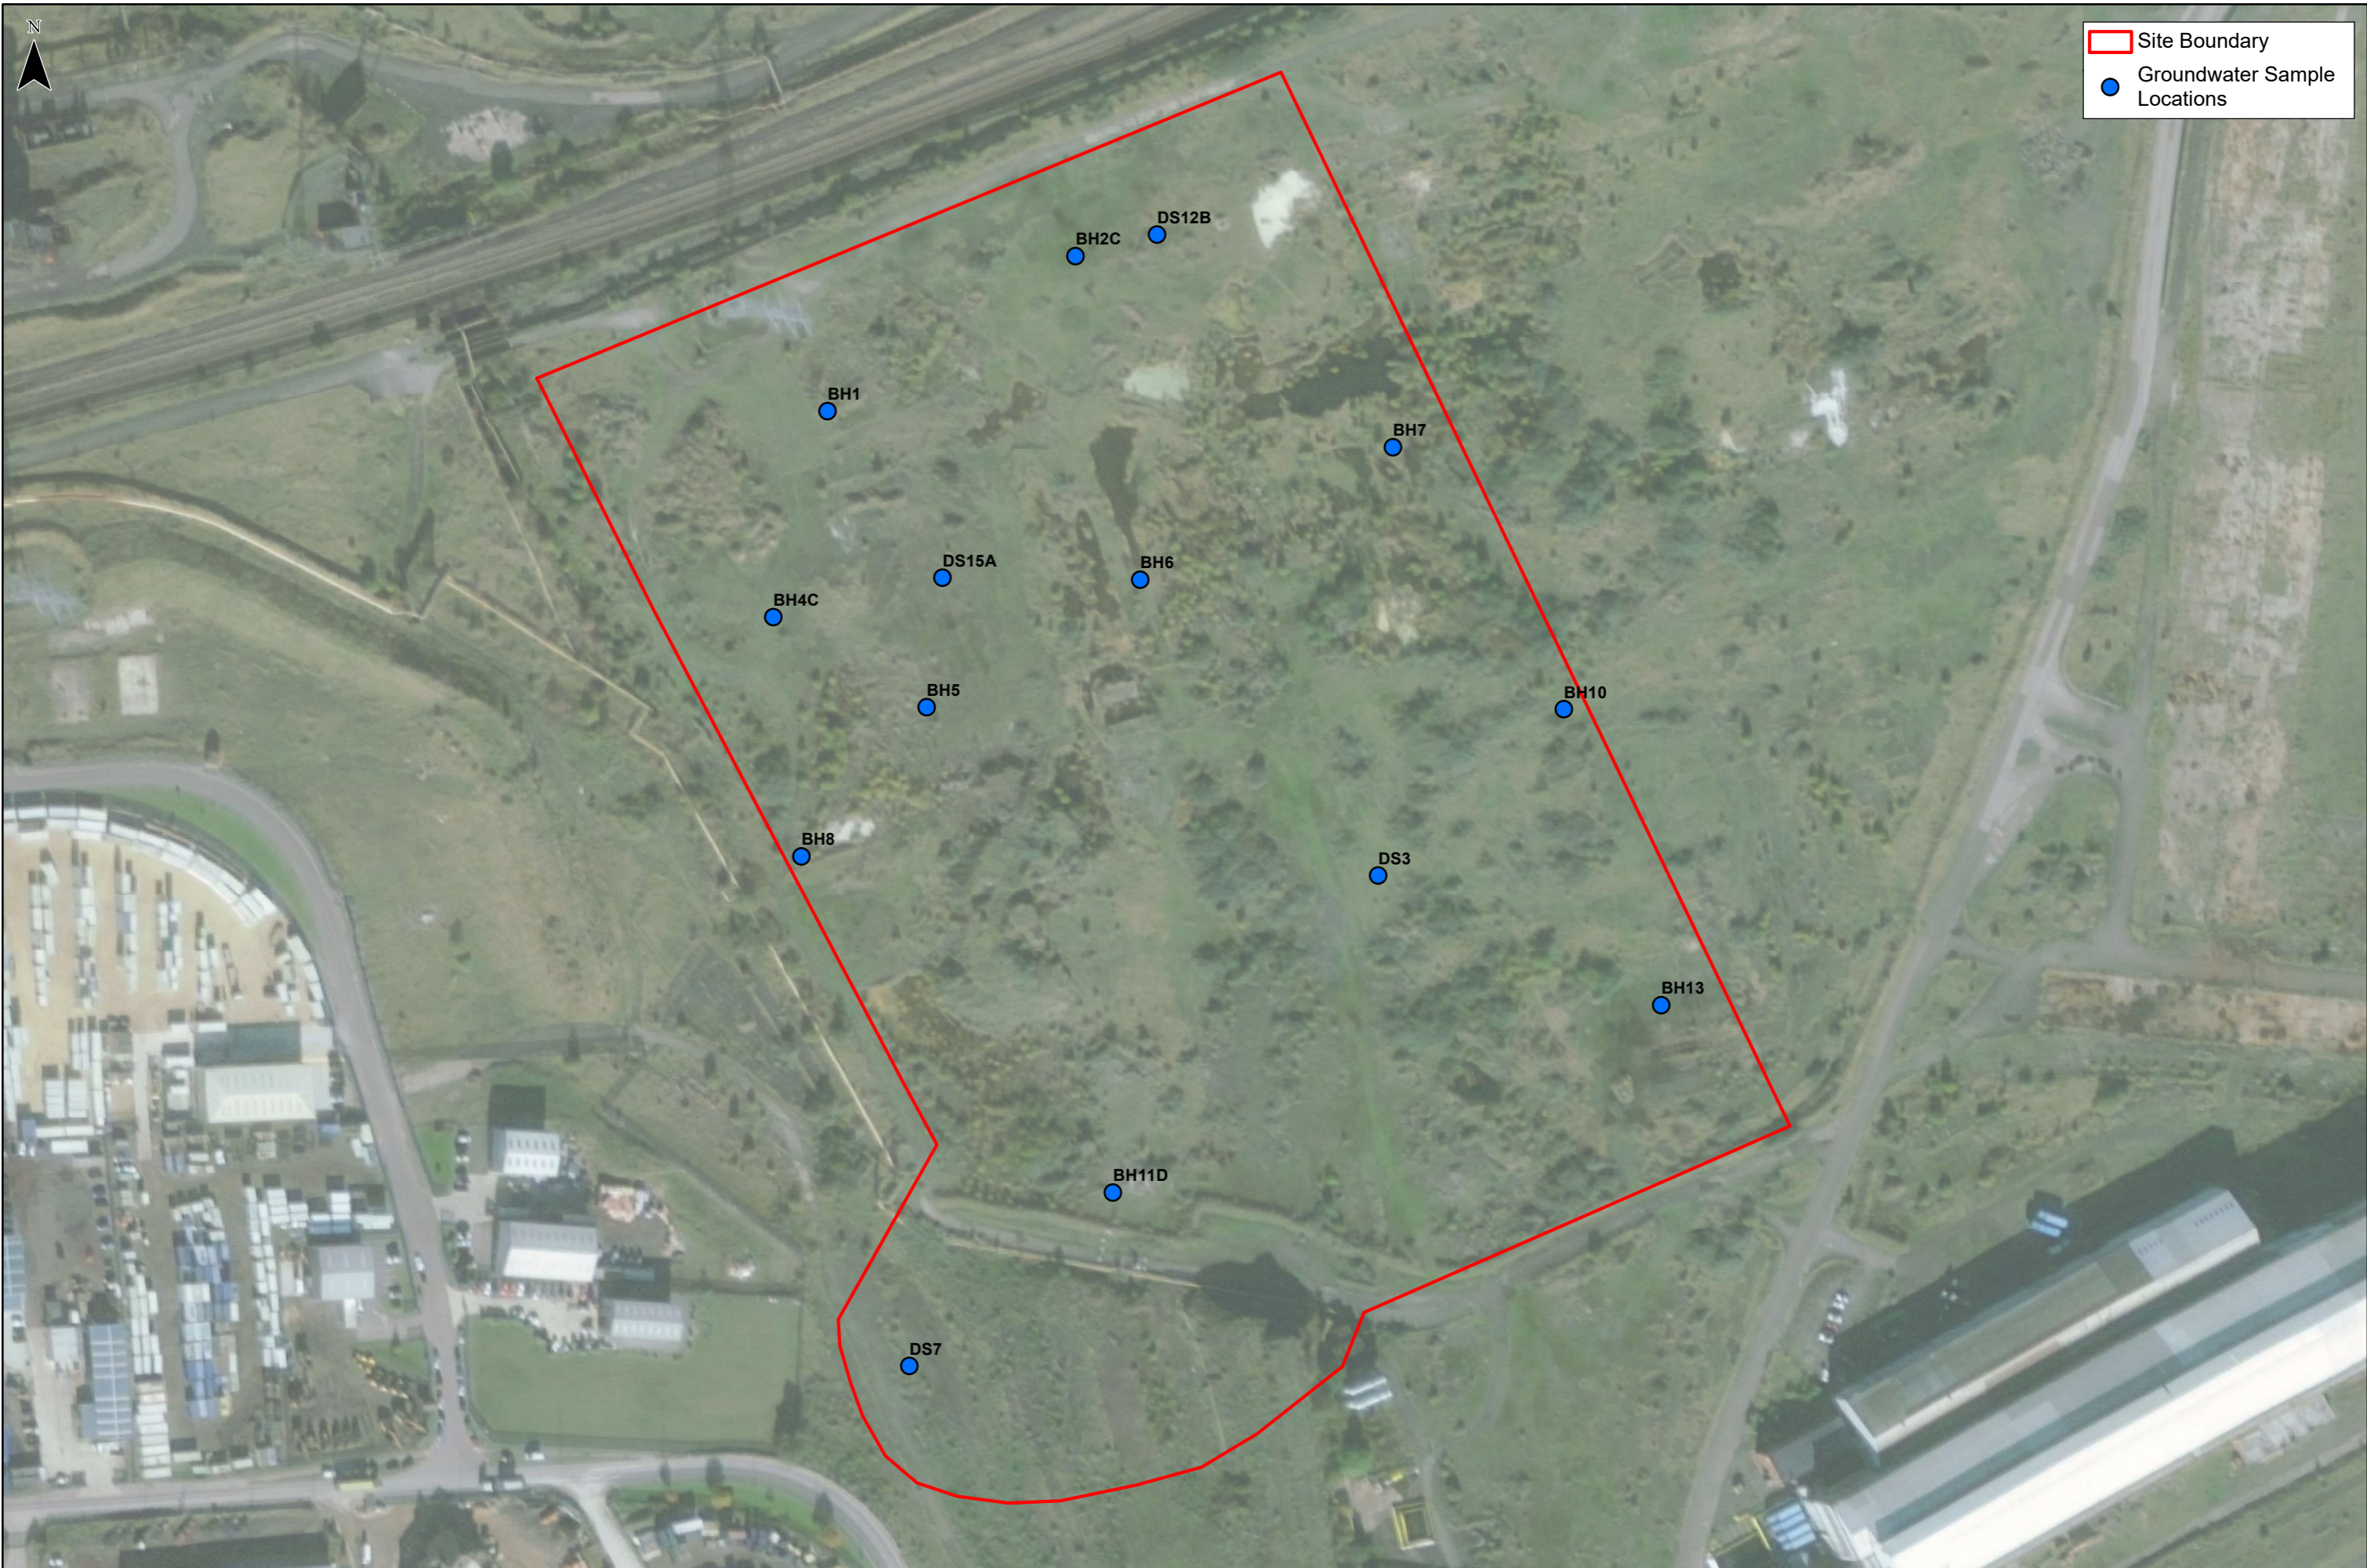
Figure 4 - Groundwater Sample Locations

- Fourteen (14) groundwater samples were retrieved during the post-works groundwater monitoring round on 8th September (see Section 5.2.2 for further details), using a low-flow peristaltic pump. The sampling was undertaken at depths close to the natural groundwater inlet within the well in order to provide an accurate representation of the groundwater. Groundwater monitoring locations can be found in Figure 4.

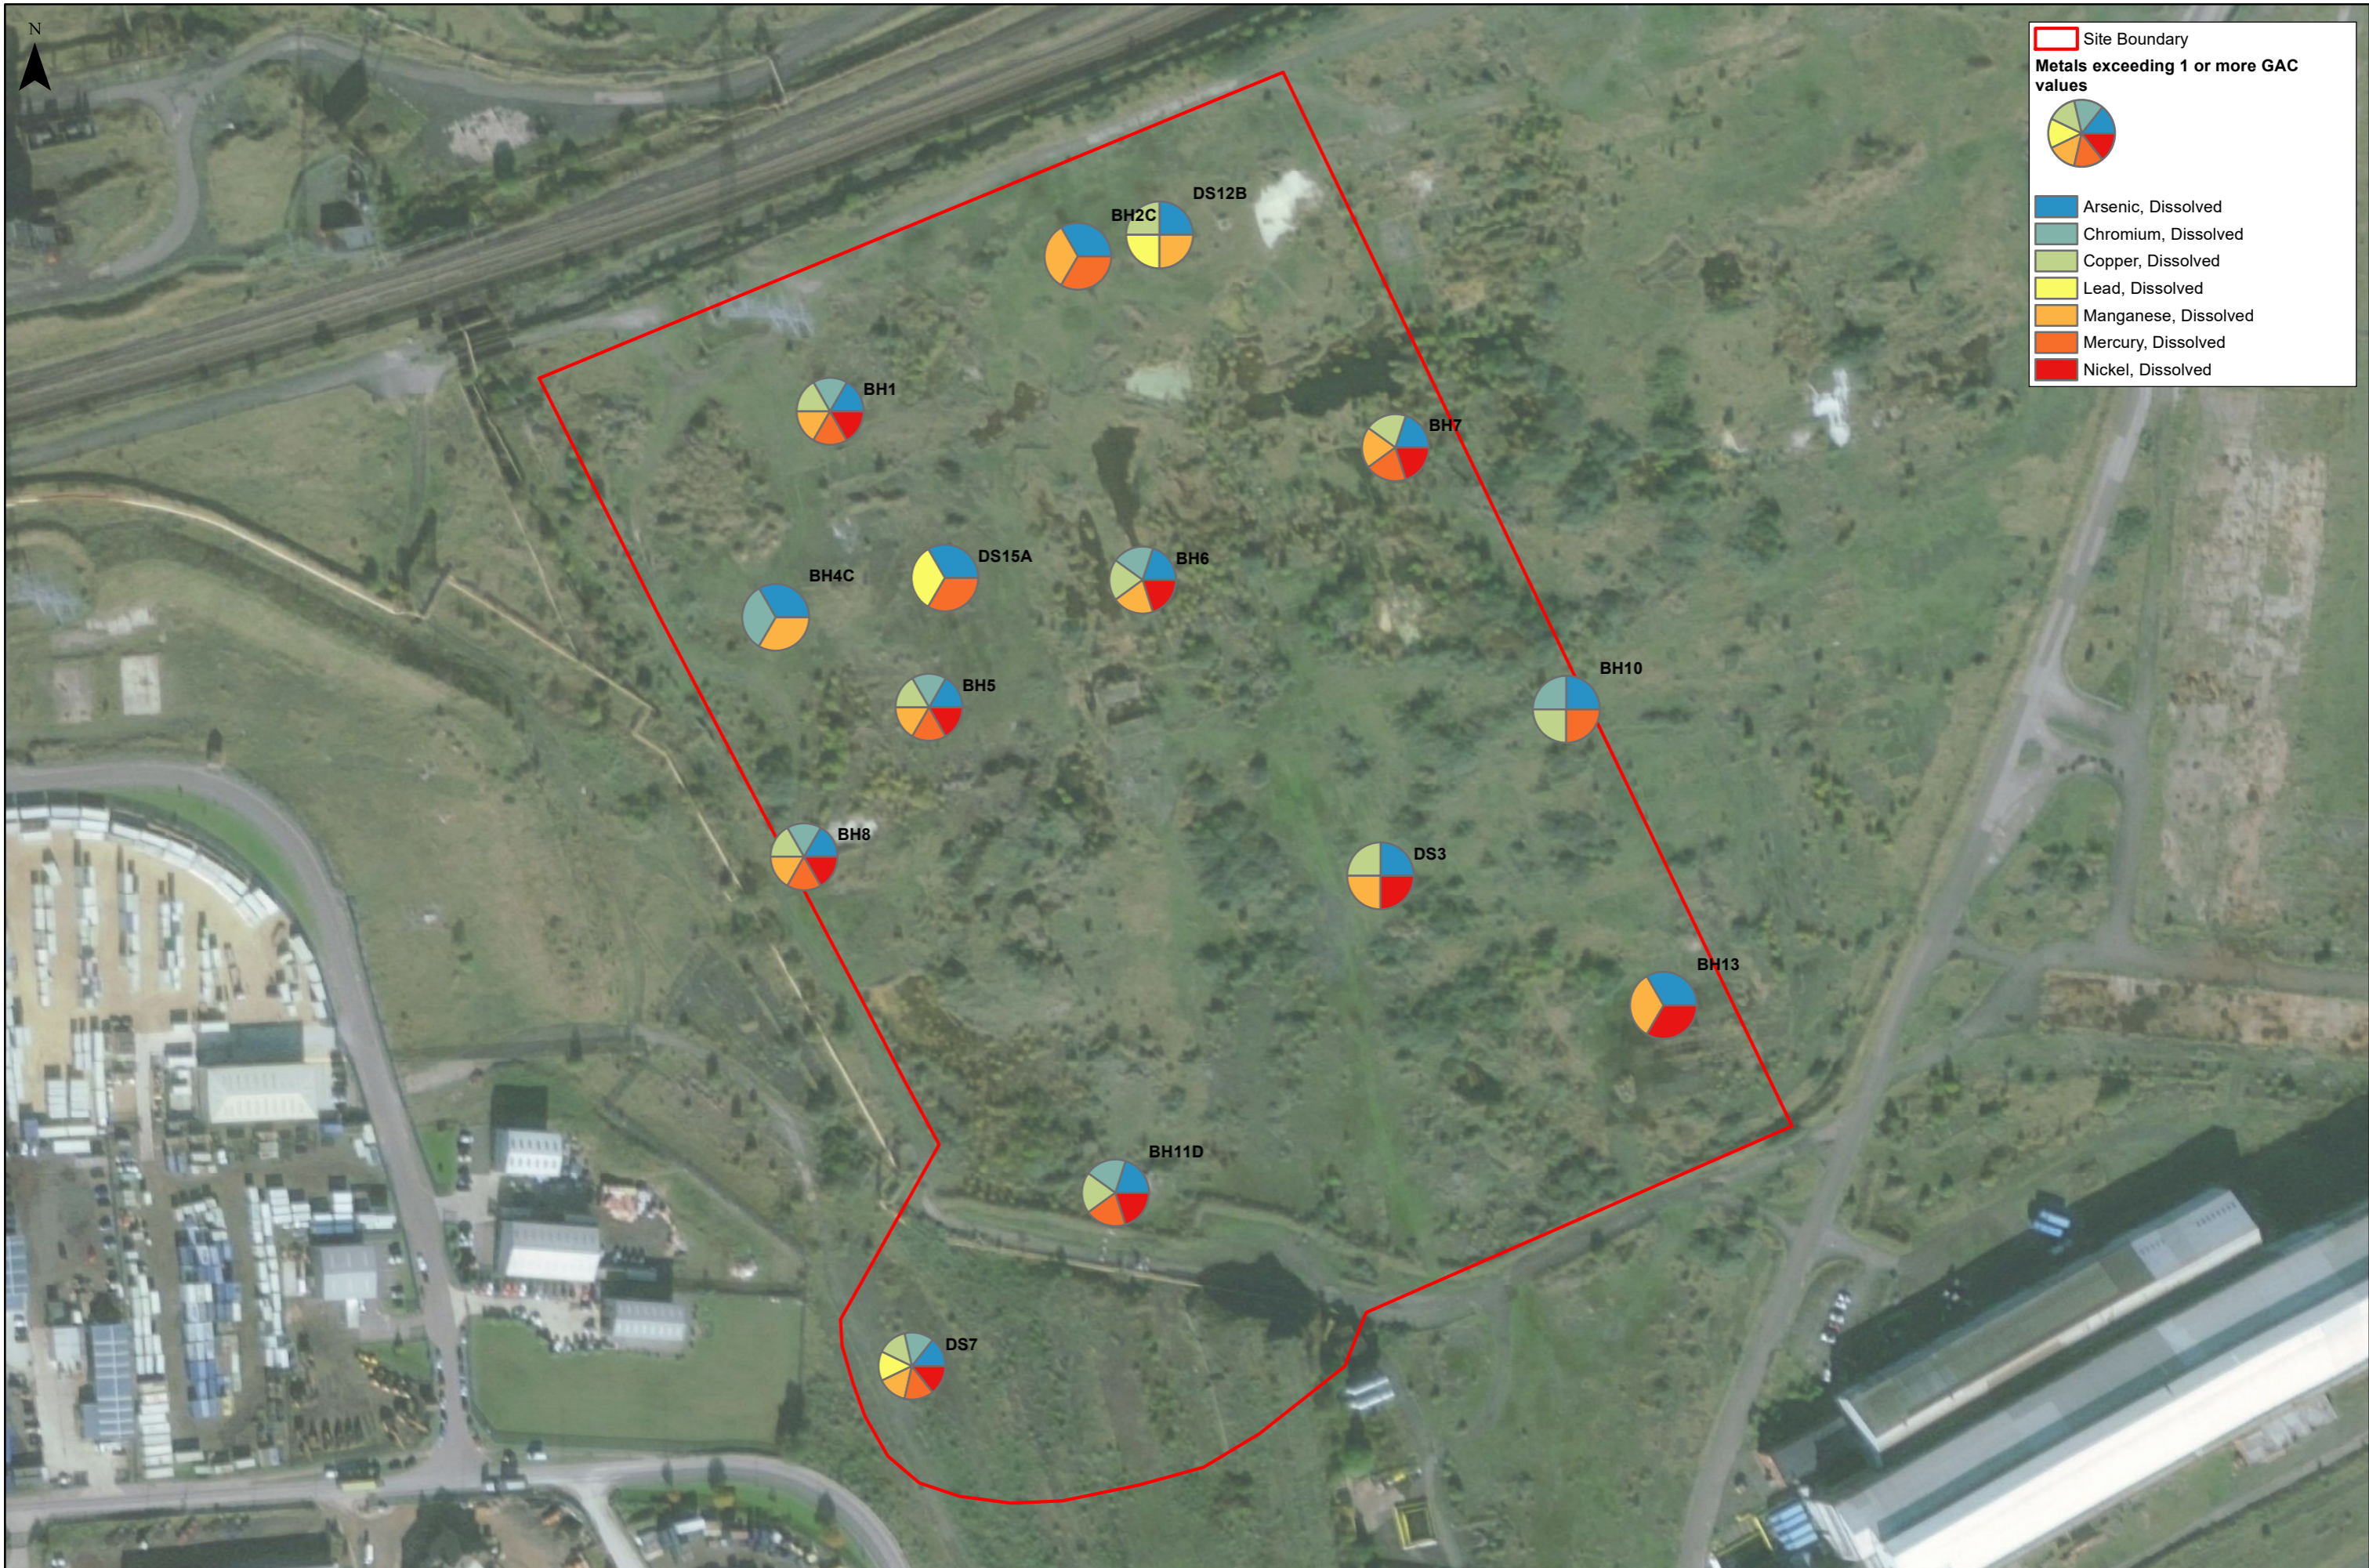
Figure 5 - Metals exceeding 1 or more GAC values

Tees Valley ERF Site
Groundwater Survey
Metals exceeding 1 or more GAC values

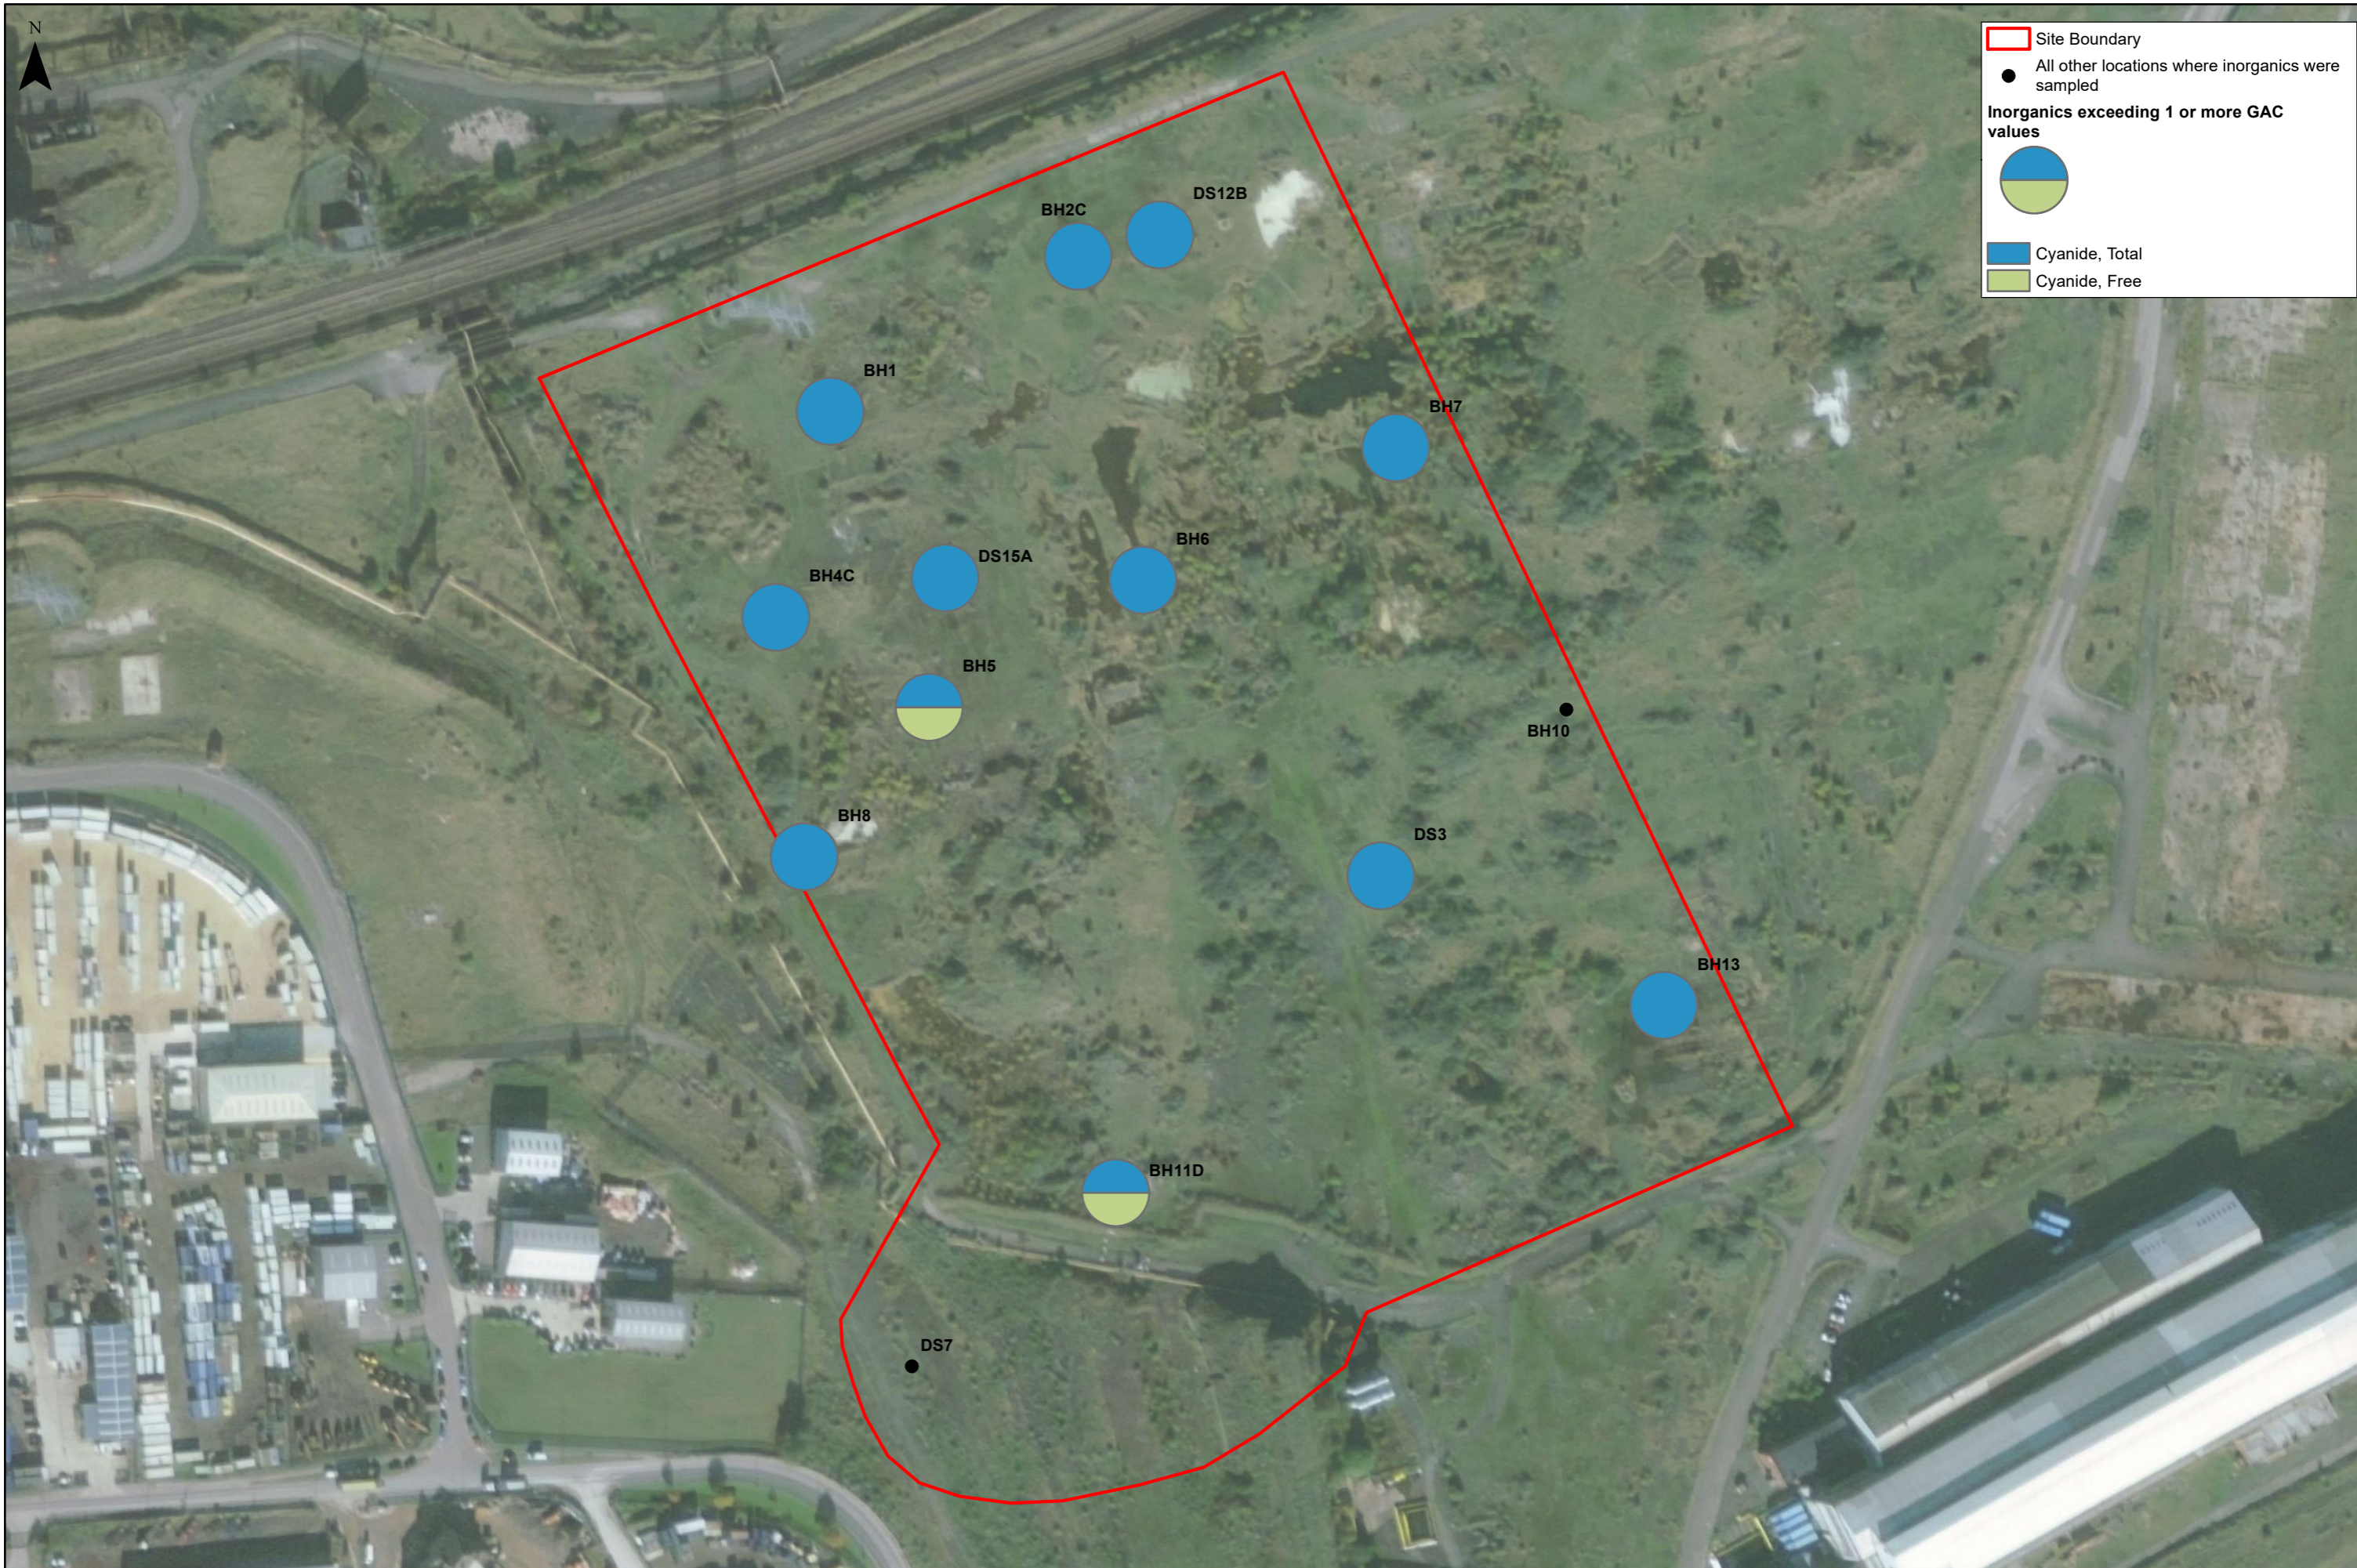
Figure 6 - Inorganics exceeding 1 or more GAC values

Tees Valley ERF Site
Groundwater Survey
Inorganics exceeding 1 or more GAC values

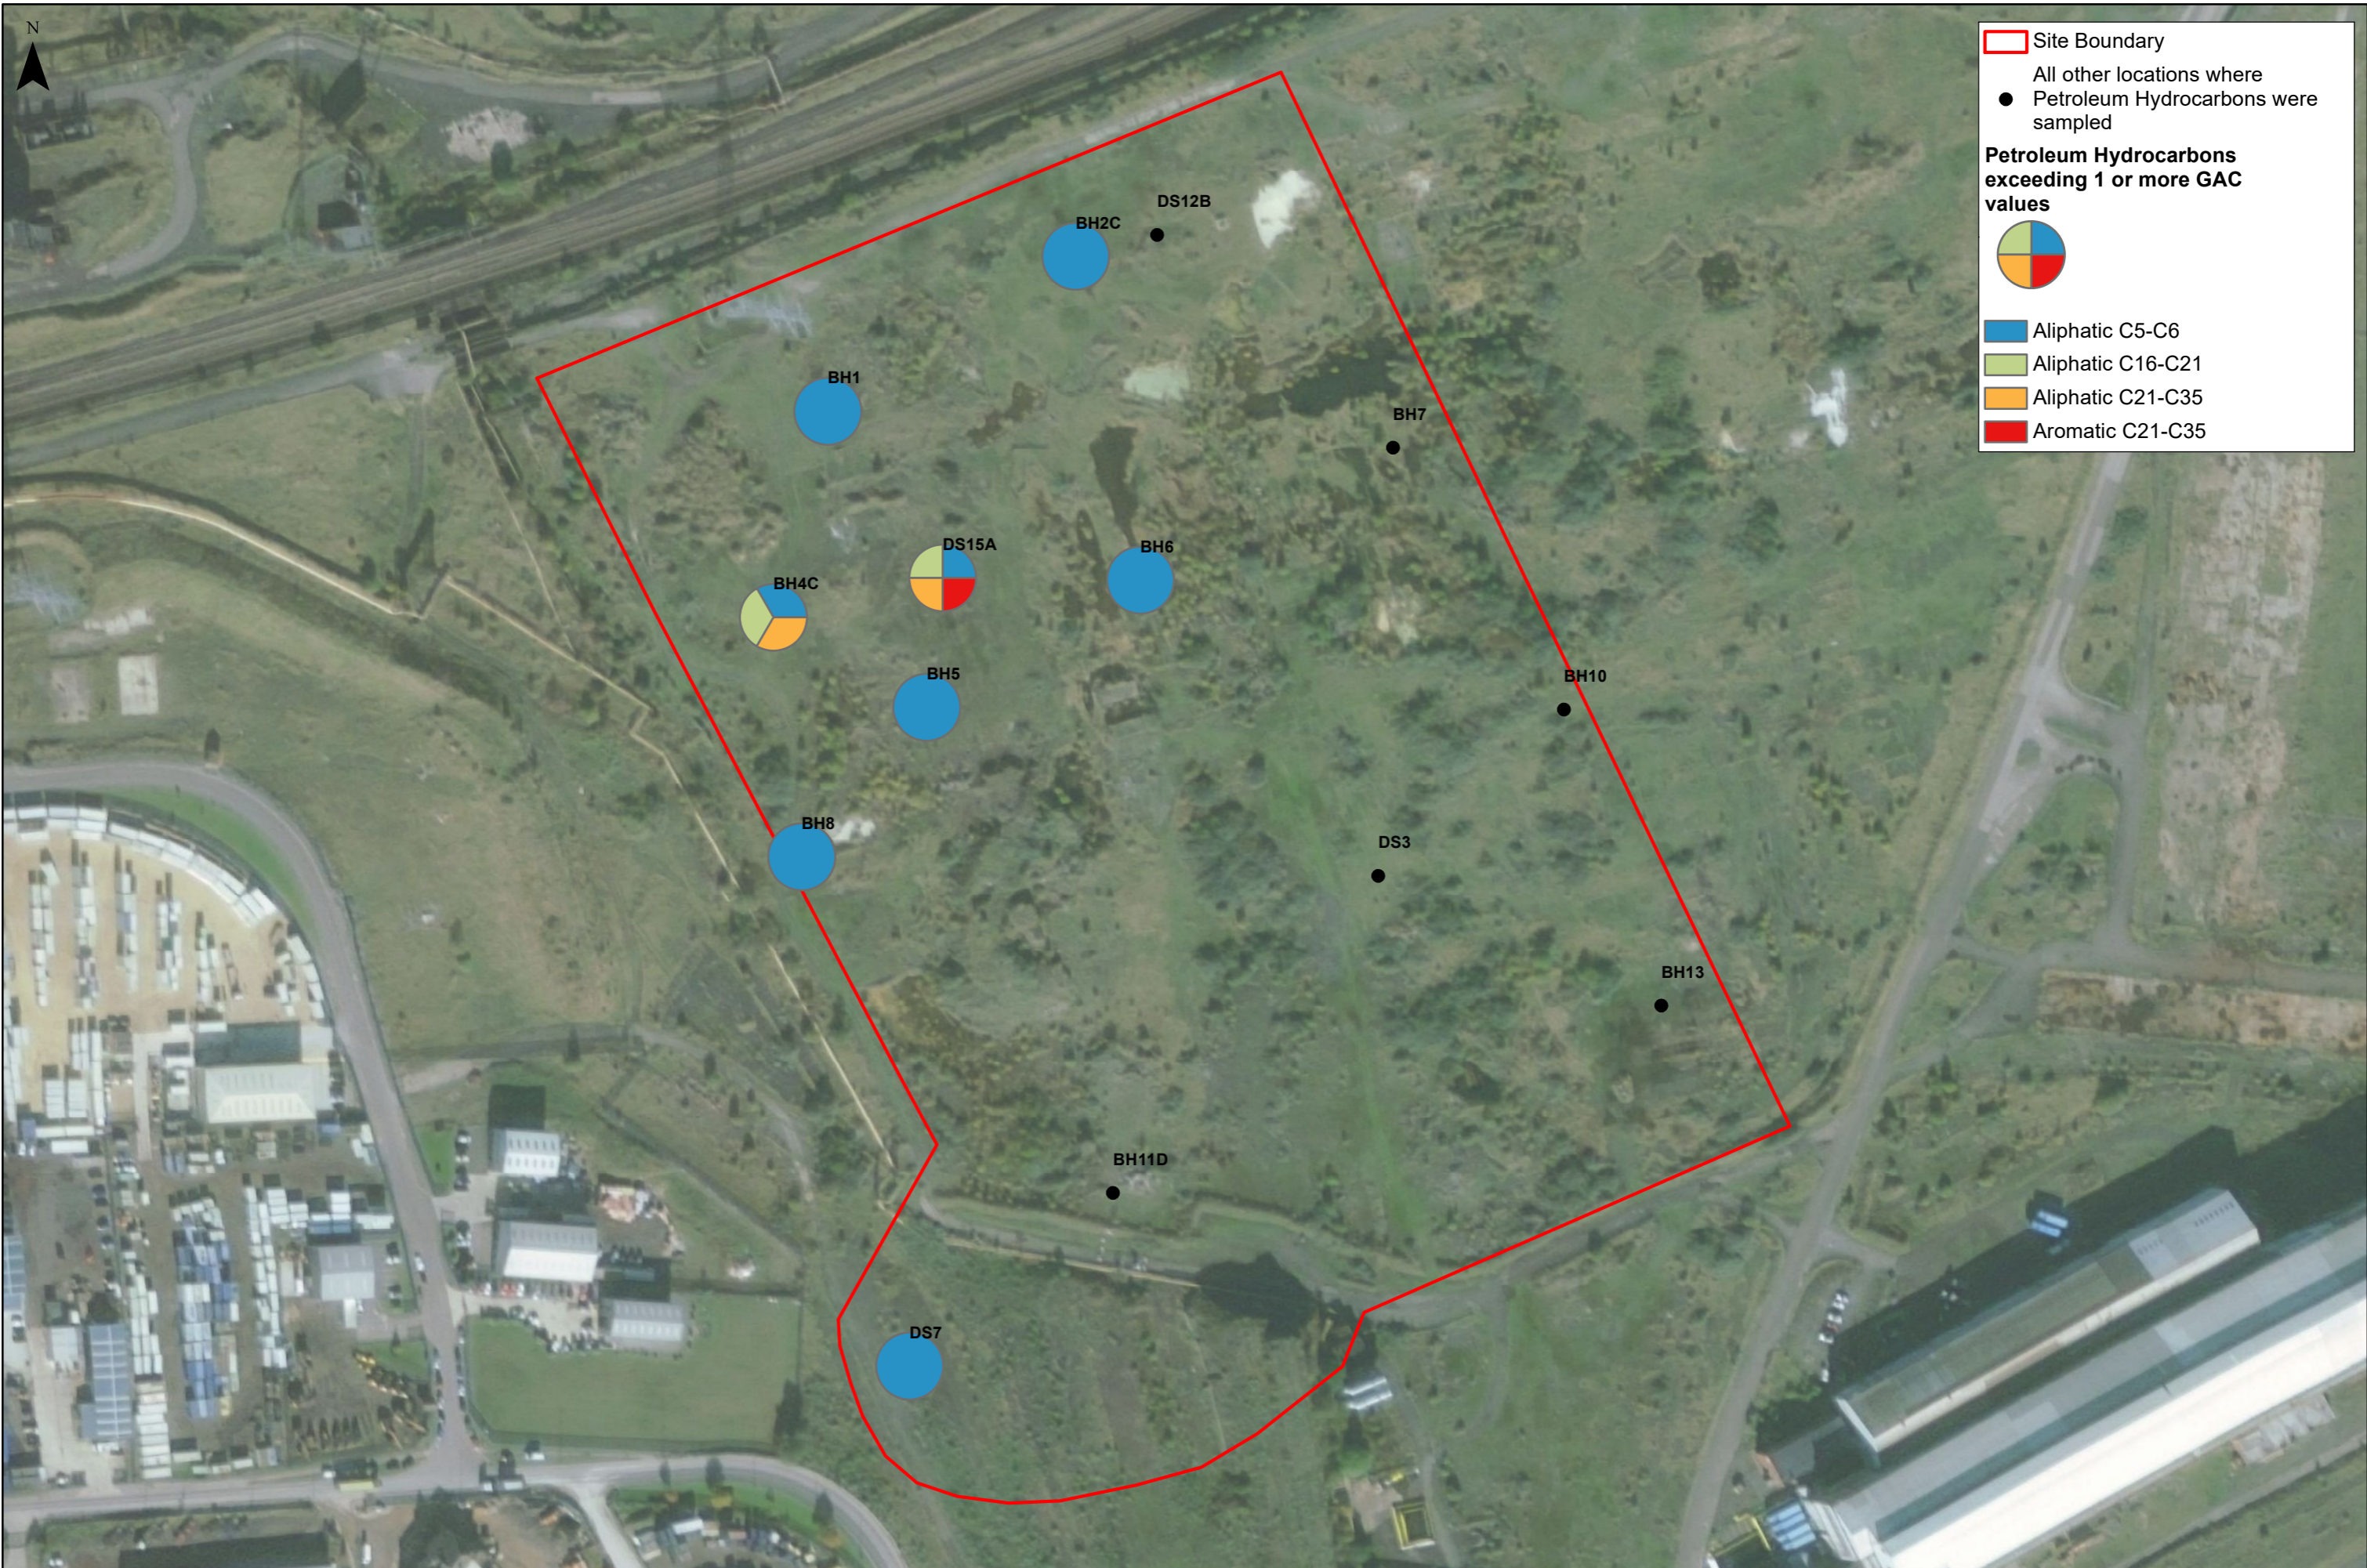
Figure 7 - Petroleum Hydrocarbons exceeding 1 or more GAC values

Tees Valley ERF Site
 Groundwater Survey
 Petroleum Hydrocarbons exceeding 1 or more GAC values
