Geo-Environmental and Geotechnical Ground Investigation Report – Tees Valley ERF Site

Grangetown Prairie, Redcar, TS10 5QW

27/11/2020

Tees Valley EfW

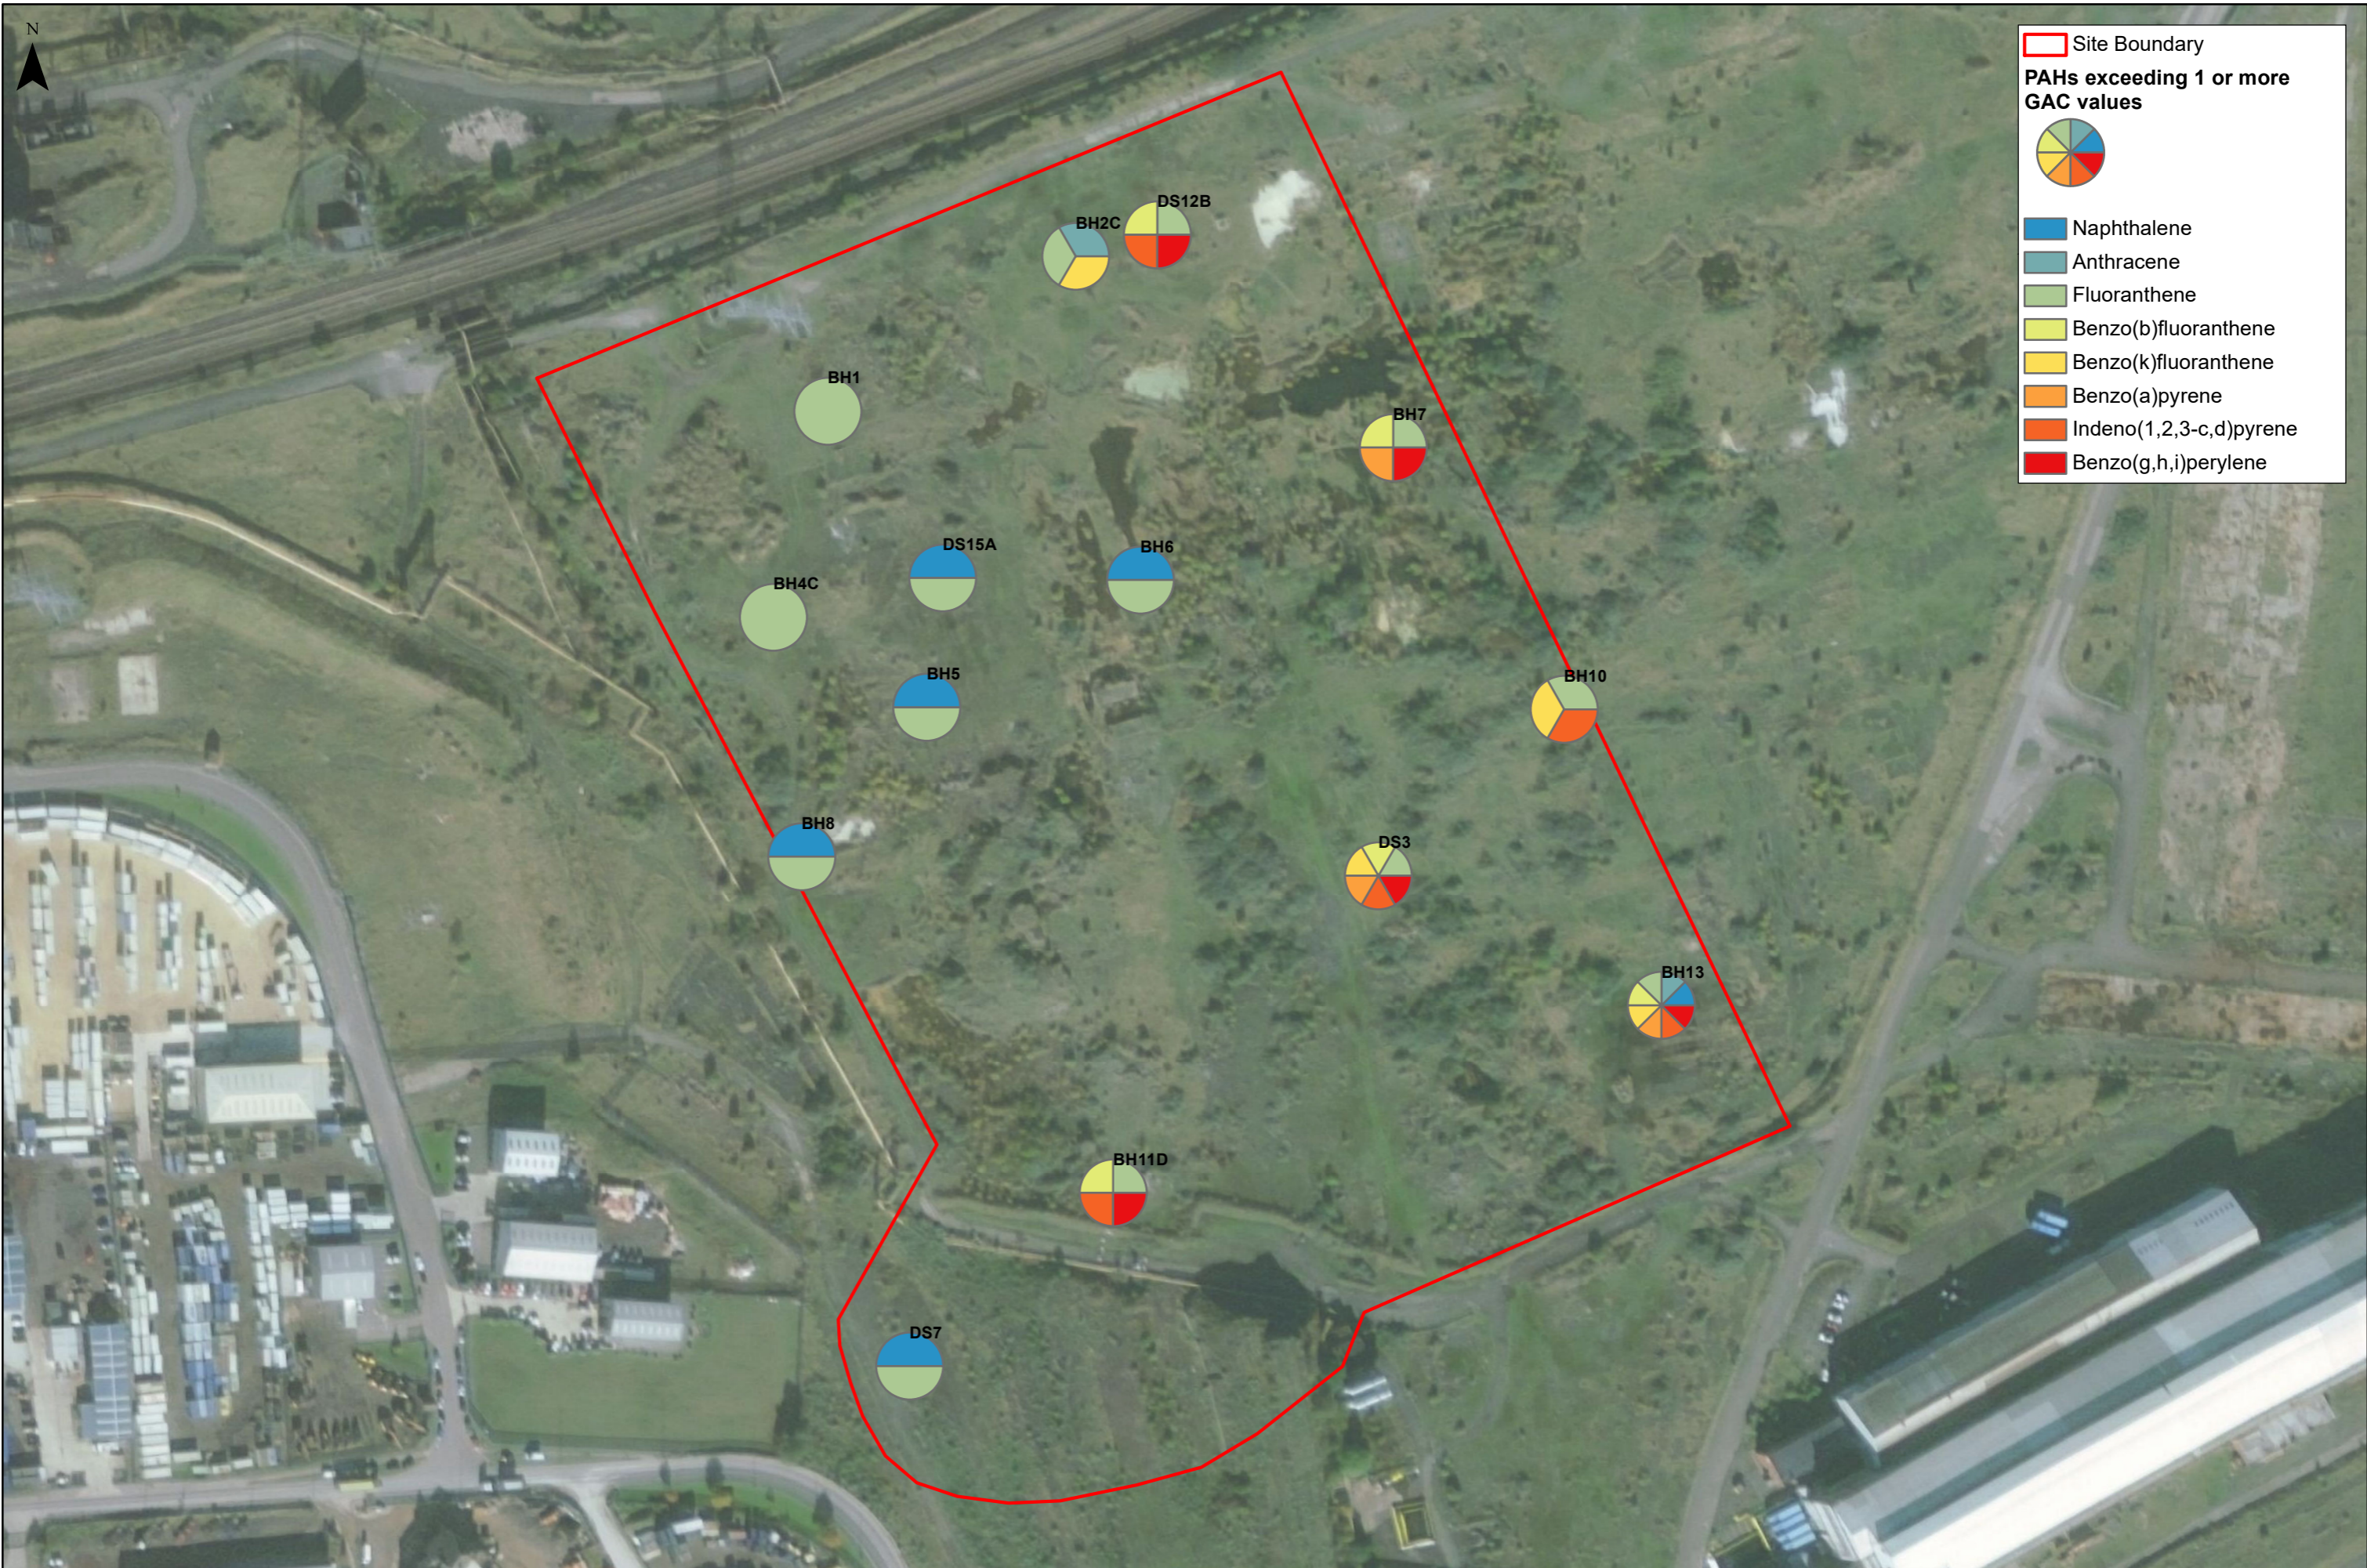
Figure 8 - PAHs exceeding 1 or more GAC values

Tees Valley ERF Site
Groundwater Survey
PAHs exceeding 1 or more GAC values

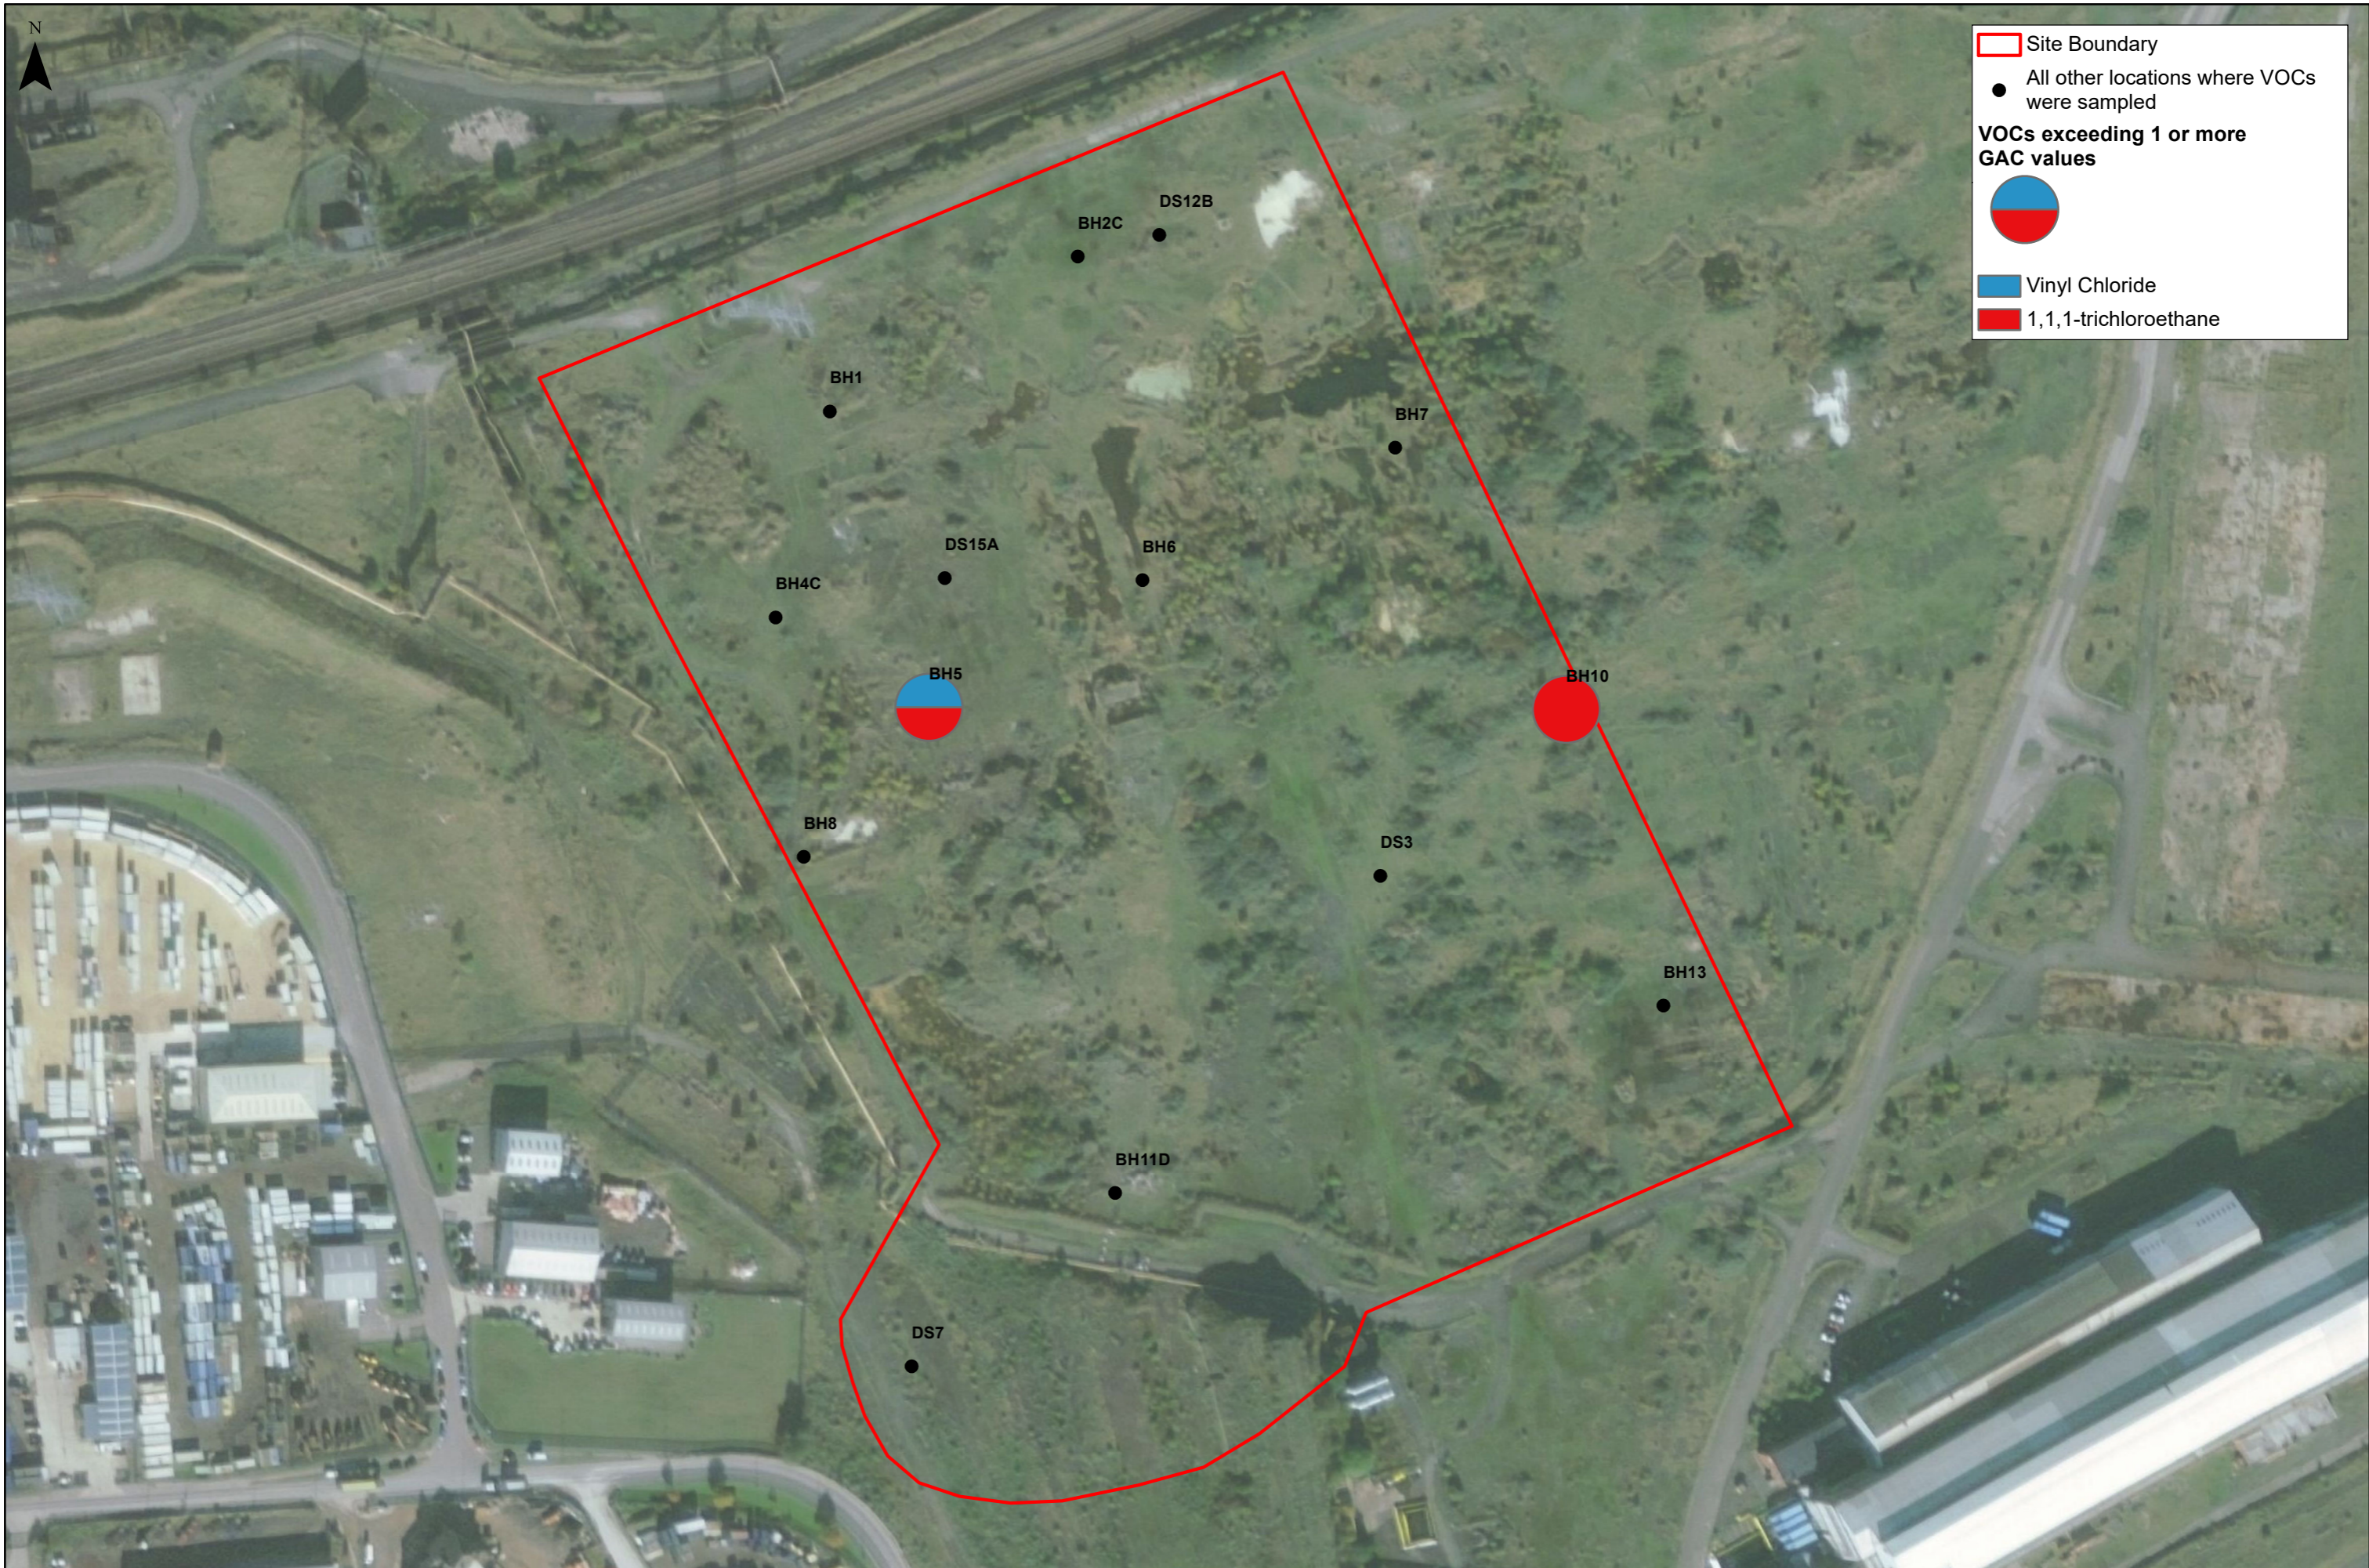
Figure 9 - VOCs exceeding 1 or more GAC values

No further exceedances were recorded, with detections found only for cresols in BH05 and DS07 (1.3 and 0.92 µg/l, respectively), phenols in BH05 and DS07 (0.83 and 2.5 µg/l, respectively), and phenols (total) in BH05, BH07, and DS07 (2.1, 60, and 3.4 µg/l, respectively). Figure 9 shows locations where VOCs exceeded one or more GAC values.

Tees Valley ERF Site
Groundwater Survey
VOCs exceeding 1 or more GAC values
