**Tees Valley Energy  
Recovery Facility**

**Viridor Tees Valley Limited**

Site Condition Report

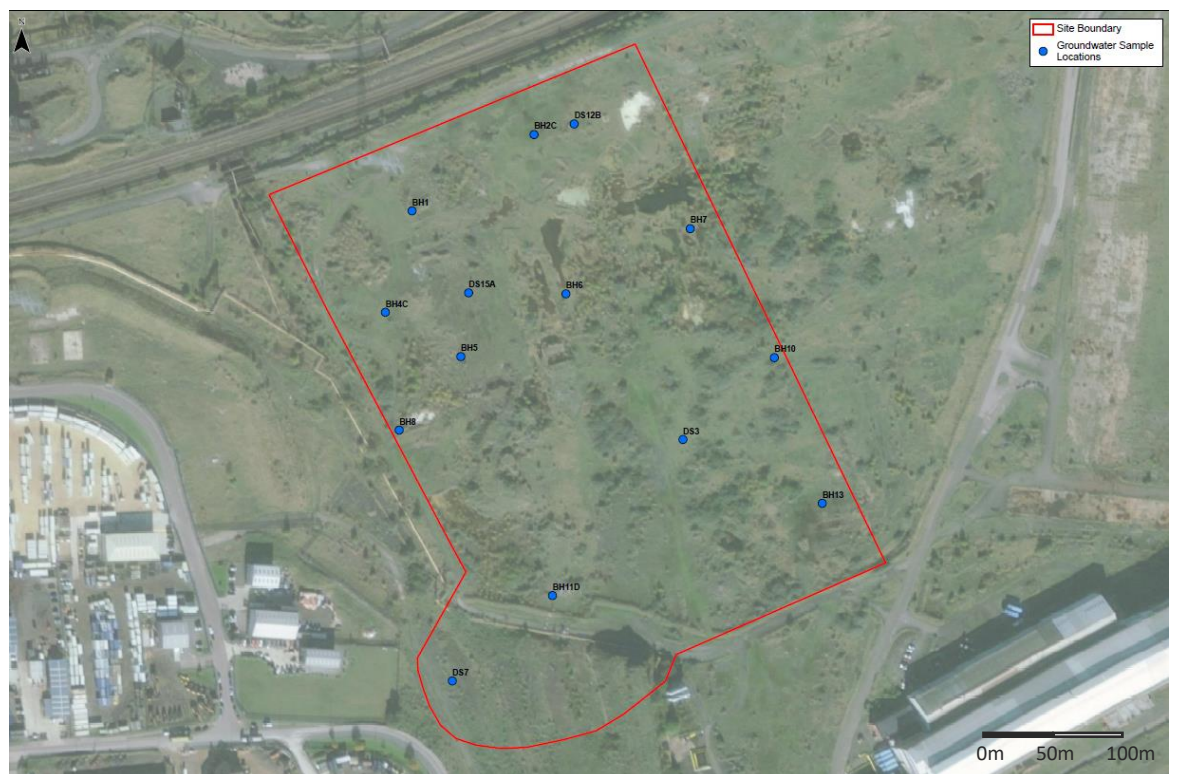
Figure 2: Aerial imagery of groundwater sample locations, Site boundary and land-use (Source: Appendix C)
