# SITE CONDITION REPORT

Virtus Hayes (LON2)

PROJECT NO. 70092911-EP2

DATE: JUNE 2022

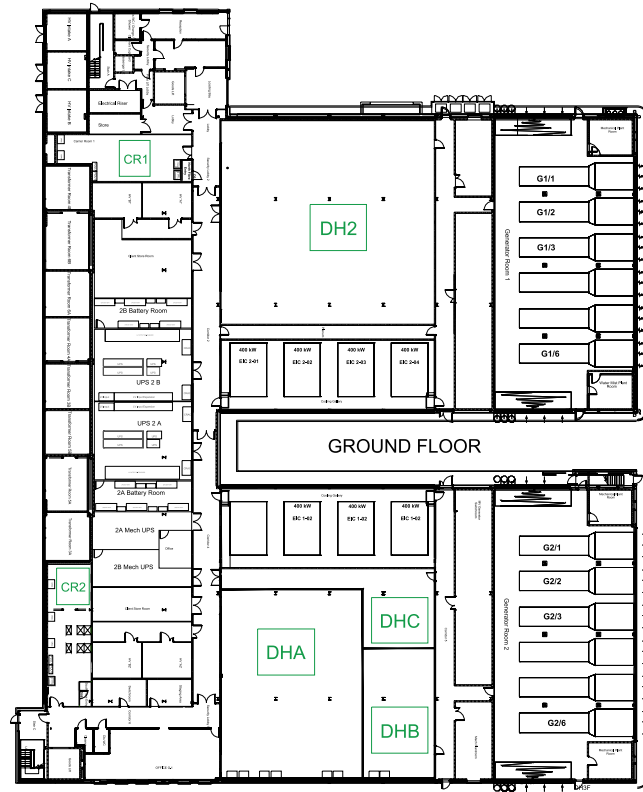
# LONDON2 - HAYES

LON2 has eight generators divided across 2 generator rooms, each room has six engine spaces, currently there are four engines in the northern room (Generator Room 1), and four in the southern room (Generator Room 2). The additional engine will be installed in GR1. The layout is provided in Appendix A.
