Project Name: MOD Records Office, Bourne Avenue

Details pursuant to condition 6(iii) (remediation scheme verification report) of Planning Permission Ref: 18399/APP/2013/1019 (Erection of distribution warehouse units (use class B8) with ancillary offices, associated car parking, access and associated landscape works within the existing Prologis Park development)

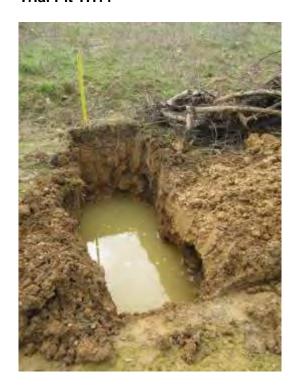
Trial Pit TH11

No contamination was observed in the trial pits other than a hydrocarbon odour and sheen in TH11.

The positions of the proposed soakaways were adjusted as a result of the investigations. The area round TH11 where hydrocarbon contamination was noted is not within any of the final soakaway areas.

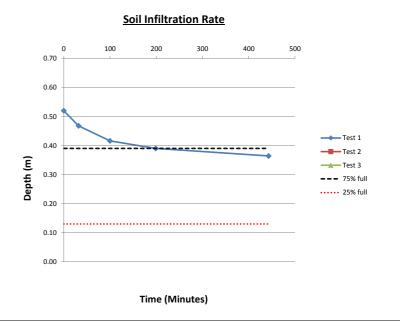
Soil Infiltration Rate (f) =

0.0000042 m/s

Infiltration tests carried out in the April 2014 trial pits by Construction Testing Solutions Ltd, gave a result of 4.2 x 10⁻⁶ m/sec, which is 0.36 m/day.

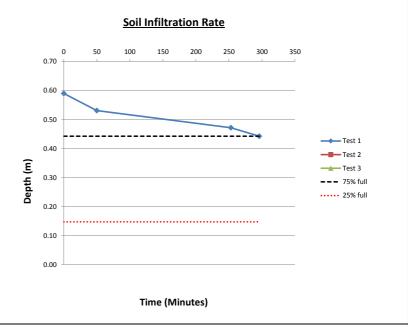
*Soil Infiltration Rate (f) = 0.0000060 m/s

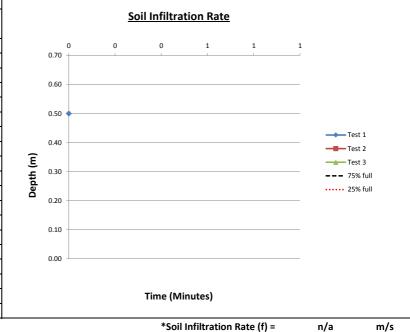
Unable to calculate Soil Infiltration Rate due to no drainage evident

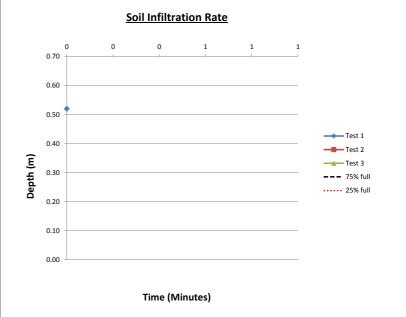
Unable to calculate Soil Infiltration Rate due to no drainage evident

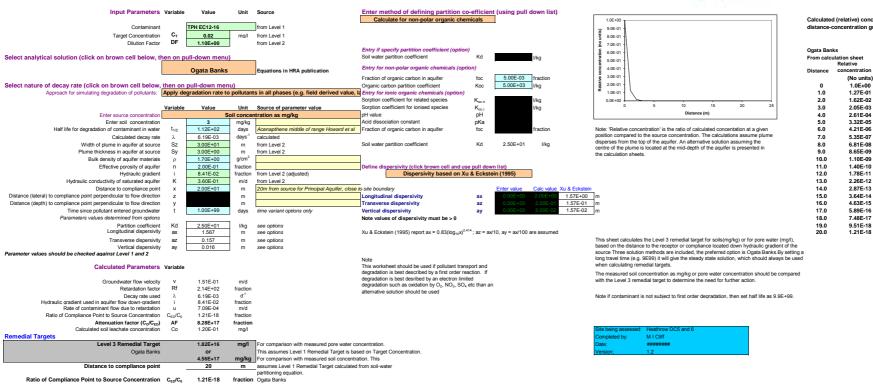
Level 3 - Soil

Contaminant Target concentration	Ст	TPH EC12-16 0.02	mg/l	from Level 1 This sheet calculates the Level 2 remedial target for soils (mg/kg) or for pore water (mg/l). from Level 1
Input Parameters	Variable	Value	Unit	The measured soil concentration as mg/kg or pore water concentration should be compared with the Level 2 remedial target to determine the need for further action. Equations presented in 'Hydrogeological risk assessment for land contamiantion' (Environment Agency 2006) Source of parameter value
Standard entry				
Infiltration	Inf	1.65E-03	m/d m²	Met office 1981-2010 average
Area of contaminant source	Α	1.50E+03	m ⁻	50m x 30m Not used in calculation
Entry for groundwater flow below site				
Length of contaminant source in direction of groundwater flow	L	5.00E+01	m	Northern soakaways
Saturated aquifer thickness	da	3.00E+00	m	From Site boreholes, 2003 investigation
Hydraulic Conductivity of aquifer in which dilution occurs	K	3.60E-01	m/d	From infiltration tests at the site

The P20 process has been repeated for the >EC12-EC16 fraction. As with the lighter fraction the remedial targets indicate that for the most likely situation free phase could be present without presenting a risk to groundwater quality. Even for the slowest degradation rate modeled the maximum recorded concentration of >EC12-EC16 of 5.0 mg/kg is well below the remedial target.
