Appendix C – Land Quality Statement

Details pursuant to condition 6(iii) (remediation scheme verification report) of Planning Permission Ref: 18399/APP/2013/1019 (Erection of distribution warehouse units (use class B8) with ancillary offices, associated car parking, access and associated landscape works within the existing Prologis Park development)

At: PROLOGIS PARK, STOCKLEY ROAD, WEST DRAYTON,

Validation Report Phase 3B ProLogis Park, Hayes

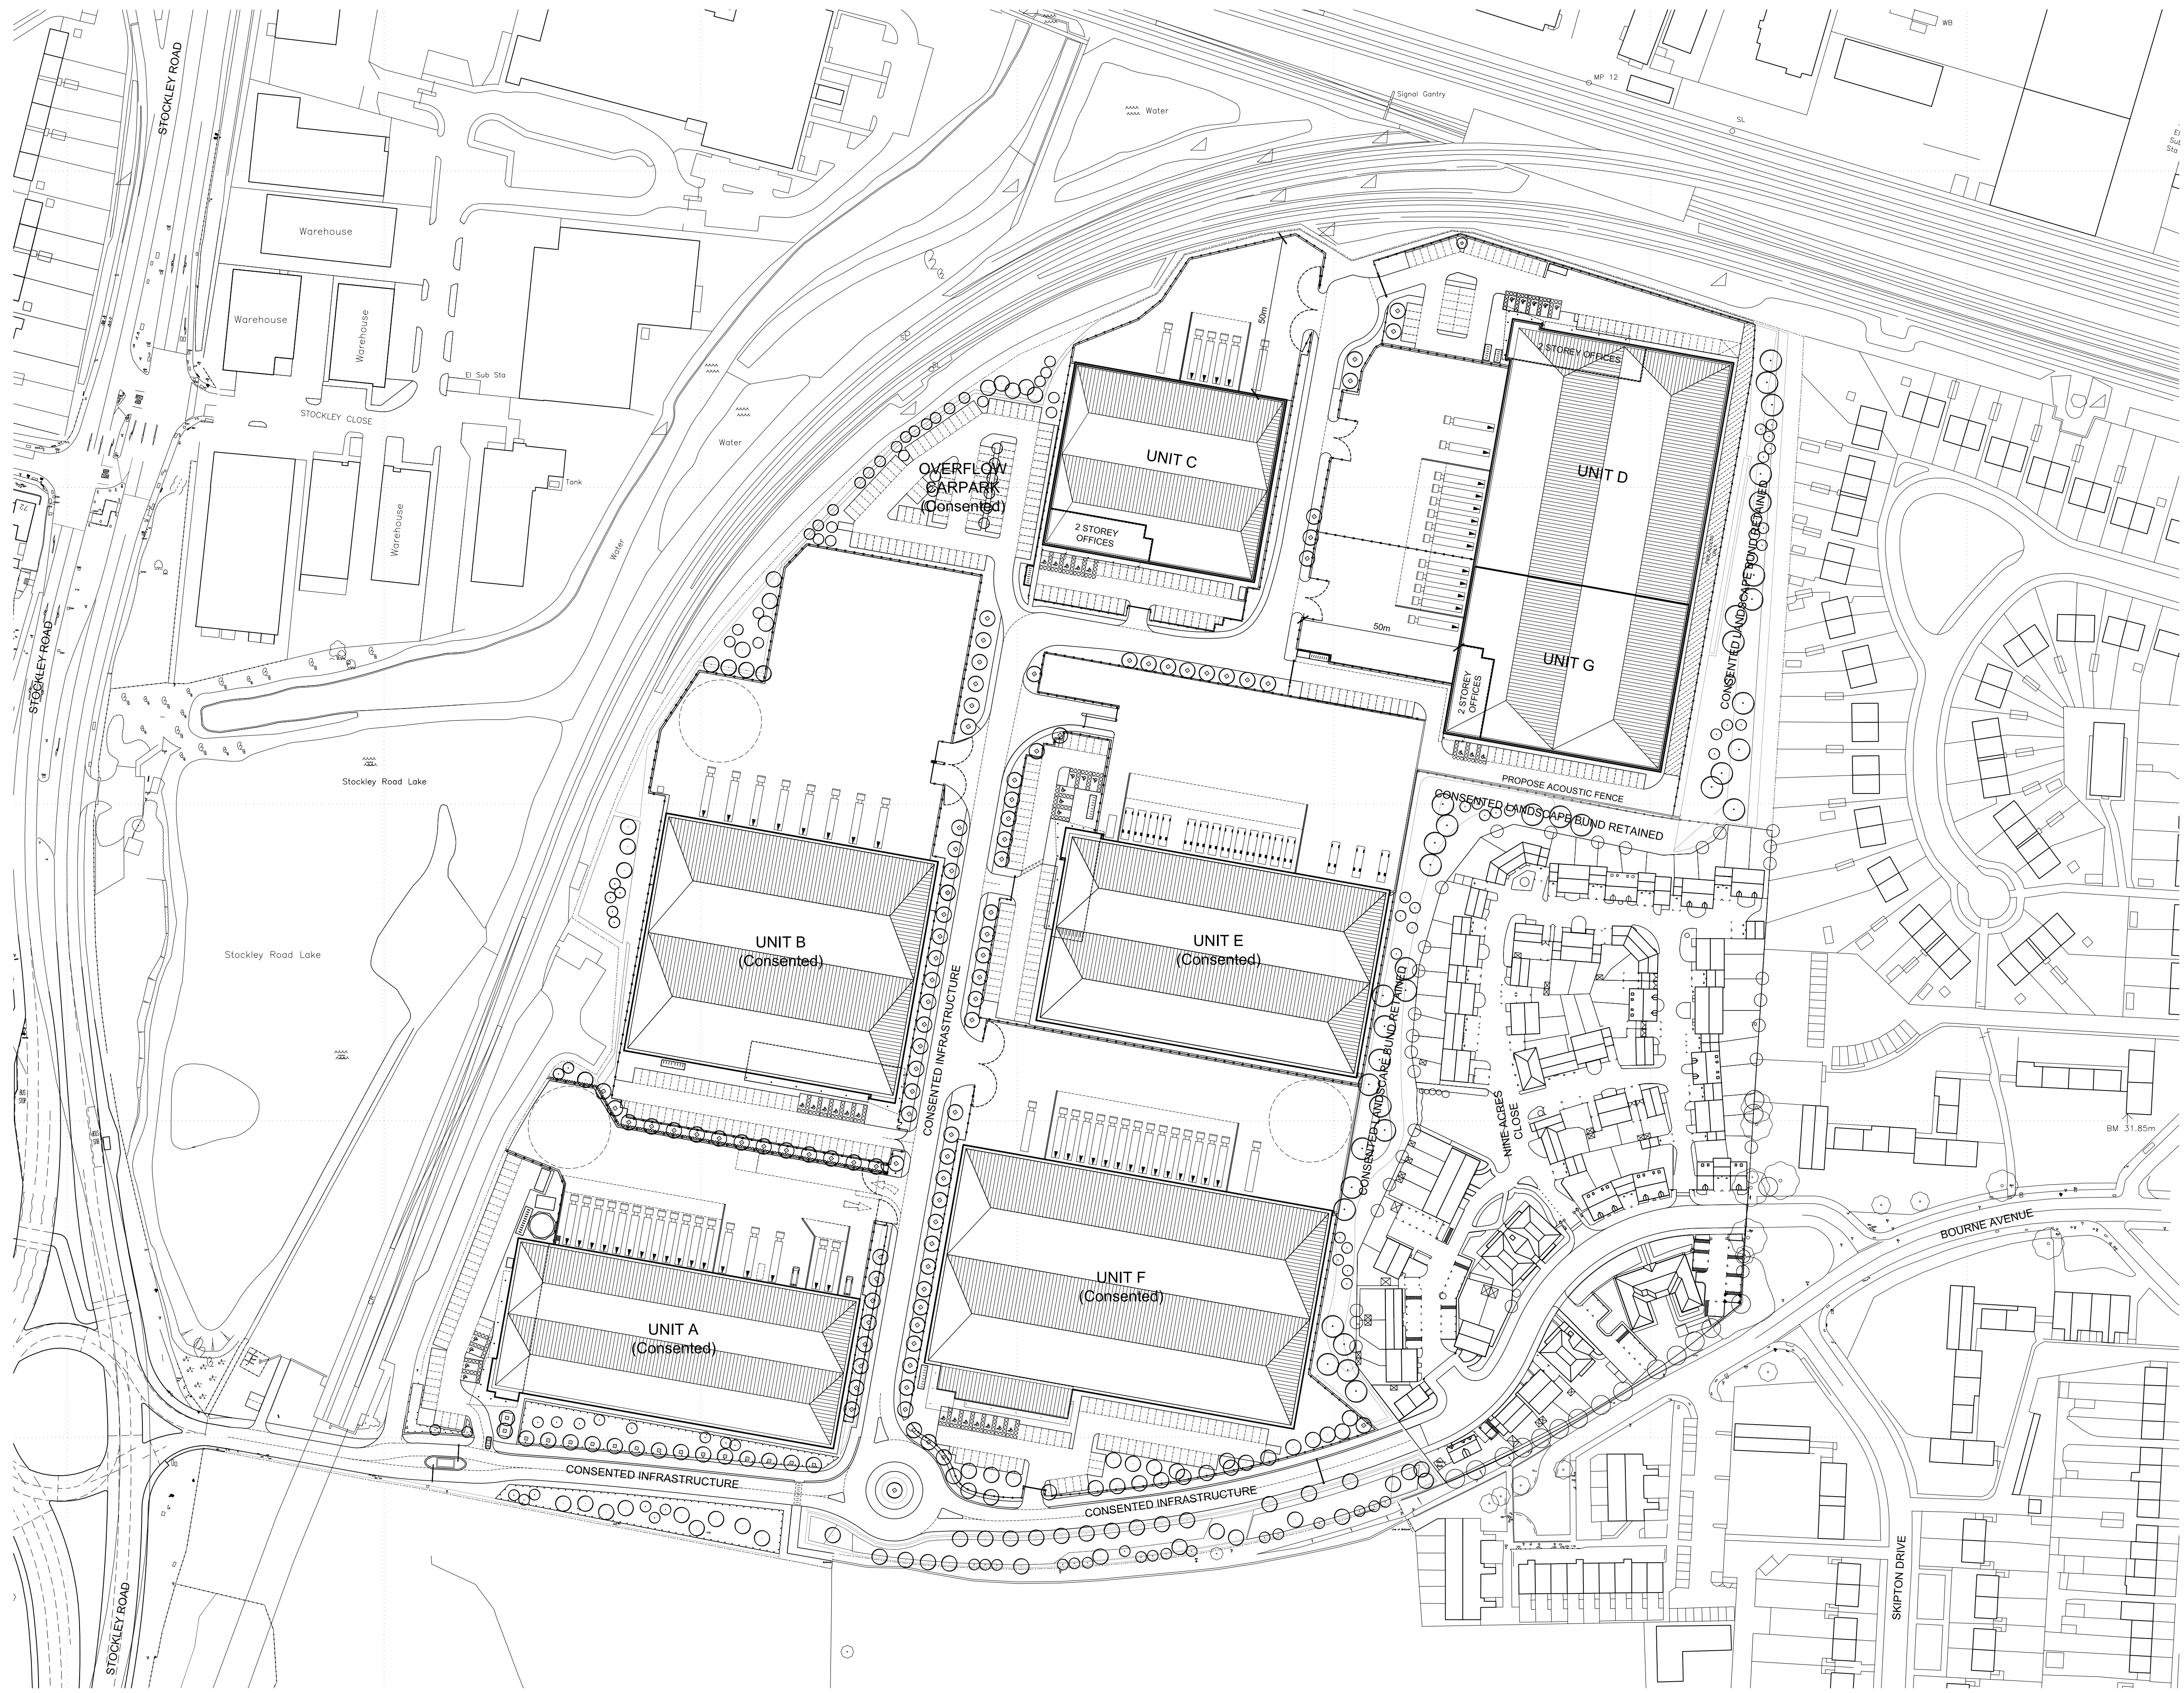
Figure 4 Drawing 30587-PL101

TITLE
PHASE 3 - PROLOGIS PARK, HEATHROW
 DRAWING
SITE LAYOUT PLAN

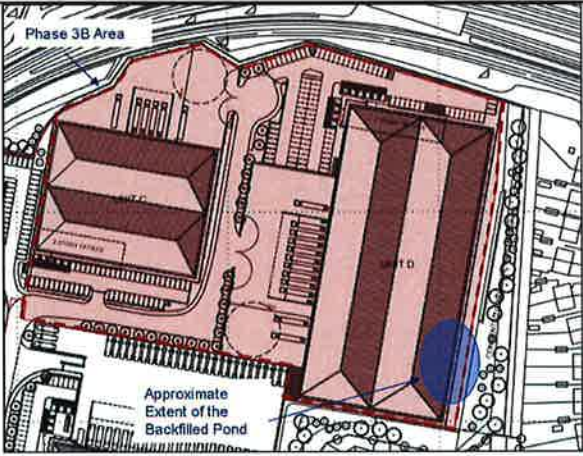
Proposed Development	It is proposed that the Phase 3B area of the site is redeveloped for two industrial units with associated car parking and loading areas. An annotated proposed layout along with the approximate position of the backfilled pond is provided in the extract below, which is taken from ProLogis Drawing (Reference: 30226-PL-101).

<p>The diagram is a site plan for the Phase 3B Area. It shows several large, rectangular building footprints in a reddish-brown color. A blue oval is located in the lower right portion of the plan, labeled 'Approximate Extent of the Backfilled Pond'. The plan also shows surrounding roads, parking areas, and other site features. The text 'Phase 3B Area' is at the top left, and 'Approximate Extent of the Backfilled Pond' is at the bottom center.</p>
<p>Scope of Works</p>	<p>The works have been designed in accordance with section 8.0 of the Demolition and Remediation Strategy and include:</p> <ol style="list-style-type: none"> 1. Sampling of soils on 50m spacing to assess the presence of further previously unidentified hotspots and confirm the absence of contamination in the footprint of the former building. 2. Collection of samples from representative strata within 600mm of final development levels (which are assumed to be the current site levels). 3. Soil samples recovered from the validation investigations will be submitted for the following chemical testing suite: <ul style="list-style-type: none"> ▪ pH ▪ Metals (Arsenic, cadmium, copper, selenium, chromium, nickel, mercury, lead, zinc) ▪ Total Petroleum Hydrocarbons (TPH) ▪ Speciated Polyaromatic Hydrocarbons (PAH) ▪ Phenols ▪ Water Soluble Sulphate ▪ Asbestos ▪ Provision of a Validation Report <p>In addition to the above work, two stockpiles are present on site, a sample from each stockpile was collected and tested for asbestos and particle size distribution (PSD). These results have been provided to ProLogis under a separate cover.</p>

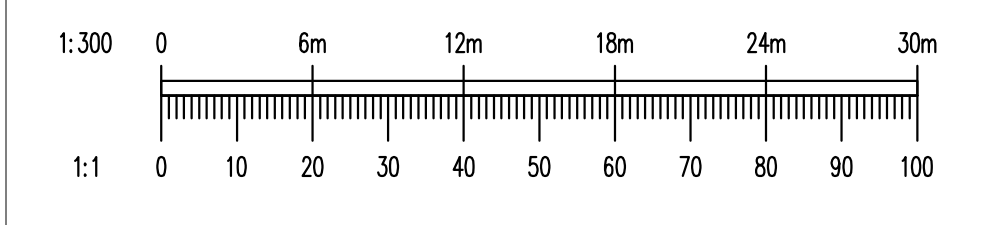
DRAINAGE LAYOUT
(Ref: 30587)
Scale 1:300

- 1200mm MANHOLE & DRAIN RUN FOUL WATER - RED
- CLEAN SURFACE WATER - BLUE
- DRY SURFACE WATER - GREEN
- 1500mm MANHOLE & DRAIN RUN CLEAN SURFACE WATER - BLUE
- DRY SURFACE WATER - GREEN
- 1800mm MANHOLE & DRAIN RUN CLEAN SURFACE WATER - BLUE
- DRY SURFACE WATER - GREEN
- EXISTING FOUL WATER DRAINAGE RUN & MANHOLE
- EXISTING CLEAN SURFACE WATER DRAINAGE RUN & MANHOLE
- HIGH LEVEL SYNCHRONIC DRAINAGE PRIMARY/SECONDARY SYSTEM
- PACKAGED PUMP STATION WITH ROOM
- SLOT DRAIN (200mm CAD CONCRETE SURROUND)
- ACCESS CHAMBER/OUTLET
- BEANY TYPE ACCESS DRAIN (150mm CAD BED & BRANCH)
- ROODABLE TRAPPED FLOOR GULLY
- SOIL & VENT PIPE
- SOIL STACK INCL. INV
- PRESSURISED SYNCHRONIC DOWNPIPE
- GRAVITY RAINWATER DOWNPIPE
- CONCRETE CLASS 1 BY-FAS PETROL RESISTANT
- PROPOSED NEW SURFACE LEVELS
- EXISTING SURFACE LEVELS
