# Environmental Risk Assessment

Bulls Bridge Industrial Estate, North Hyde Gardens, Hayes, UB3 4QQ

**FOR AND ON BEHALF OF ARK DATA CENTRES LIMITED C/O HURLEY PALMER FLATT**

Issue Date:	11 March 2020
Revision NO:	B
Revision Date:	04 June 2020

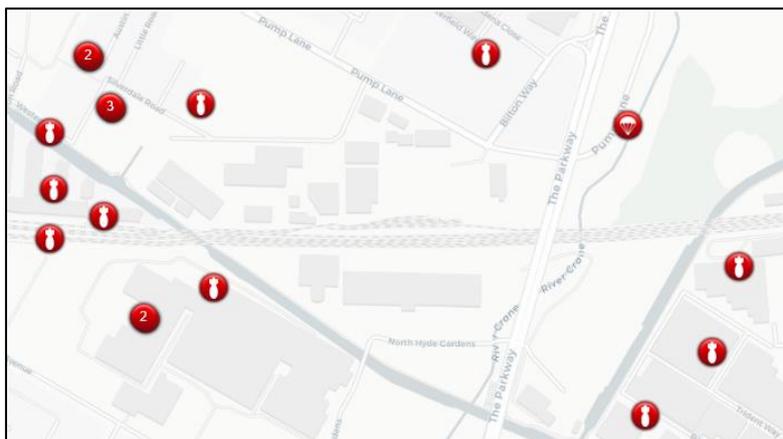
Accessed: <http://bombsight.org/#16/51.5028/-0.4112>

1.4.3	<p>Online information indicates that there were several bomb strikes recorded around the site during World War II.</p>

A UXO Desk Study should be completed and an on-site presence by a UXO specialist may be required to check each borehole as it is advanced.

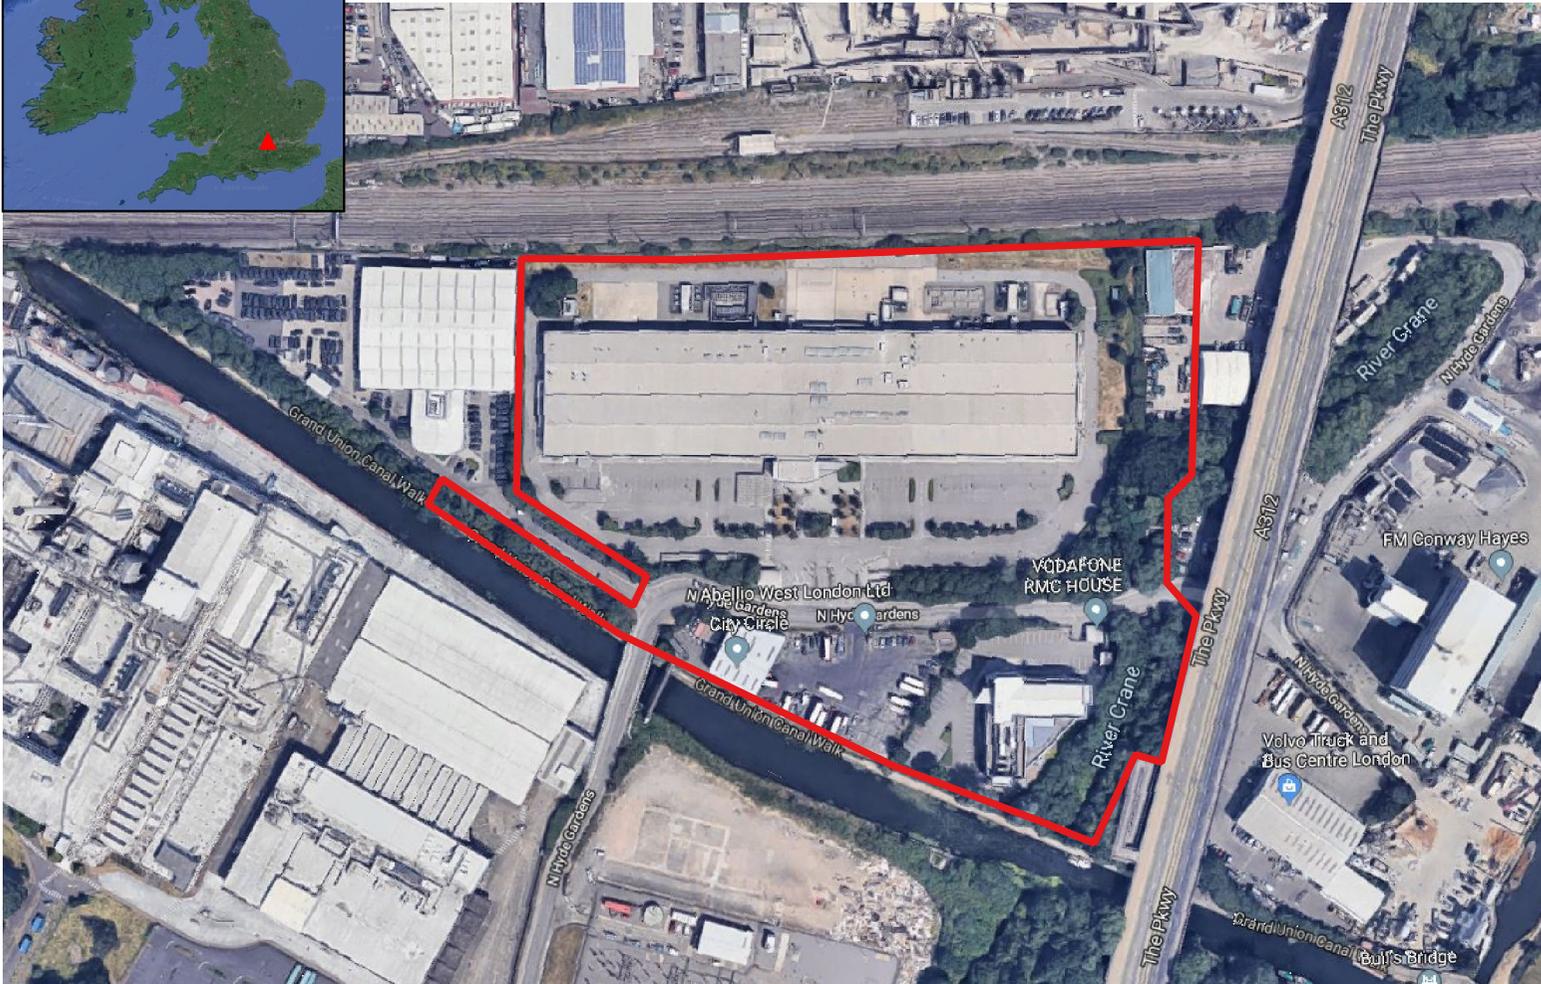
Project Bulls Bridge, Hayes	Scale 1:3000
	Drawn by CB
	Approved By CK
Title Site Location Plan	Drawing Number 1
	Date 21/05/2020

Site Location

Development Area

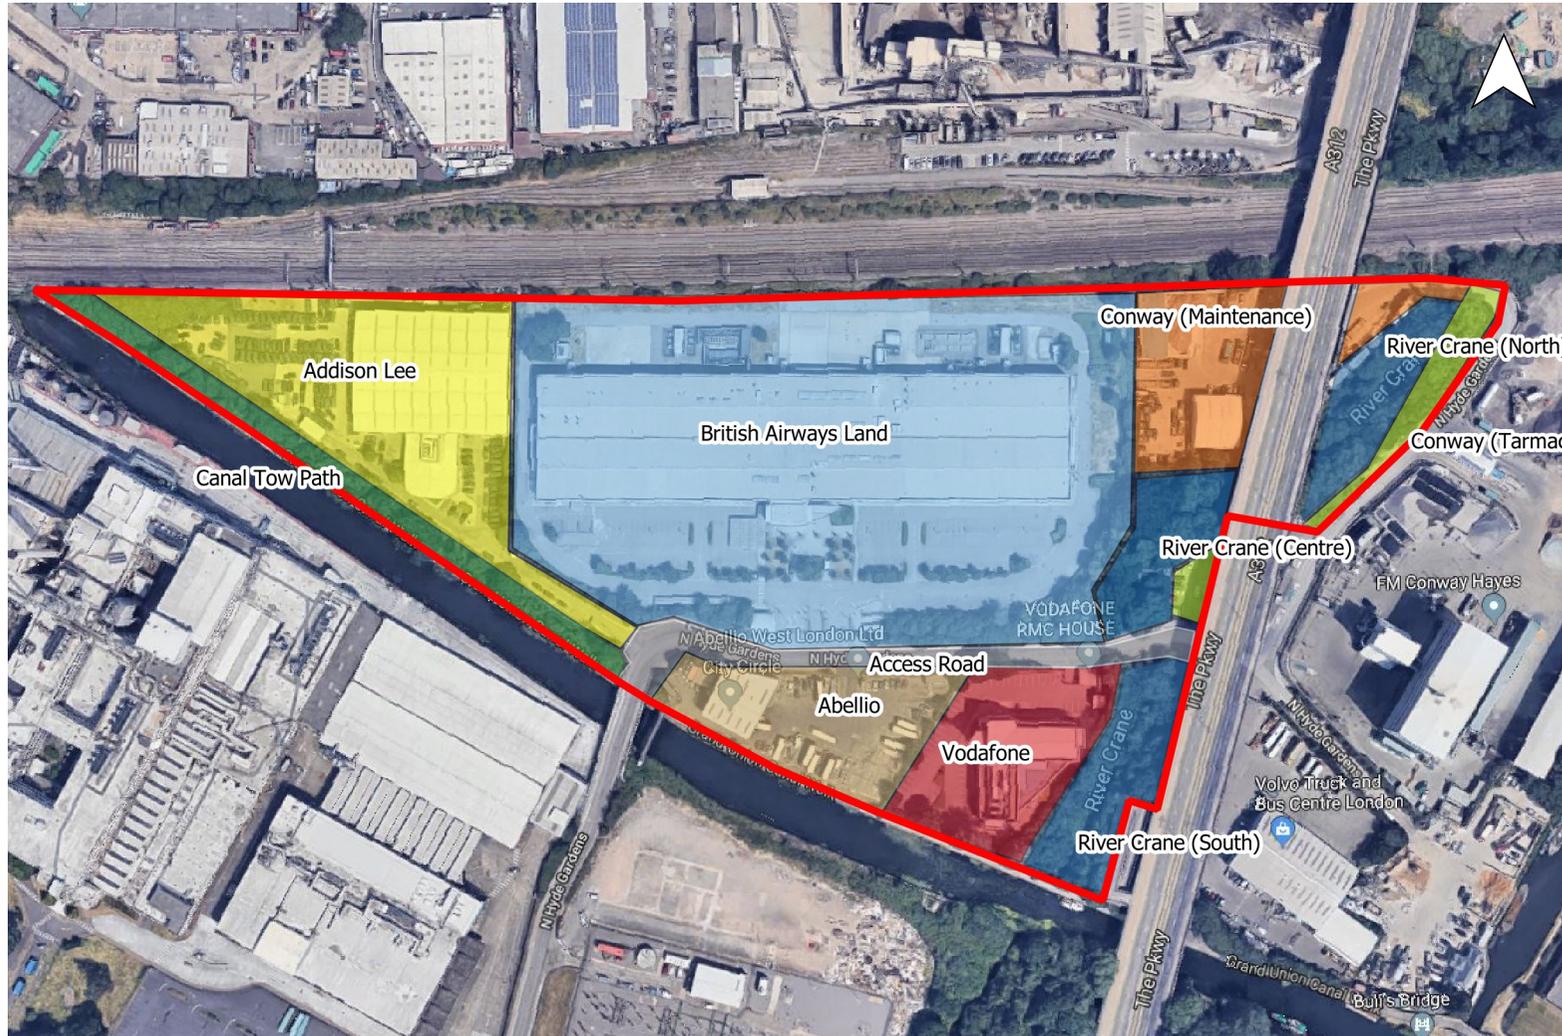
Project Bulls Bridge, Hayes	Scale 1:3000
	Drawn by CB
	Approved By CK
Title Site Areas Plan	Drawing Number 2
	Date 21/05/2020

Site Boundary

Site Areas

- Access Road
- Addison Lee
- British Airways Land
- Canal Tow Path
- Conway (Maintenance)
- Conway (Tarmac)
- River Crane (North)
- River Crane (Centre)
- River Crane (South)
- Vodafone
- Abellio

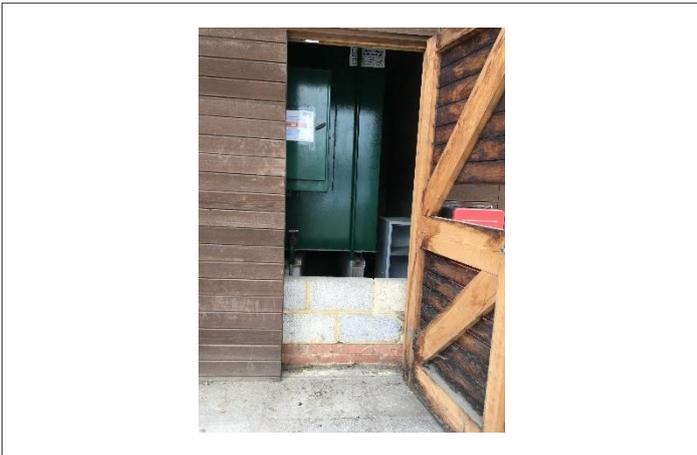
07: Vodafone (Fuel Storage Tank)

2.4.1	Potential onsite sources of contamination include an above ground fuel tank (ASTs) was noted in the northeast corner of the Vodafone plot. It is possible that spillages of fuel could result in petroleum hydrocarbons in the soil and groundwater. During the inspection, the tank appeared to be in good order with no obvious damage or staining to surrounding ground. The tank was noted to be within a concrete bund.

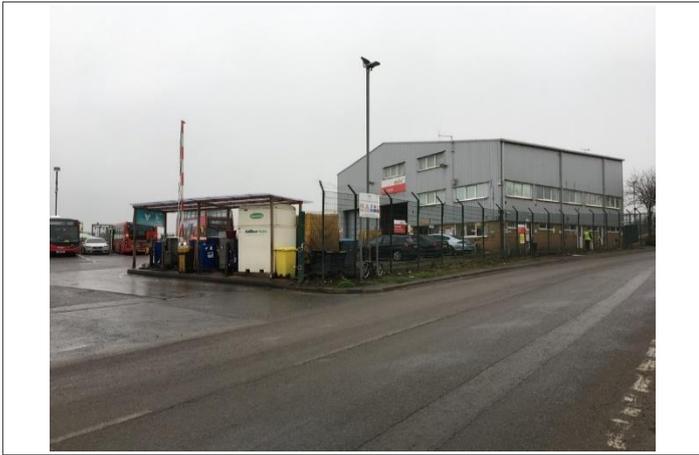
1.3.3	<p>The Abellio plot comprises a bus garage, which includes parking areas for buses, an internal car wash, repair garage and a refuelling point. The refuelling point is located at the entrance to the bus garage and comprised two pumps each with two pump handles. An ad-blue tank was also situated on the pump island. The pipework runs underground to the east of the site entrance where it ran above ground to the 85,000L diesel tank in the northeast corner of the site. The tank was noted to have a bund alarm, and at the time of the survey contained 41,260L of fuel. The tank and infrastructure is currently the responsibility of the tenant (Abellio West London) who remain in occupation at the time of writing.</p>

01: Abellio Site Overview

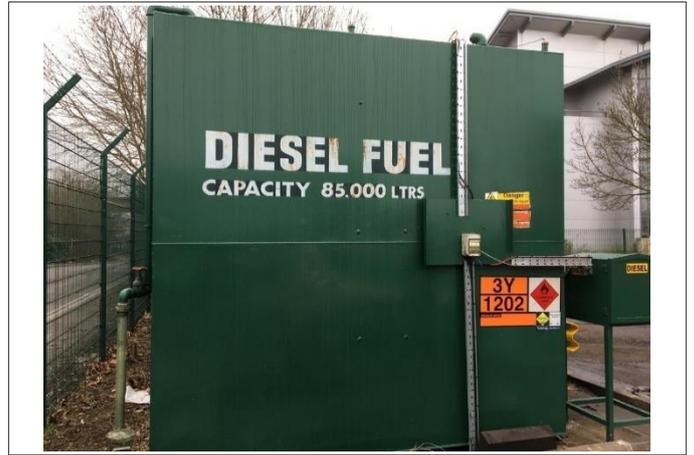
02: Abellio Fuel Tank

2.4.2	There is a large AST within the Abellio bus garage plot, which is the responsibility of Abellio West London who remain in occupation of the site. There was some residual staining to the hard surfacing from bus parking and movements on this part of the site.

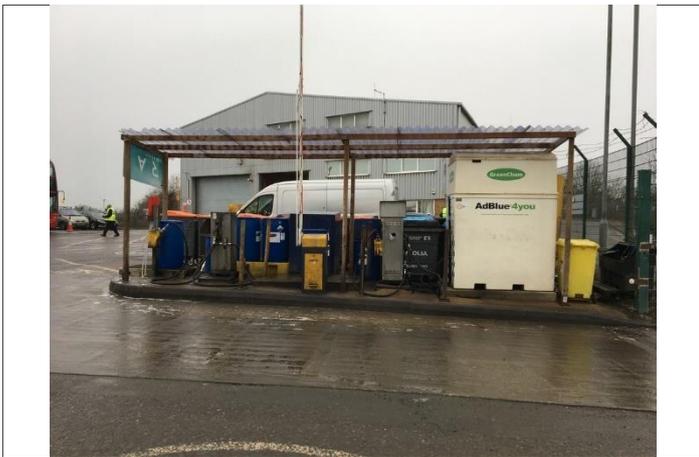
03: Abellio refuelling area
