ISSUING OFFICE: Paragon, The Harlequin Building, 65 Southwark Street, London, SE1 0HR
Tel: 020 7125 0112

REFERENCE: 20.0023/CB/DCN

2.1 This report has been prepared to discharge Condition 31(1b) of the planning application ref. 75111/APP/2020/1955 to cover the British Airways and Vodafone plots. The Abellio plot is to be investigated separately. The aims of this report are:

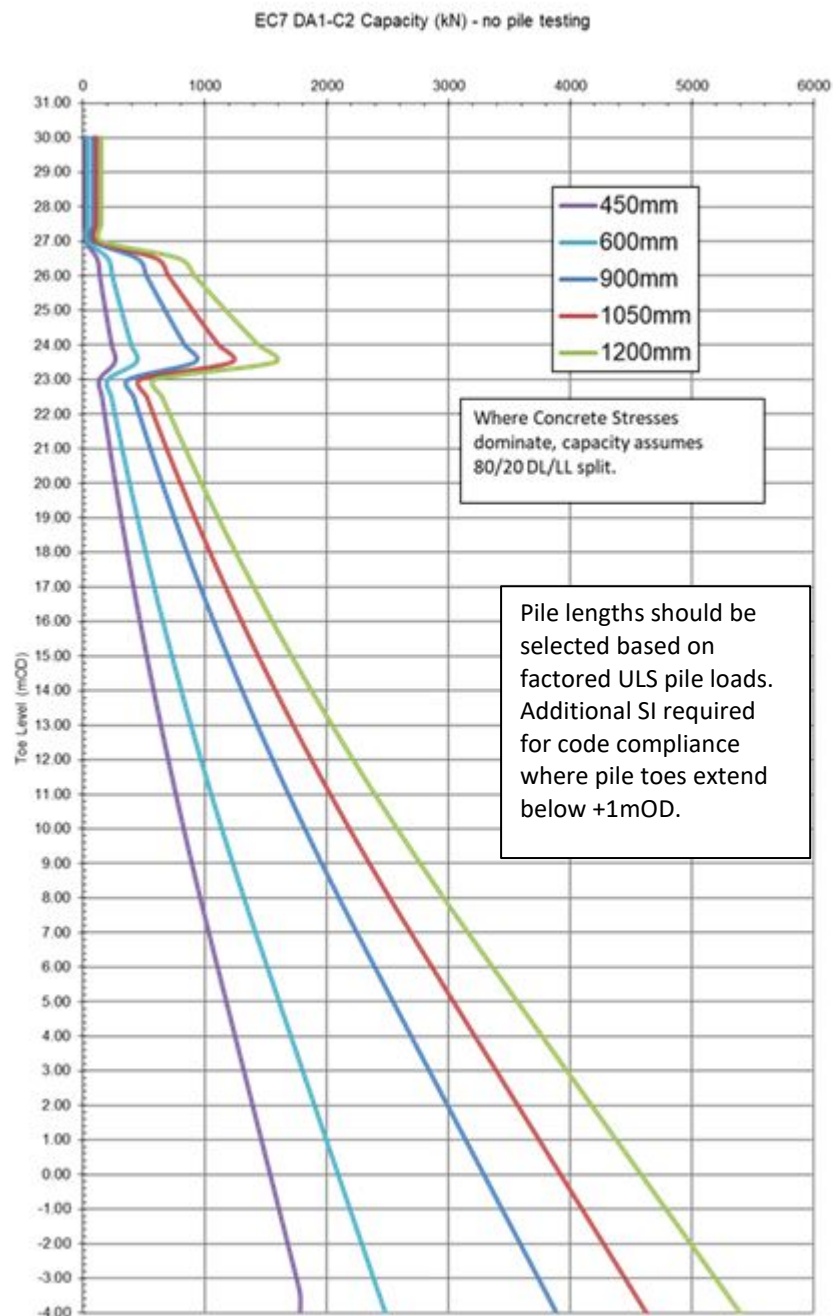
Graph 2. Preliminary pile design

13.5.4	<p>Eurocode 7 recommends that for pile foundations, the minimum borehole depth should be the largest of the following; note that current investigation data extends to 35mbgl (approximately -4mOD), therefore on this data, pile toe levels should be restricted to a minimum level of 30mbgl (+1mOD).</p> <ul style="list-style-type: none"> • Pile length + smaller side of the rectangle circumscribing the group of the piles forming the foundation at the level of pile base; • Pile length + 5m; • Pile length + (3 times the pile base diameter).

13.5.5	<p>Based on the above, the approximate loadings for piles with a diameter of 450mm, 600mm, 900mm, 1050mm and 1200mm at a depth of 30mbgl (+1mOD) would be 1200kN, 2000kN, 3200kN, 3700kN and 4400kN respectively. These are factored loads in accordance with Eurocode 7 Design Approach 1, combination 2. Therefore, the London Clay formation is considered to be a suitable bearing stratum at this stage. However, this will need to be reassessed once further information becomes available, because, if the loads increase, or the pile diameters reduce, then deeper boreholes would be required as the recommended minimum investigation depth required under Eurocode 7 could exceed the existing site investigation depth.</p>

5. A preliminary pile design has been provided based on three pile diameters within the report. Based on the site investigations carried out to date, the ground conditions below the site have been proven to a maximum depth of 35m bgl. Based on Eurocode 7, the pile depth should not exceed the borehole depth -5m, and as such a pile depth of 30mbgl (+1mOD) has been used to calculate potential loads under each pile diameter. Therefore, the approximate loadings for piles with a diameter of 400mm, 600mm, 900mm, 1050mm and 1200mm at a depth of 30mbgl would be 1200kN, 2000kN, 3200kN, 3700kN and 4400kN respectively. These are factored loads in accordance with Eurocode 7 Design Approach 1, combination 2. However, the pile capacities are dependent on the London Clay Formation, the surface of which has been found to vary across the site. This variation should be taken into consideration when finalising the pile length as it will affect the overall capacity. An intermediate level of 23mOD based on the top of the London Clay Formation has been selected for preliminary design. The assumed level of the top of the London Clay is selected as an intermediate value for the provision of an initial pile design; detailed design will need to consider the variation in levels.

6. Based on the above, the London Clay Formation is considered to be a suitable bearing stratum at this stage. However, this will need to be reassessed once further information becomes available, because, if the loads increase, or the pile diameters reduce, then deeper boreholes would be required as the recommended minimum investigation depth required under Eurocode 7 could exceed the existing site investigation depth.
