Holloway Lane

Preliminary Ground Investigation Report

SUEZ Recycling and Recovery

SLR Project No.: 416.064581.00001_P2

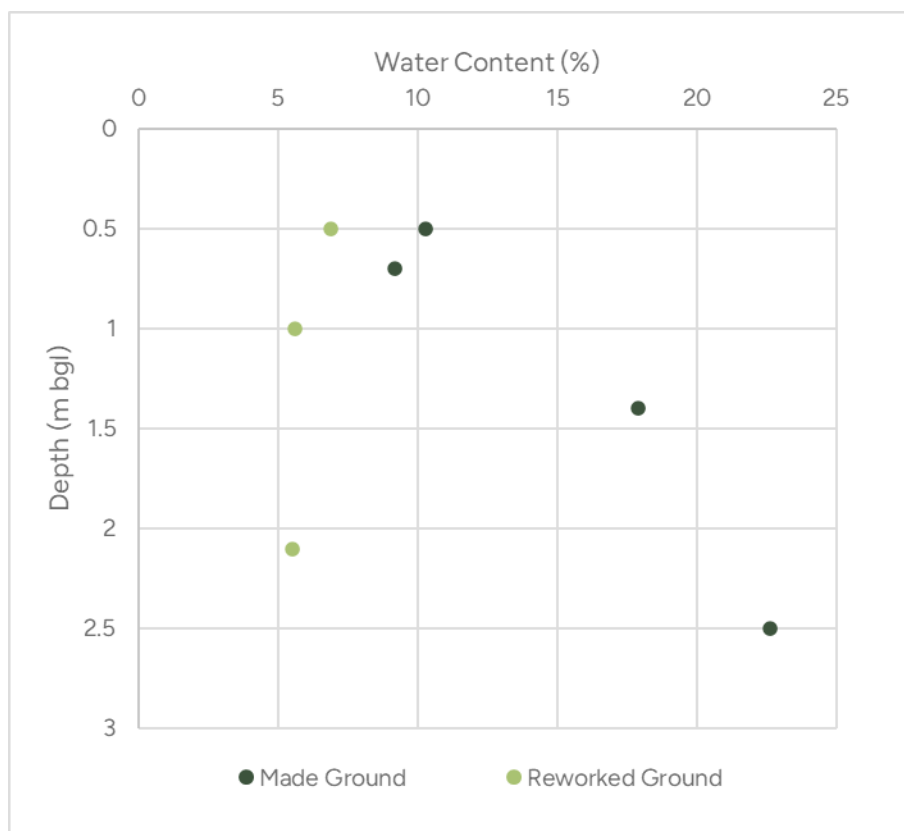
Figure 2: Water Content with Depth

Water content testing was carried out on seven samples of Made Ground deposits at depths of between 0.50m and 2.70m bgl. Water contents varied between 5.5% and 22.6%. The highest water content was recorded in TP01 (2.5m – 2.70) at 22.6%. Figure 2 shows an increase in water content with depth within the variable Made Ground deposits, and shows limited variability within the gravel deposits.

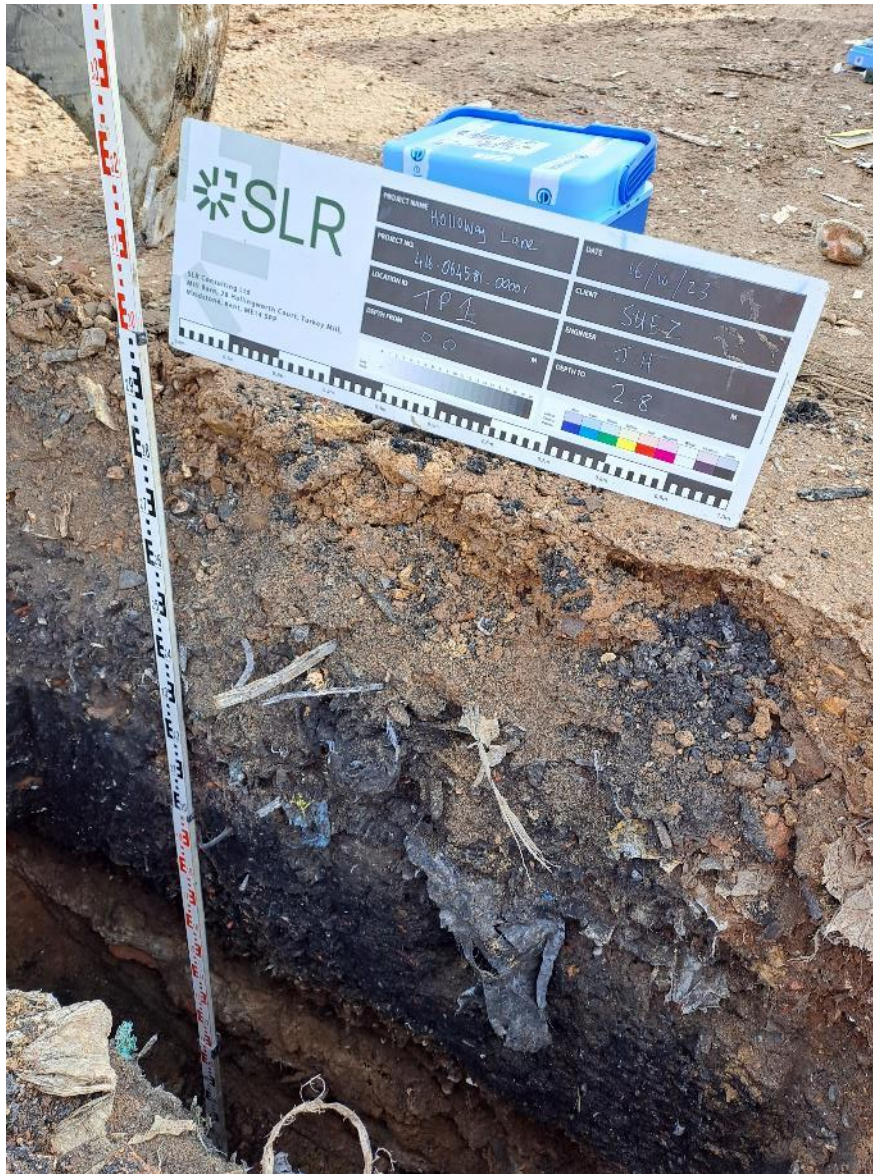
Photo 1: TP01 (16/10/23)

- Asbestos fibres have been detected within samples TP01 (0.4m) and TP01 (1.7m). This trial pit location was in the northwestern area of the site, where the skips are stored. The ground in this location consists of a raised platform of Made Ground material. No visible fibre bundles or fragments were observed during sampling.
- Concentrations of contaminants in soils are generally low and exceeded the laboratory LOD.
- TP01 (0.4m) and TP03 (1.2m) contained TPH concentrations (sum of aliphatics and aromatics) of 1,002 mg/kg and 1,463 mg/kg.

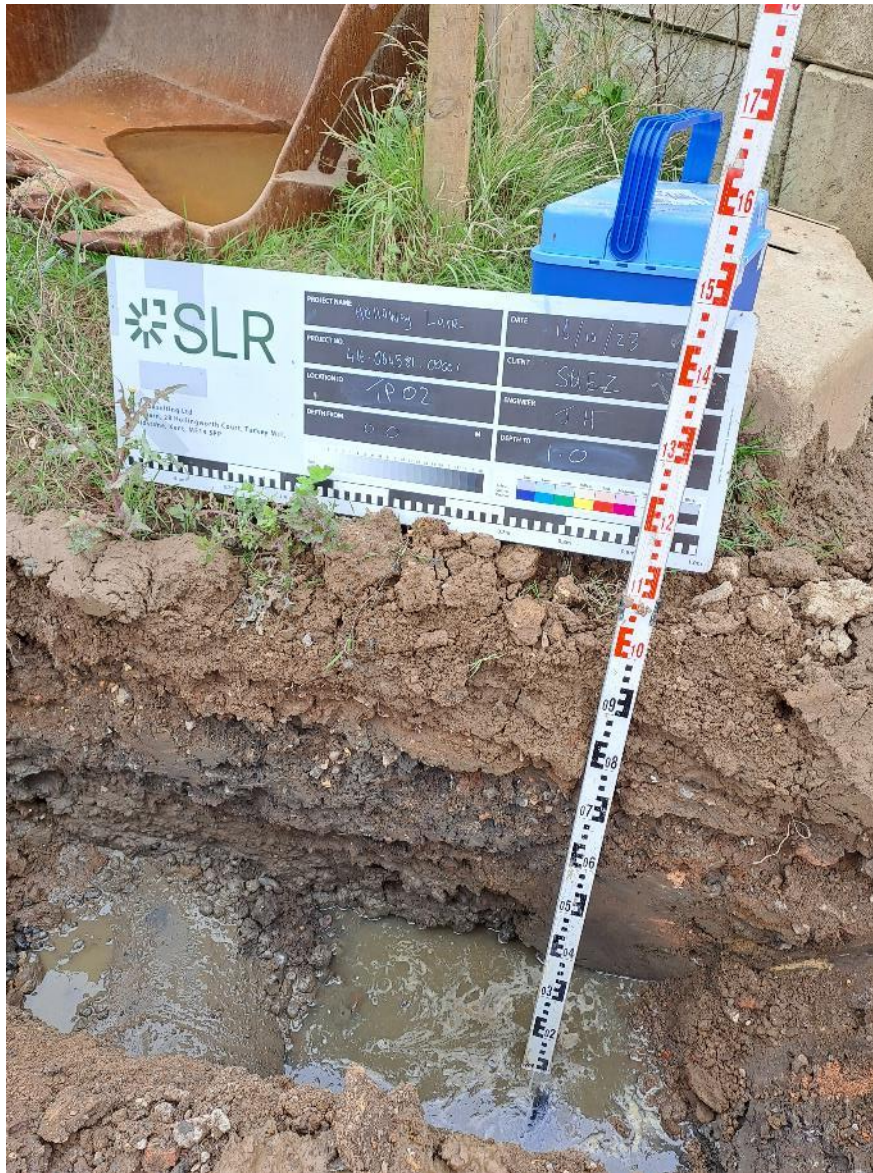
Photo 3: TP02 (16/10/23)

During ground excavation, a black HDPE pipe was encountered at a depth of 0.9m bgl in TP02. The excavation was terminated and the excavation backfilled. The pipe was not damaged prior to it being covered.

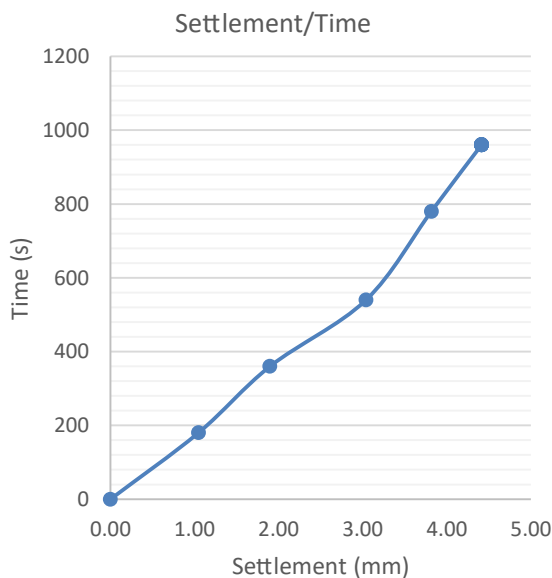
Maximum Applied Stress (kPa):	250
Maximum Settlement (mm):	4.41
Equivalent CBR Value (%):	4
Modulus of Subgrade Reaction, k_{762} (MN/m²/m):	32
