# 2021 Site Condition Report:

## Caprolactone Business Areas

### Baronet Works, Warrington

Project Number: GCU0141023

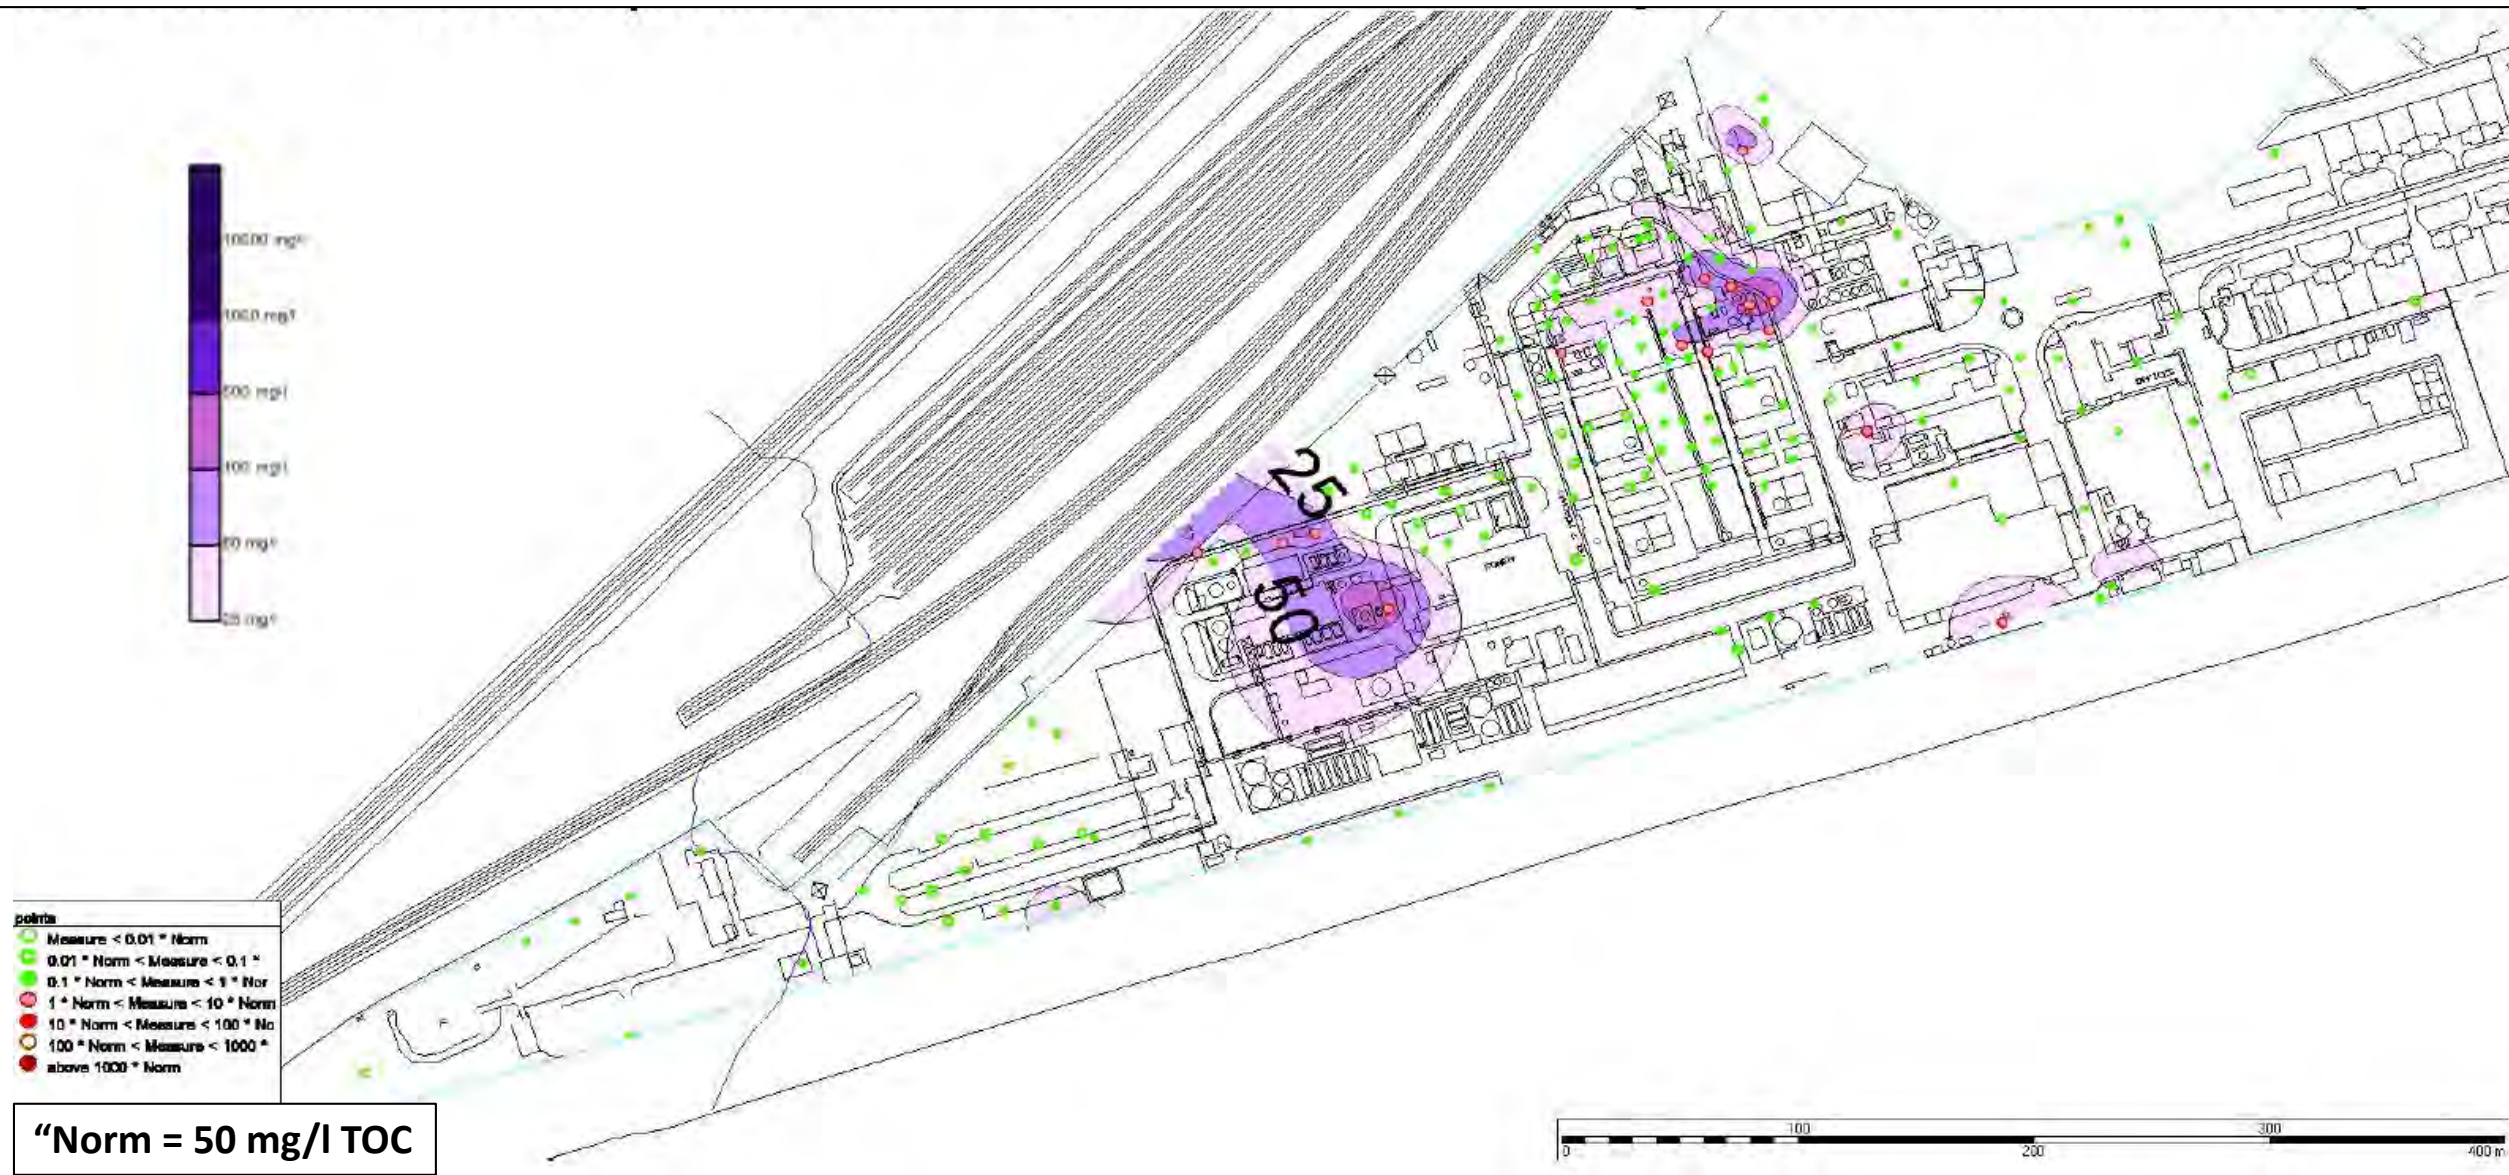
# Surfer plot of TOC concentrations in groundwater, Summer 2012

The time series total organic carbon (TOC) plots presented in **Appendix B**, illustrate the key organic contaminant impact areas (within the shallow drift aquifer) as measured in 1995; the former sextate and organic peroxide plants, the pumphouse area and AO Plant related impacts. An improvement in groundwater quality is observed over time as shown by comparison of TOC plots from 1995 and 2012/2013. Note that the contoured areas are relative to a norm of 50 mg/l TOC.
