Knottingley Waste to Resource Facility

FCC Recycling (UK) Limited

Environmental Permit Variation Application

Site Condition Report

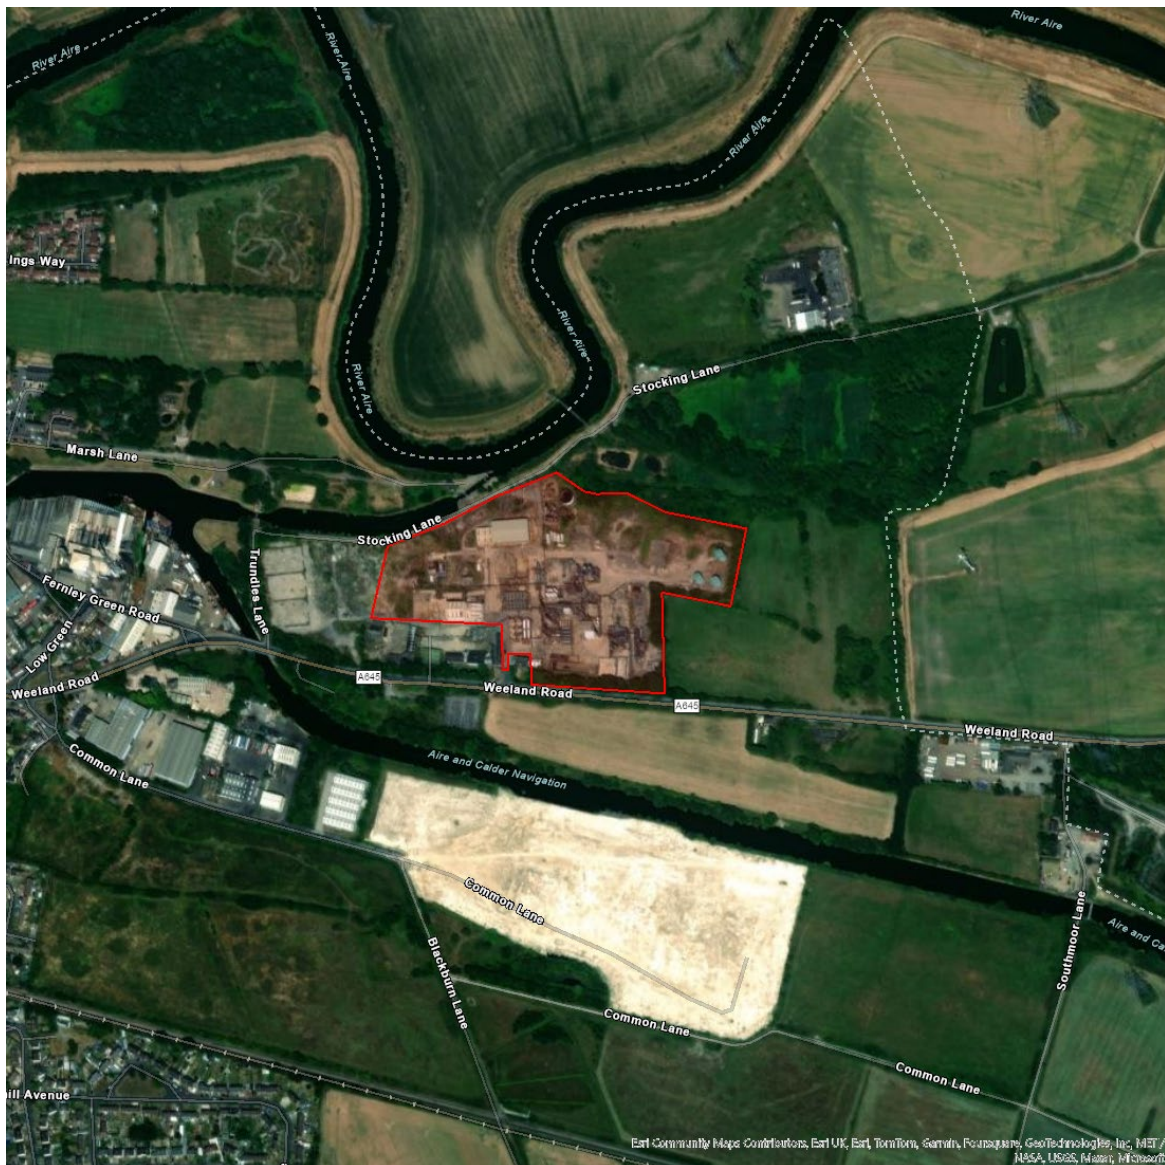
Figure 1 – Site Location (permit boundary in Red).

2.2.3 The Site location (shown within the red line boundary) is displayed in **Figure 1** below:

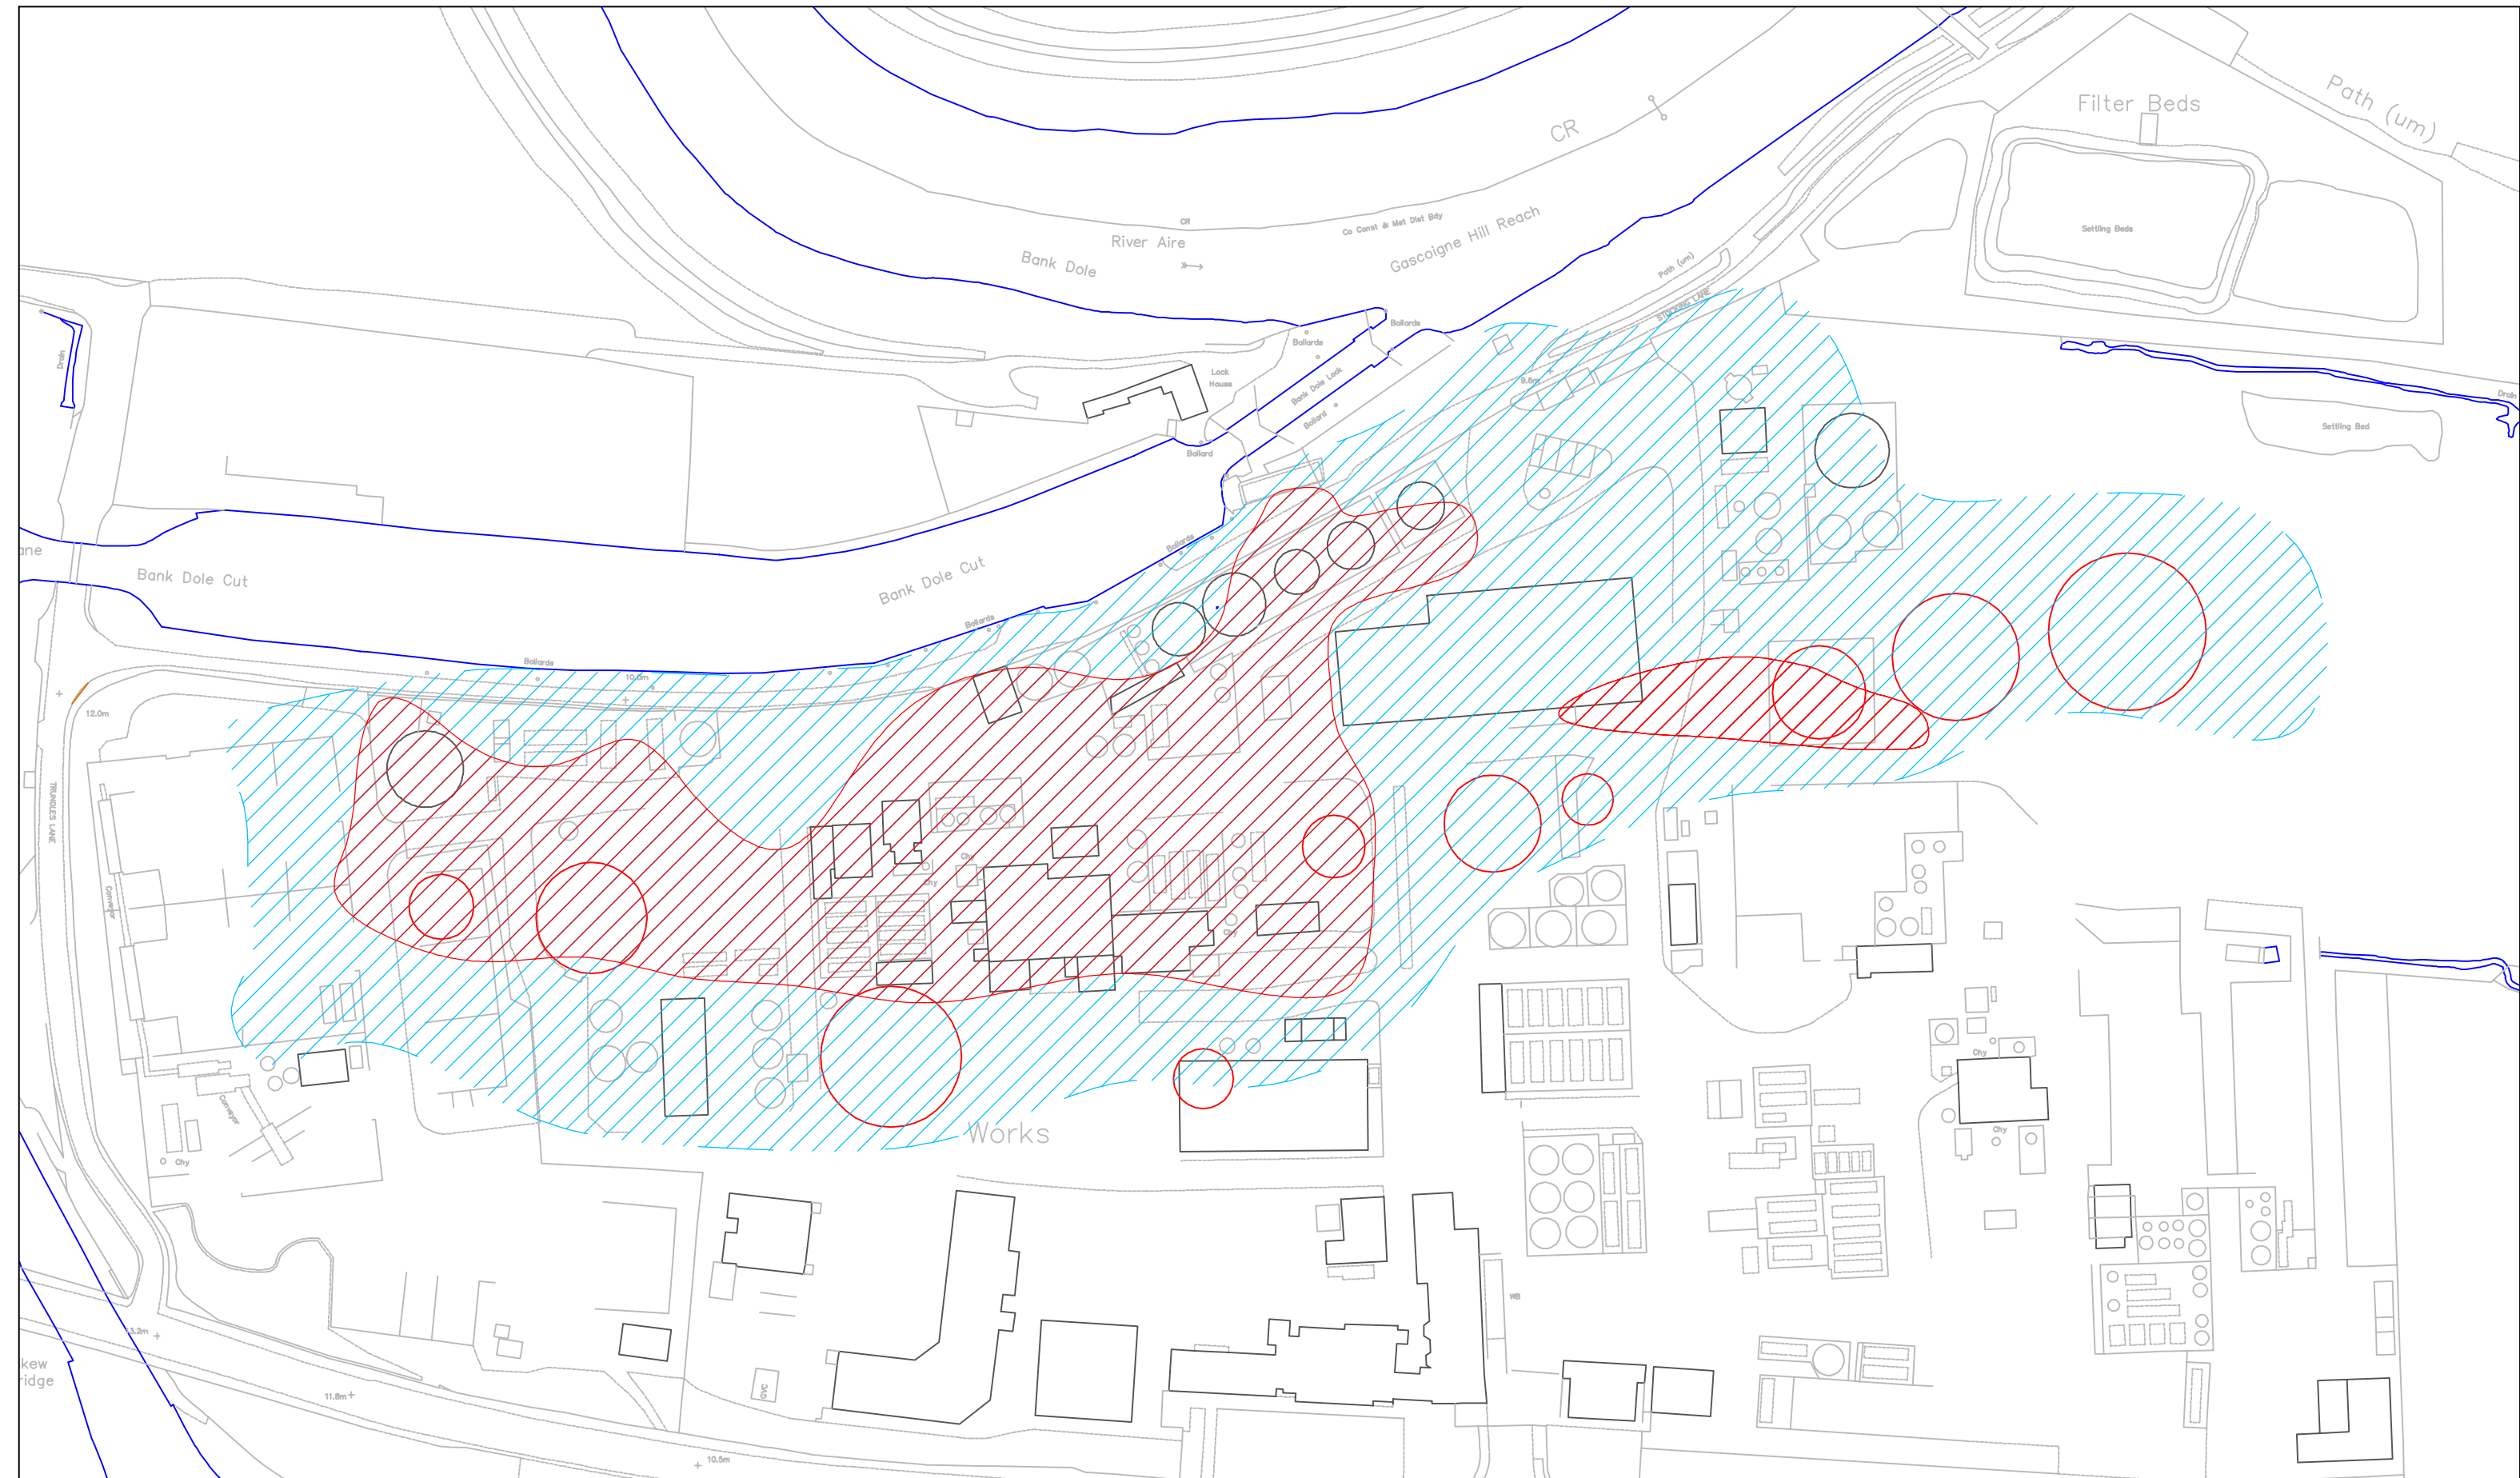
- Identified NAPL Extent
- Anticipated NAPL Extent based upon investigation data

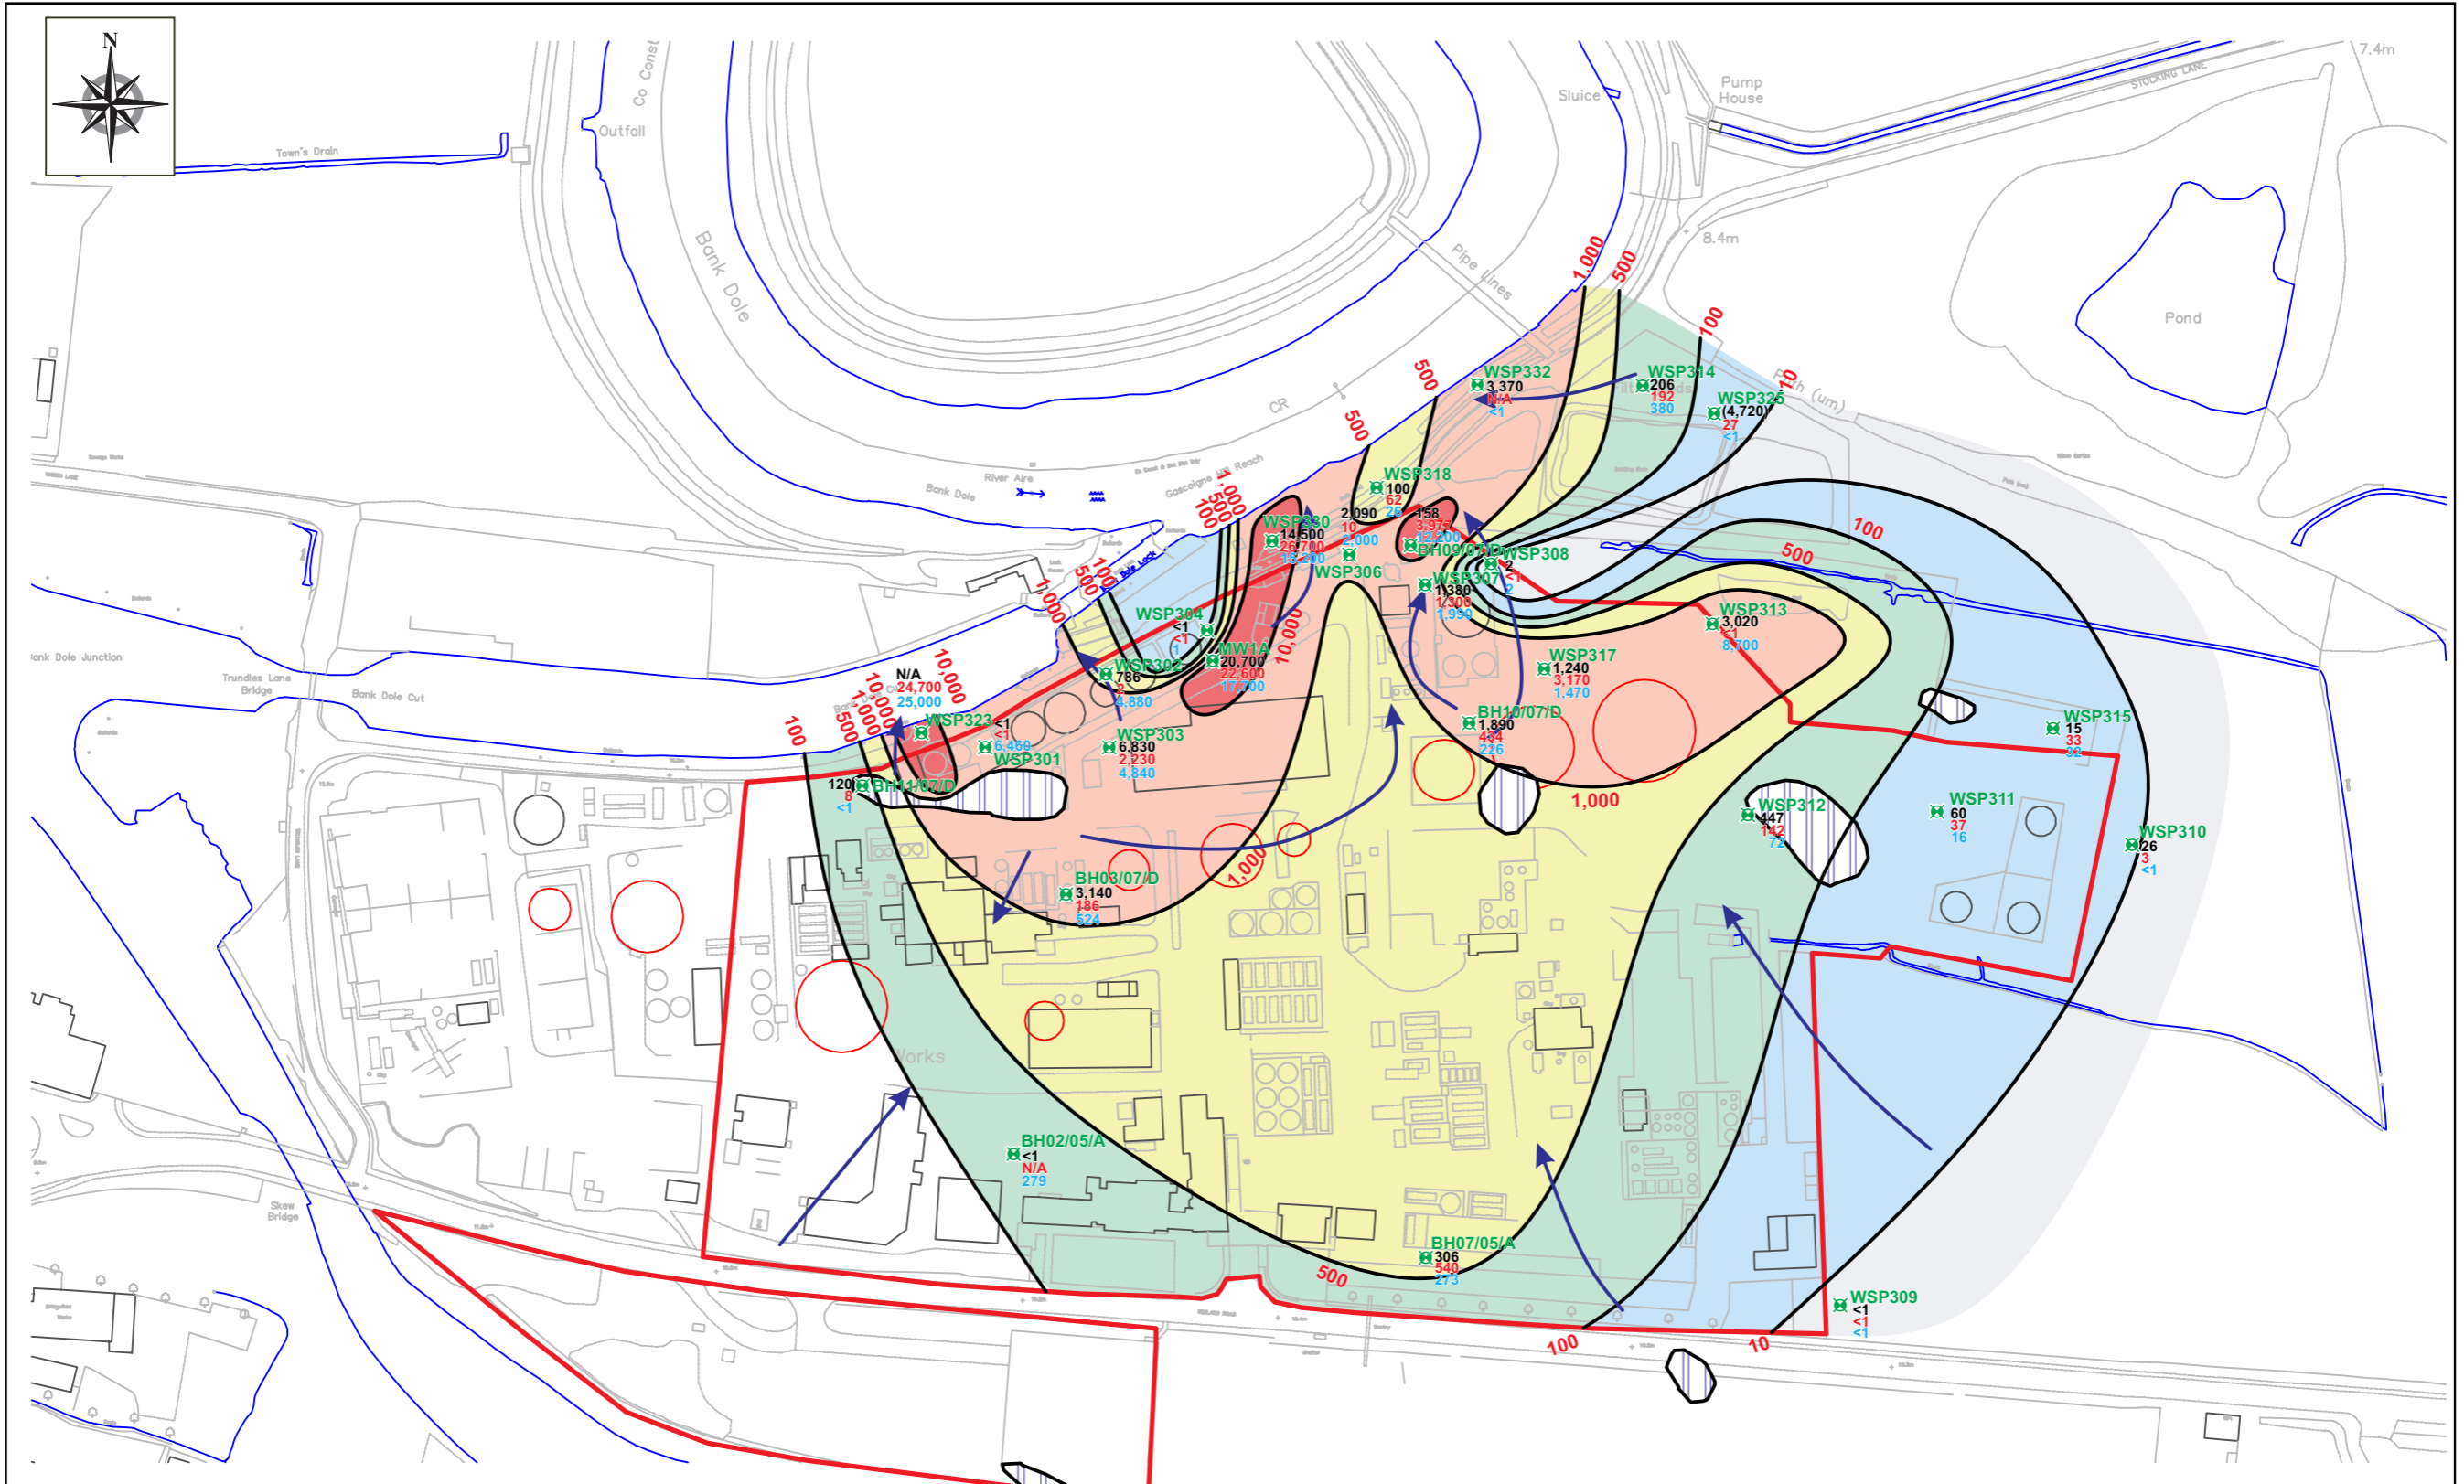
Note: Methane Concentration Contours based on highest recorded Methane concentration in 2023.
