Photographs of the Quarry Floor at Went Edge Quarry for the Permit Variation. December 2018

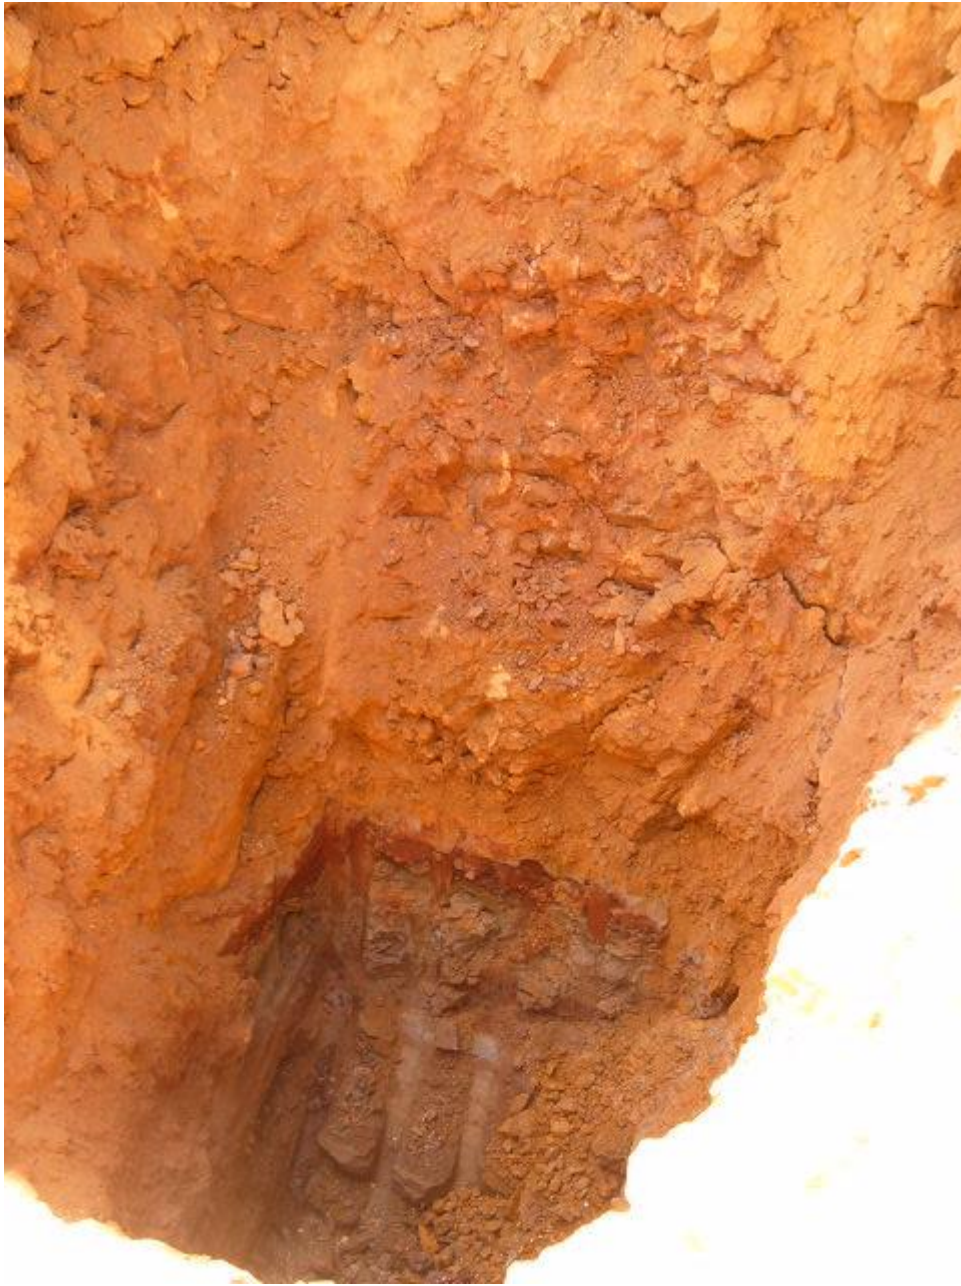
Photograph number 1 showing the base of the limestone and the red marl below at 2.4 metres in May 2007.

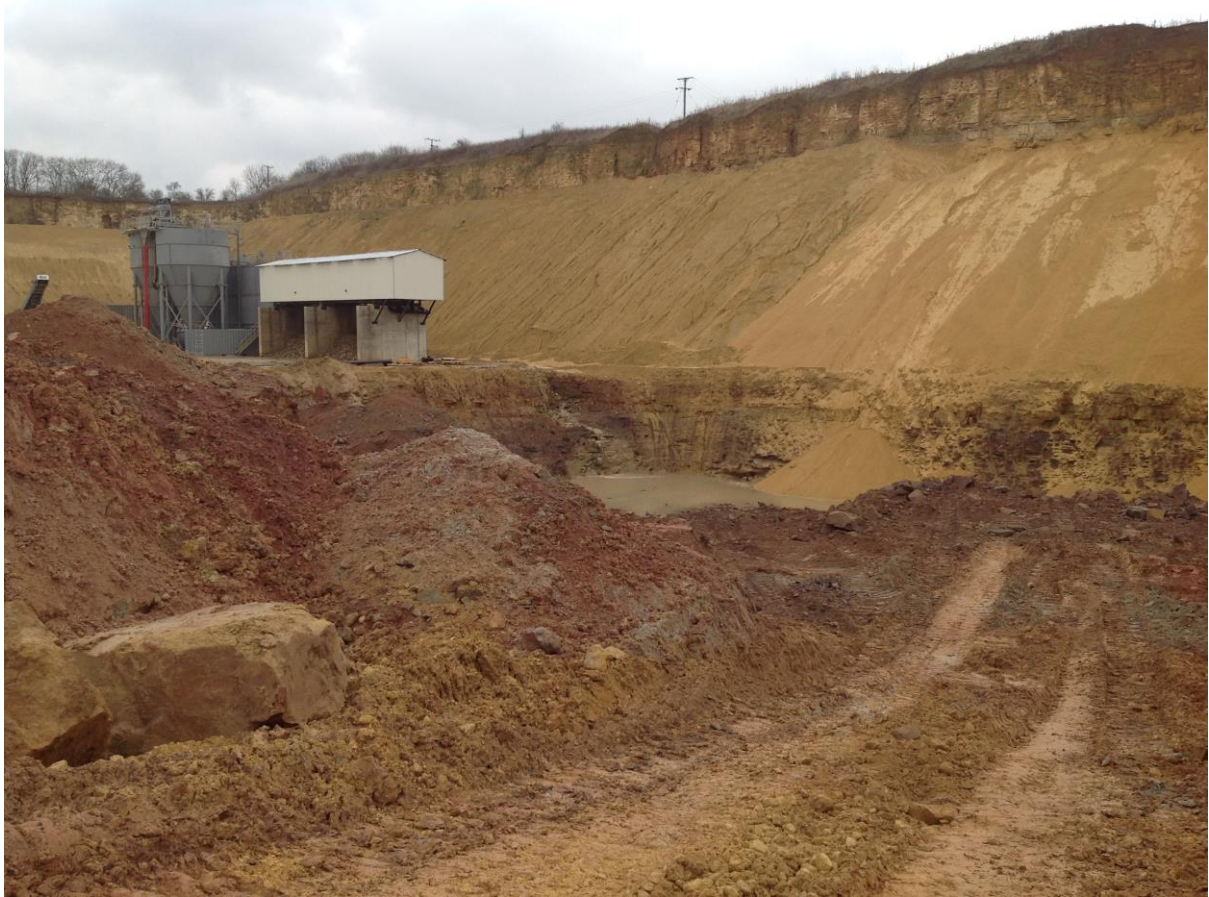
Photograph number 2 showing the temporary quarry sump on the marl excavated in February 2017 near to the wash plant for the quarrying operation to obtain the limestone and use the red marl for the clay lining of the permanent quarry sump.

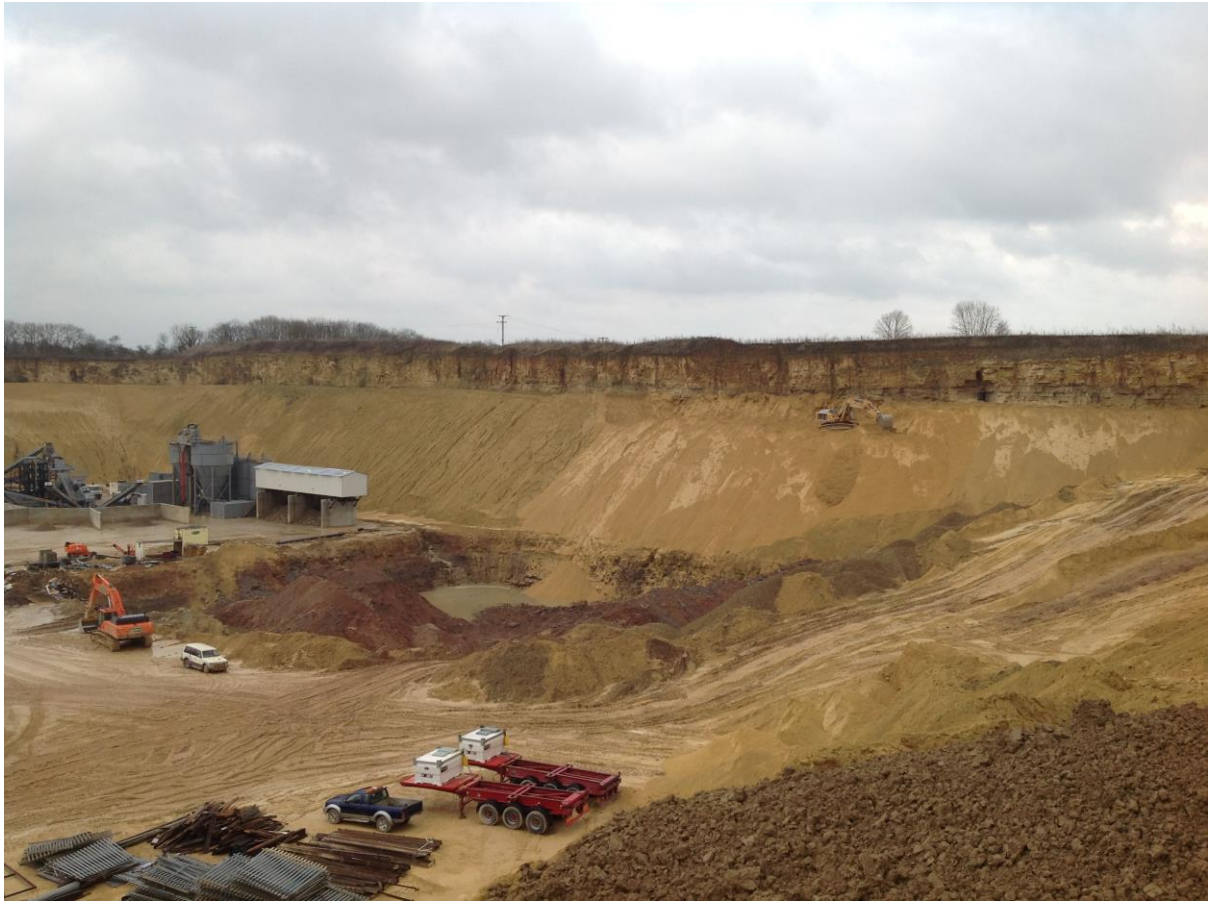
Photograph number 3 showing the sump and the wash plant area in the north east corner of the quarry in February 2017. The sump has now been backfilled with compacted limestone fines and marl after dewatering the sump.
