Birch Tree Poultry Site

SITE CONDITION REPORT

Ref: CFL/19/SCR

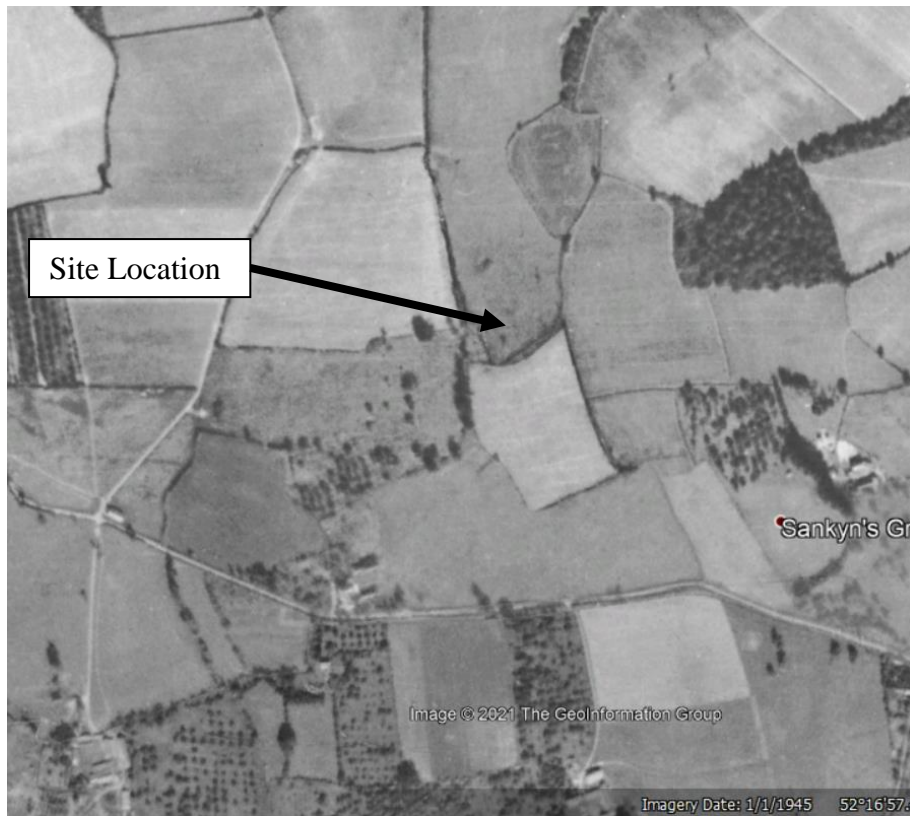
The first imagery available on Google Earth (1945) shows the site as a field

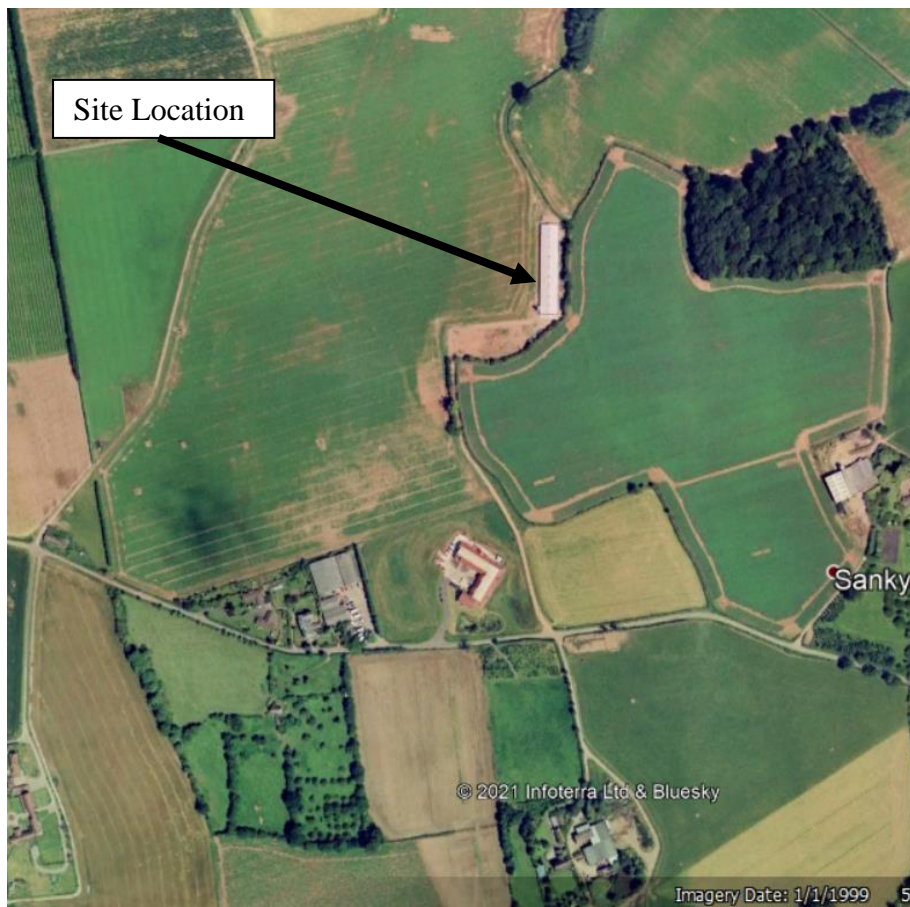
Coming forward to 1999, Google Earth shows the first poultry building has been constructed, and the rest of the site is planted with crops.

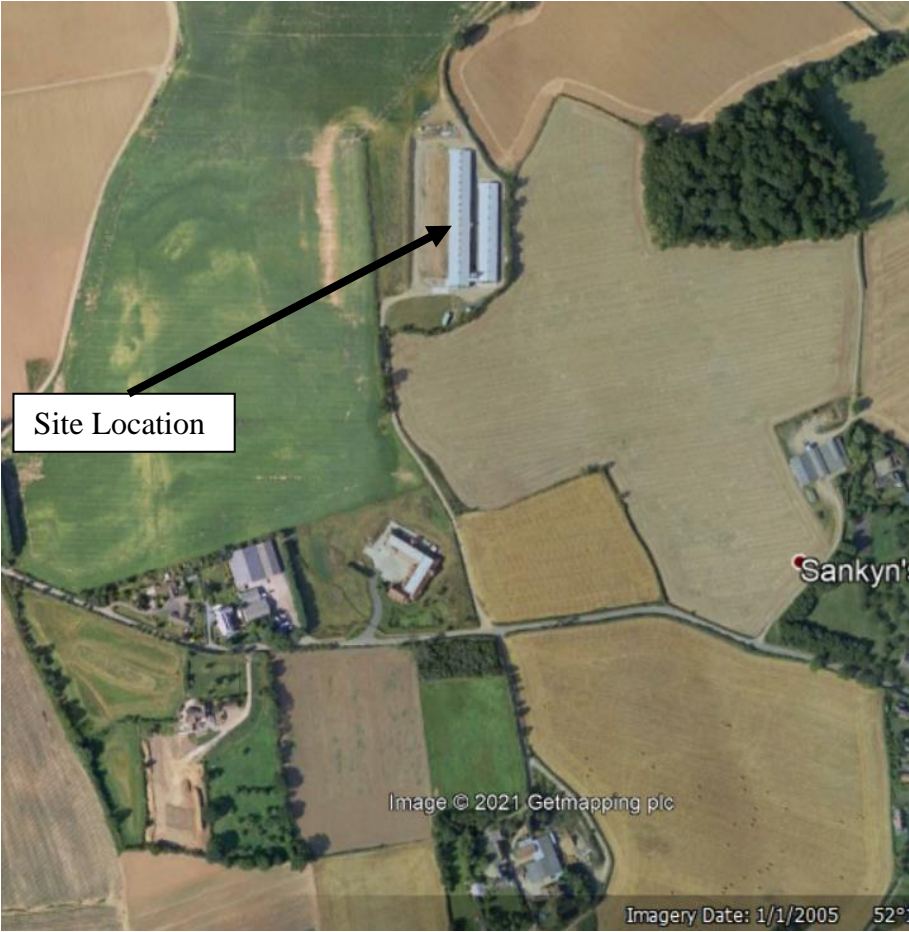
By 2005 the second building has been constructed, and the site for the third has been stripped of topsoil. The Third building would not be built until 2021.
