Variation of Environmental Permit EPR/GP3292FT Site Condition Report

European Metal Recycling Ltd
EMR Darlaston – Fridge Destruction
Bentley Road South
Darlaston
West Midlands
WS10 8LW

IED Groundwater Monitoring Assessment Report

Report Reference: 129-002365-02

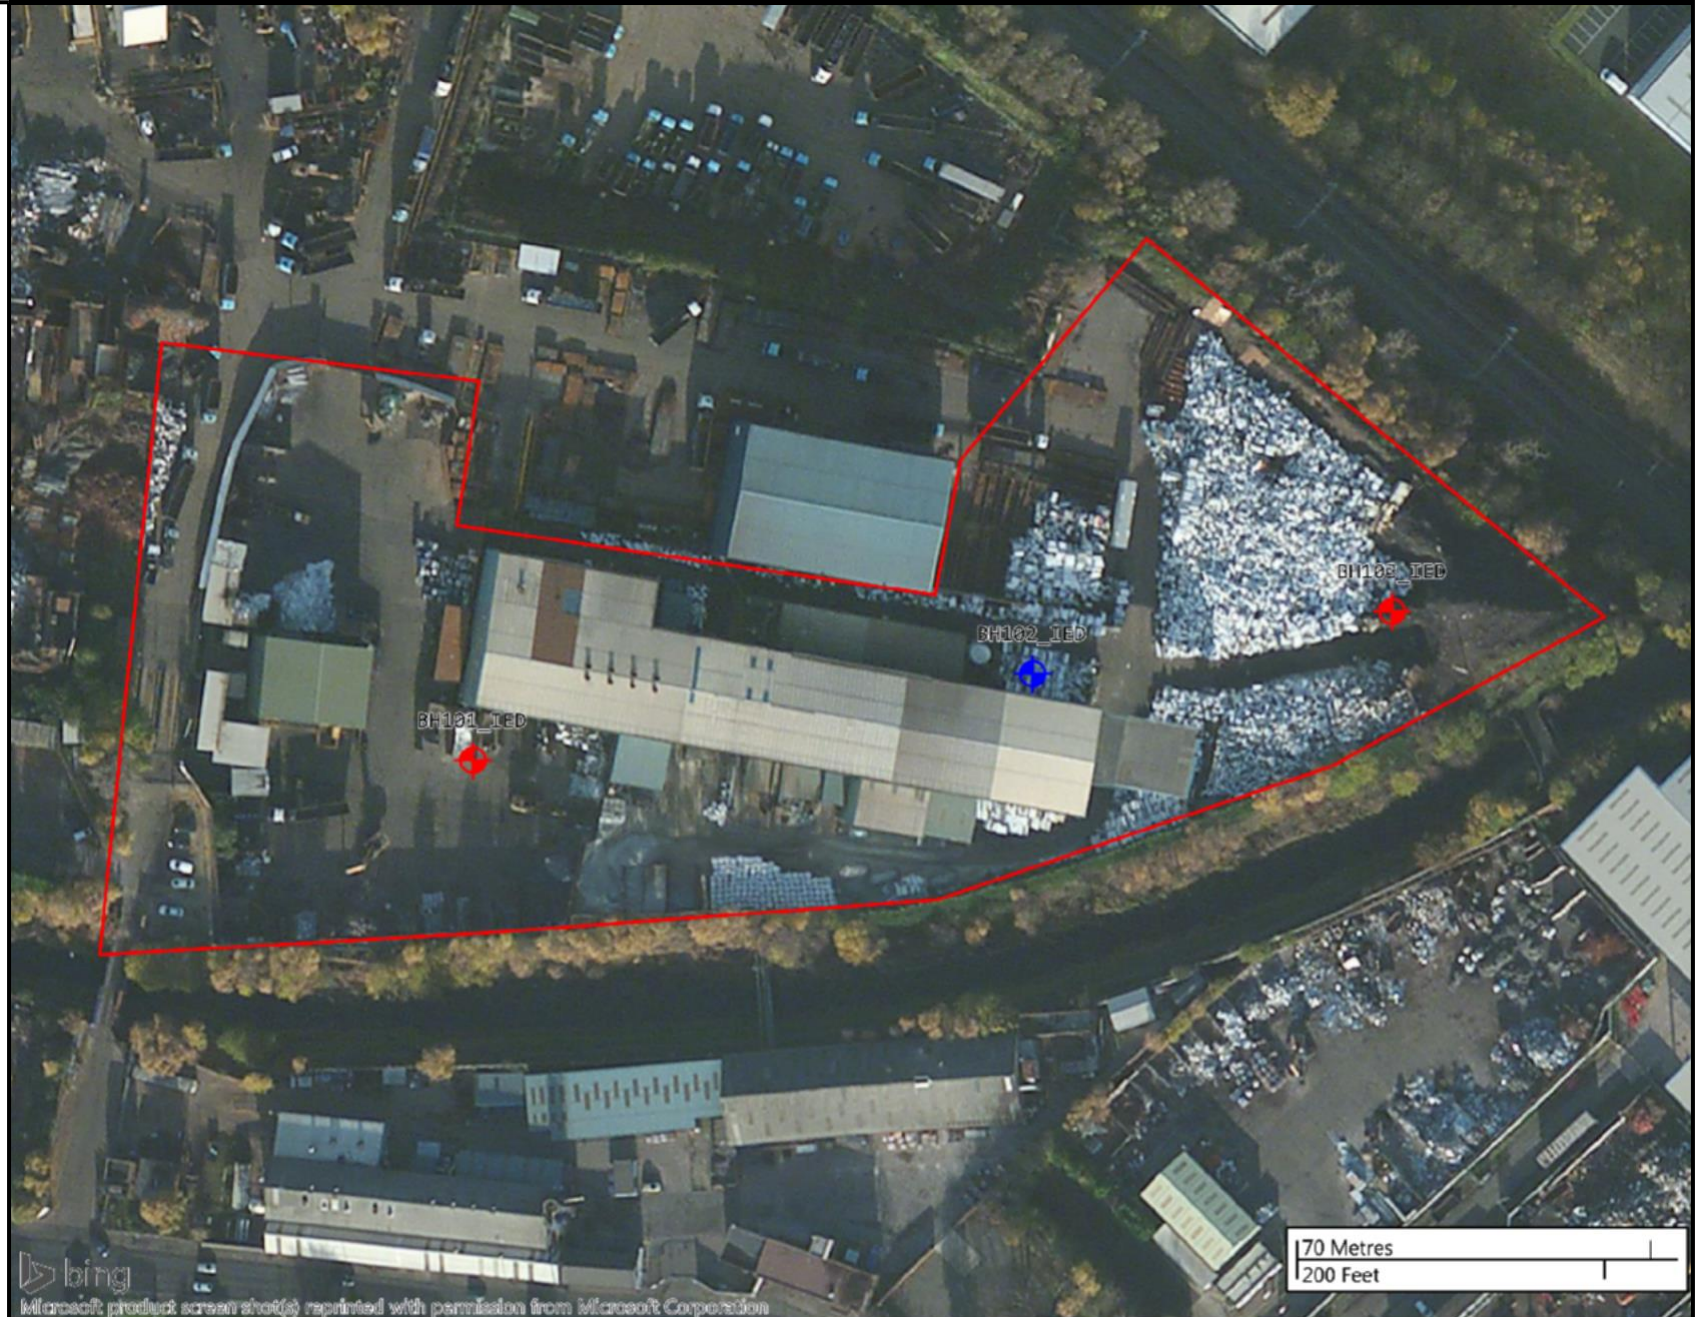
Title: Site Plan
Scale: 1:1500
Consultant: Callum Sutcliffe
Contractor: Mayer Environmental Ltd

A location plan with a red line boundary of the subject site is included in Appendix A.

MEL undertook the groundwater monitoring on the 16th February 2023. The locations sampled were determined by the previous investigation in 2017. A map of the locations from this investigation can be found in Appendix A. BH101_IED was the only location that could still be accessed for groundwater monitoring as BH102_IED did not have a monitoring well installed in 2017 and BH103_IED could not be located due to the volume of fridges within the fridge storage area.

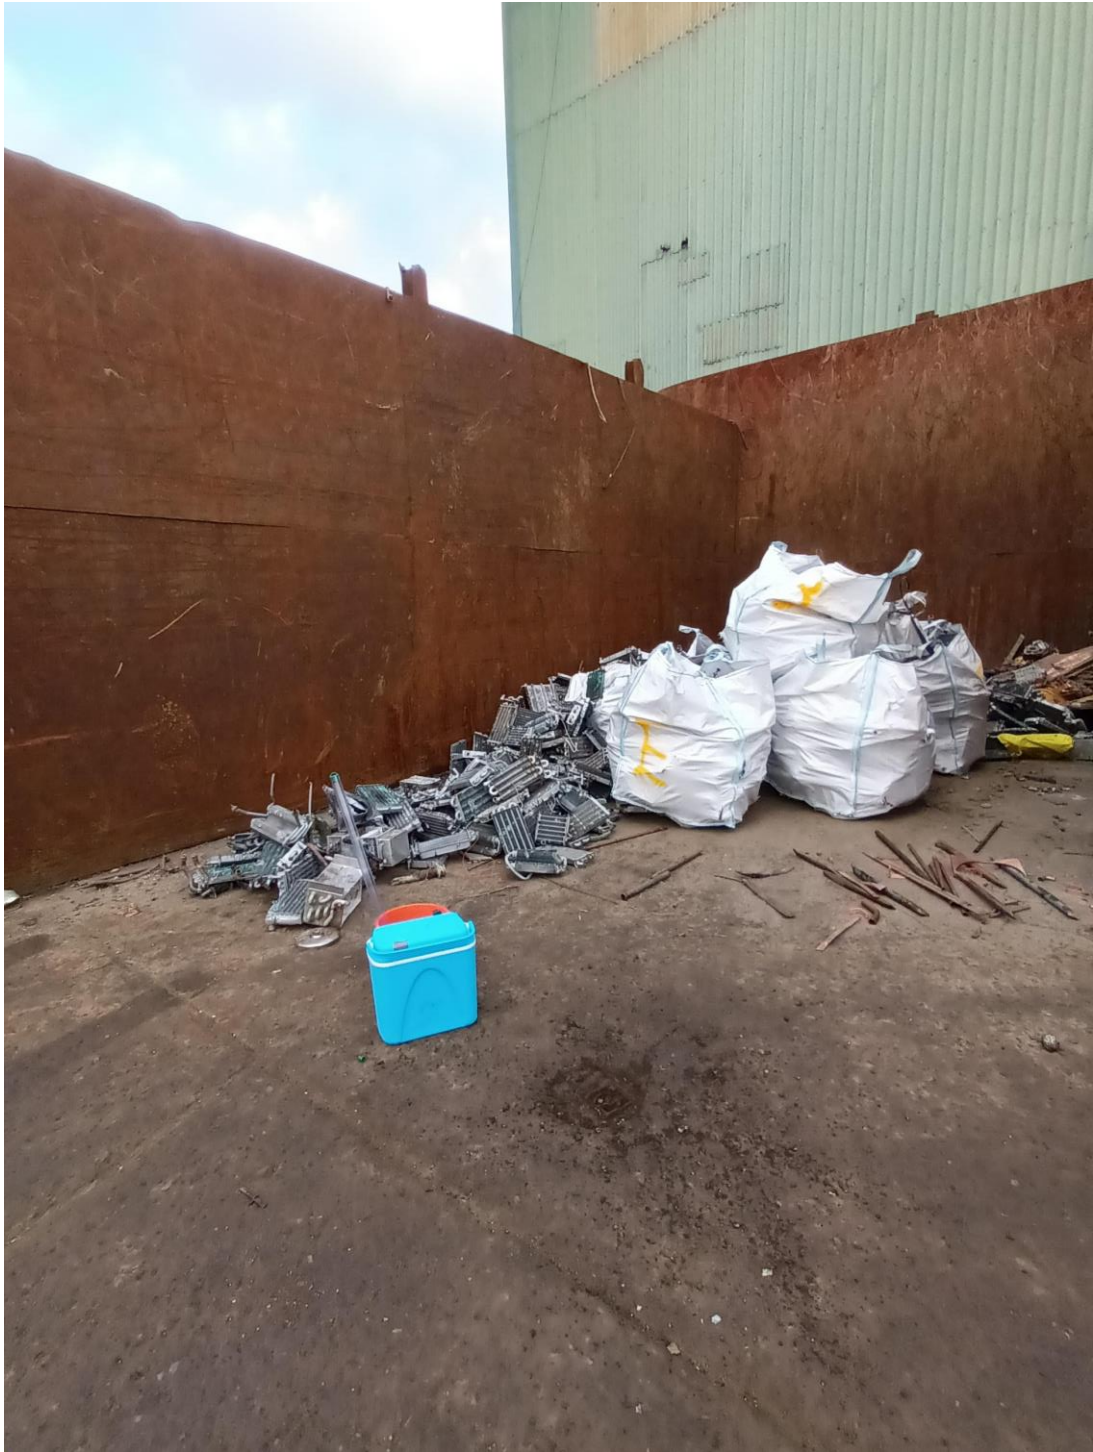
Photograph 1: Location of BH101

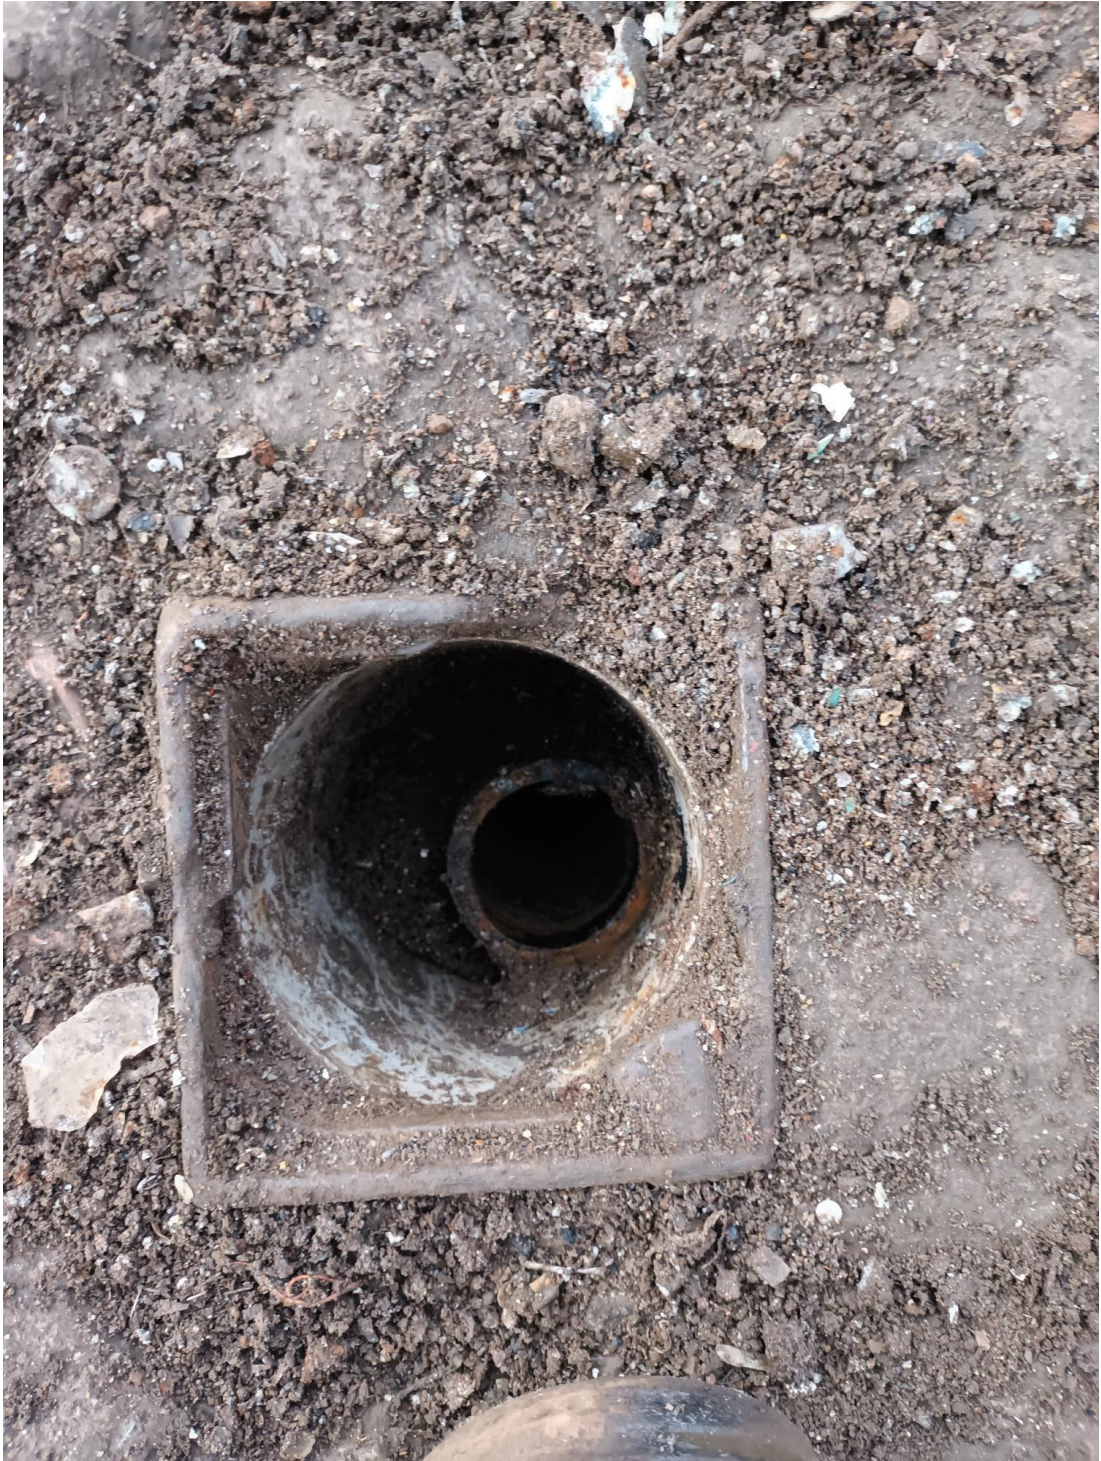
Due to the steel protective lid being removed from the borehole there was some interference with the standpipe which meant an inertial pump was used with a 16mm diameter and a maximum flow rate of 2 litres per minute. The standpipe internal diameter was 50mm and the height of standing water column in the borehole was 5.5m.

Photograph 2: Photo of BH101 with no steel protective lid

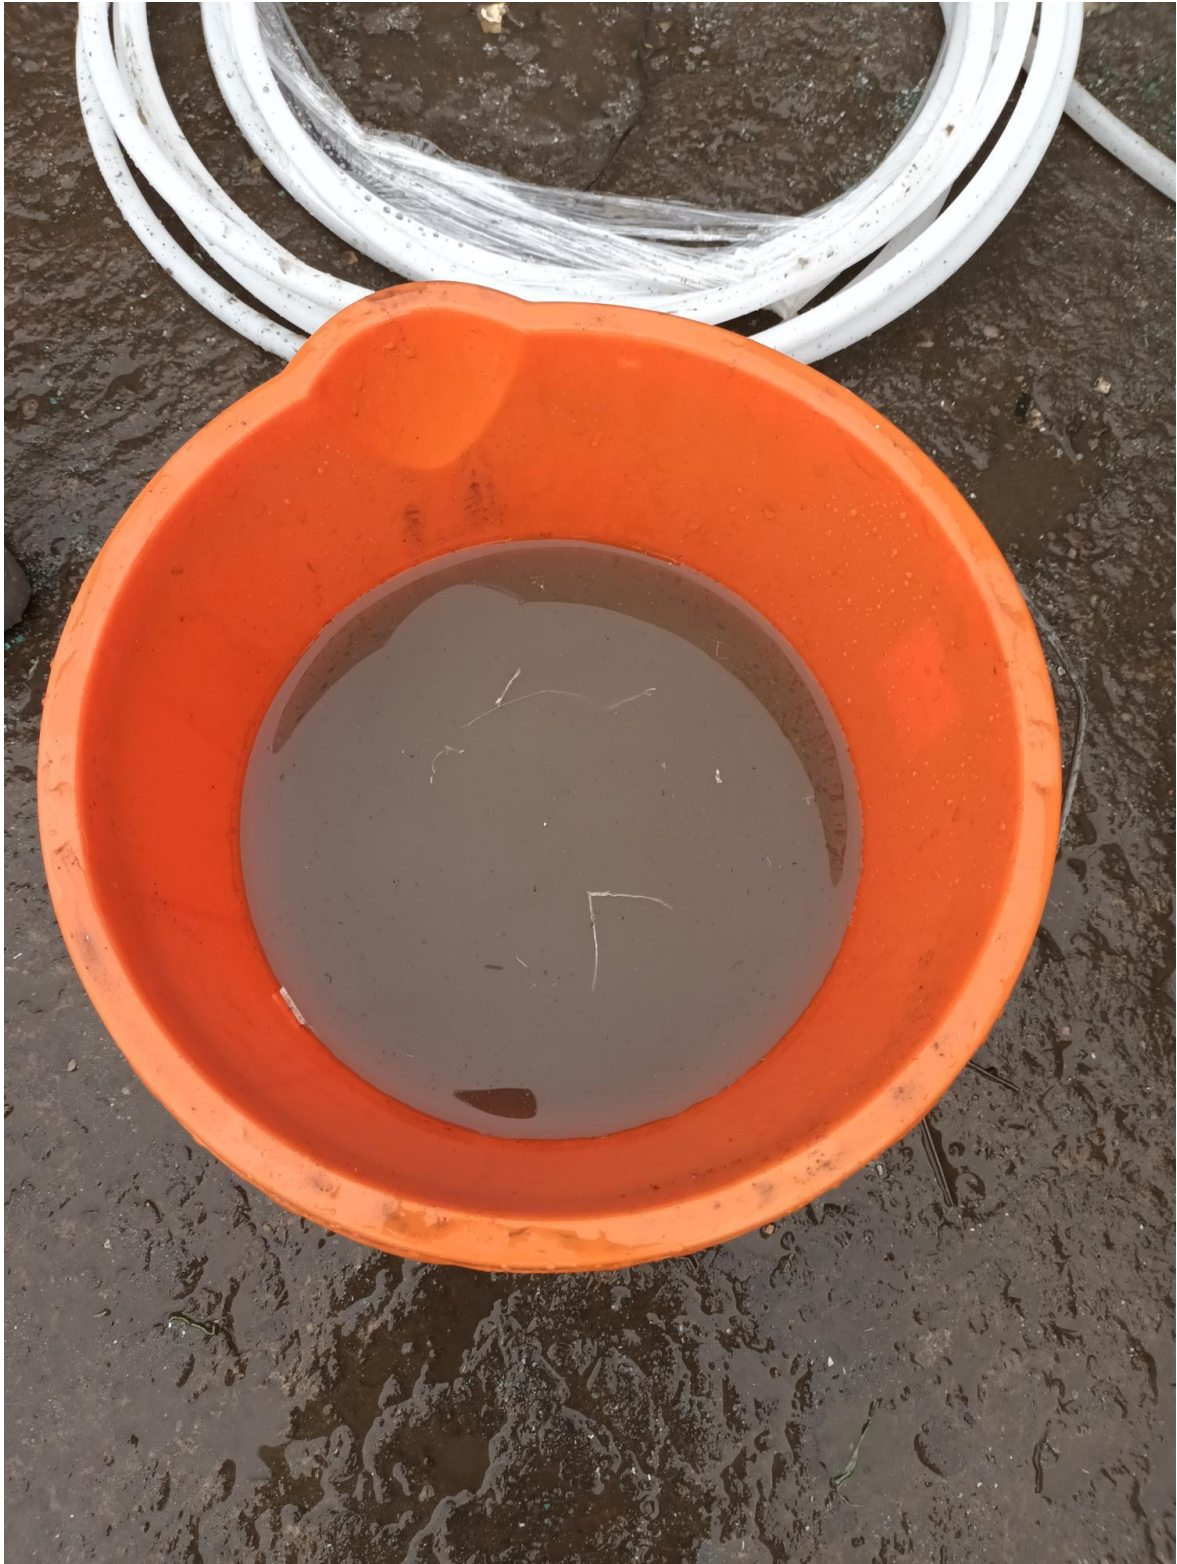
The water purged from BH101_IED was generally noted to have a high proportion of sediment and brown in colour. No sheen or hydrocarbon odour were noted. A photo of the purged water can be found in Appendix B.

Photograph 3: Photo of the purged water from BH101

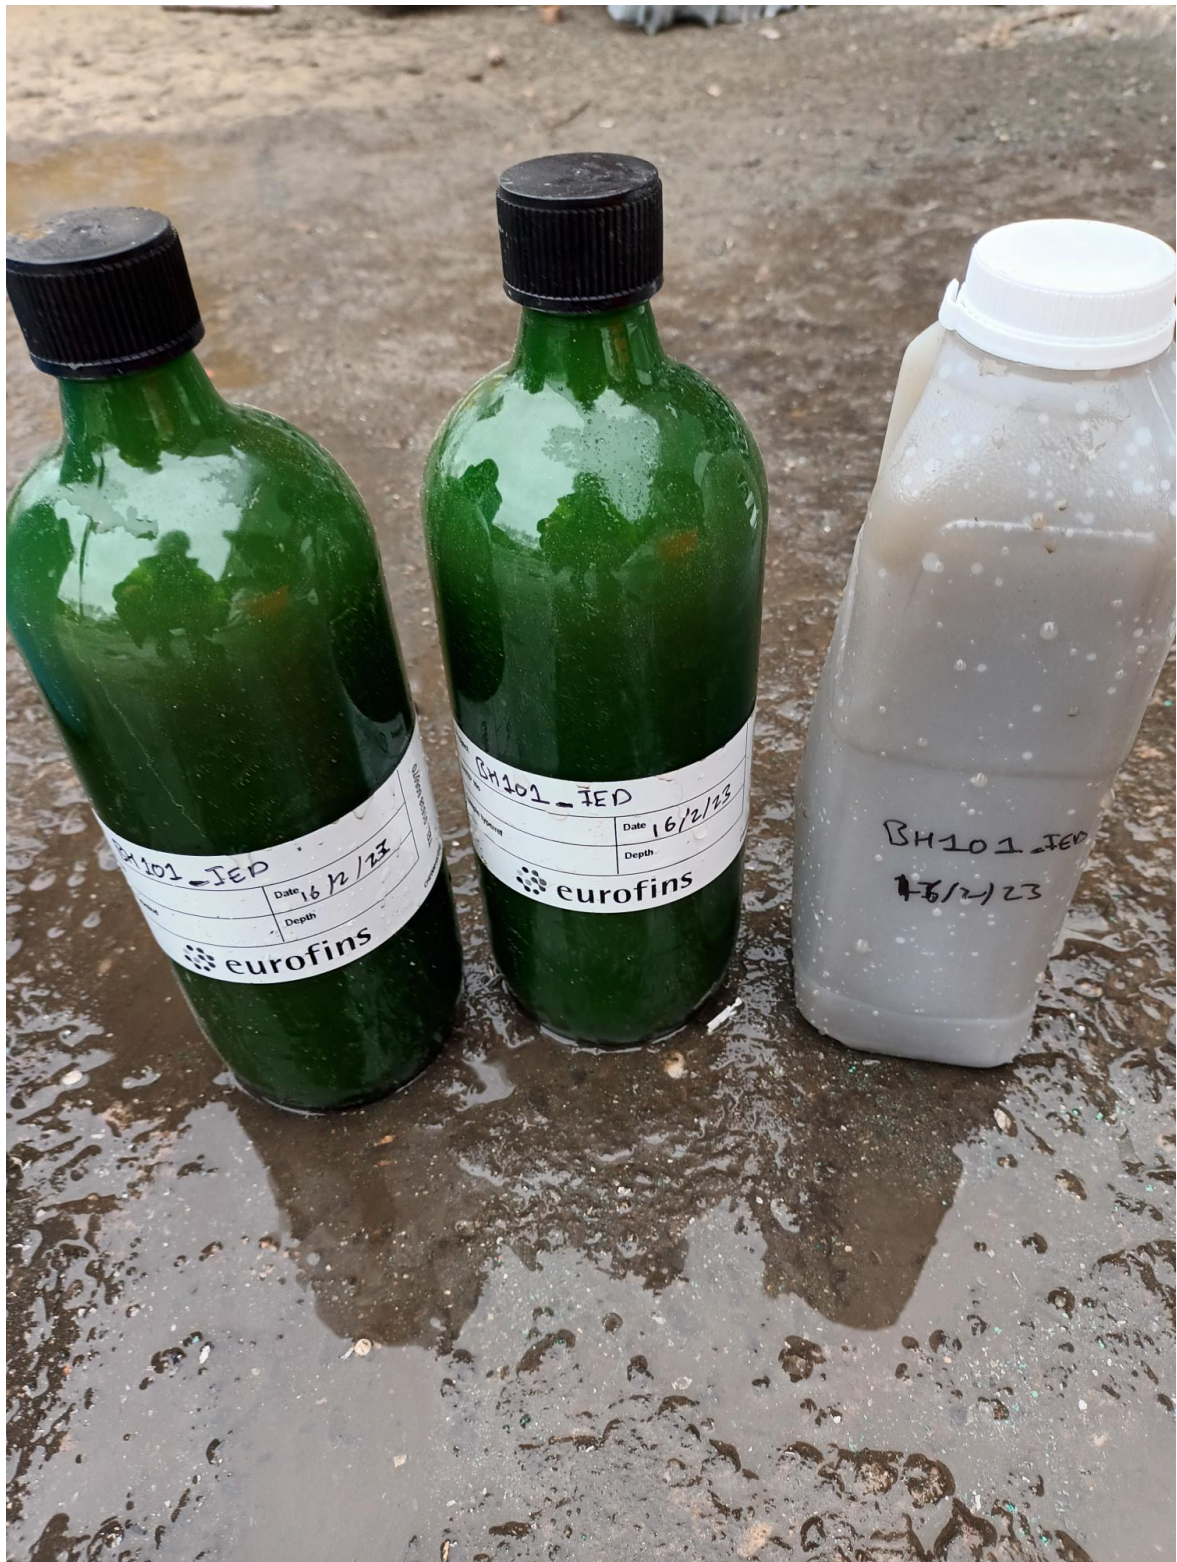
Photograph 4: Photo of the sampled water from BH101 inside the sampling containers
