# ENVIRONMENTAL SENSITIVITY AND SITE DESIGN REPORT

Waste Recovery Permit - Deposit for Recovery

Reclamation of the former British Sugar Refinery Site, York

Report No 10024487-AUK-XX-XX-RP-GE-0058-03-Environmental Sensitivity and Site Design Report

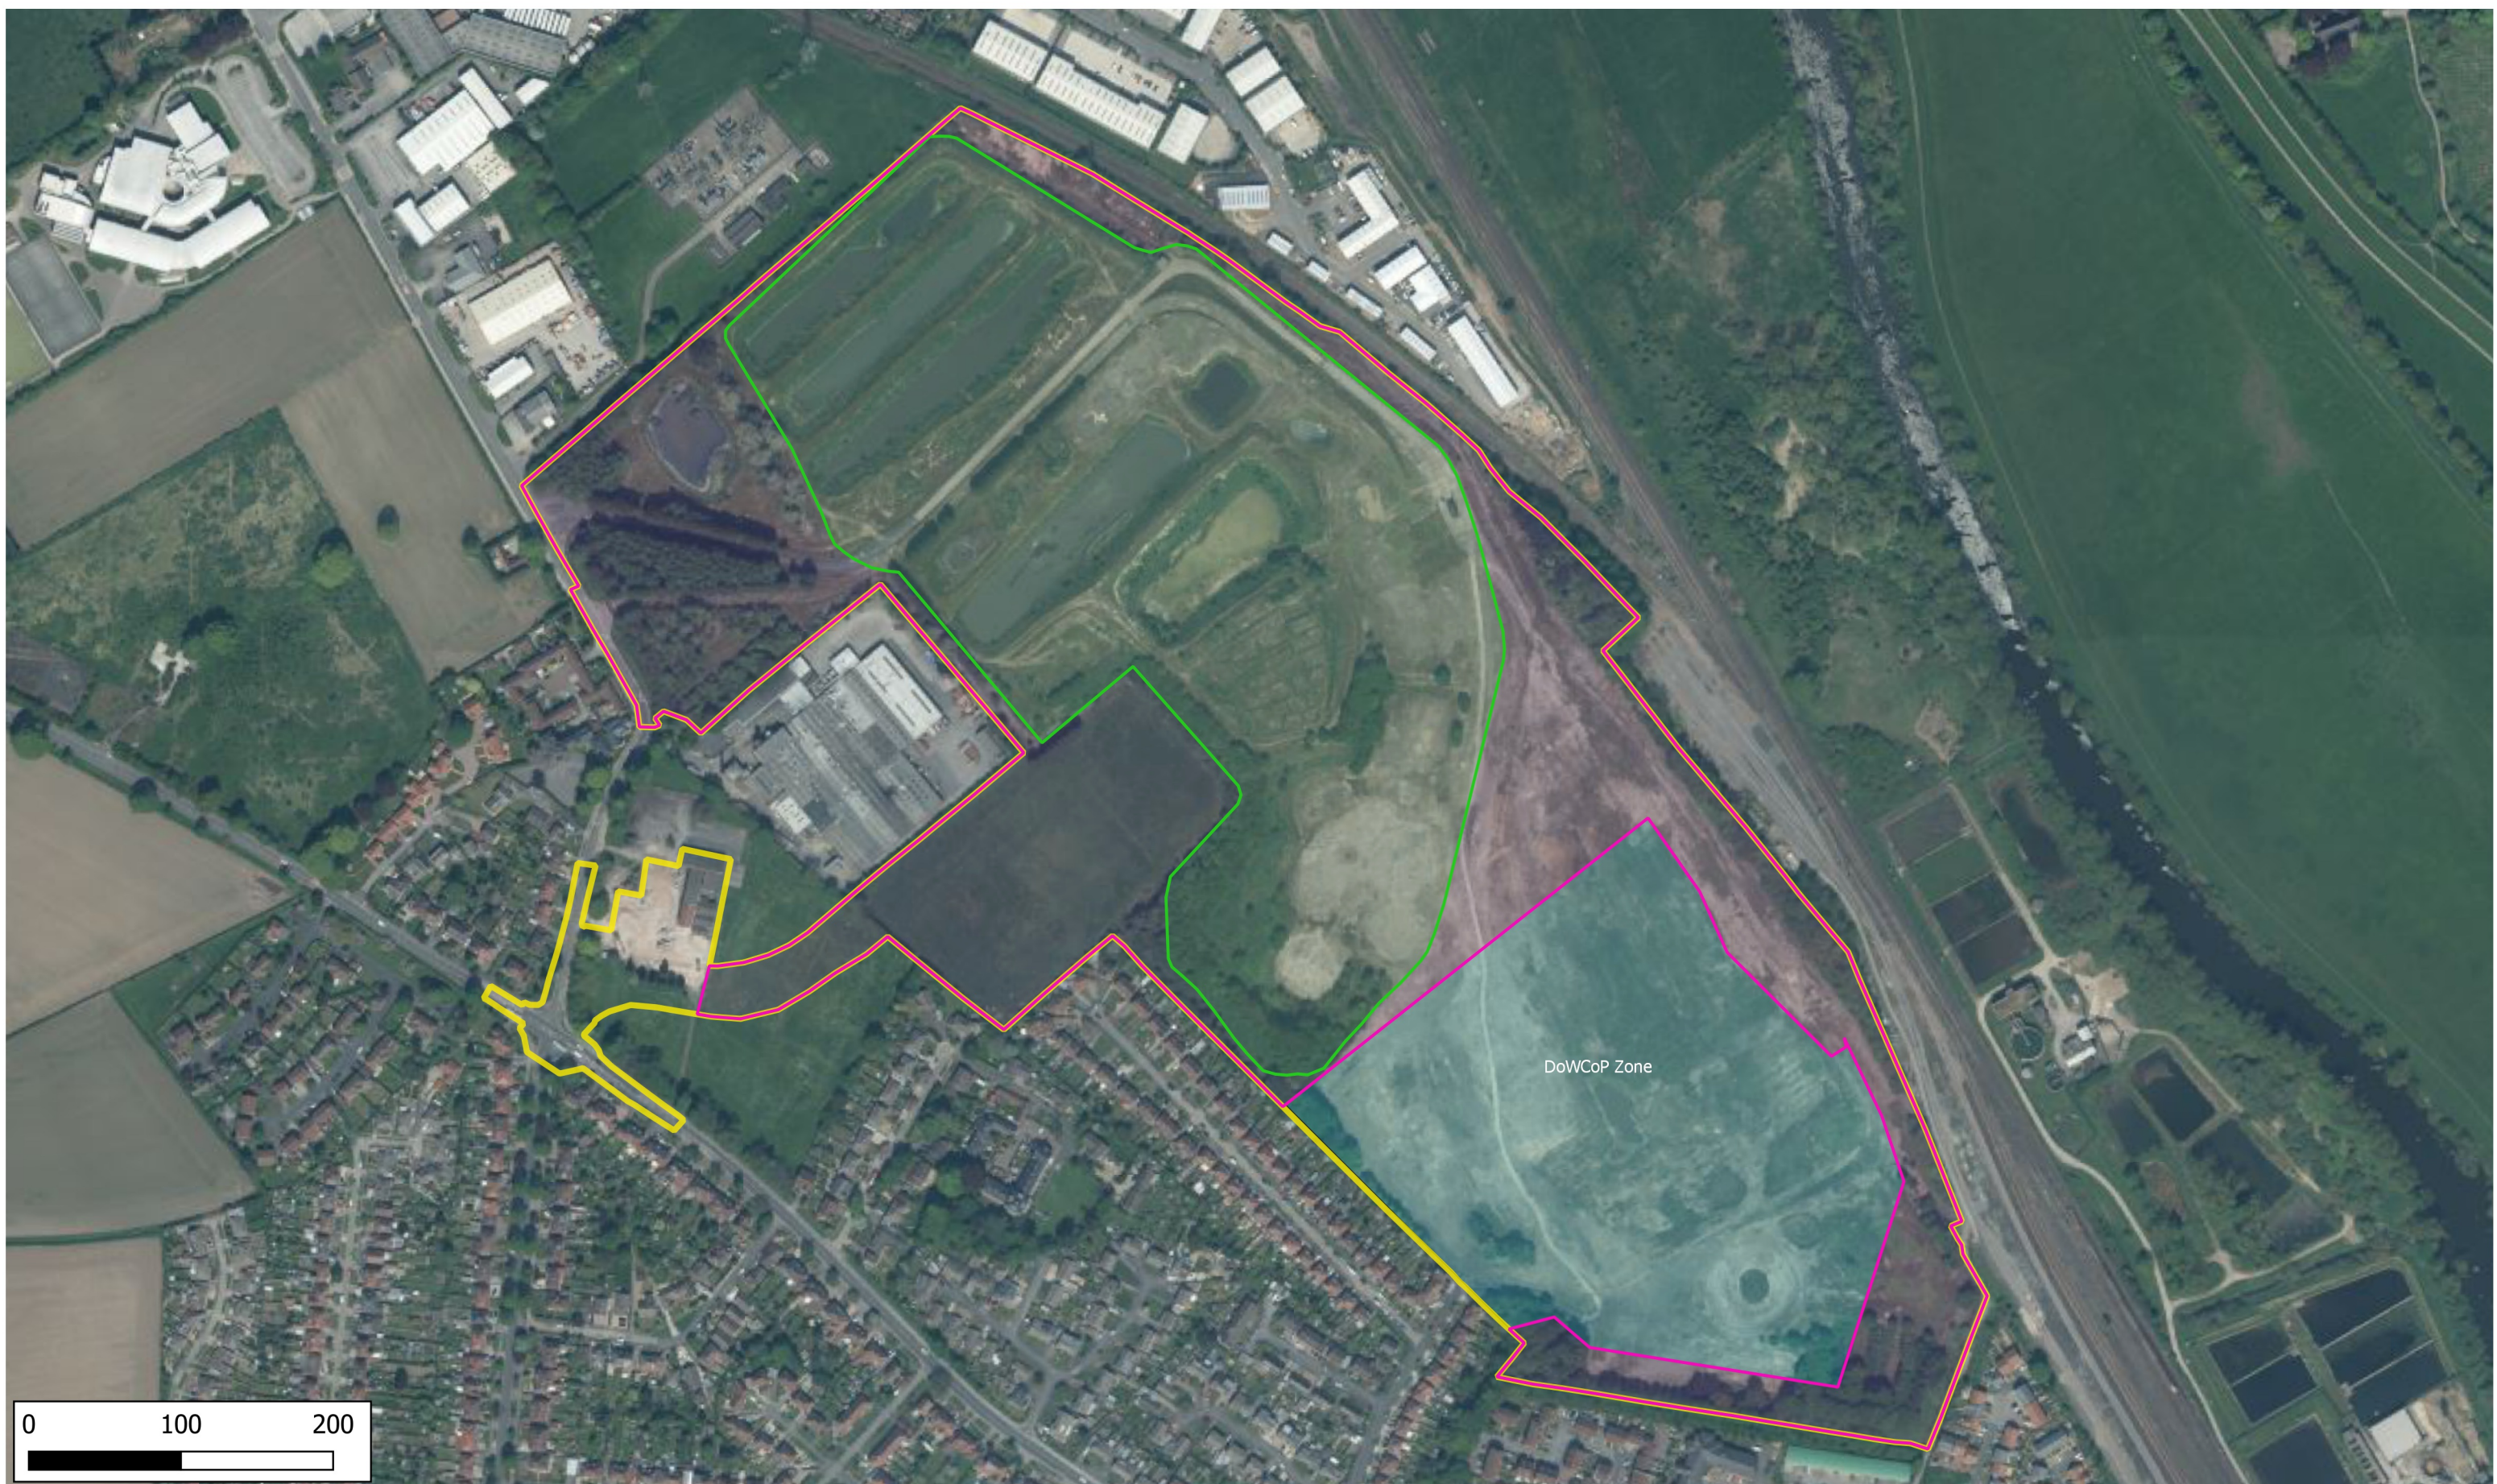
Drawing Number: 10024487-AUK-XX-XX-DR-ZZ-0047-P1-Site layout Plan

- Legend**
- Site Boundary
  - Current Environmental Permit Boundary
  - Proposed Extended Environmental Permit Boundary
  - DoWCoP Zone

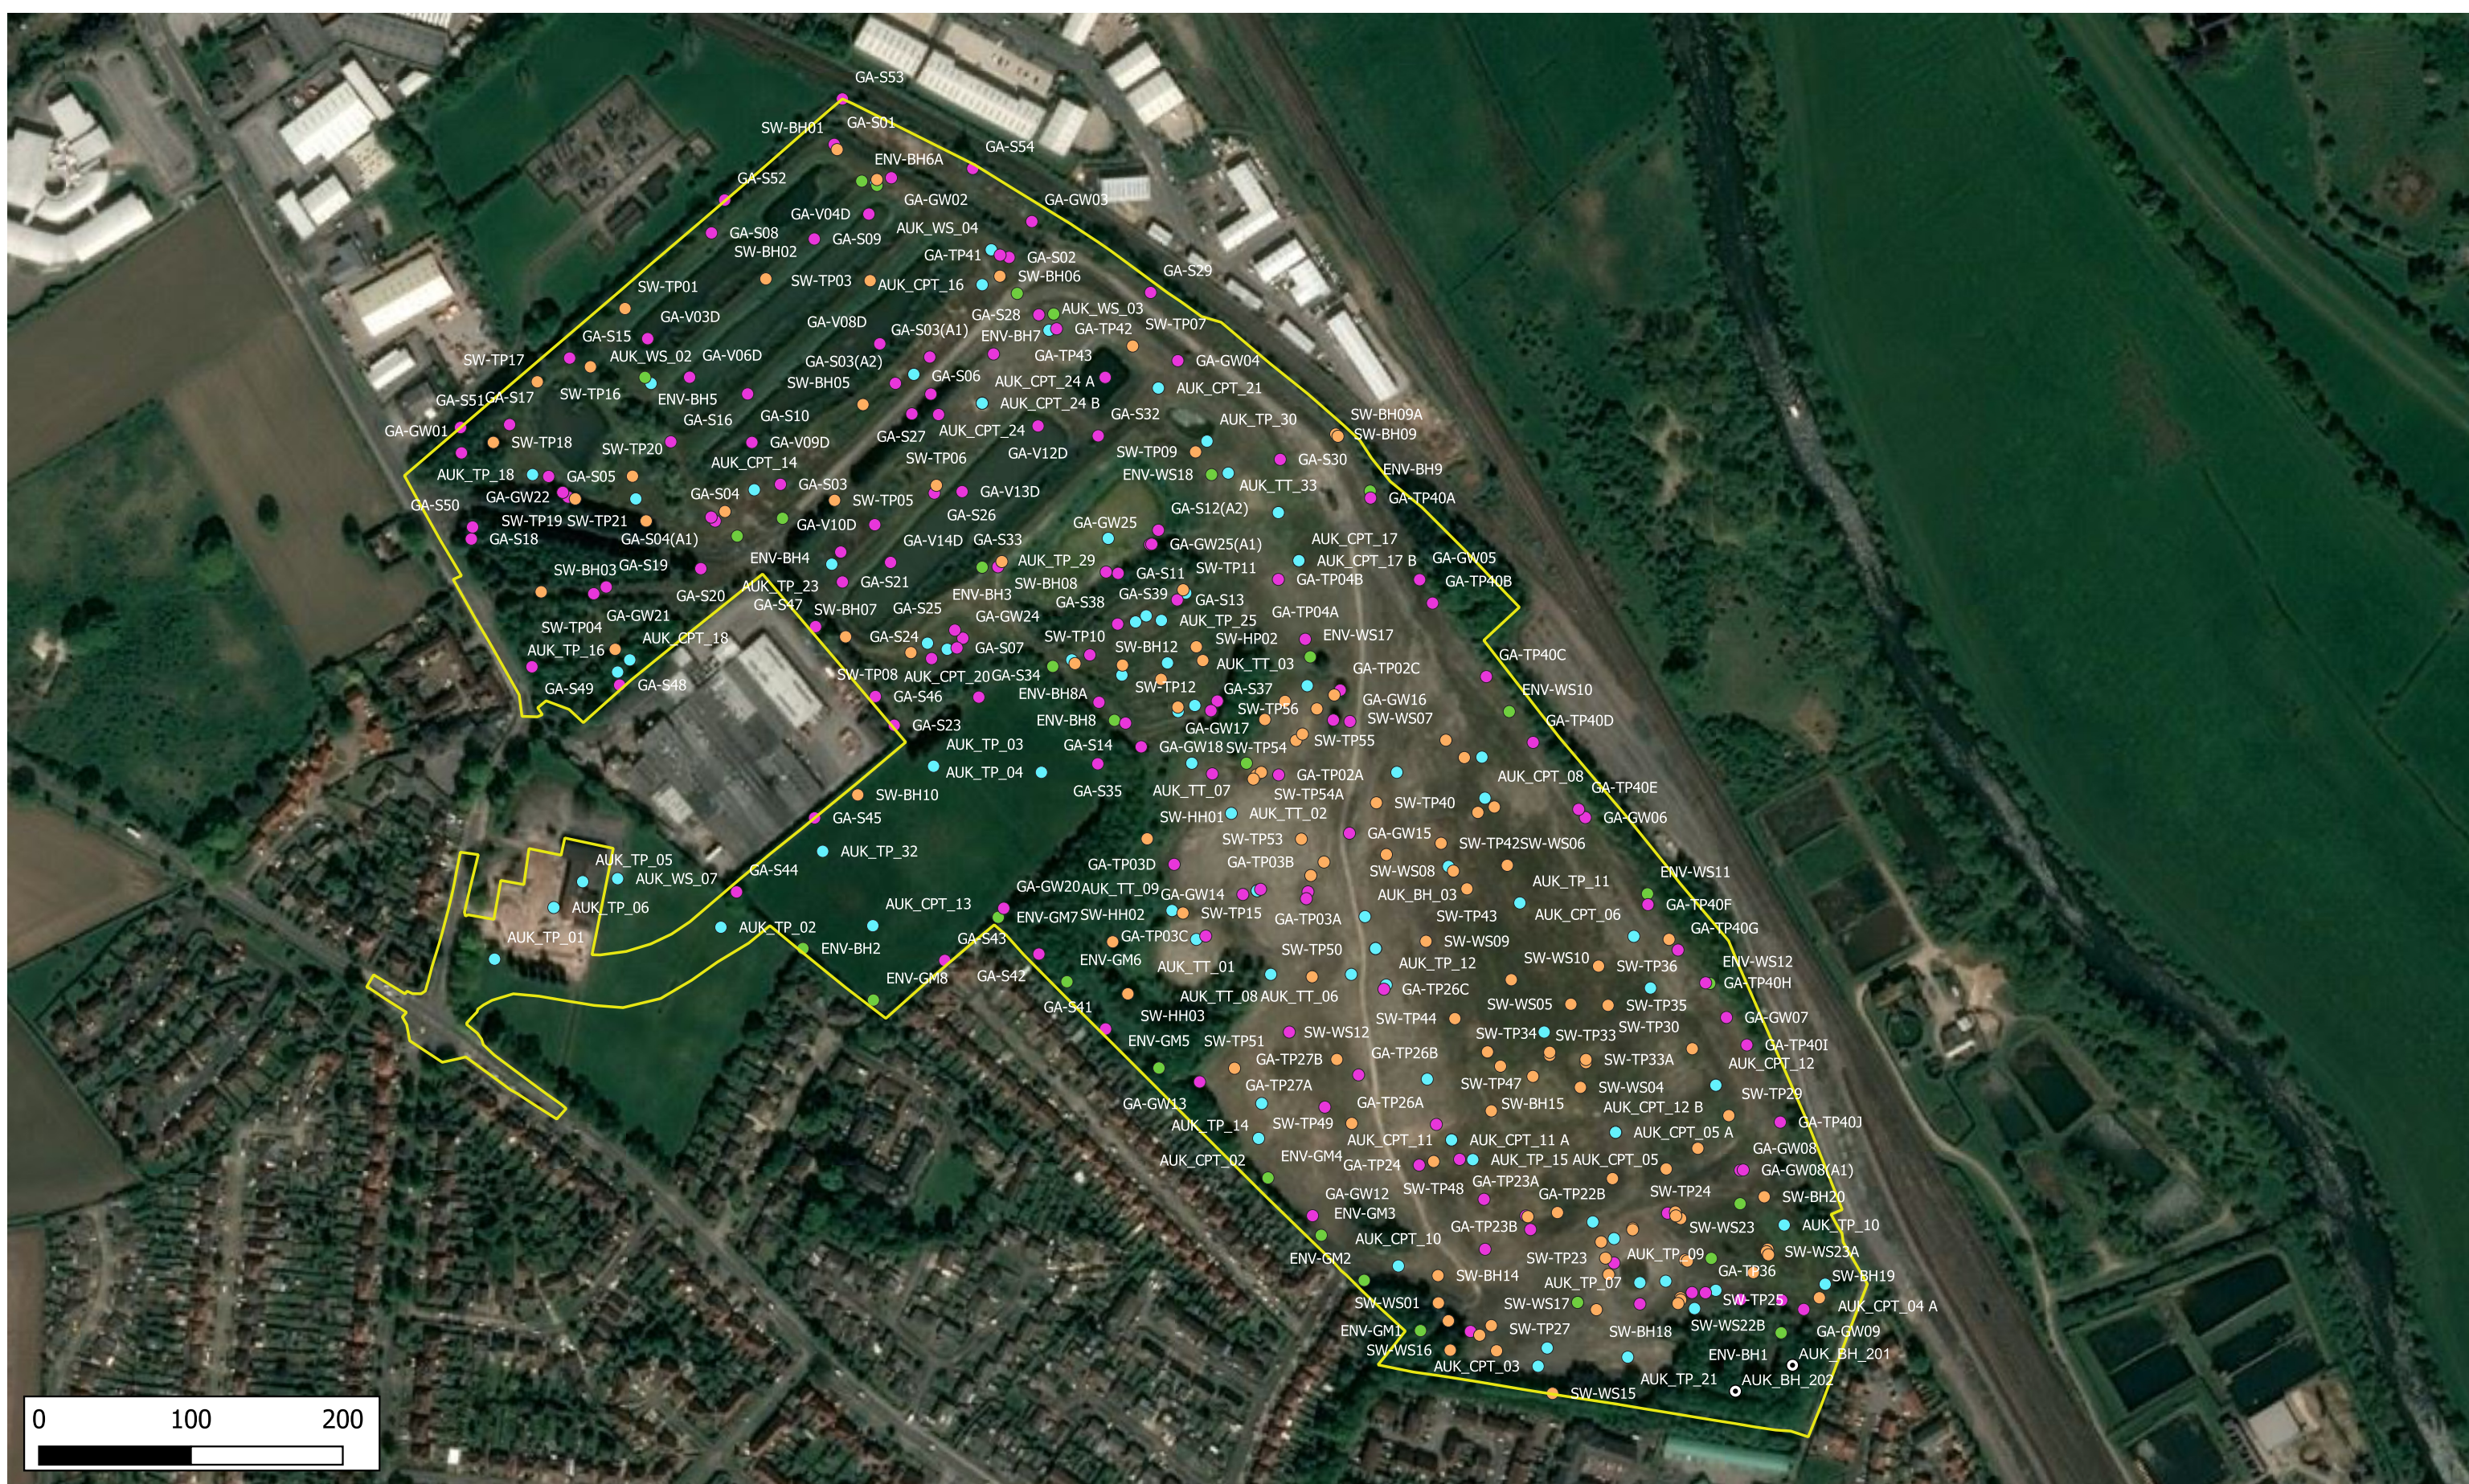
Drawing Number: 10024487-AUK-XX-DR-ZZ-0035-P1-Borehole Location Map - Historic and Current Locations

- Legend**
- LocationDetails3D
  - Arcadis Exploratory Location
  - Enviros Exploratory Location
  - Golder Exploratory Location
  - Scott Wilson Exploratory Location
  - Arcadis Additional Boreholes
  - Site Boundary

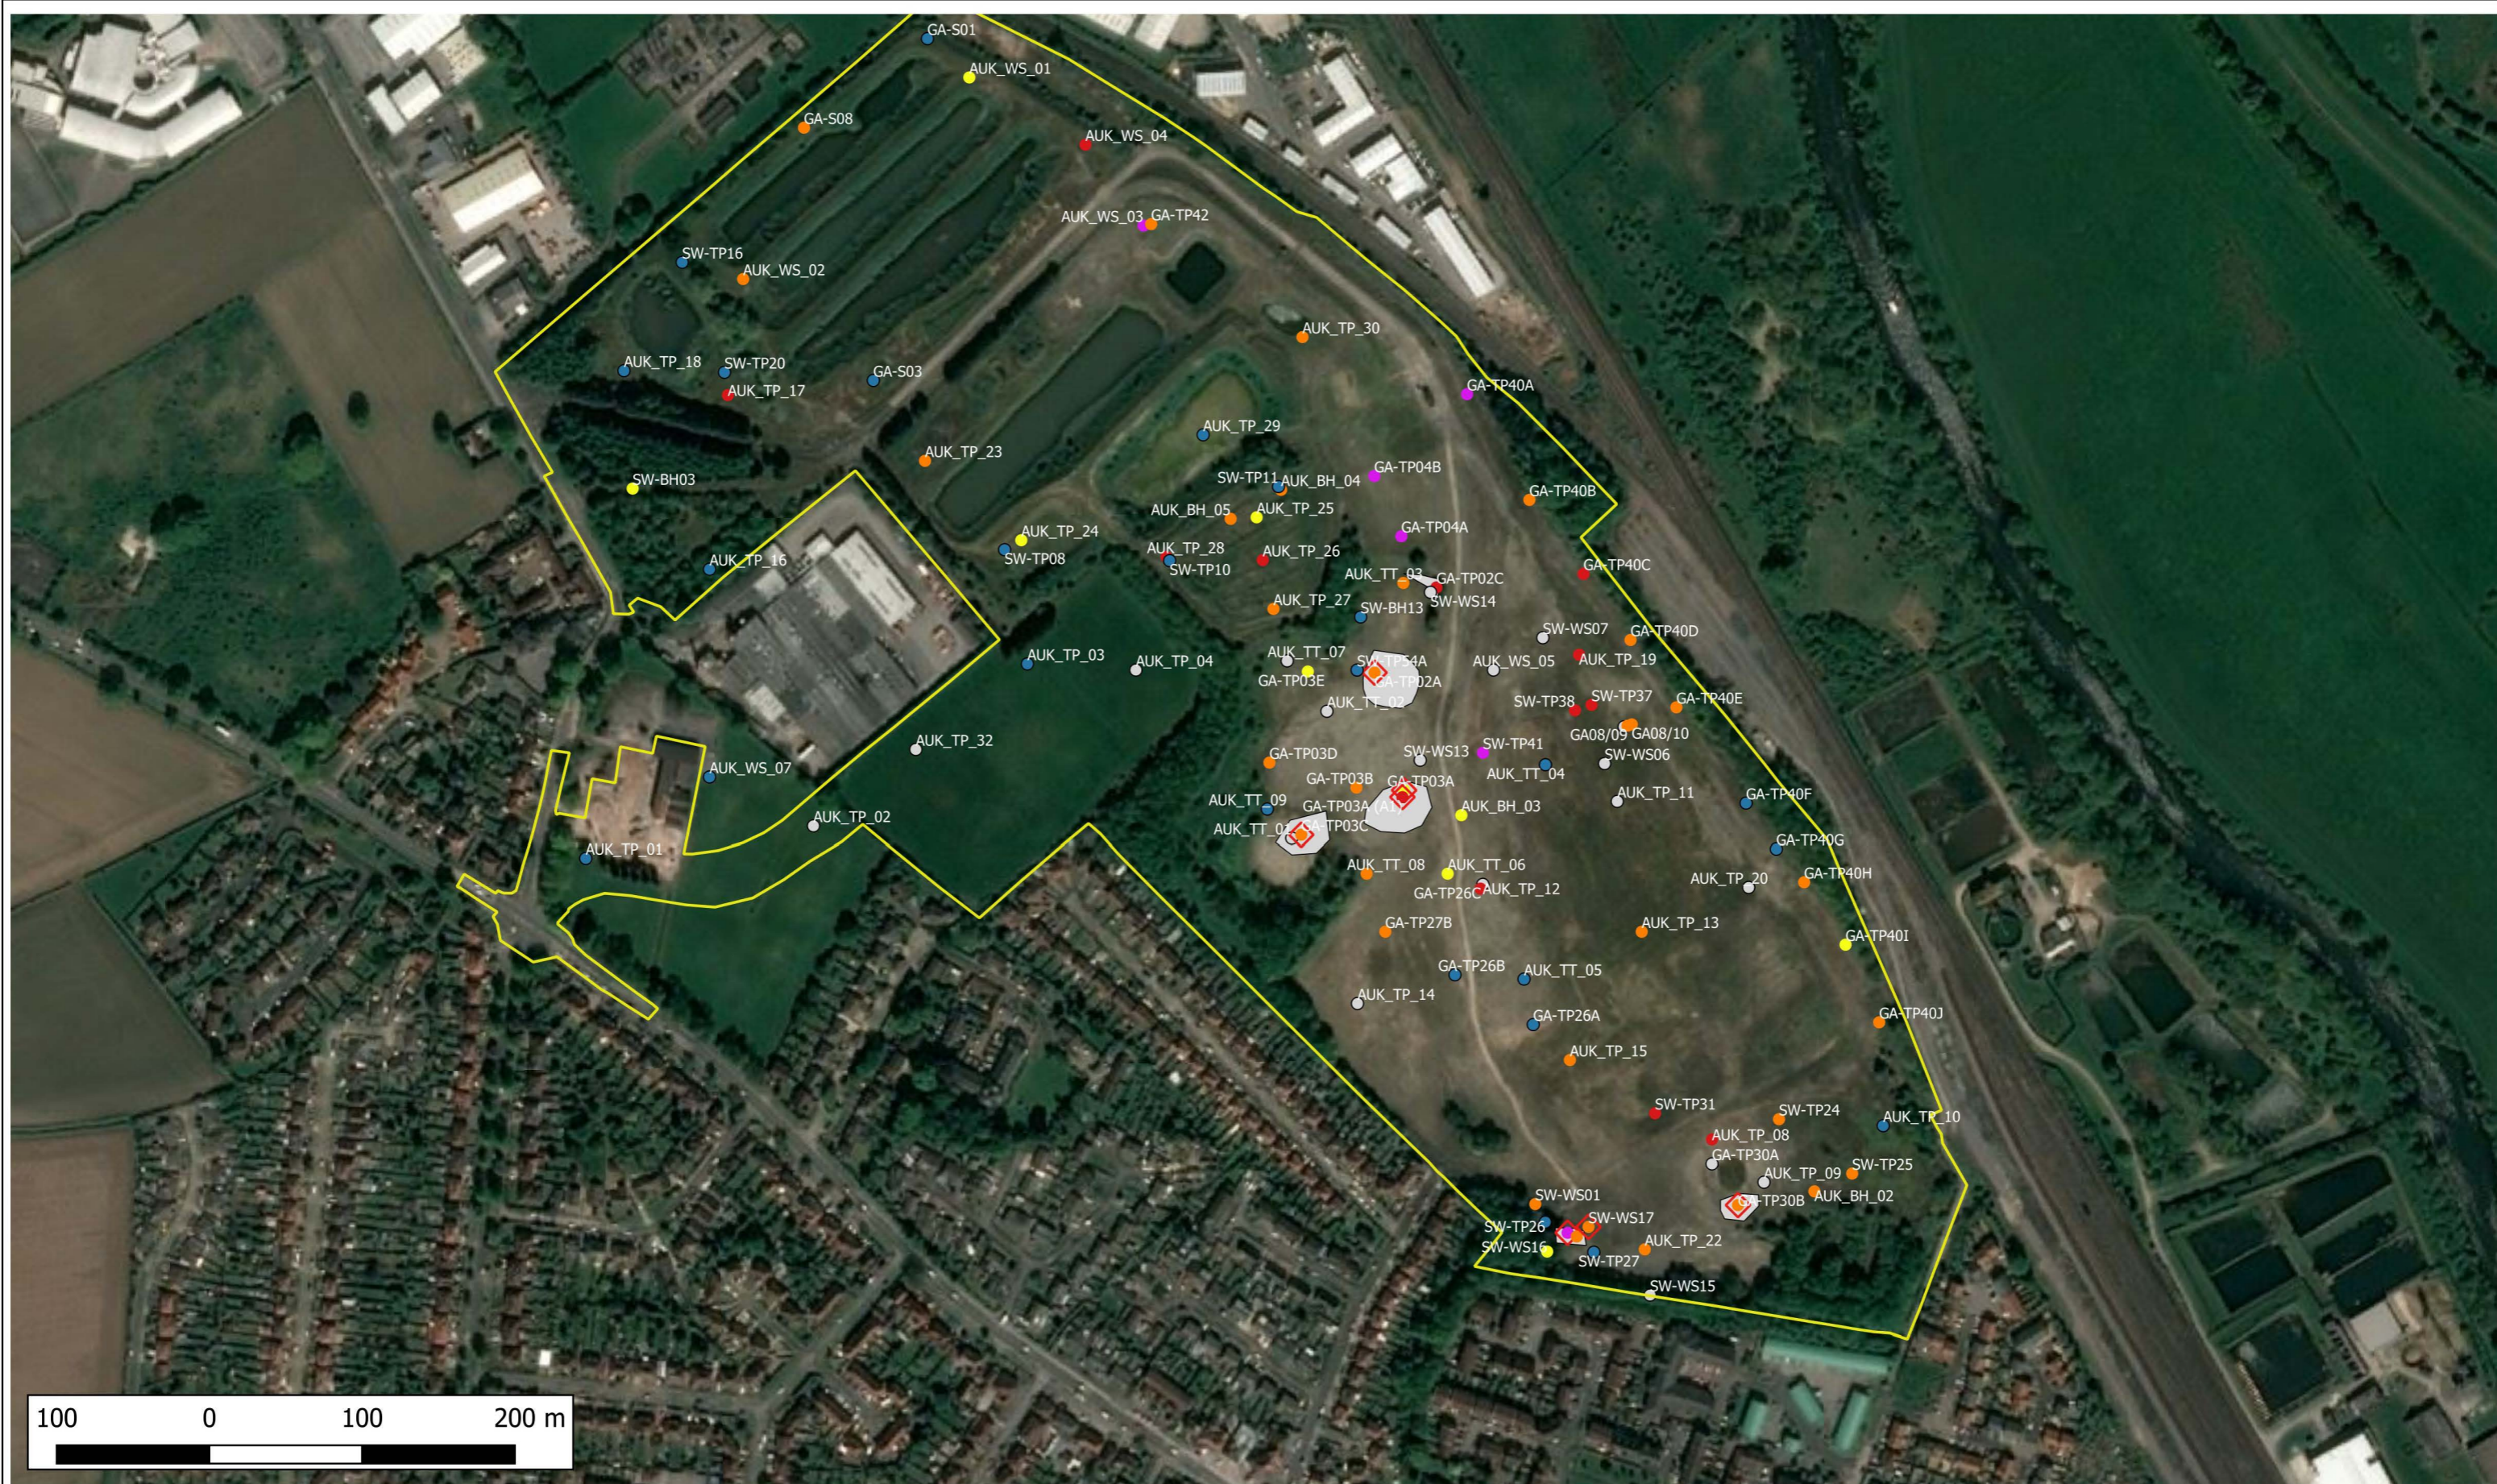
Drawing Number: 10024487-AUK-XXXX-DR-ZZ-0044-P1-TPH Distribution Map

**Sum Total Petroleum Hydrocarbons**

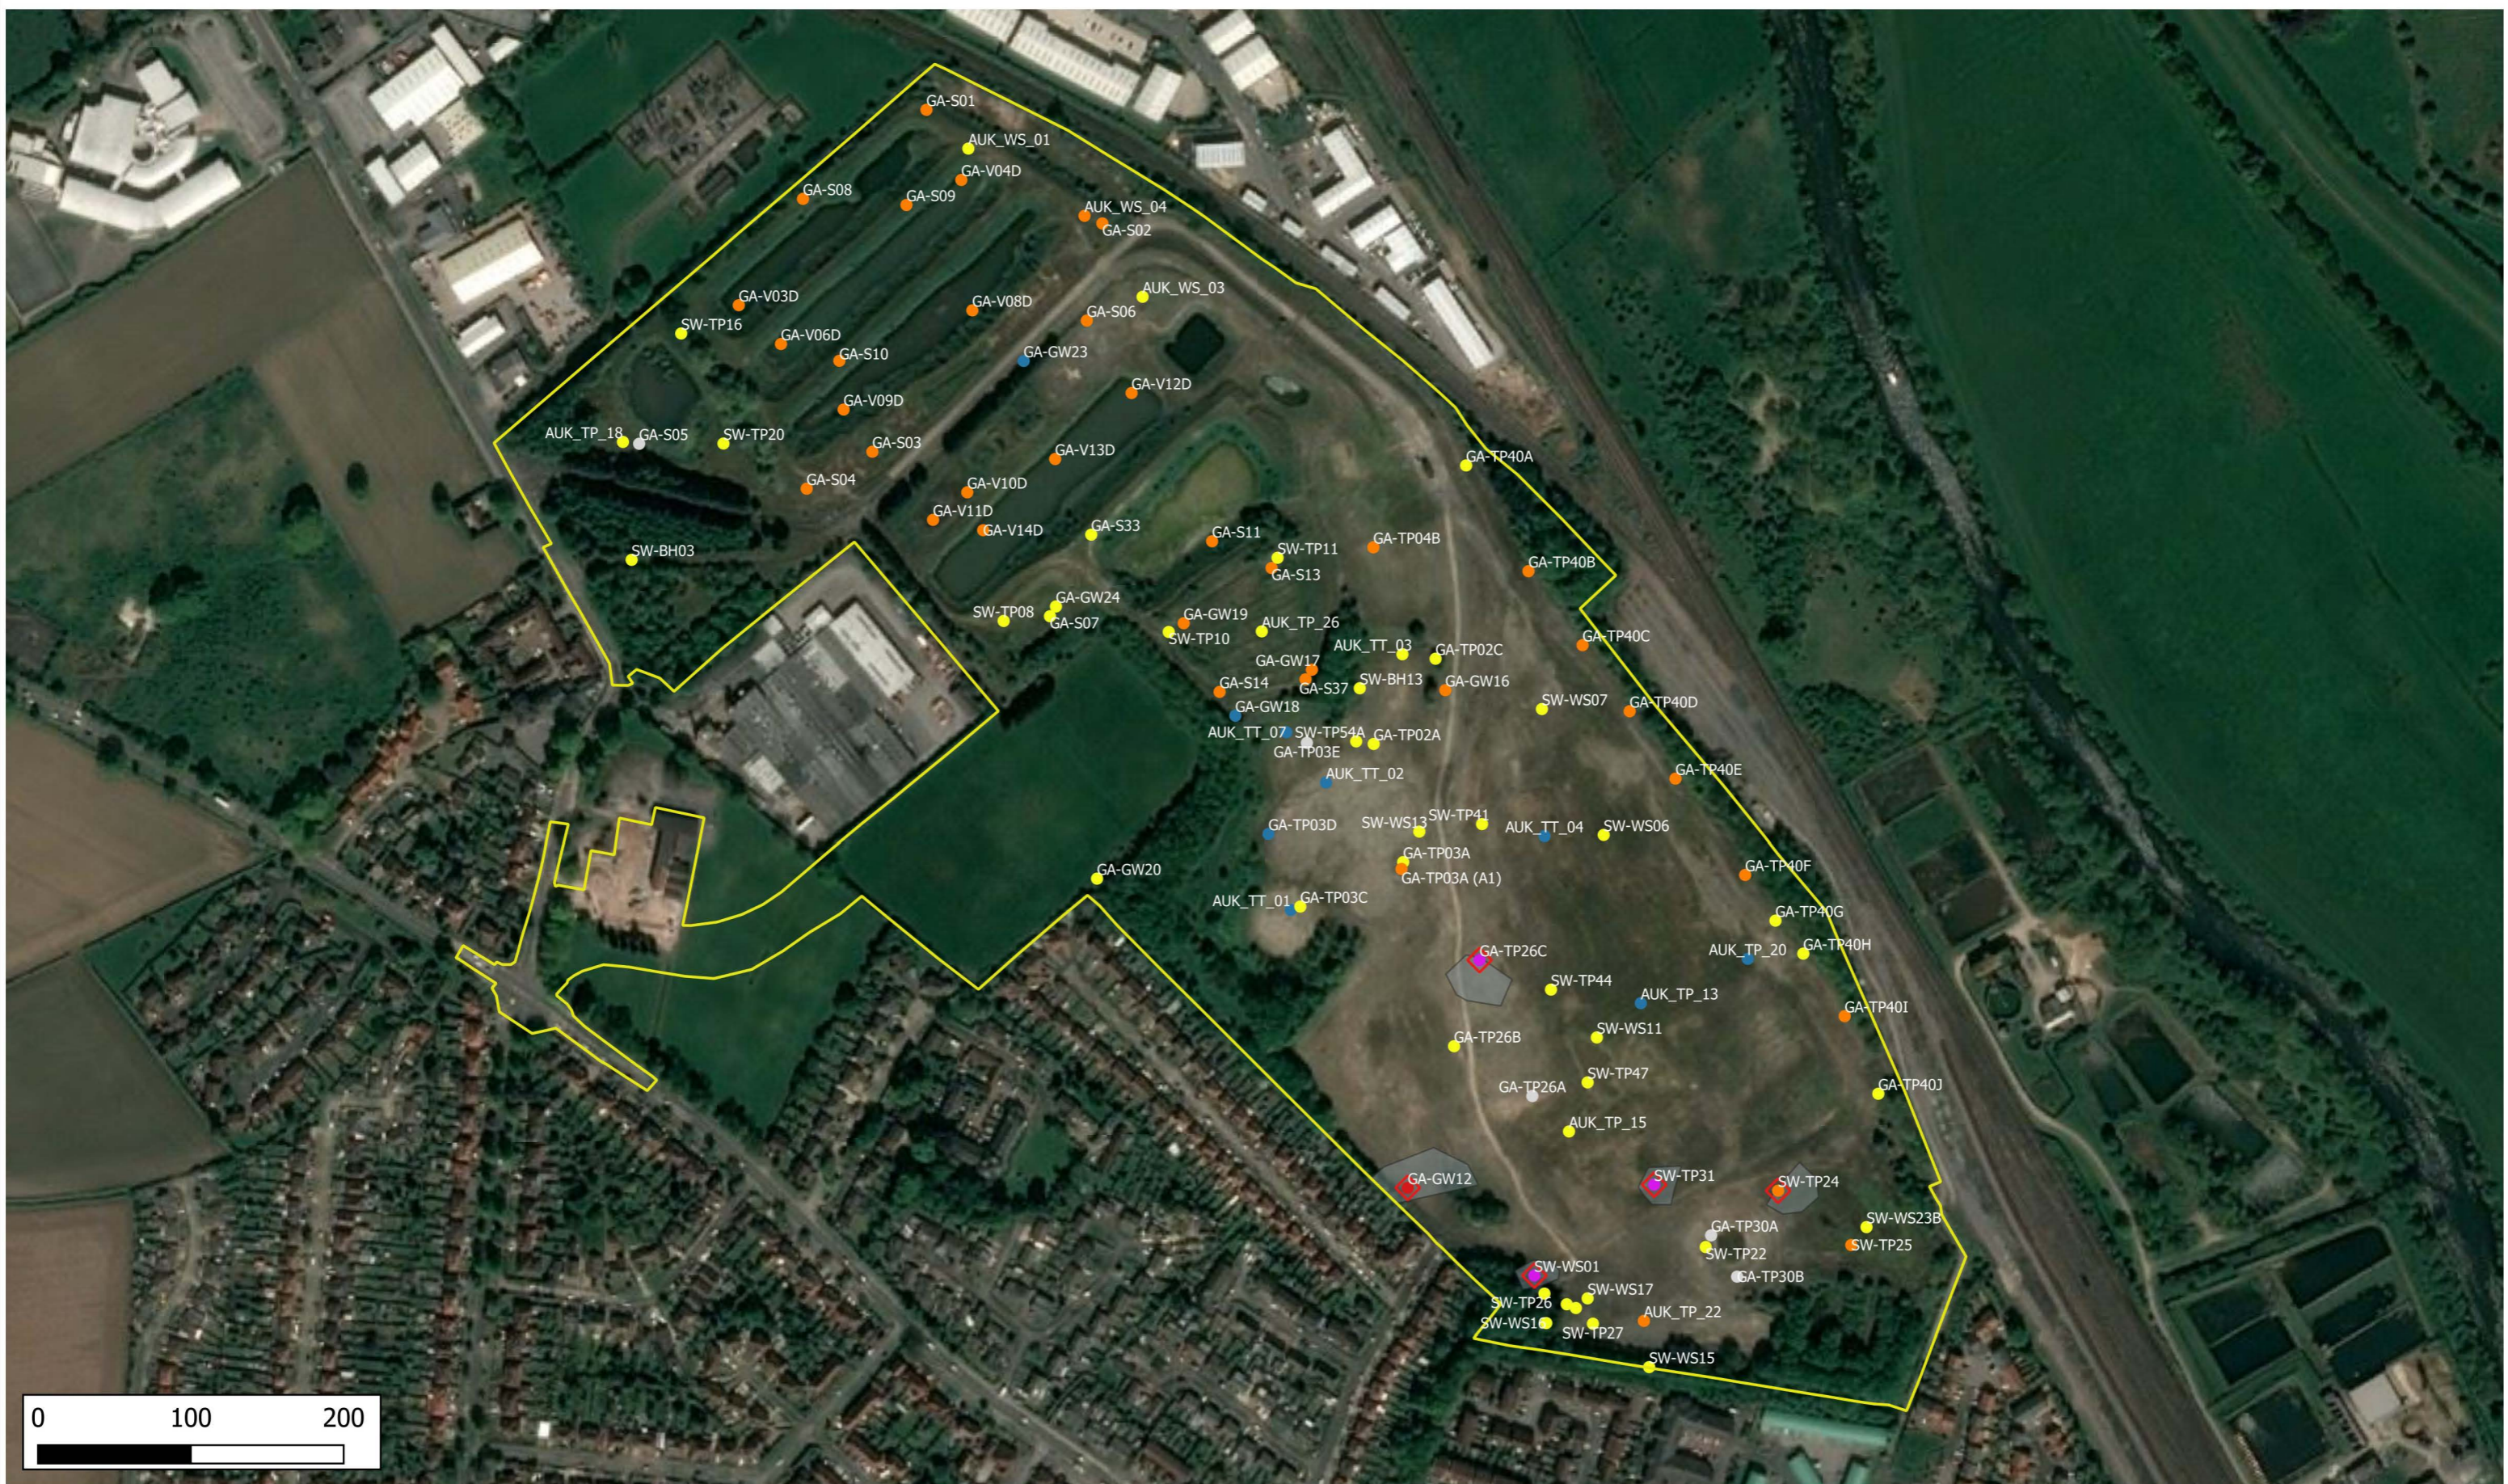
Drawing Number: 10024487-AUK-XXXX-DR-ZZ-0045-P1-PAH Distribution Map

- Legend**
- Sum Polycyclic Aromatic Hydrocarbons
- 0.5 - 5 mg/kg
  - 5 - 50 mg/kg
  - 50 - 100 mg/kg
  - >100 mg/kg
  - <Method Detection Limit
  - 0.05 - 0.5 mg/kg

- ◇ Exceedance
- PAH Hotspots
- Site Boundary

This comparison identified isolated exceedances of individual PAH compounds within shallow (<1m bgl (below ground level)) soils collected from 5 locations located across the Main Factory area (SW-TP24, SW-TP31, SW-WS01, GA-TP26C, and GA-GW12). A review of soil descriptions associated with these exceedances recorded on third party exploratory logs indicates these PAH exceedances were frequently associated with sand and gravel Made Ground where ash and bituminous material were noted to be present.

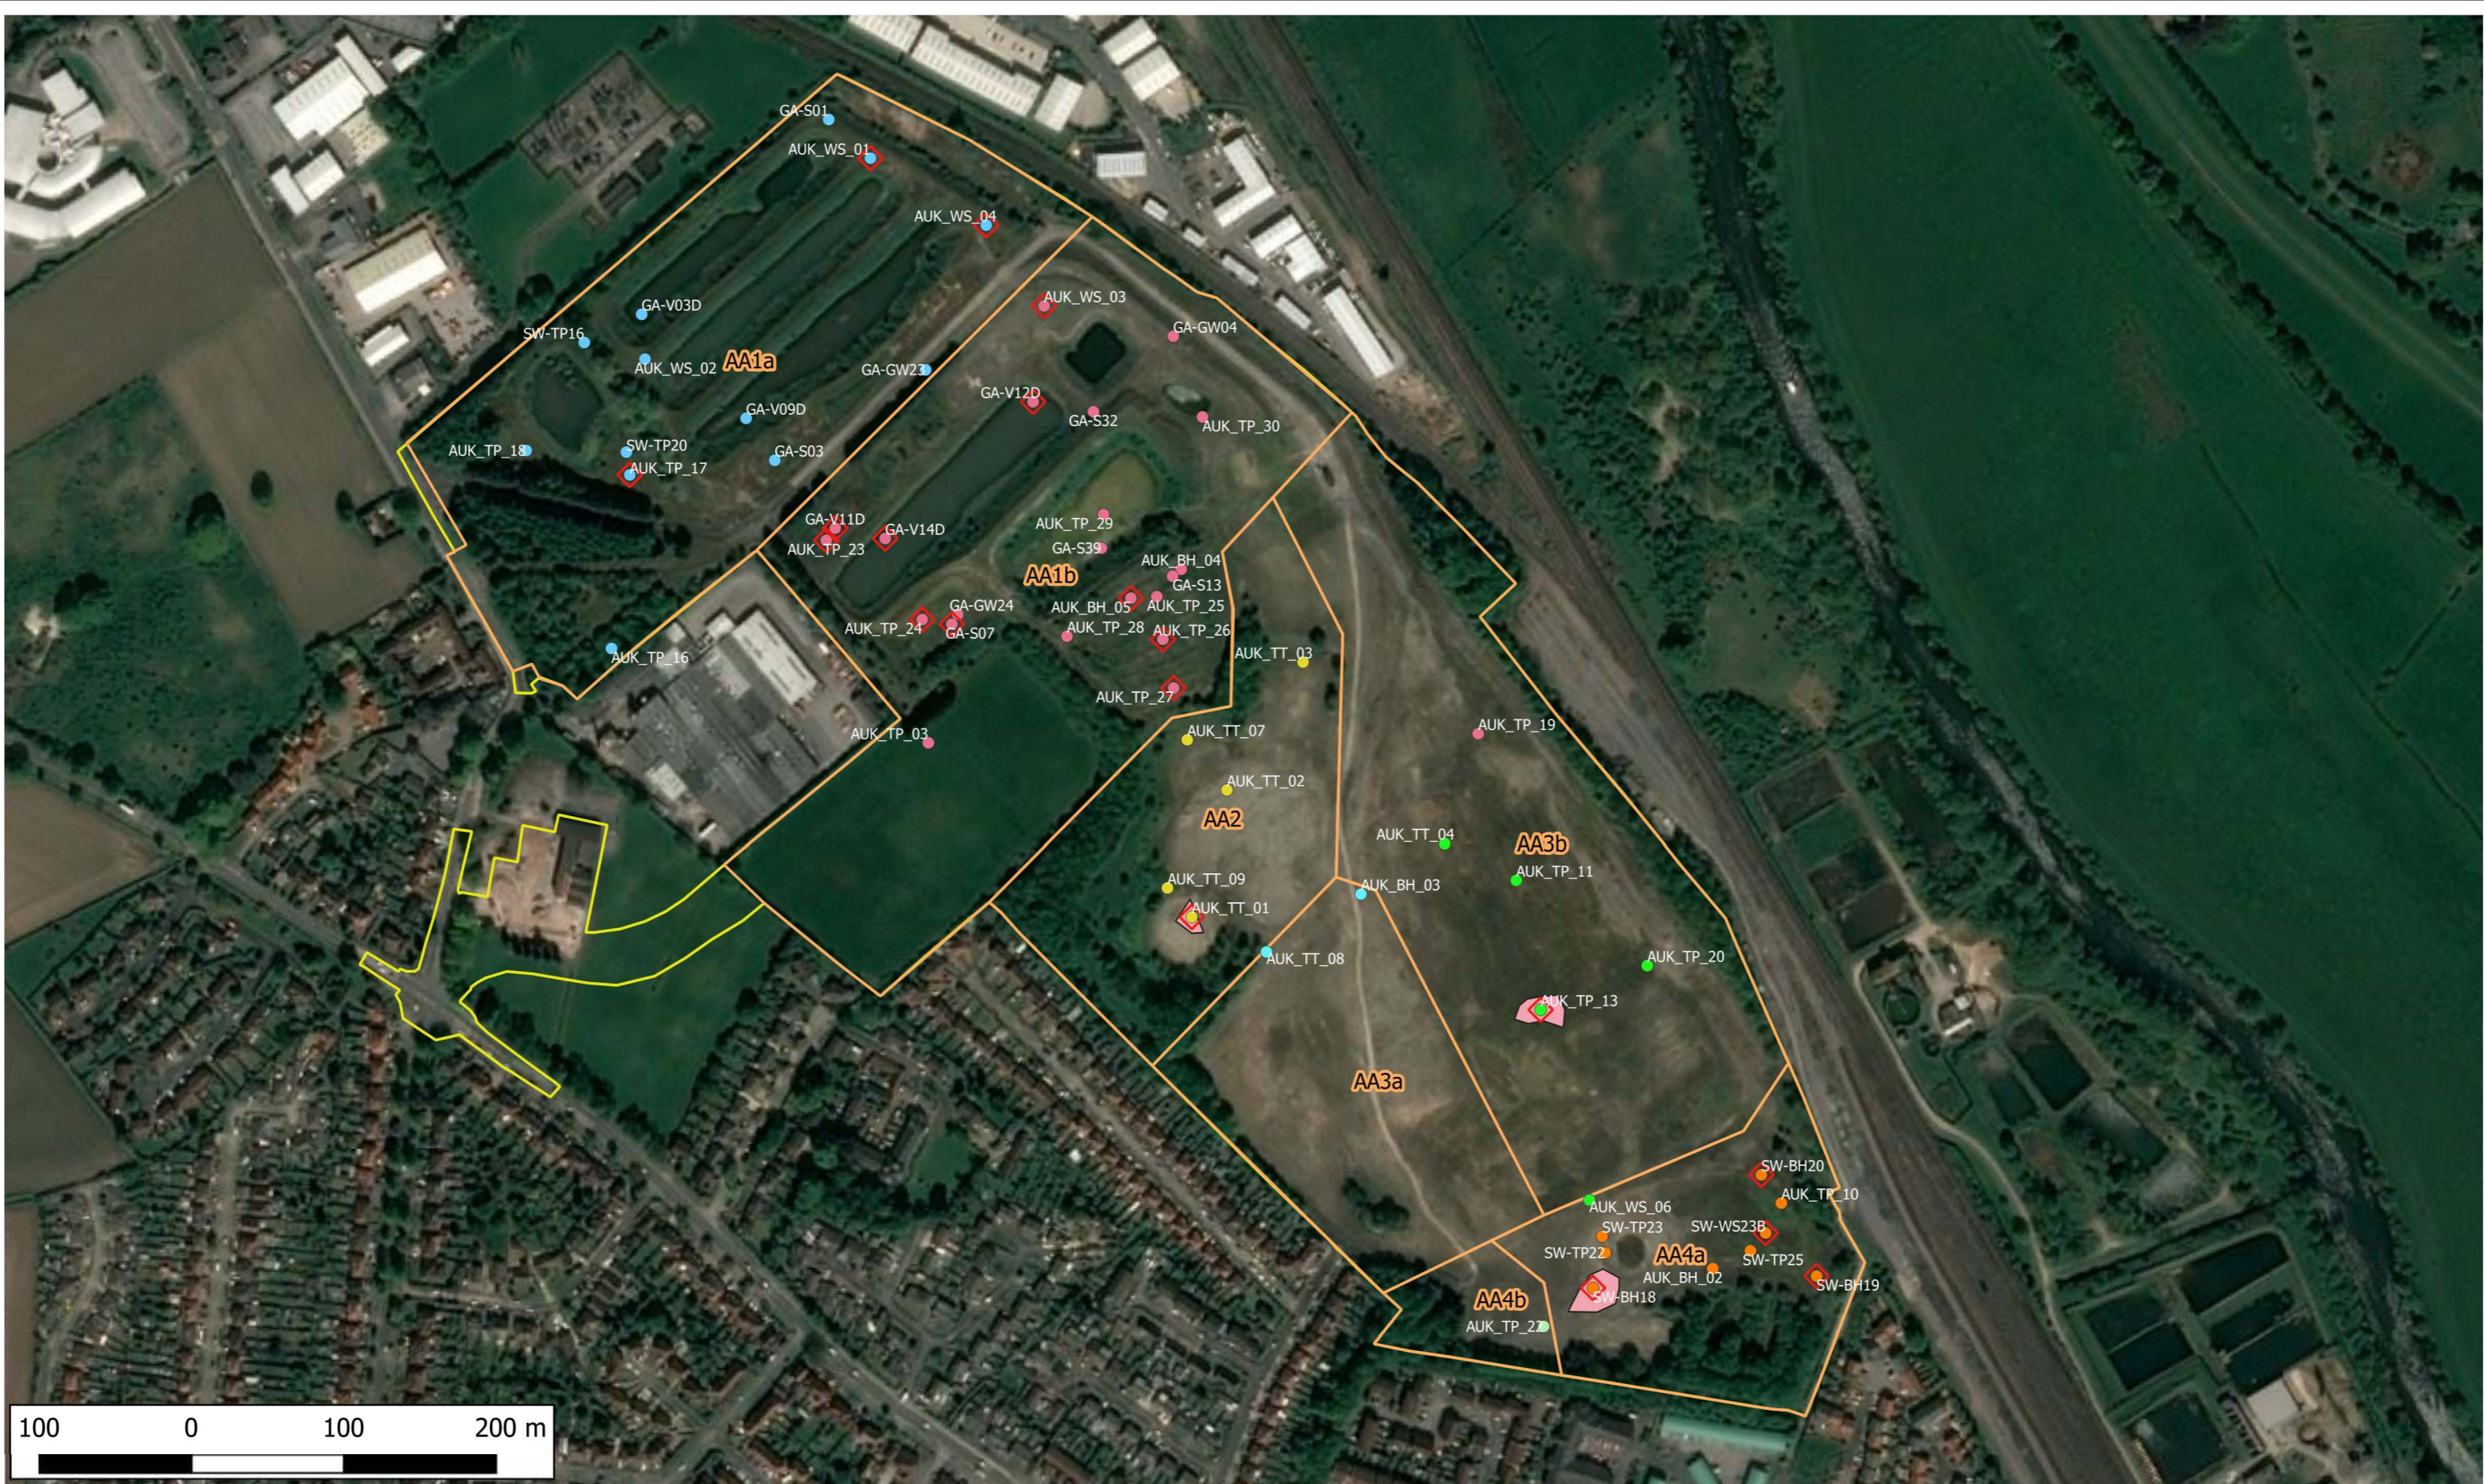
Drawing Number: 10024487-AUK-XXXX-DR-ZZ-0042-P1-Ammoniacal Nitrogen Distribution and Hotspot Area

- Legend**
- Ammoniacal Nitrogen Distribution and Hotspot Area
  - AA1b ● Monitoring Locations in Averaging Area AA1b
  - AA1a ● Monitoring Locations in Averaging Area AA1a
  - AA4b ● Monitoring Locations in Averaging Area AA4b
  - AA4a ● Monitoring Locations in Averaging Area AA4a
  - AA3b ● Monitoring Locations in Averaging Area AA3b
  - AA3a ● Monitoring Locations in Averaging Area AA3a
  - AA2 ● Monitoring Locations in Averaging Area AA2
  - ◇ Exceedance of Soil Pore RTV
  - Ammoniacal Nitrogen Hotspot
  - Averaging Areas
  - Site Boundary

The derivation of the ammoniacal nitrogen RTV for soil leachates using the Remedial Target Methodology (RTM) has been described within the 2015 RRS with a Tier 3 assessment undertaken to assess the fate of ammoniacal nitrogen in leachate and groundwater under the aerobic conditions identified to be present.

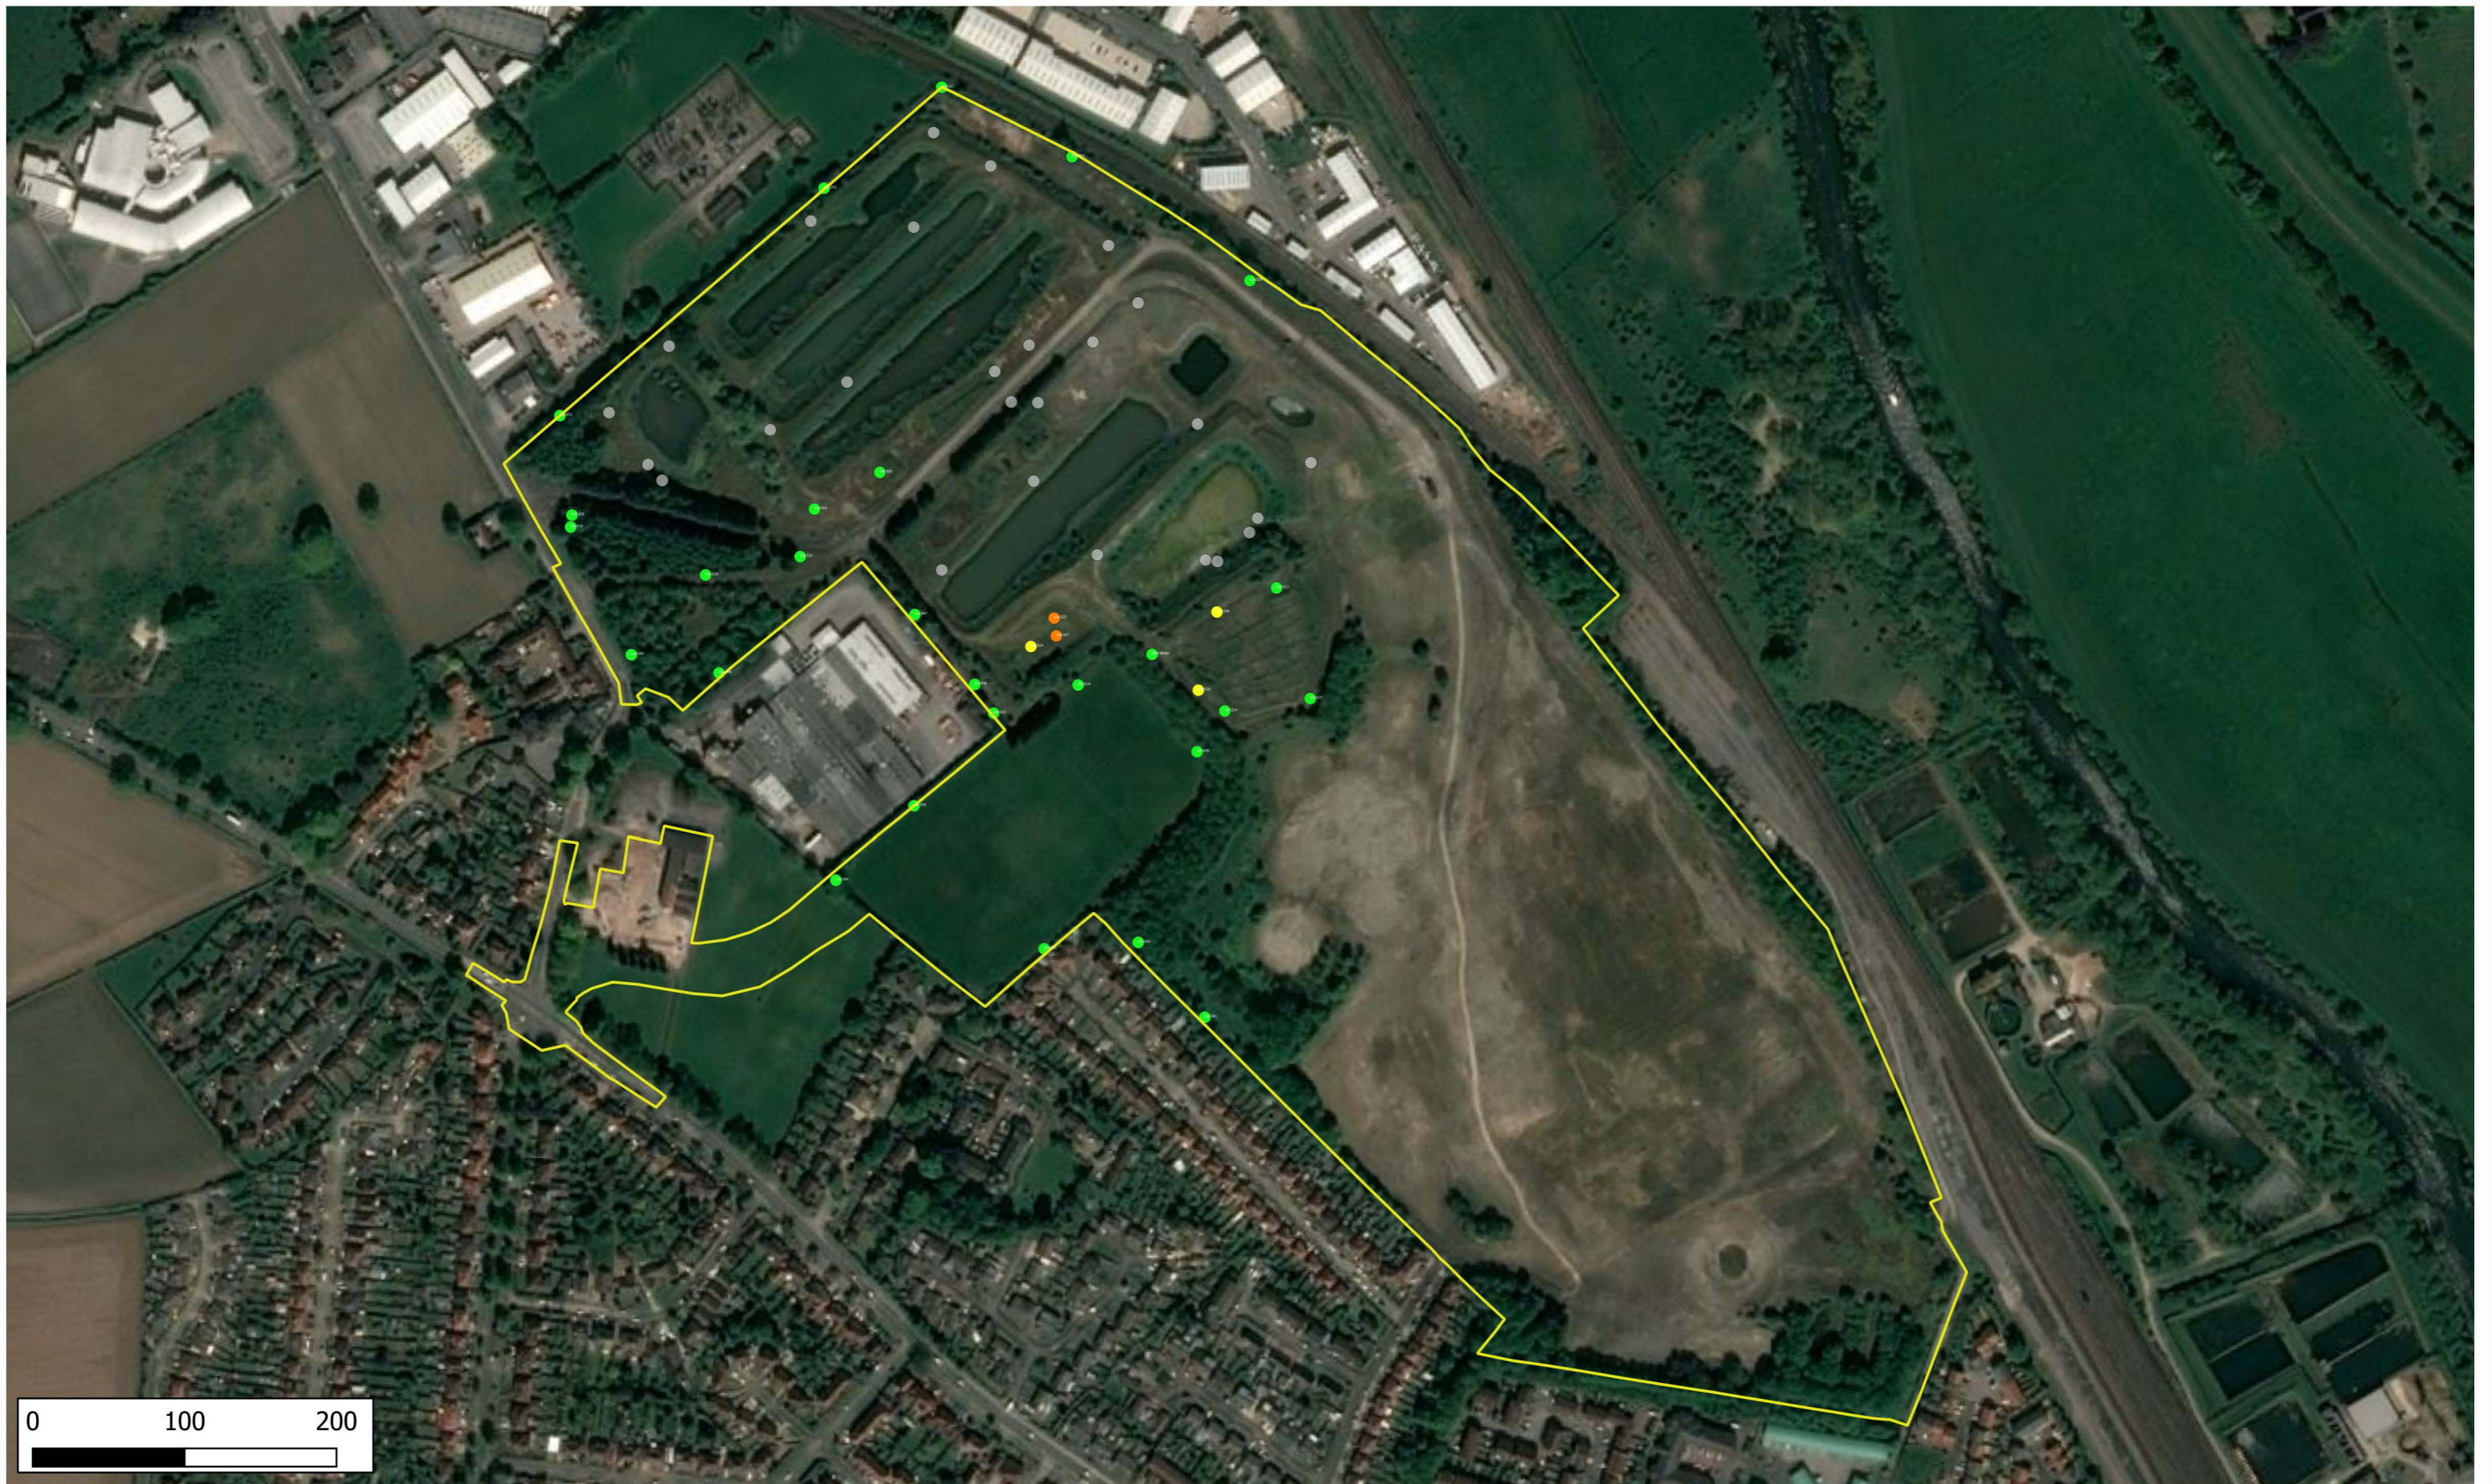
Drawing Number: 10024487-AUK-XXX-DR-ZZ-0036-P1-Distribution of NHBC Classification of Ground Gas

- Legend**
- NHBC Classification
  - Green
  - Amber1
  - Amber 2
  - No Ground Gas Monitoring Undertaken between Jan 2018 - Apr 2019
  - Site Boundary

The compliance criterion in respect of ground gas for the built residential properties complies with the requirements of the NHBC and related published UK guidance. The objective of the remediation and reclamation works will be to reduce ground gas concentrations and flow to a level compliant with the Amber 1 level of the NHBC traffic light system, with the proviso that conditions following remediation and reclamation will be no greater than Amber 2.
