# ENVIRONMENTAL SENSITIVITY AND SITE DESIGN REPORT

Waste Recovery Permit - Deposit for Recovery

Reclamation of the former British Sugar Refinery Site, York

Report No 10024487-AUK-XX-XX-RP-GE-0058-03-Environmental Sensitivity and Site Design Report

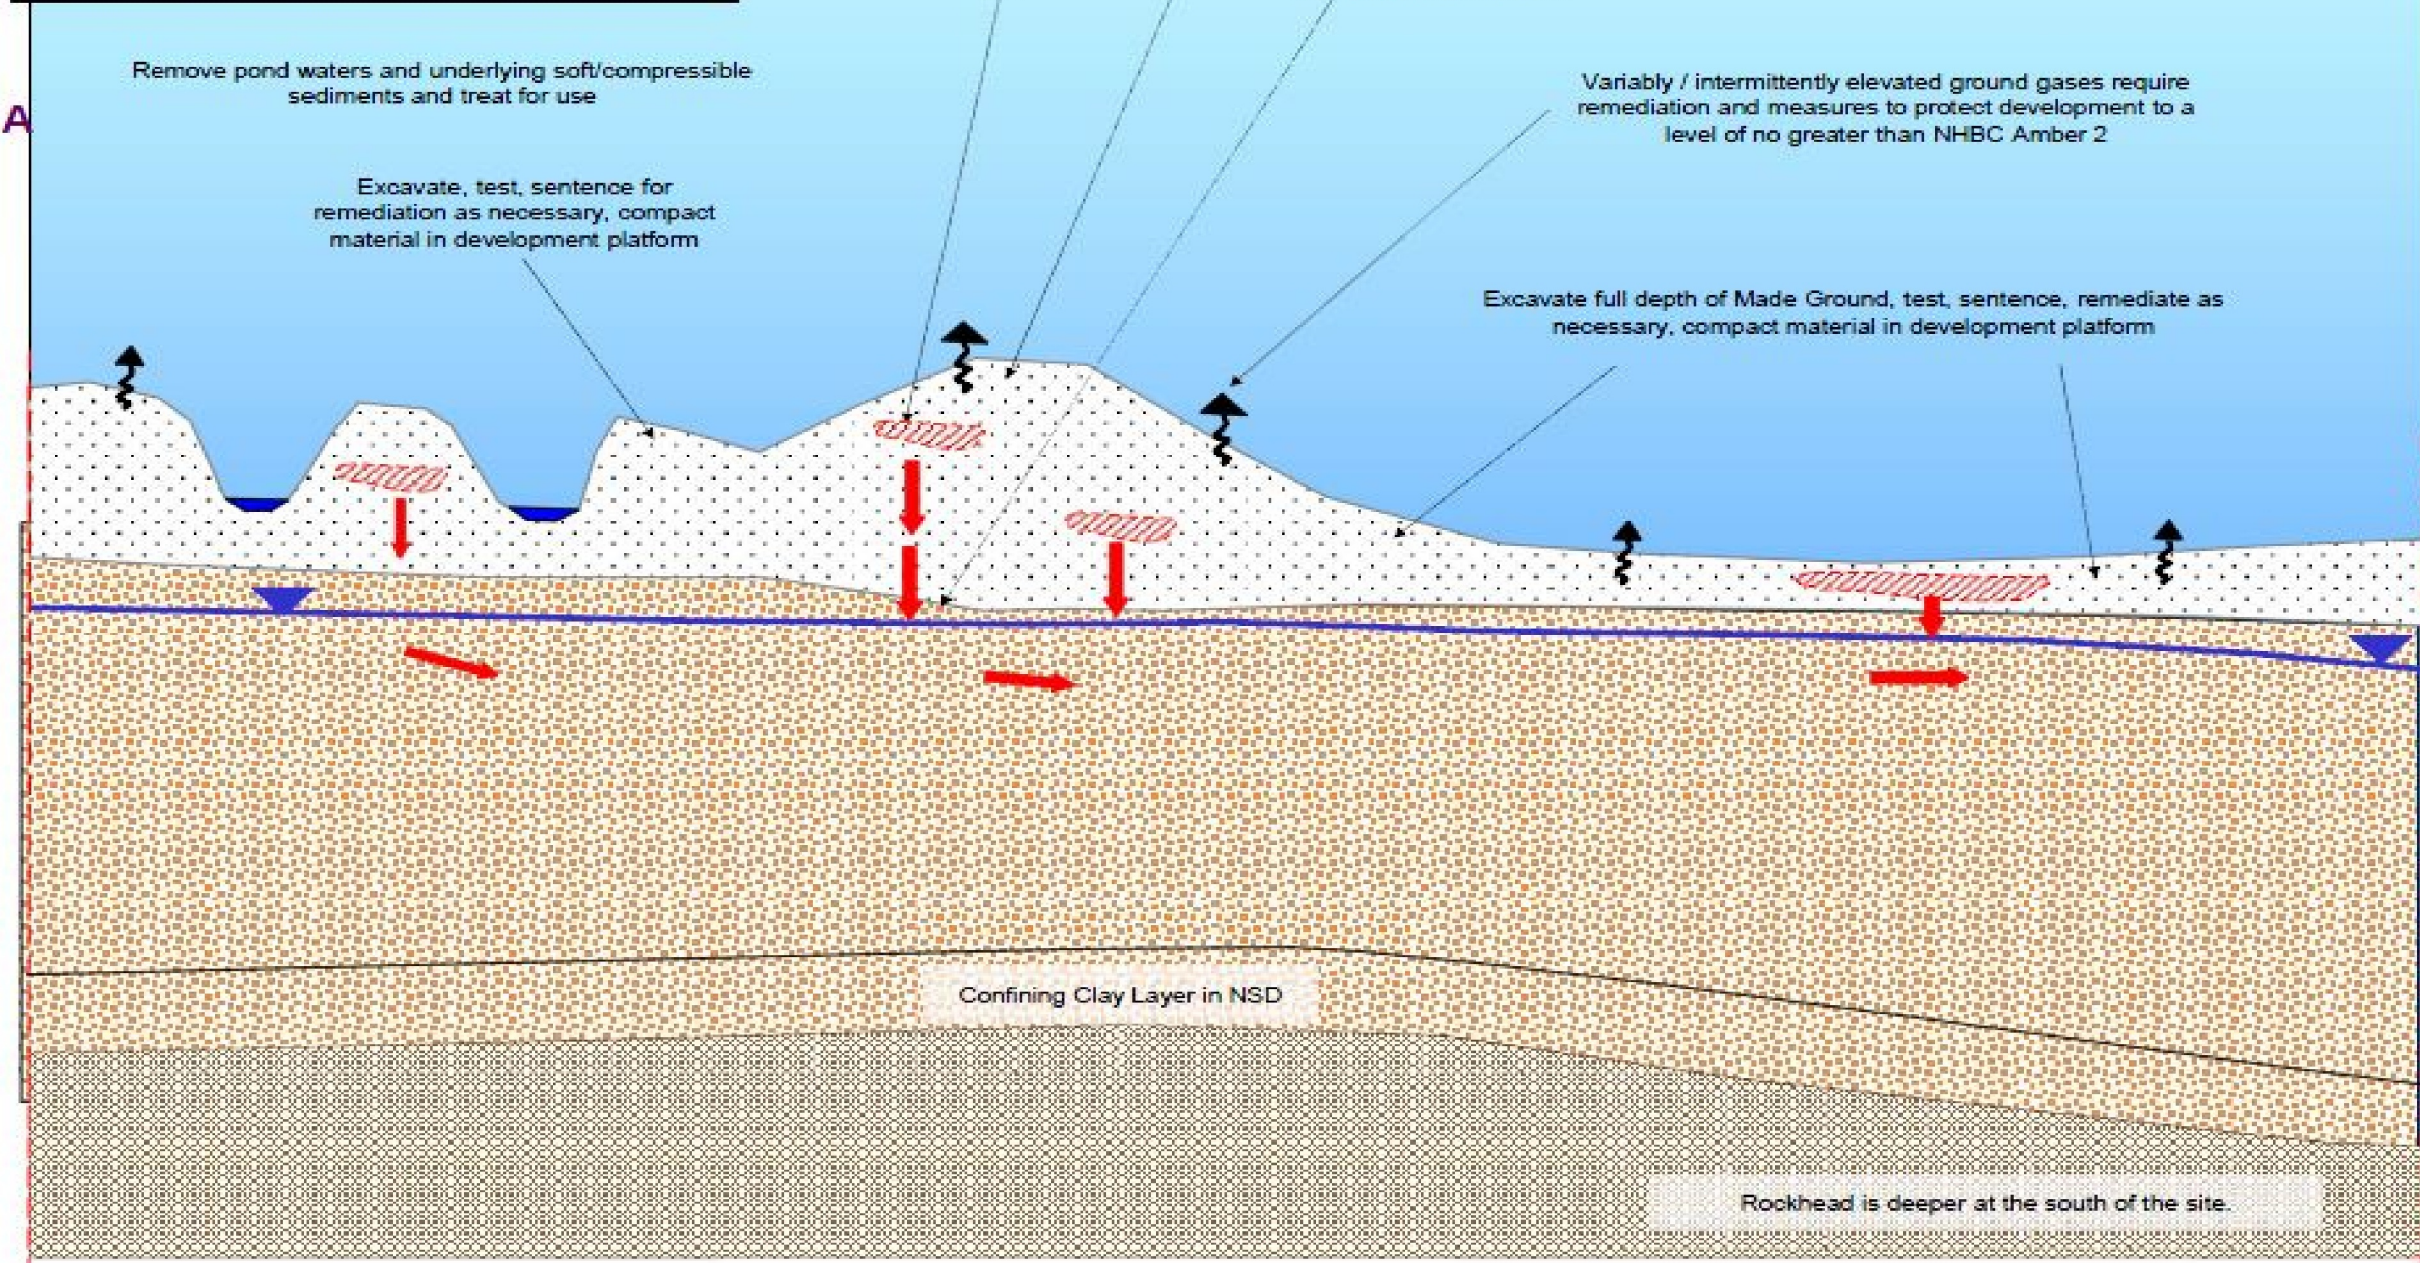
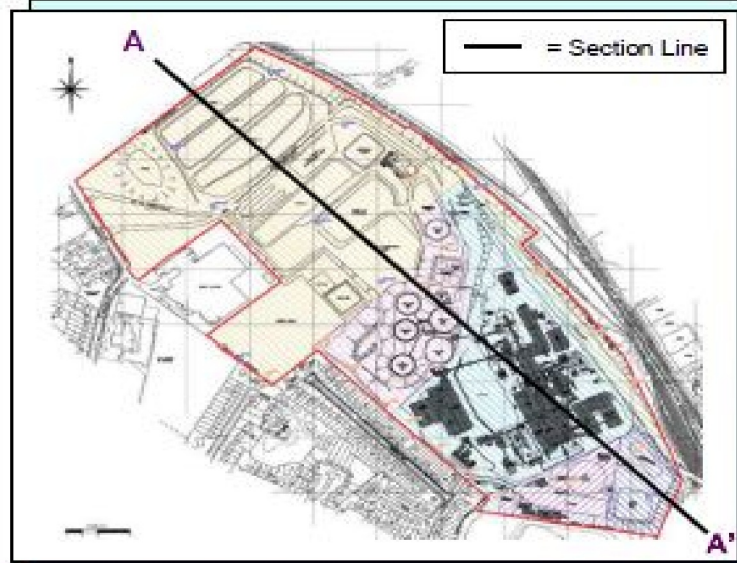
Drawing Number: 10024487-AUK-XX-XX-DR-ZZ-0061-P1-Conceptual Site Model Pre-Remediation and Reclamation

- KEY**
- Made Ground
  - Natural Superficial Deposits (sands and gravels, with sandy and silty clay horizons)
  - Sherwood Sandstone
  - Ground contamination sources – includes elevated hydrocarbons and ammoniacal nitrogen
  - Site Boundary
  - Contaminant Pathway
  - Ground Gas Pathway
  - Water table

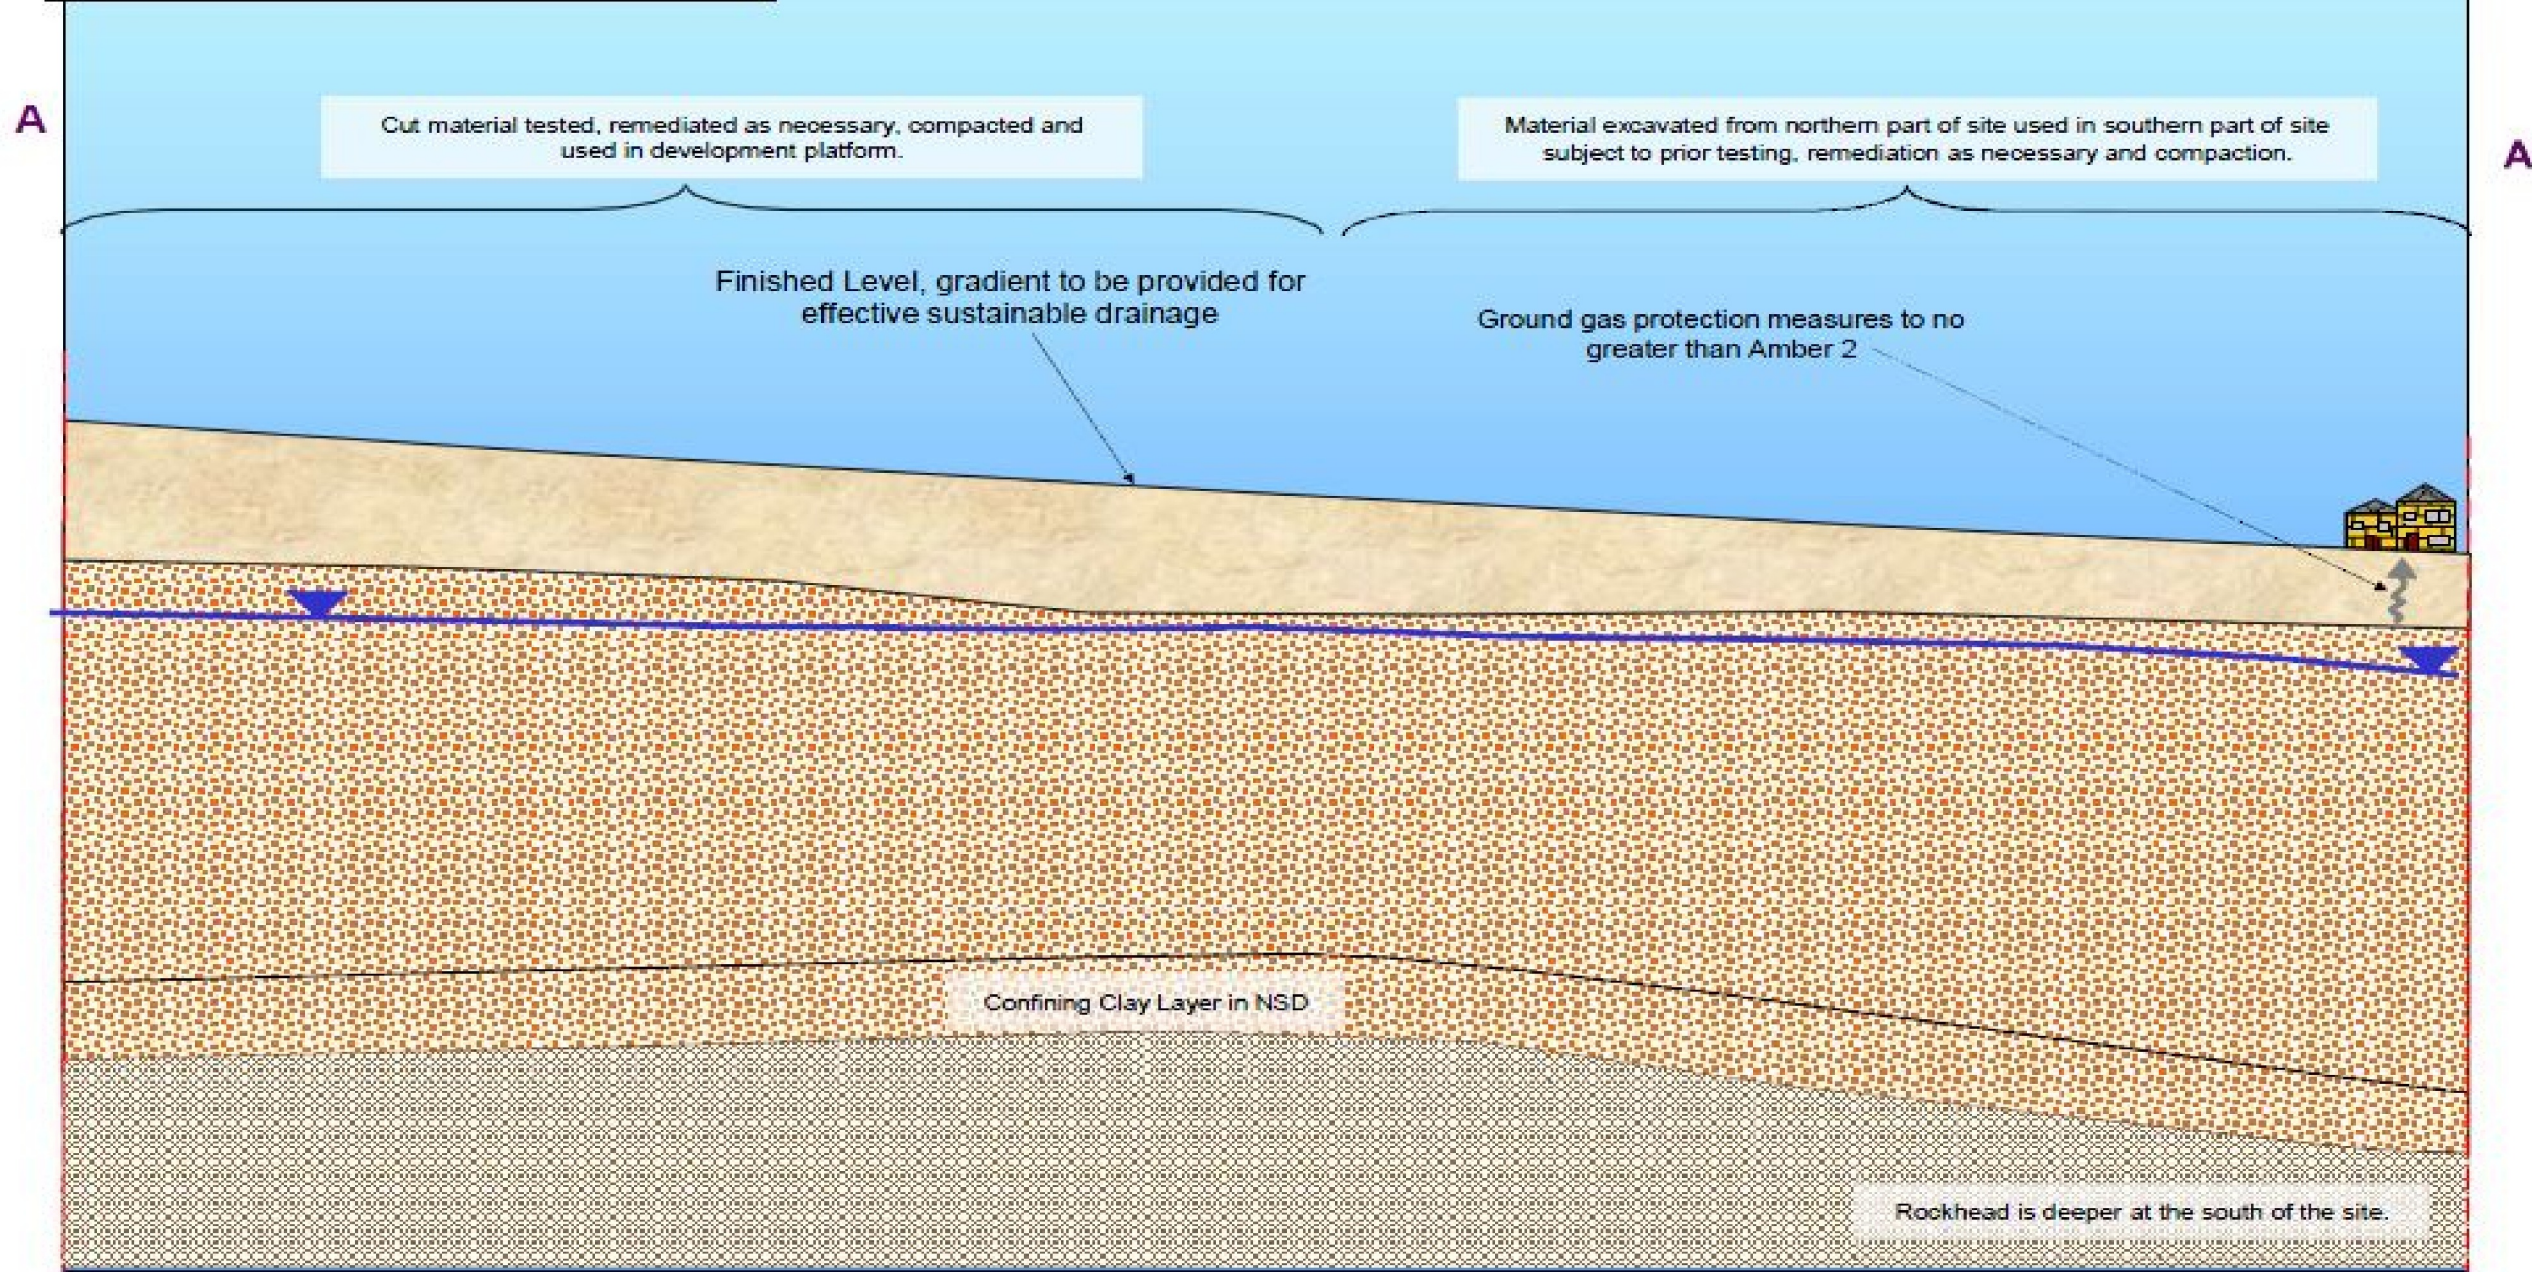
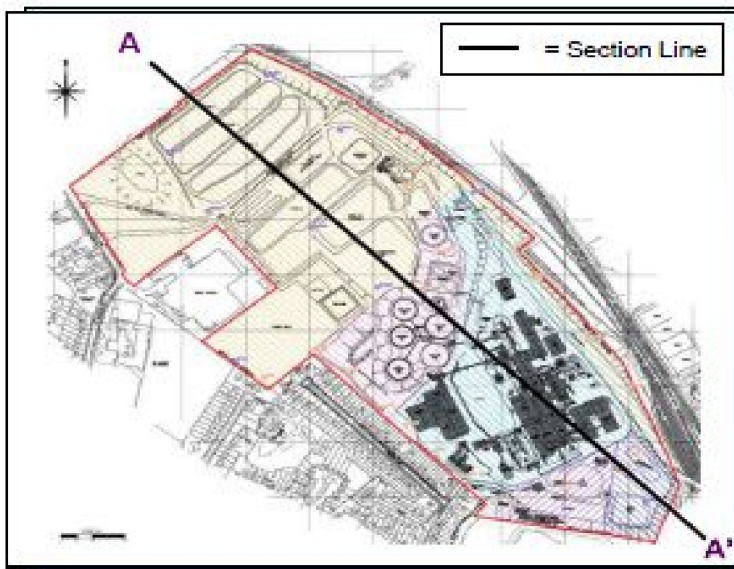
Drawing Number: 10024487-AUK-XX-XX-DR-GE-0064-P1-Conceptual Site Model Post-Remediation and Reclamation

- KEY**
-   Engineered Fill obtained from remediation
  -   Natural Superficial Deposits (sands and gravels, with sandy and silty clay horizons)
  -   Sherwood Sandstone
  -   Site Boundary
  -   Ground Gas Pathway
  -   Water table

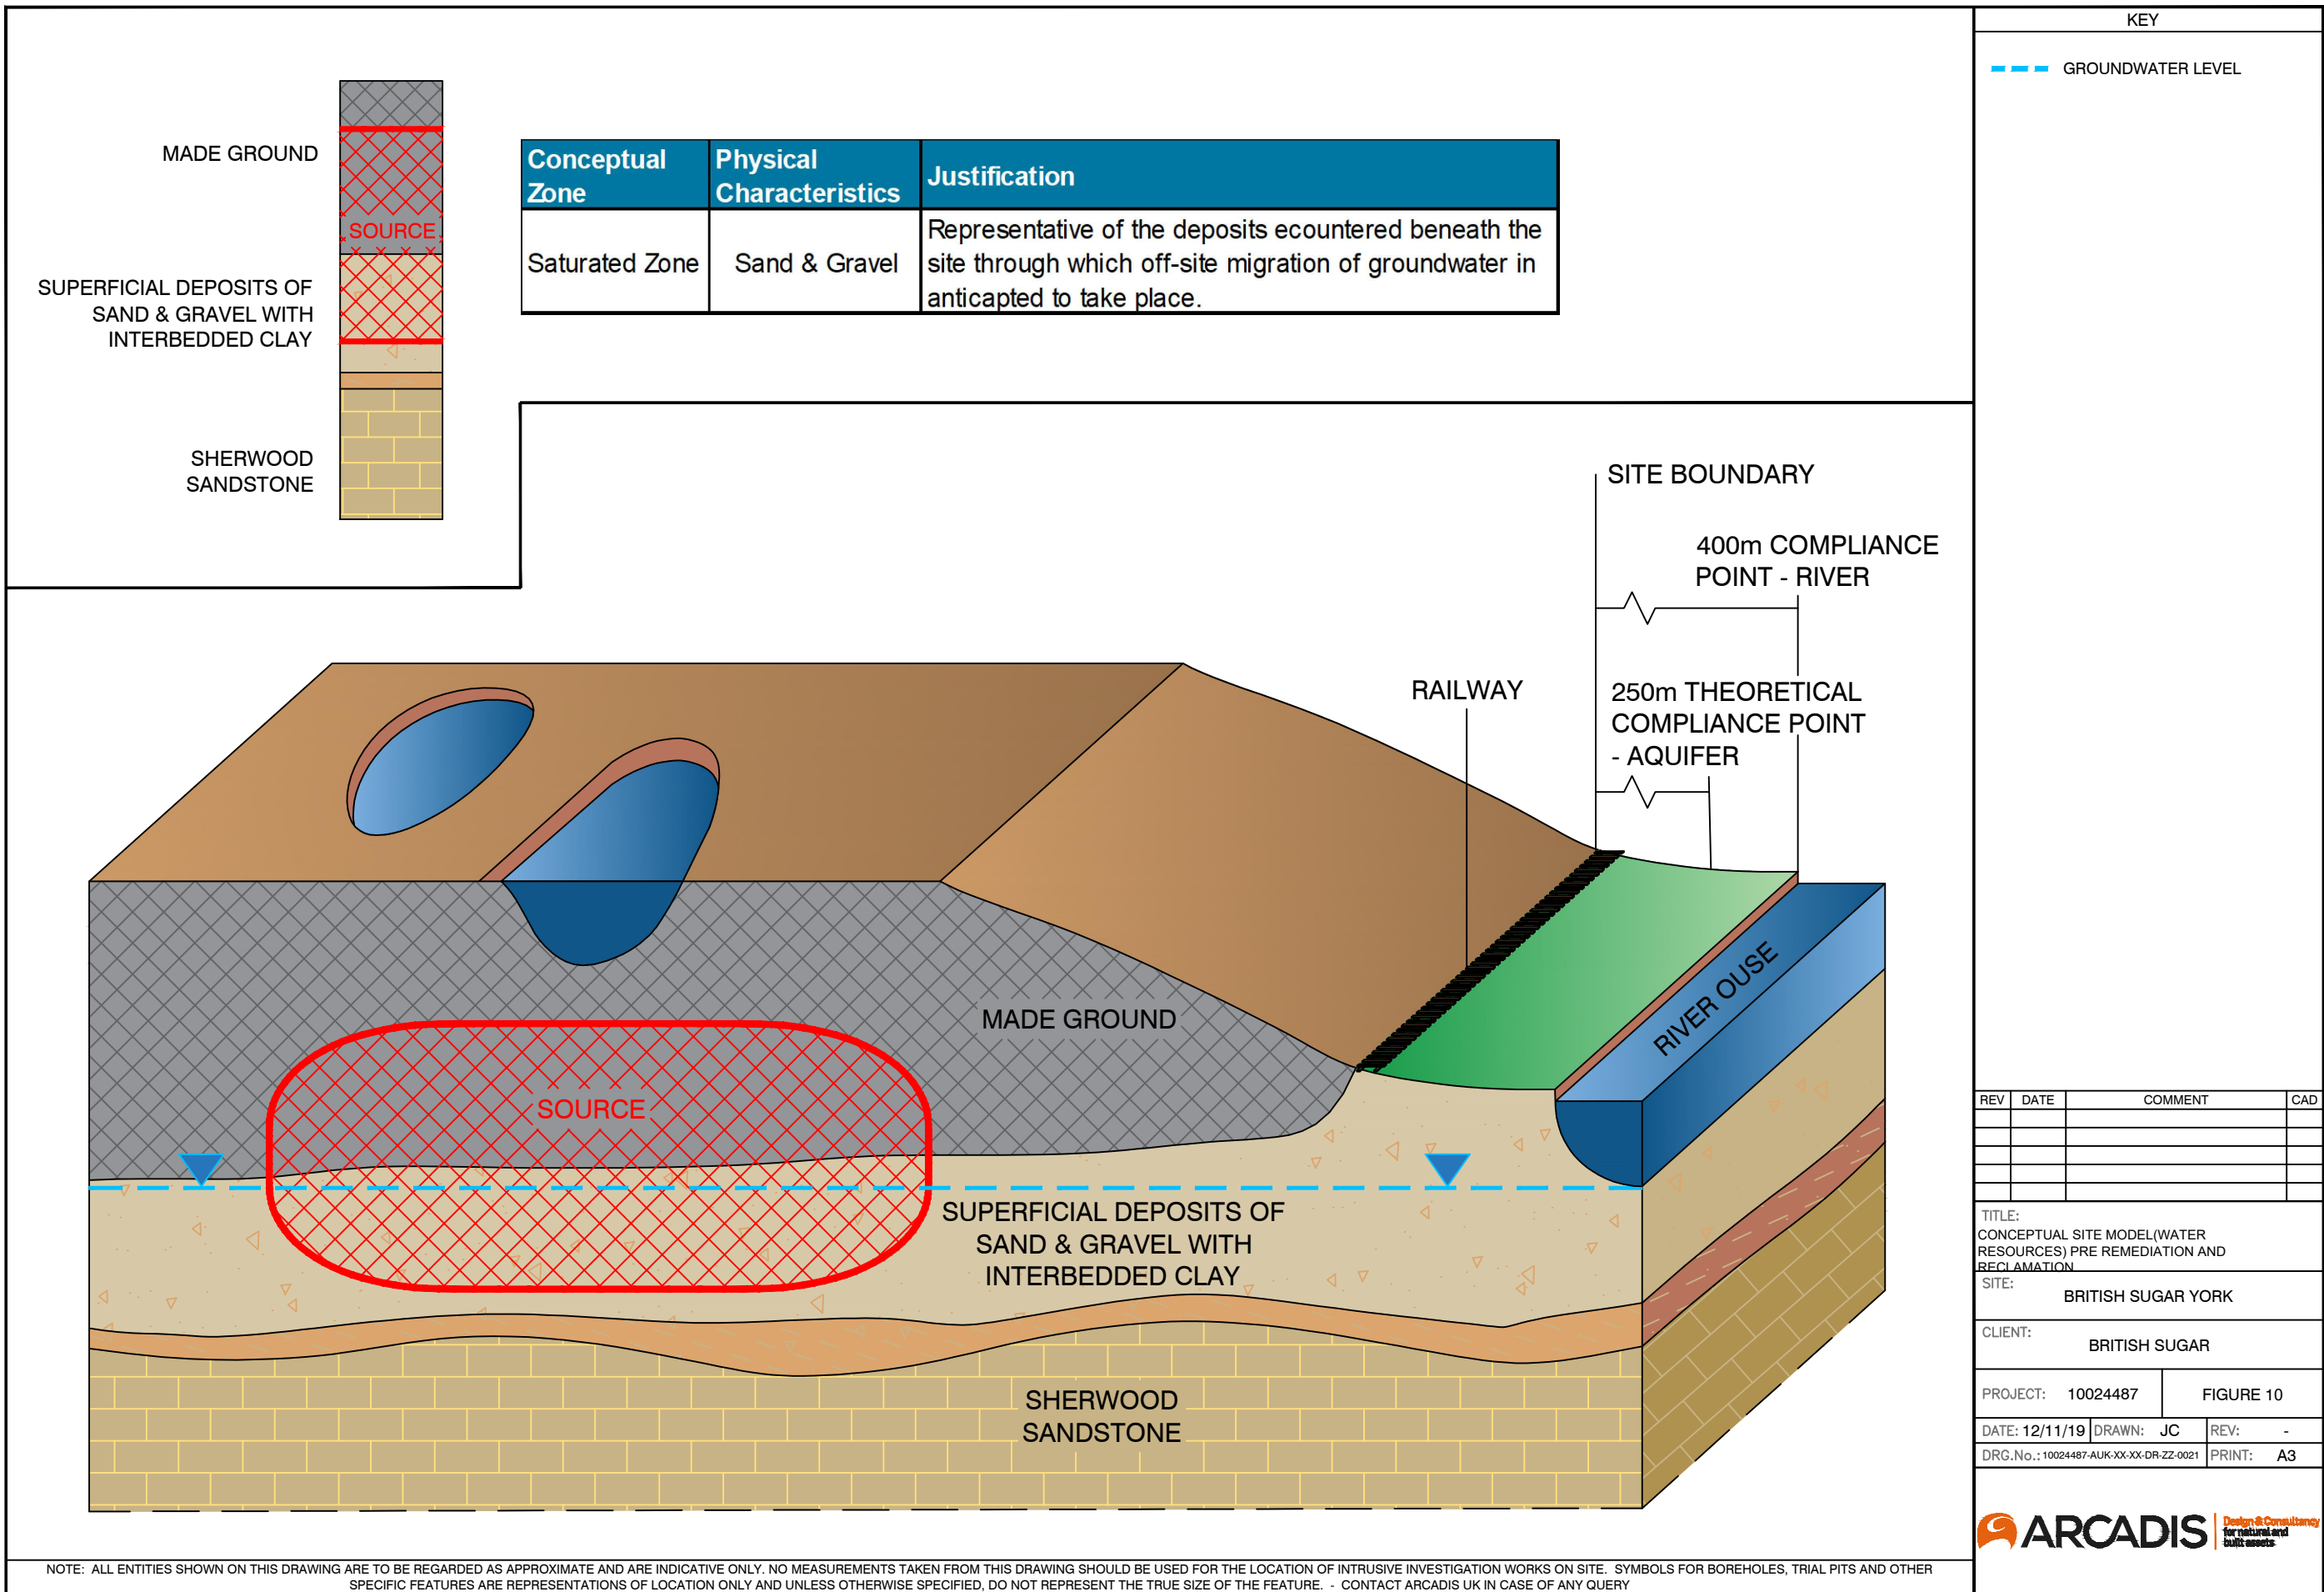
Conceptual Zone	Physical Characteristics	Justification
Saturated Zone	Sand & Gravel	Representative of the deposits encountered beneath the site through which off-site migration of groundwater is anticipated to take place.

KEY	
	GROUNDWATER LEVEL

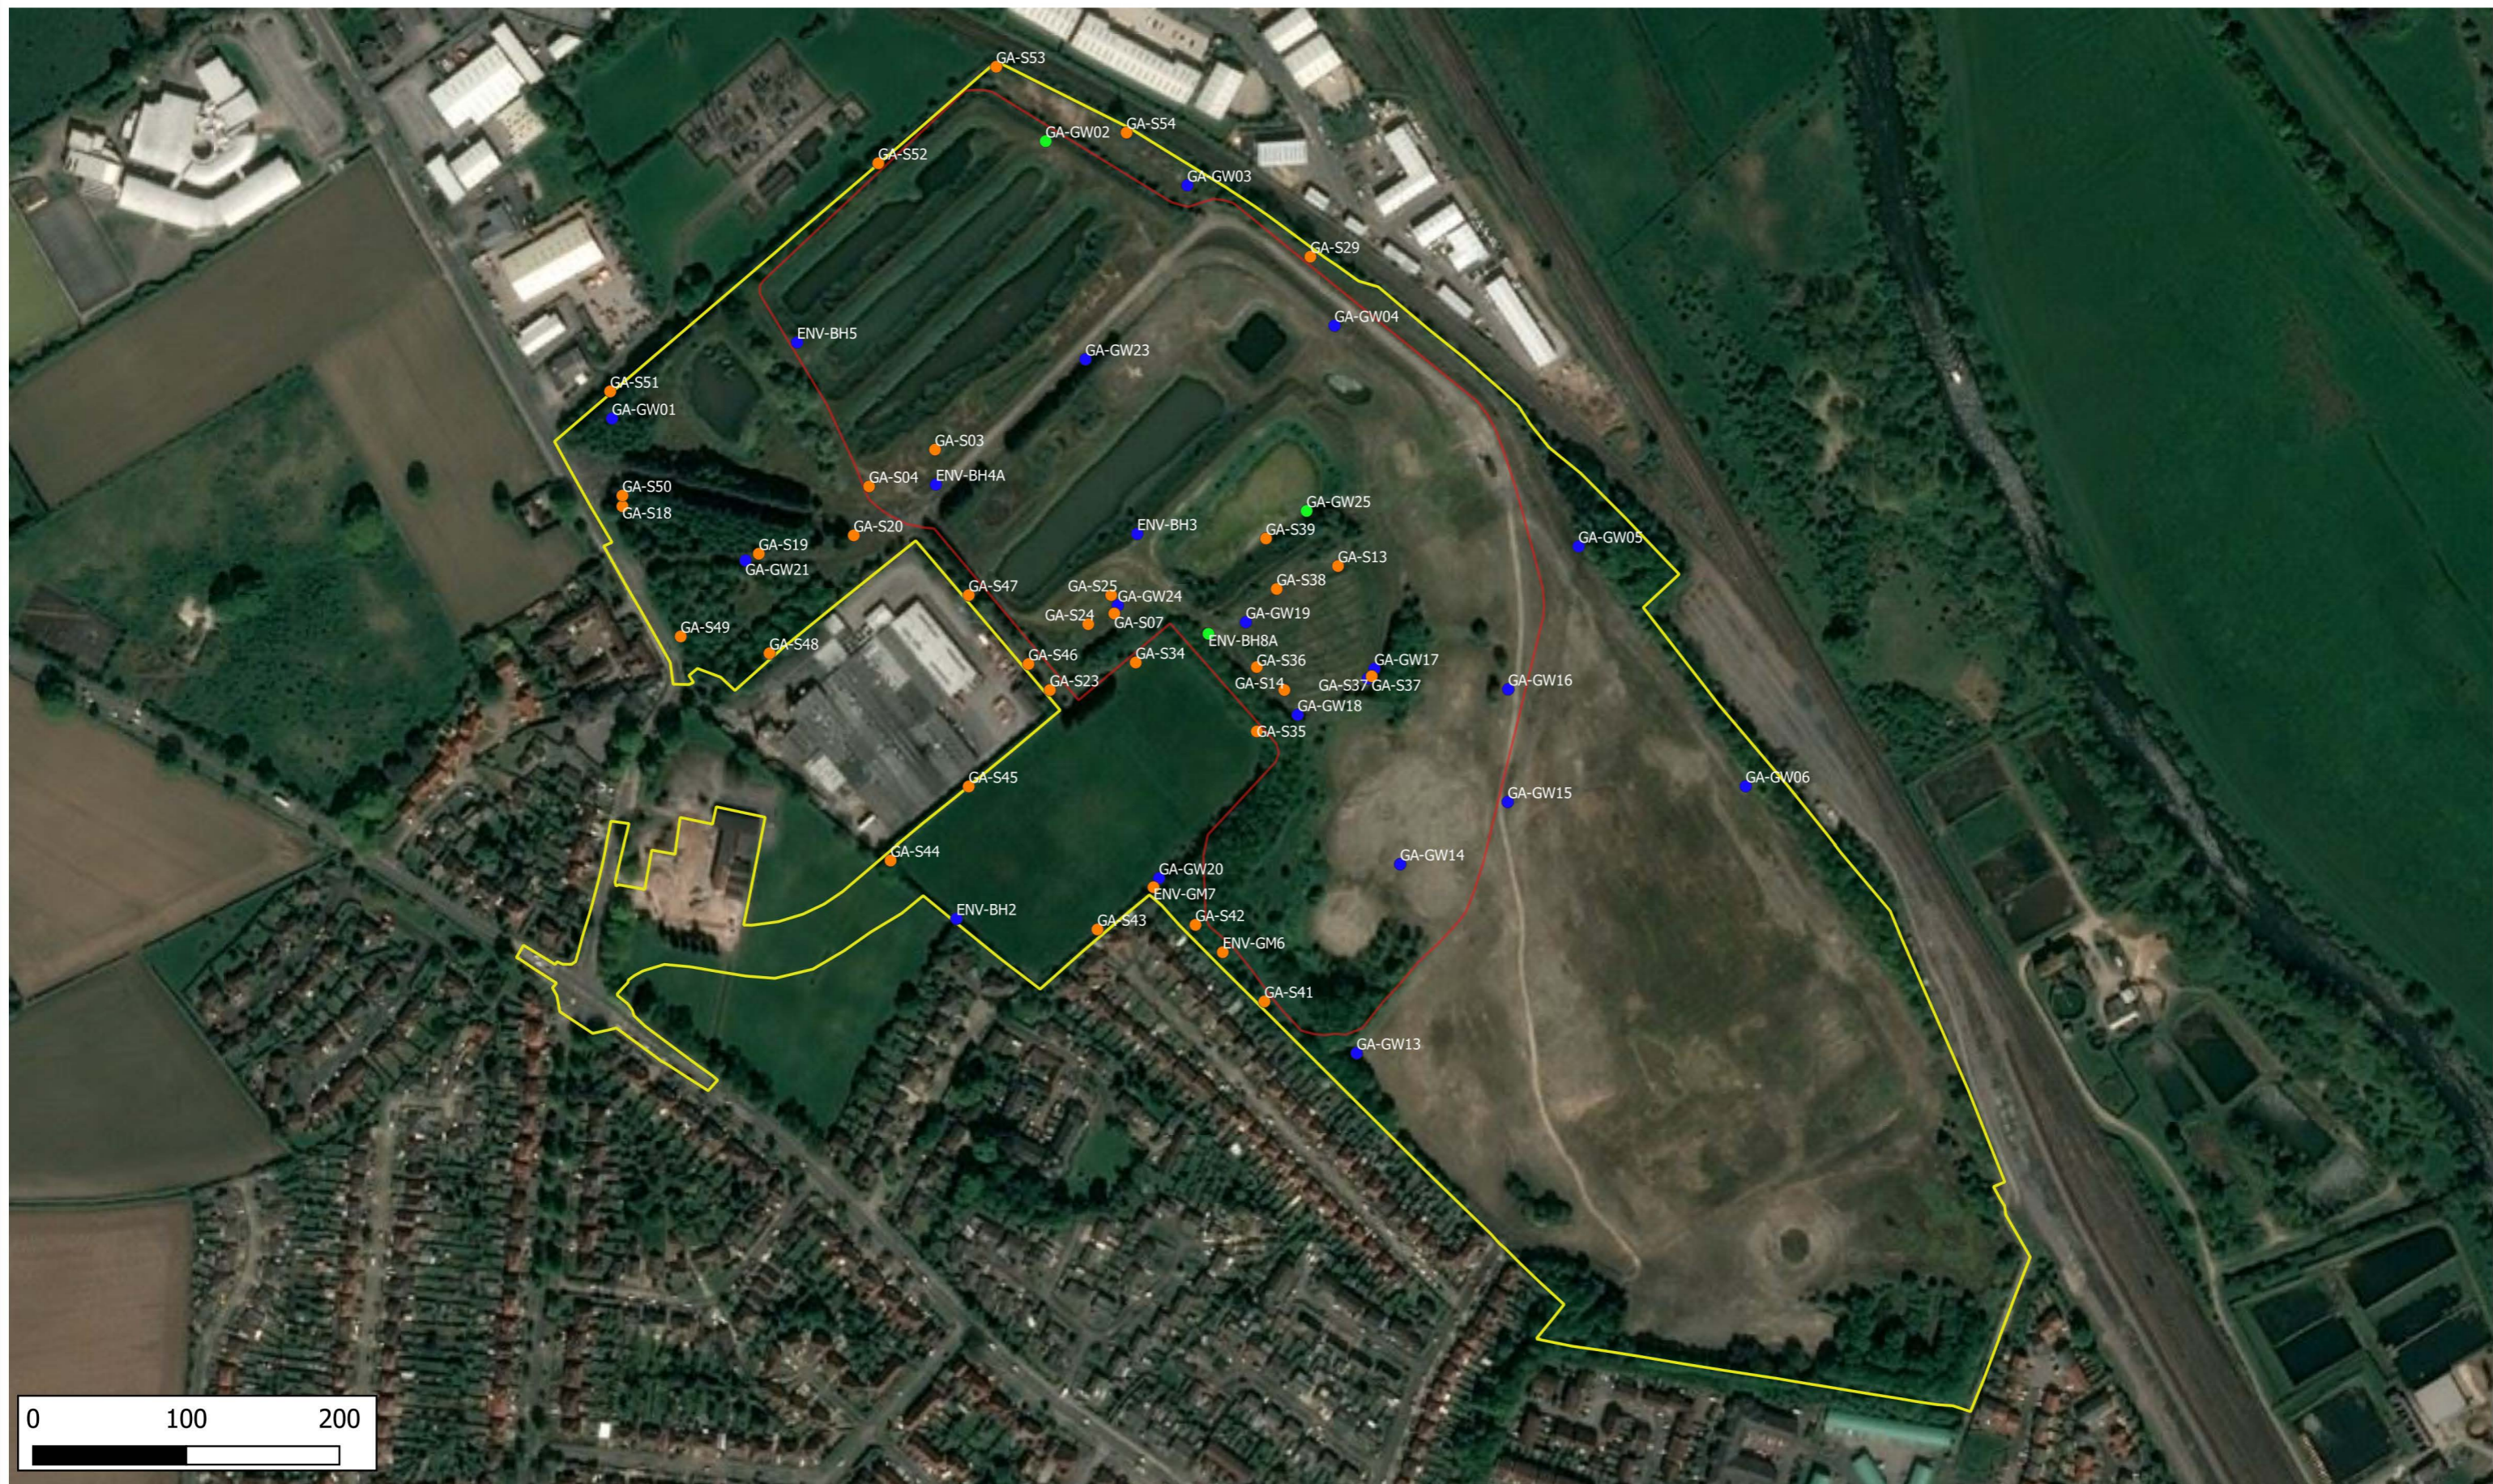
Drawing Number: 10024487-AUK-XXXX-DR-ZZ-0043-P1-Groundgas and Groundwater monitoring Location Map

- Legend**
- Monitoring Locations**
- Ground gas Monitoring Locations
  - Groundwater and Groundgas Monitoring Well
  - Groundwater Monitoring

- Site Boundary
- Permit Boundary

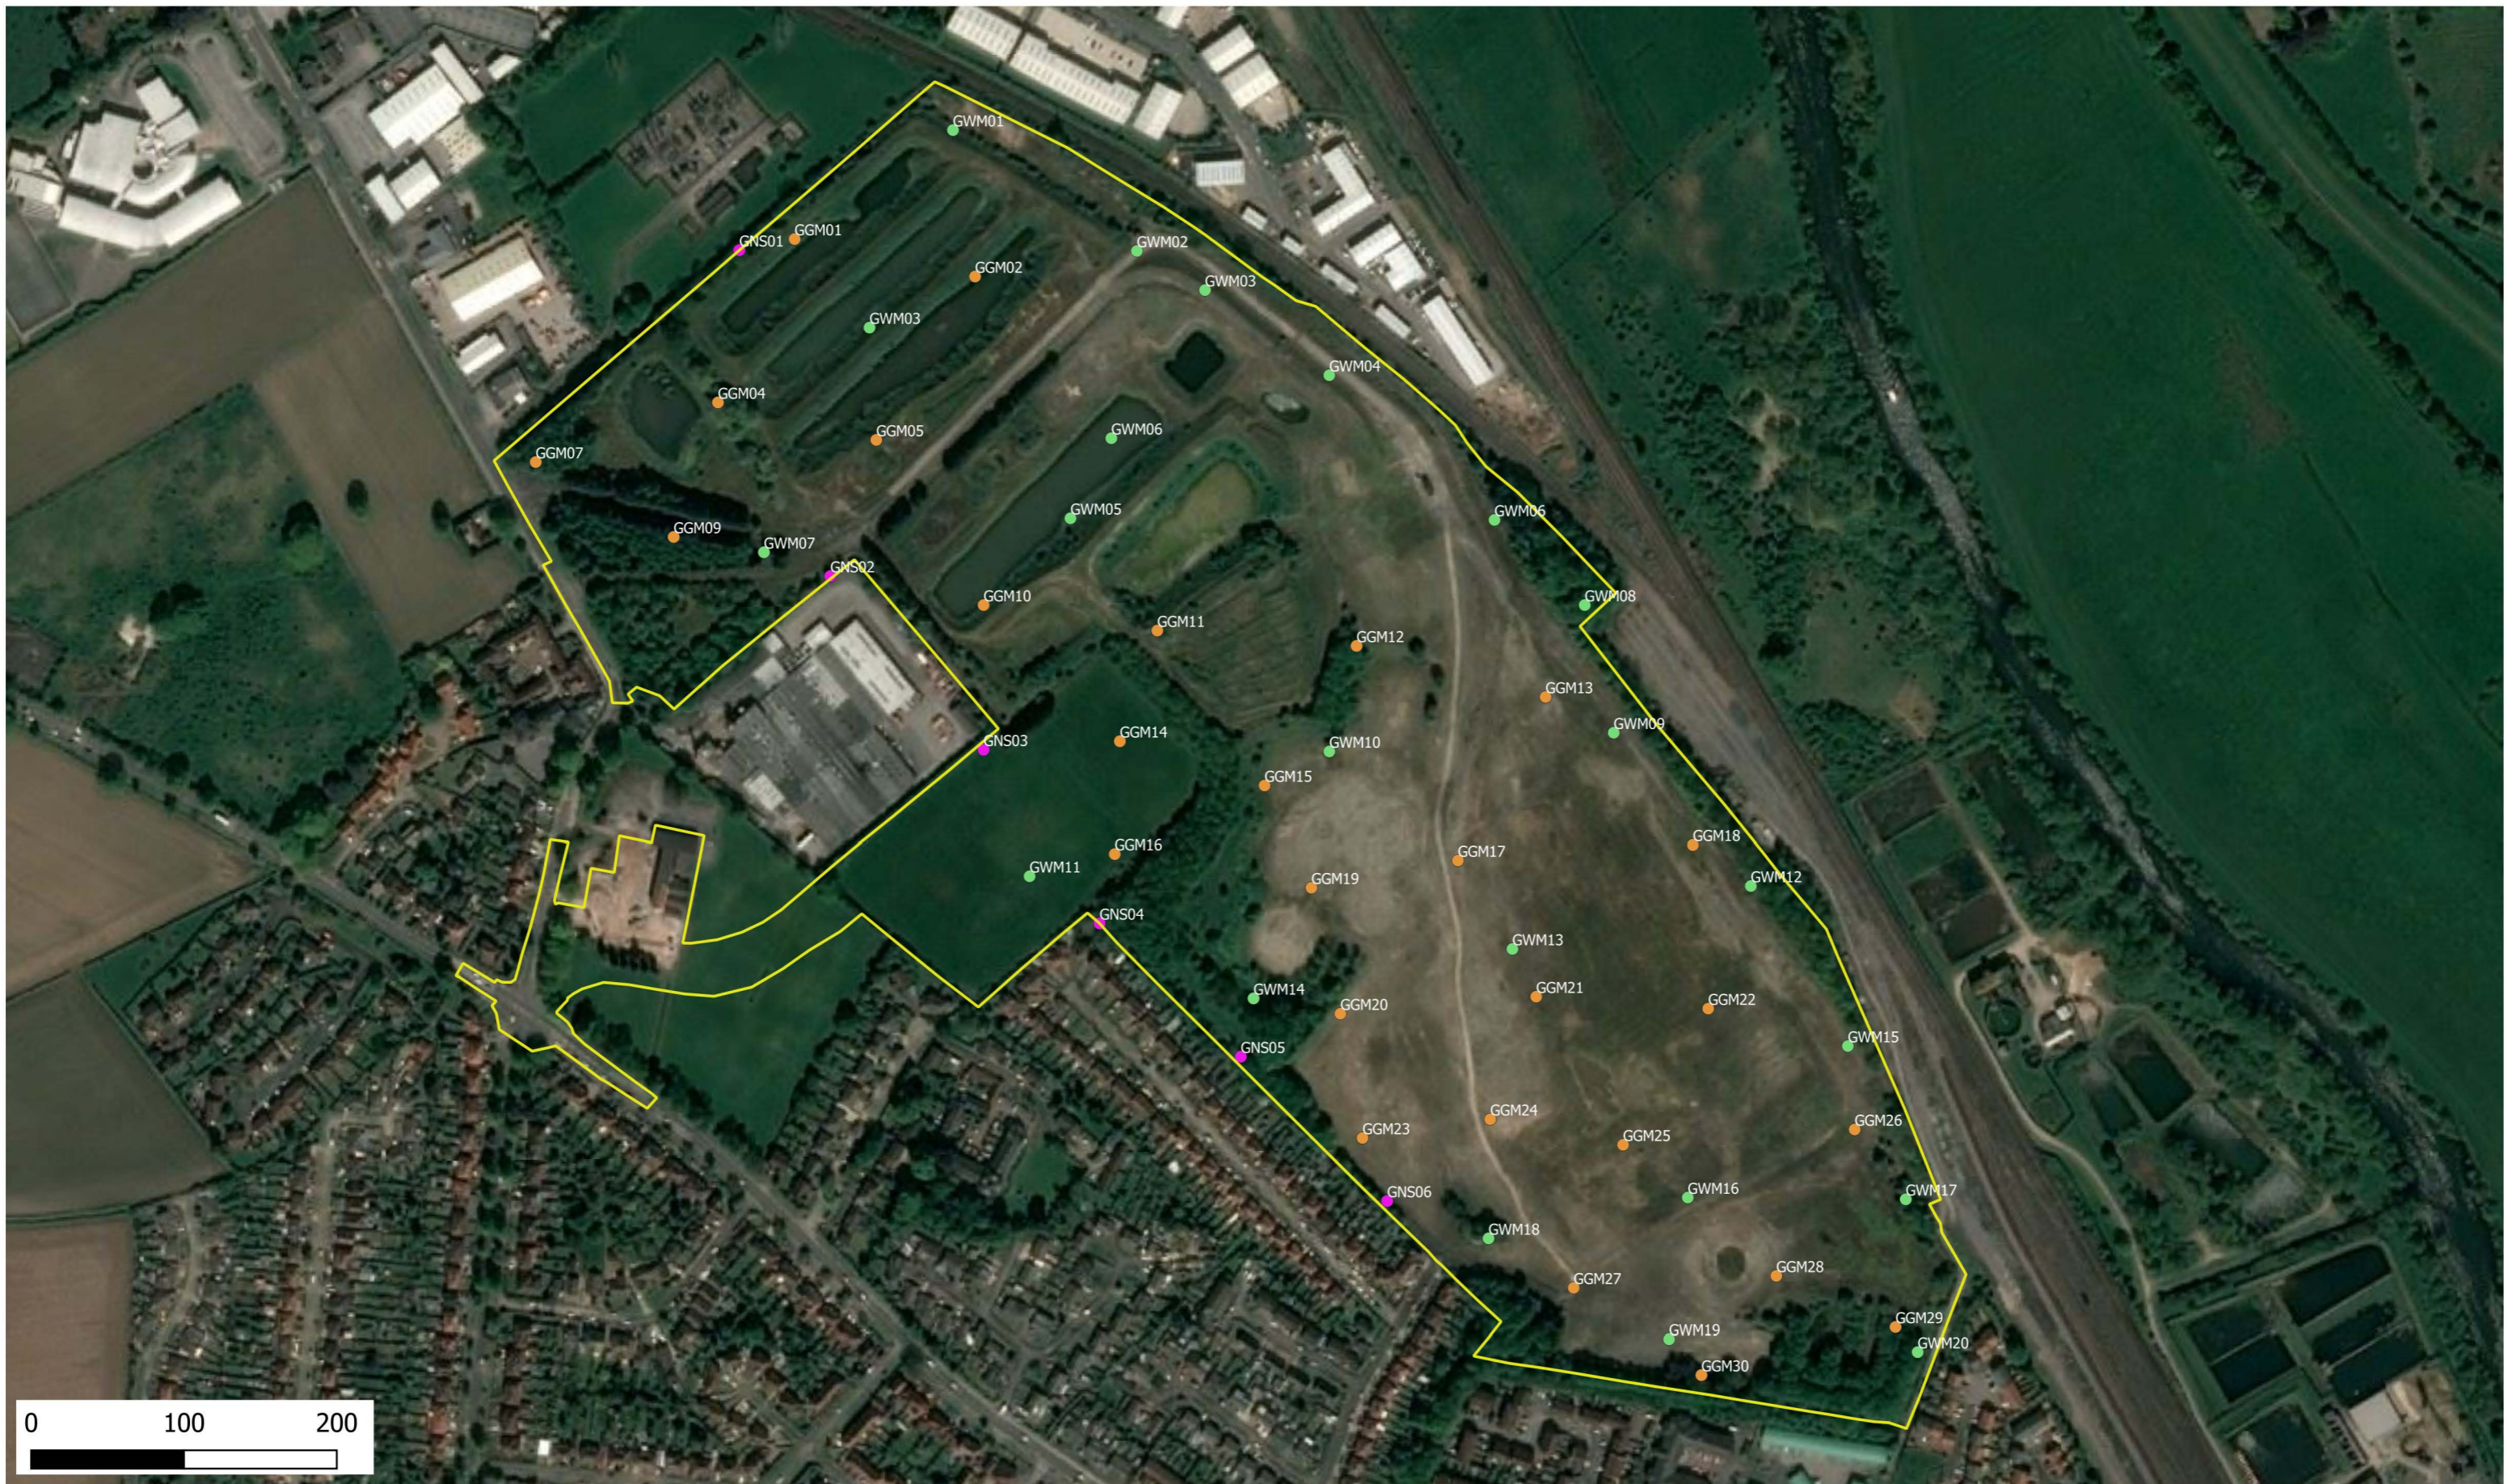
PROJECT	British Sugar, York
TITLE	Proposed Replacement Ground Gas and Groundwater Monitoring Wells

- Legend**
- Proposed Ground Gas and Groundwater Monitoring Locations
- Proposed Ground Gas Monitoring Location
  - Proposed Ground Gas Monitoring Location in Natural Strata
  - Proposed Groundwater Monitoring Location
  - Site Boundary
