BRITISH SUGAR, YORK

Slope Stability Assessment

10024487-AUK-XX-XX-RP-GE-0074-03-Slope Stability Report

SEPTEMBER 2022

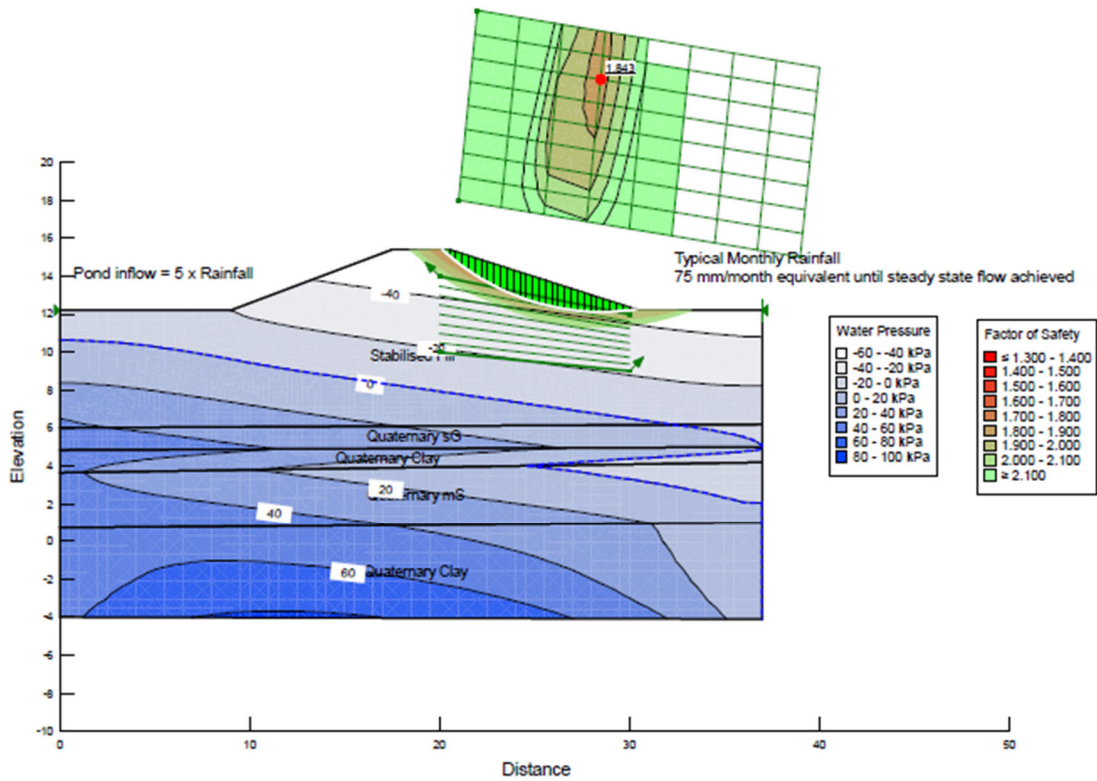
Figure 3: A typical output from the Slope/W analysis

A typical output from the Slope/W analysis is shown below:

The slope stability analysis has been conducted for a number of situations and groundwater conditions and the ratio of resisting moments to overturning moments (F) is calculated. Where $F > 1$, the slope is stable as resisting moments are greater than overturning moments. Where $F < 1$, the slope is unstable.

The overall stability of the proposed slopes was assessed to confirm whether there was potential for a large-scale failure to occur. This analysis was carried out for average, historic peak, and worst case rainfall conditions.

The outputs from each iteration are included in Appendix D and summarised below:

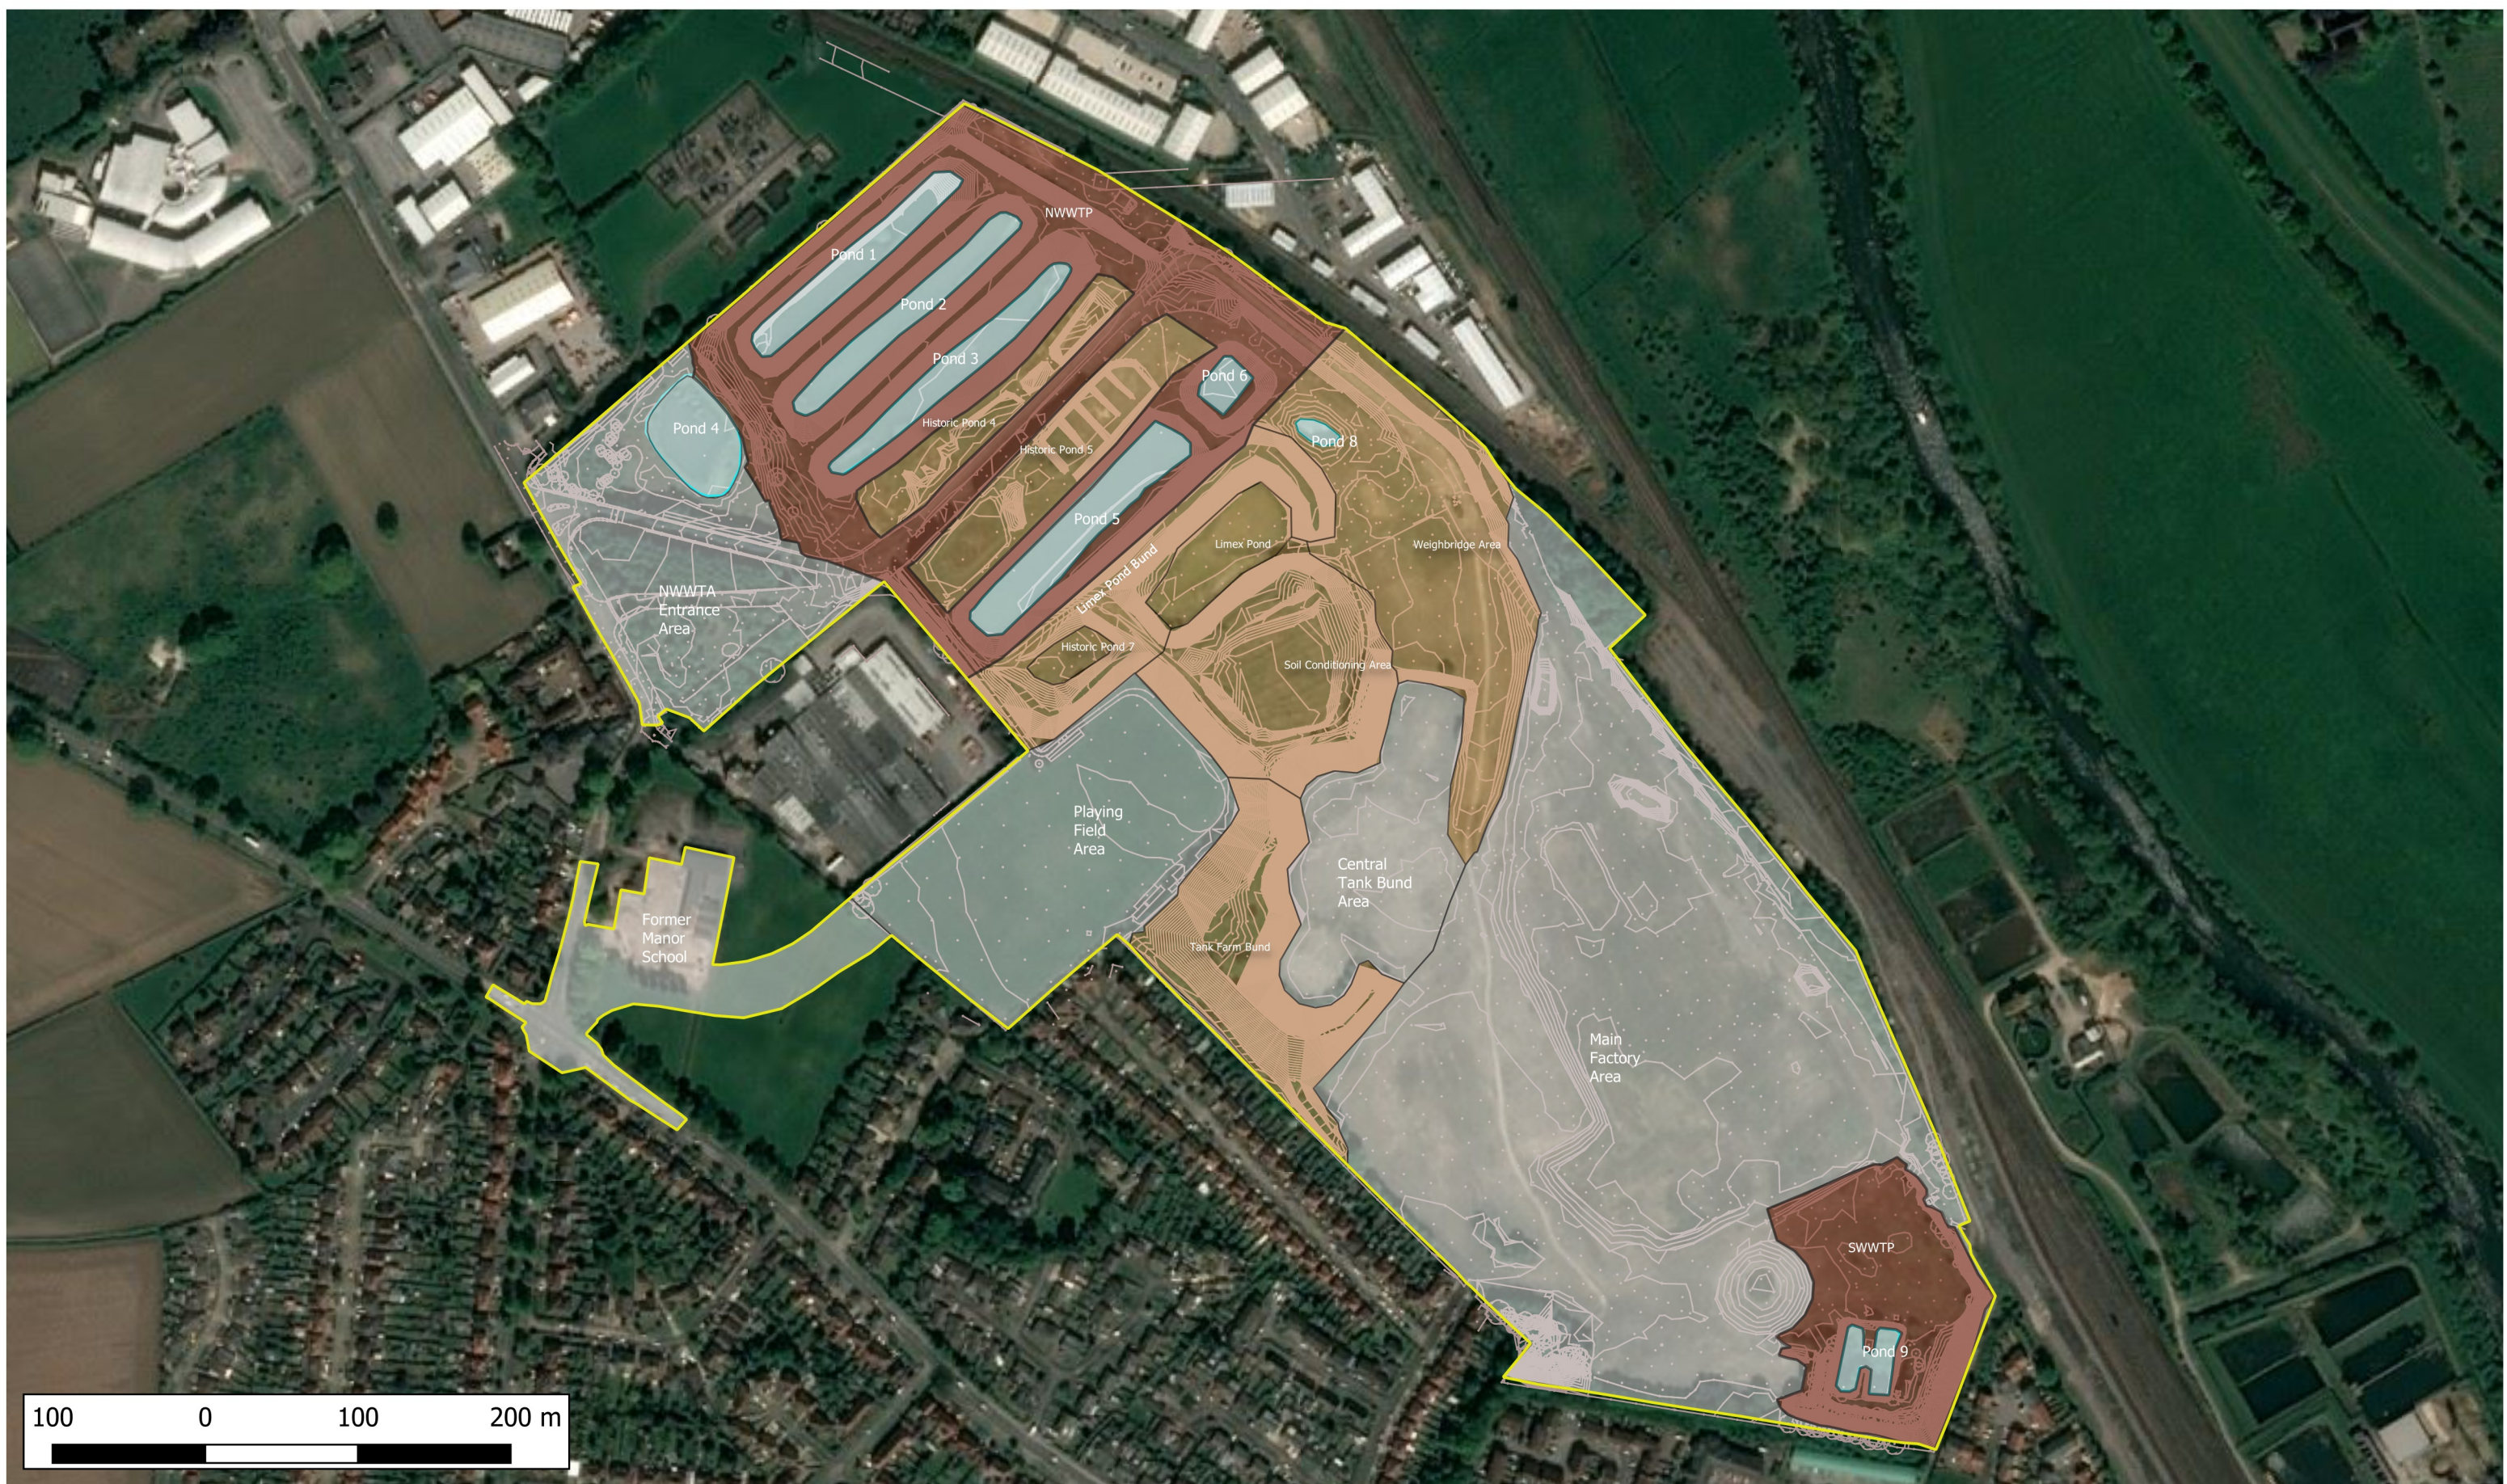
- Legend**
- Former Water Treatment Area
 - Former Factory Area
 - Historic Ponds and Soil Conditioning Area
 - Site Boundary
 - Current Ponds on Site
 - Site Wide Topo Countours

A site location plan is presented as Figure 1, and the location of the permitted and non permitted sections of the site is shown in Figure 2.

1. **Adding land** to the current EP by extending (and including) the current EP boundary. The current and proposed EP boundaries are shown on Figure 2;
2. **Addition of a Bespoke Waste Operation** – specifically a Deposit for Recovery (DfR) waste operation to enable recovery of waste material present within the current EP boundary followed by reuse / deposit of recovered waste across the proposed extended EP boundary as fill to create the development platform;
3. **Adding a R11 recovery code** activity to the permit to allow the 'use of wastes obtained from any of the operations numbered R1 to R10', in this case as fill to create the development platform; and

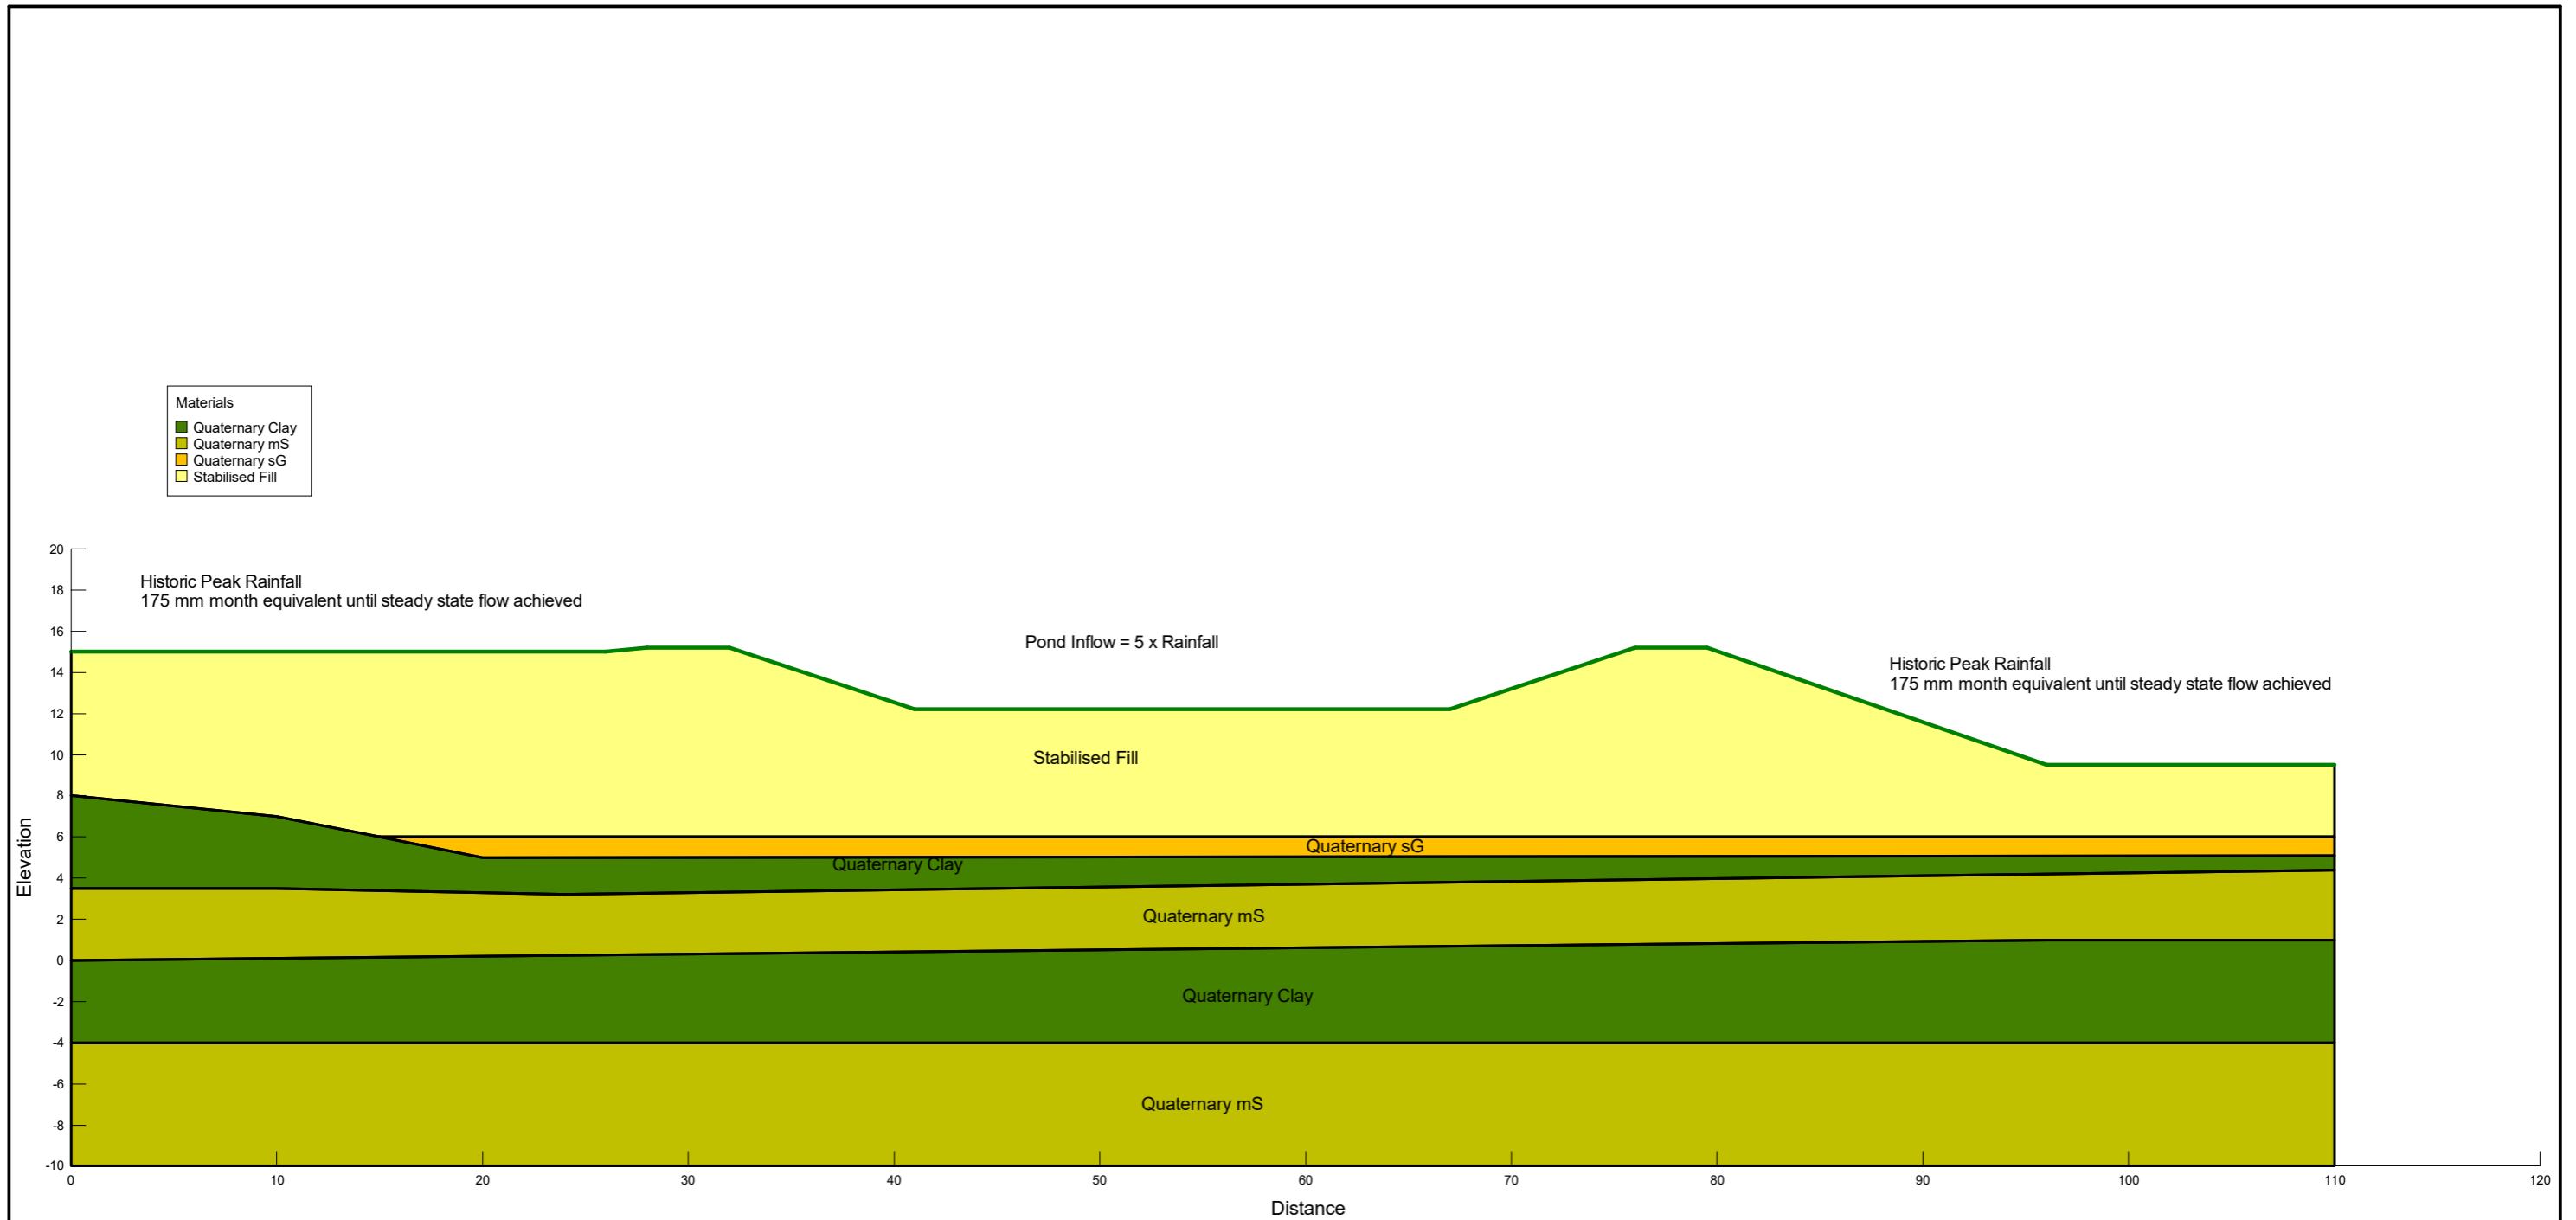
Name	Model	Vol. WC. Function	K-Function	Ky'/Kx' Ratio	Rotation (°)
Quaternary Clay	Saturated / Unsaturated	QCLAY VWC FN1	QClay Hyd FN1	0.2	0
Quaternary mS	Saturated / Unsaturated	QmSAND VWC FN1	QmSAND Hyd FN1	0.2	0
Quaternary sG	Saturated / Unsaturated	QsG VWC FN1	QsG Hyd FN1	1	0
Stabilised Fill	Saturated / Unsaturated	FILL water FN1	FILL Hyd FN1	1	0

SEEP/W Analysis	
Profile A Seep_slope - Historic Rain WC1 - slip 2.gsz	
18/06/2020	1:318

Groundwater conditions were modelled using Geosolve SEEP/W. SEEP/W allows for modelling of pore water pressures based on saturated steady state conditions based on average, historic peak and worst case rainfall data. These assumed average monthly rainfall rates of 75, 175 and 225mm respectively.

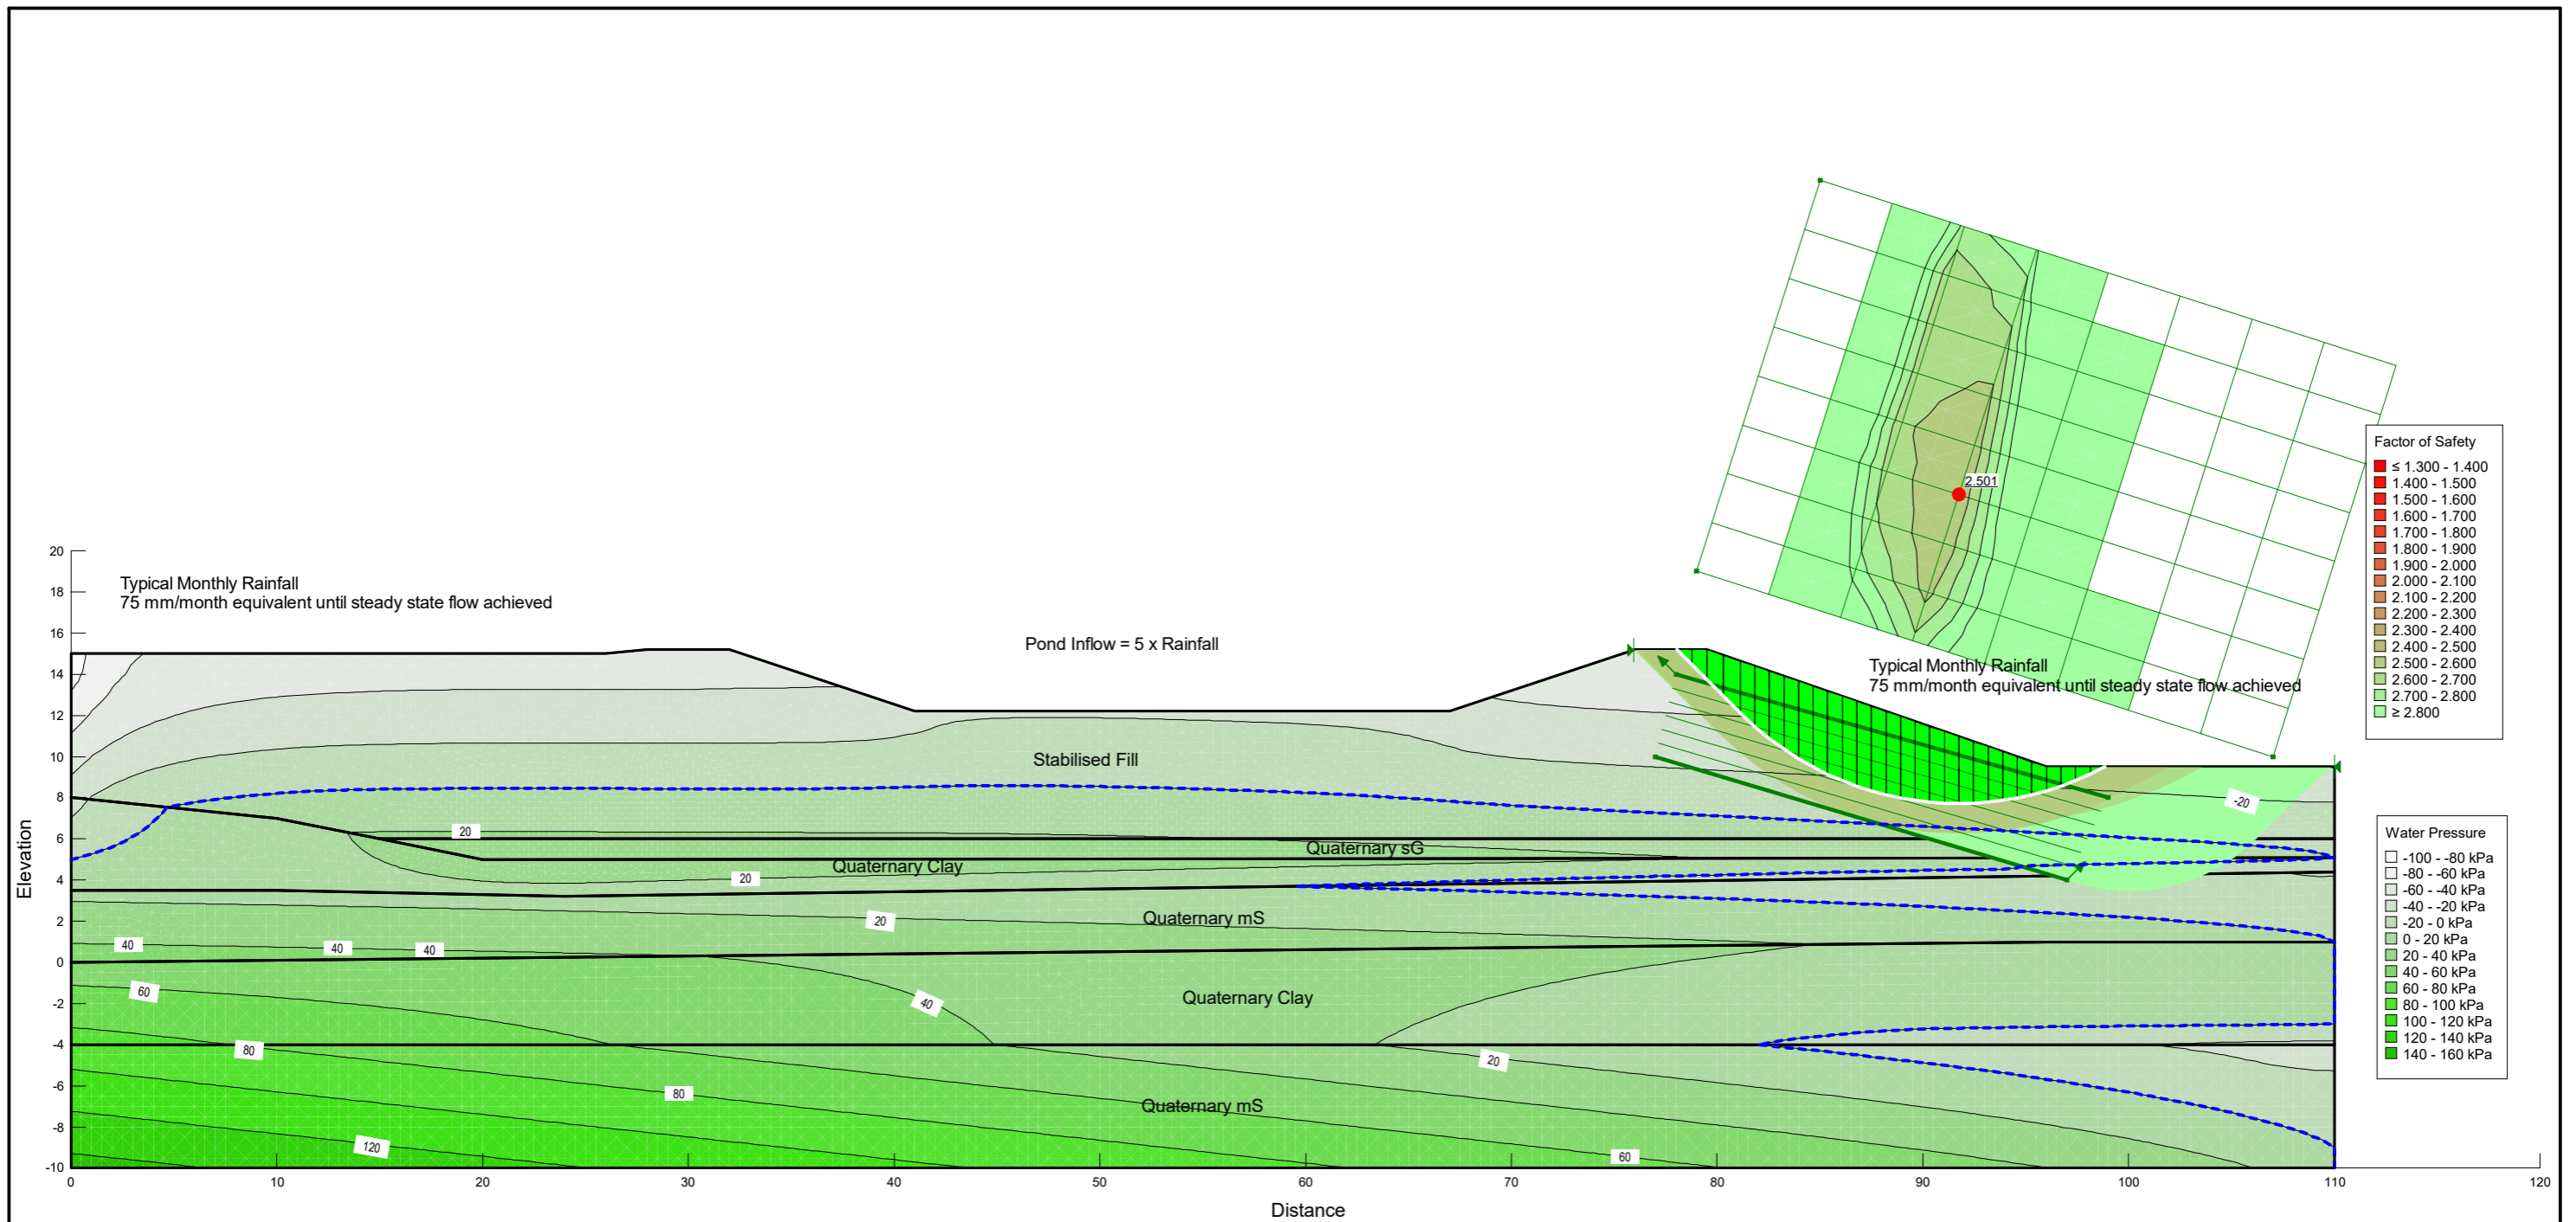
Name	Model	Unit Weight (kN/m ³)	Cohesion' (kPa)	Phi' (°)	Vol. WC. Function	Residual Water Content (% of Sat WC) (%)	Vol. WC Fn used for Unit Wt. Above Water Table
Quaternary Clay	Mohr-Coulomb	19.6	2	28	QCLAY VWC FN1	50	QCLAY VWC FN1
Quaternary mS	Mohr-Coulomb	18	0	36	QmSAND VWC FN1	50	QmSAND VWC FN1
Quaternary sG	Mohr-Coulomb	18	0	38	QsG VWC FN1	50	QsG VWC FN1
Stabilised Fill	Mohr-Coulomb	17.6	1	25	FILL water FN1	50	FILL water FN1

Slope Stability Main Slope	
Profile A Seep_slope - Average condition 75 mmper month.gsz	
18/06/2020	1:318

Location	Rainfall Condition	F	Stability
Profile A- External Slope	Average	2.501	Stable
	Historic Peak	1.844	Stable
	Worst Case	1.207	Stable
Profile A- Internal Slope	Average	3.209	Stable
	Historic Peak	2.369	Stable
	Worst Case	6.174	Stable
Profile A-Rapid Drawdown	Worst Case	1.337	Stable
Profile B-External Slope	Average	1.843	Stable
	Historic Peak	1.843	Stable
	Worst Case	1.843	Stable
Profile B- Internal Slope	Average	1.612	Stable
	Historic Peak	1.612	Stable
	Worst Case	1.604	Stable
Profile C-External Slope	Average	2.323	Stable
	Historic Peak	2.323	Stable
	Worst Case	2.323	Stable
Profile C- Internal Slope 1	Average	2.315	Stable
	Historic Peak	2.204	Stable
	Worst Case	3.506	Stable
Profile C- Internal Slope 2	Average	2.105	Stable
	Historic Peak	1.980	Stable
	Worst Case	2.413	Stable
Profile D- External Slope	Average	1.539	Stable
	Historic Peak	1.539	Stable
	Worst Case	1.539	Stable
Profile G- External slope	Average	1.712	Stable

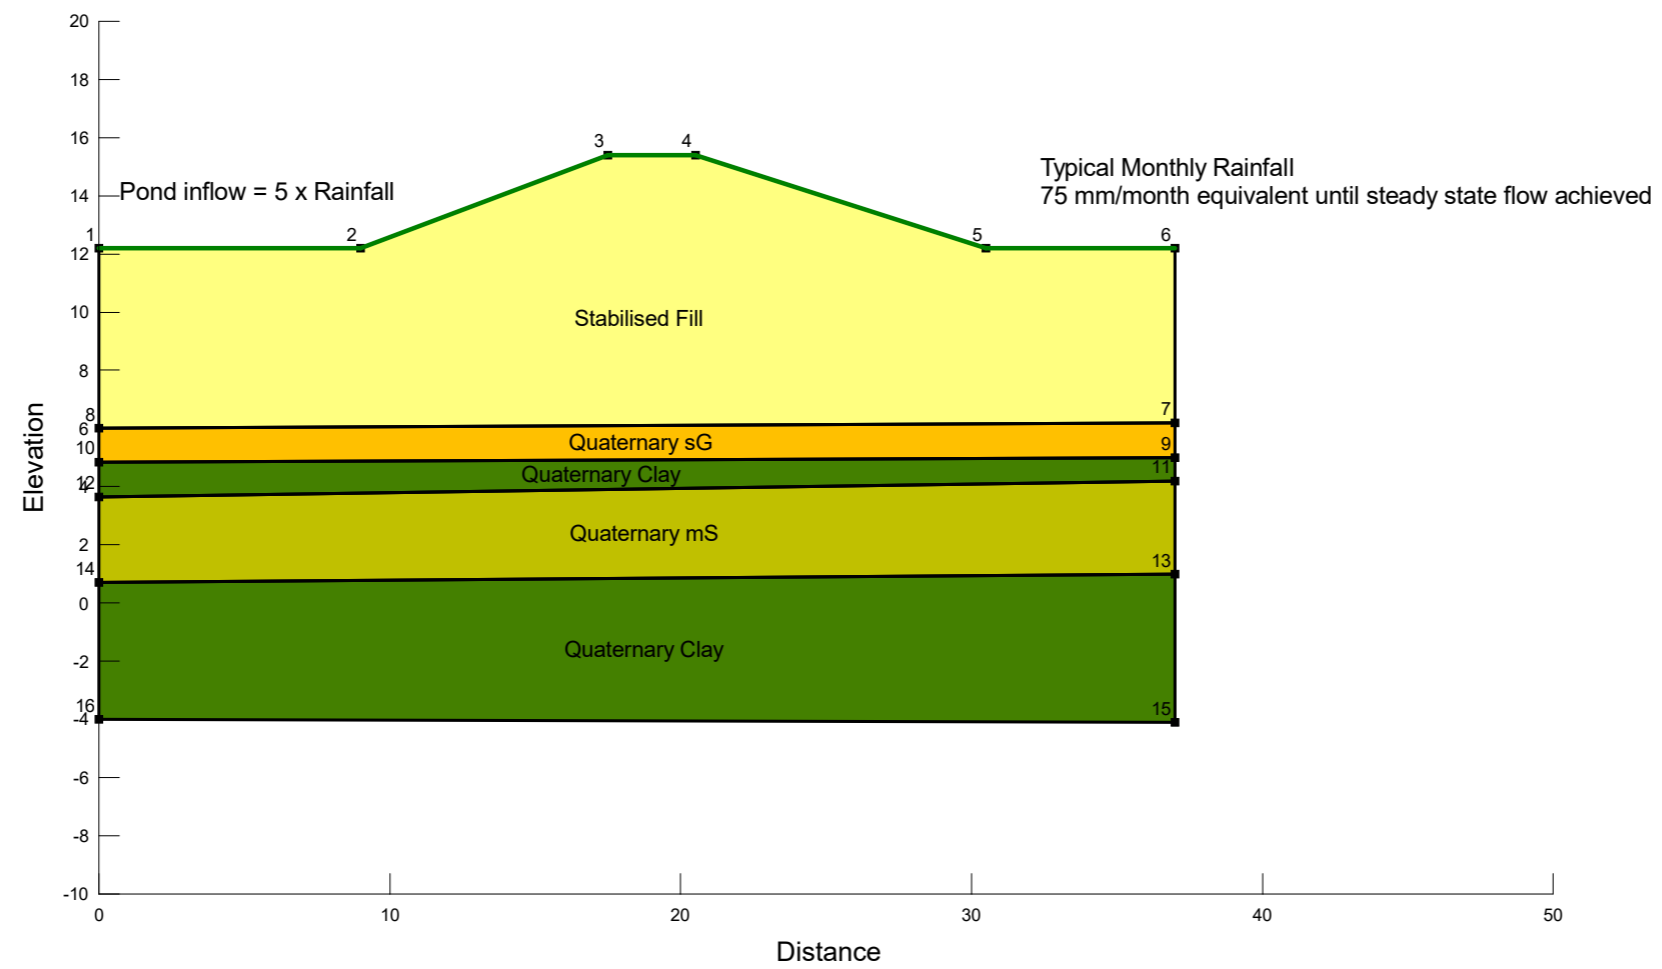
Profile B Seep-Slope	
Profile B Average 75 mm_month.gsz	
19/06/2020	1:260

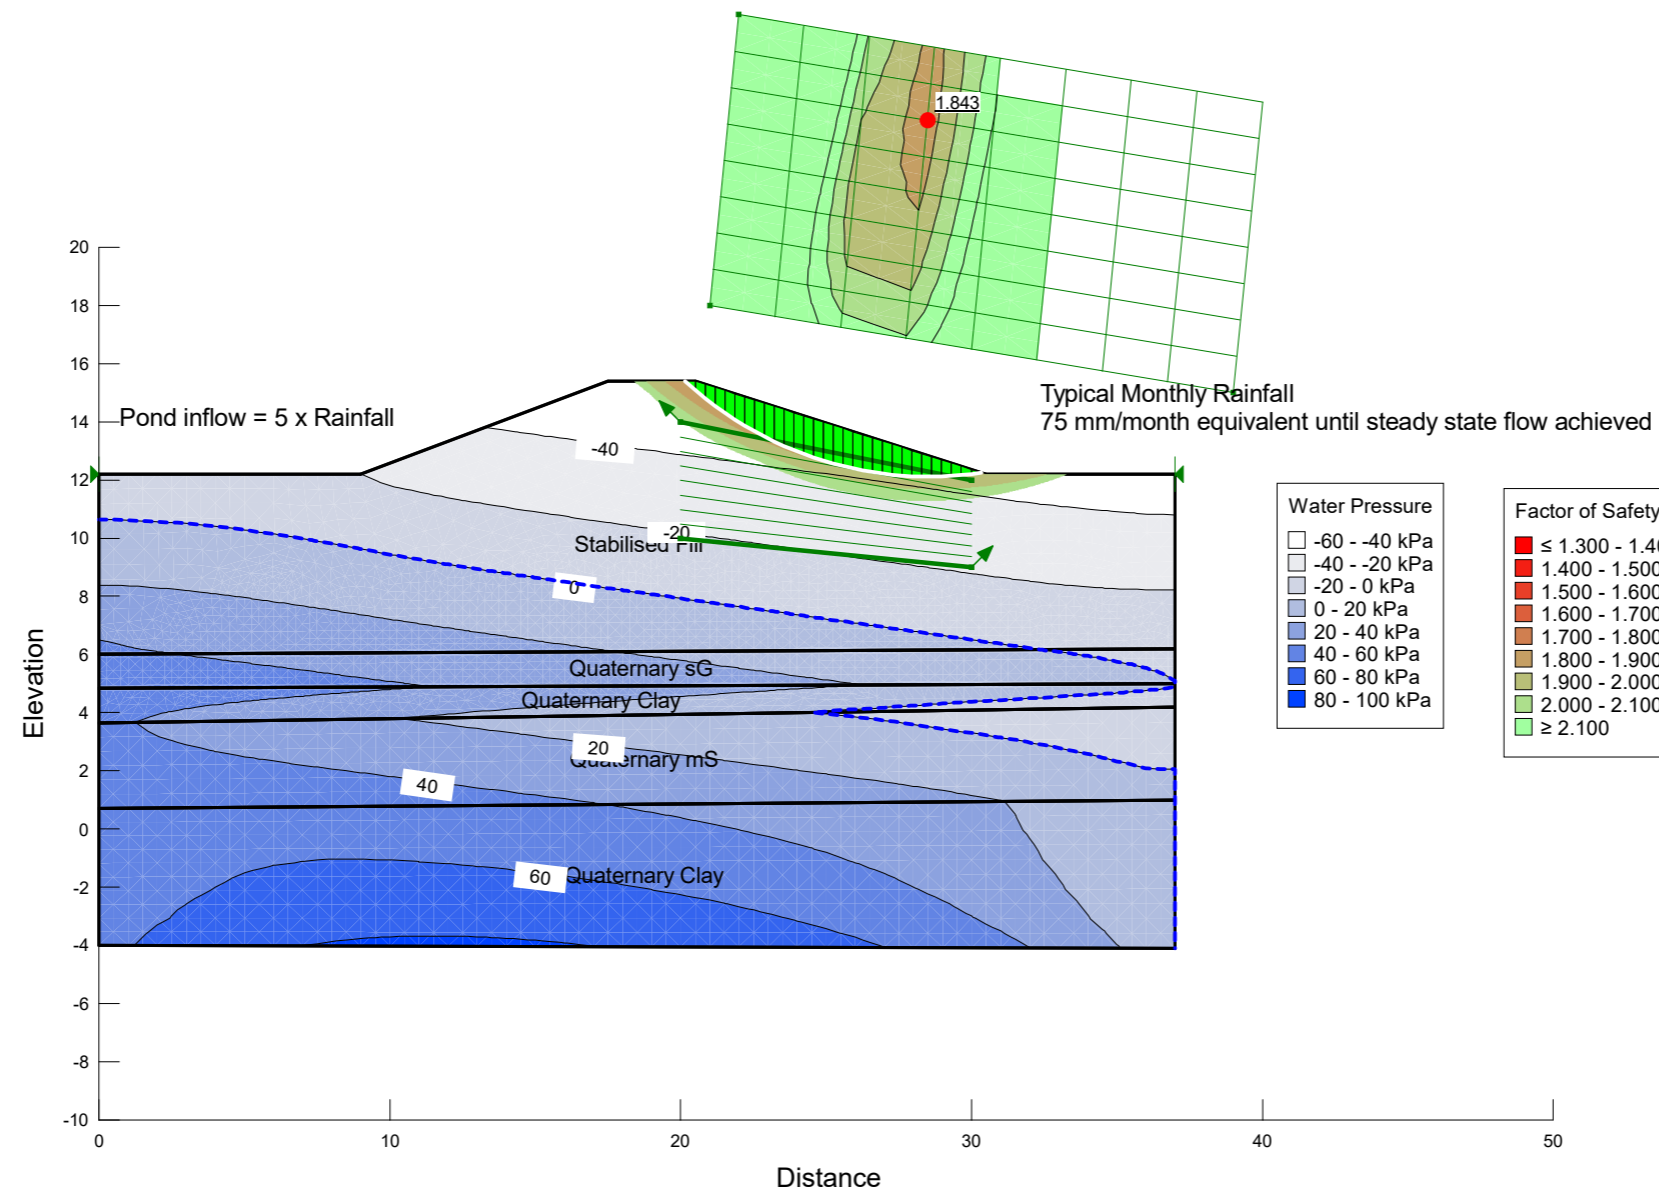
Slope Stability	
Profile B Average 75 mm_month.gsz	
19/06/2020	1:260

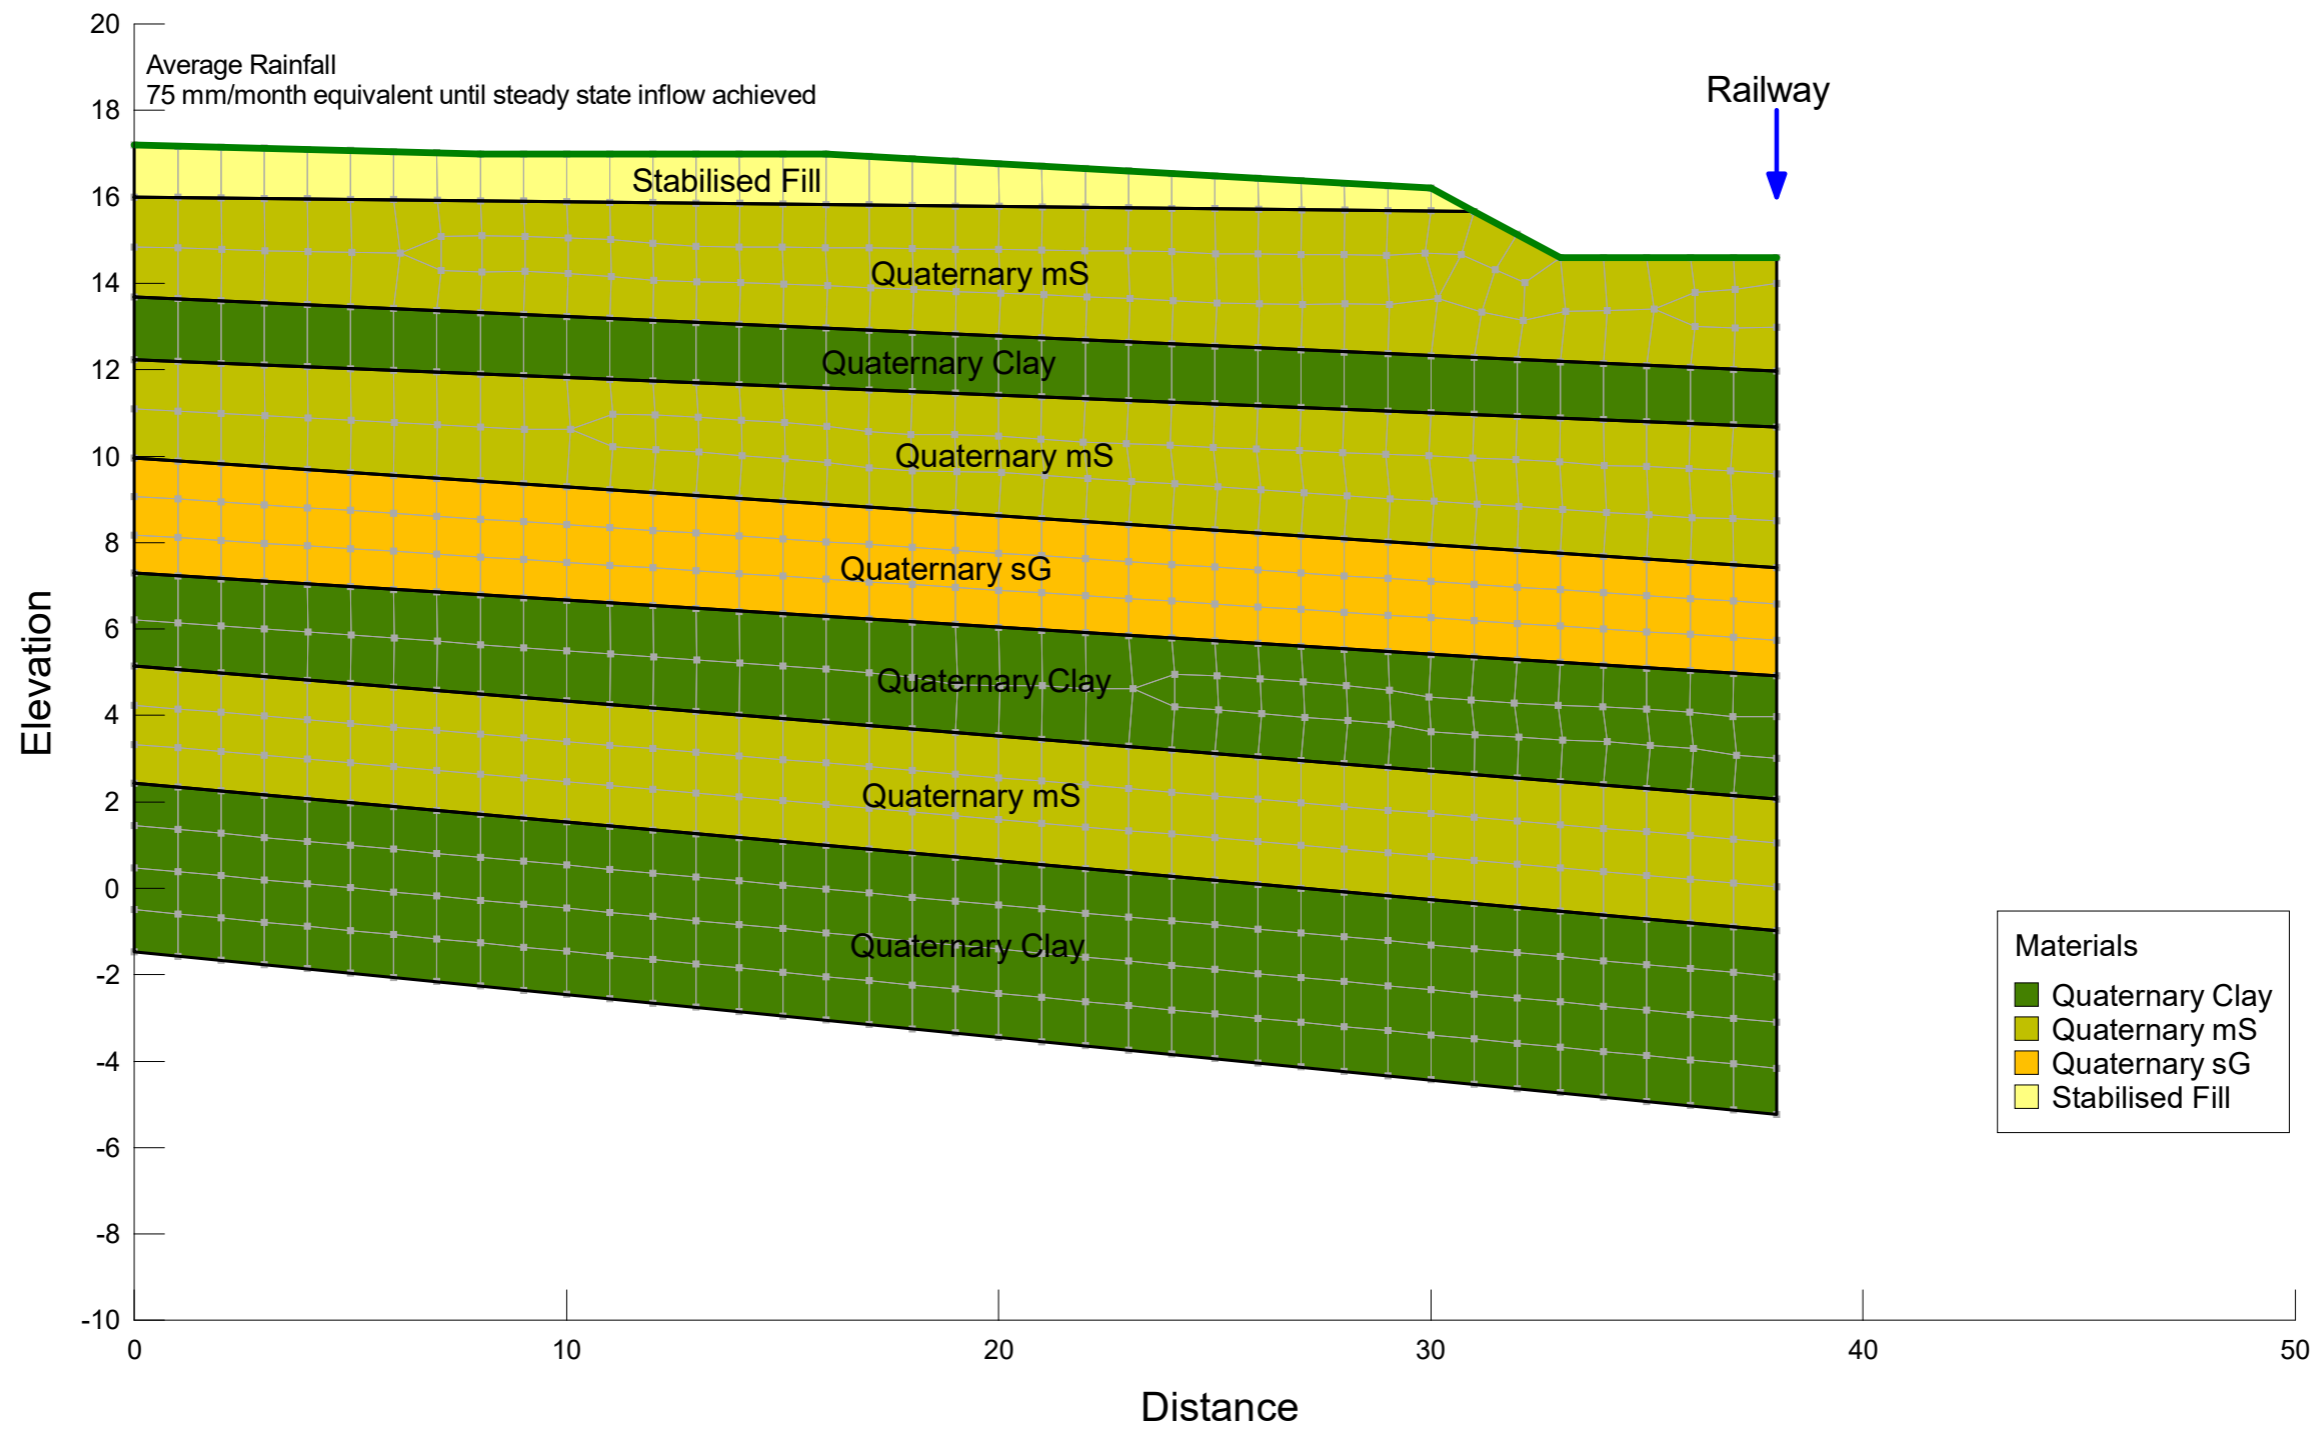
- Quaternary Clay
- Quaternary mS
- Quaternary sG
- Stabilised Fill

Slope Stability 1 - Railway	
Profile D Average Conditions.gsz	
19/06/2020	1:175
