Phase 1: Desk Study

I'Anson Site, Dalton Industrial Estate

I'Anson Bros. Ltd.

S190224

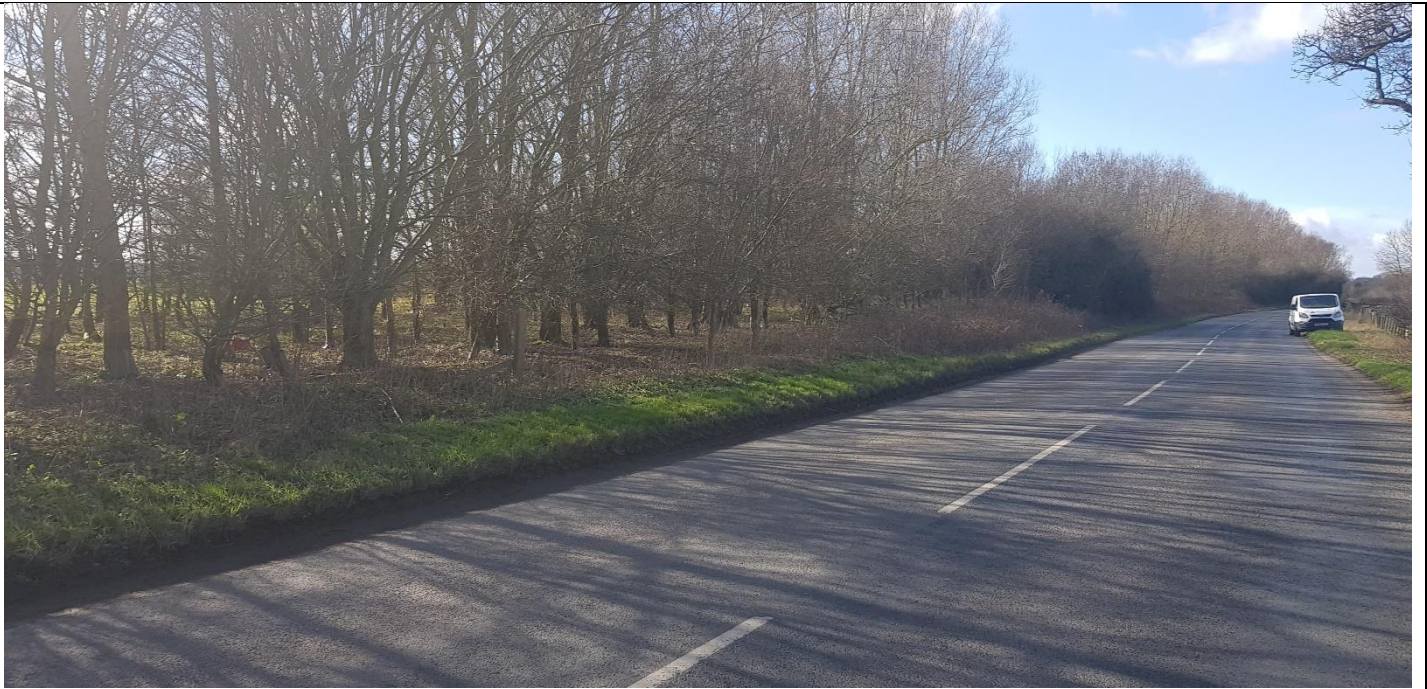
Figure 4: View looking west along the road to the north of the site.

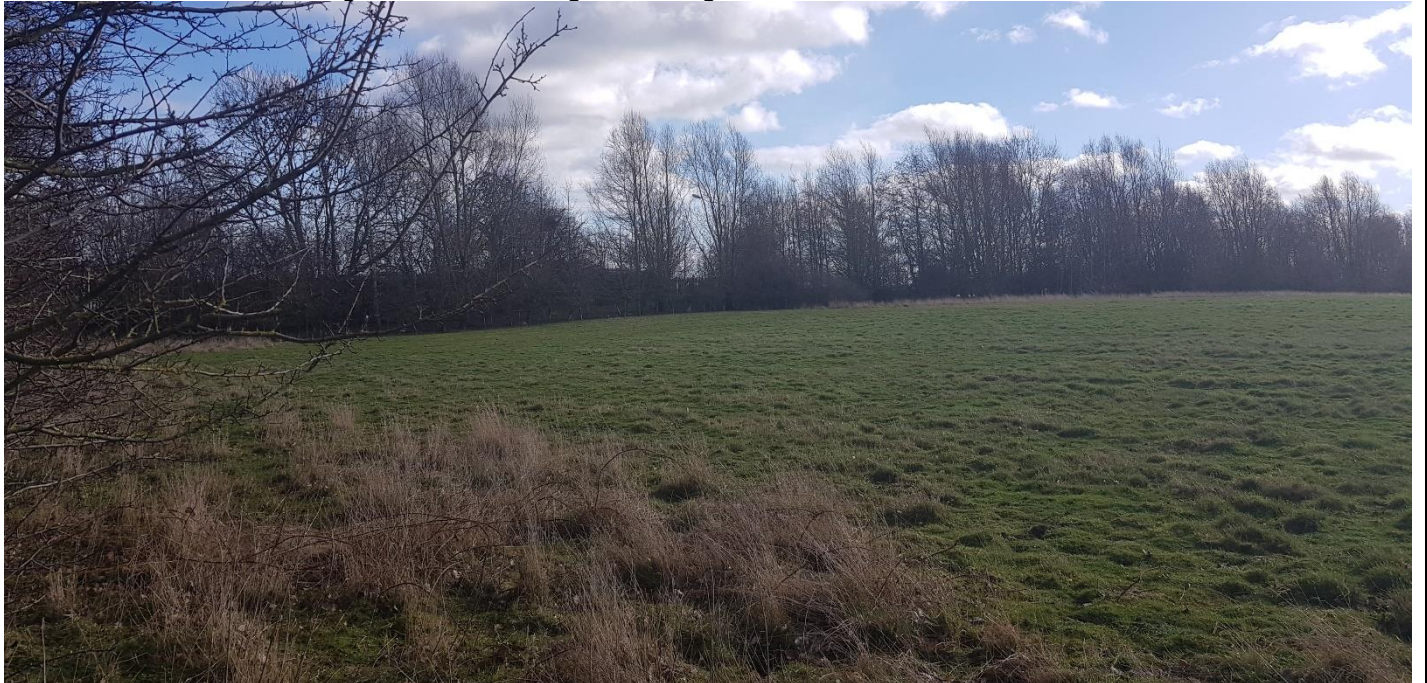
Figure 5: View looking across the site towards the east.

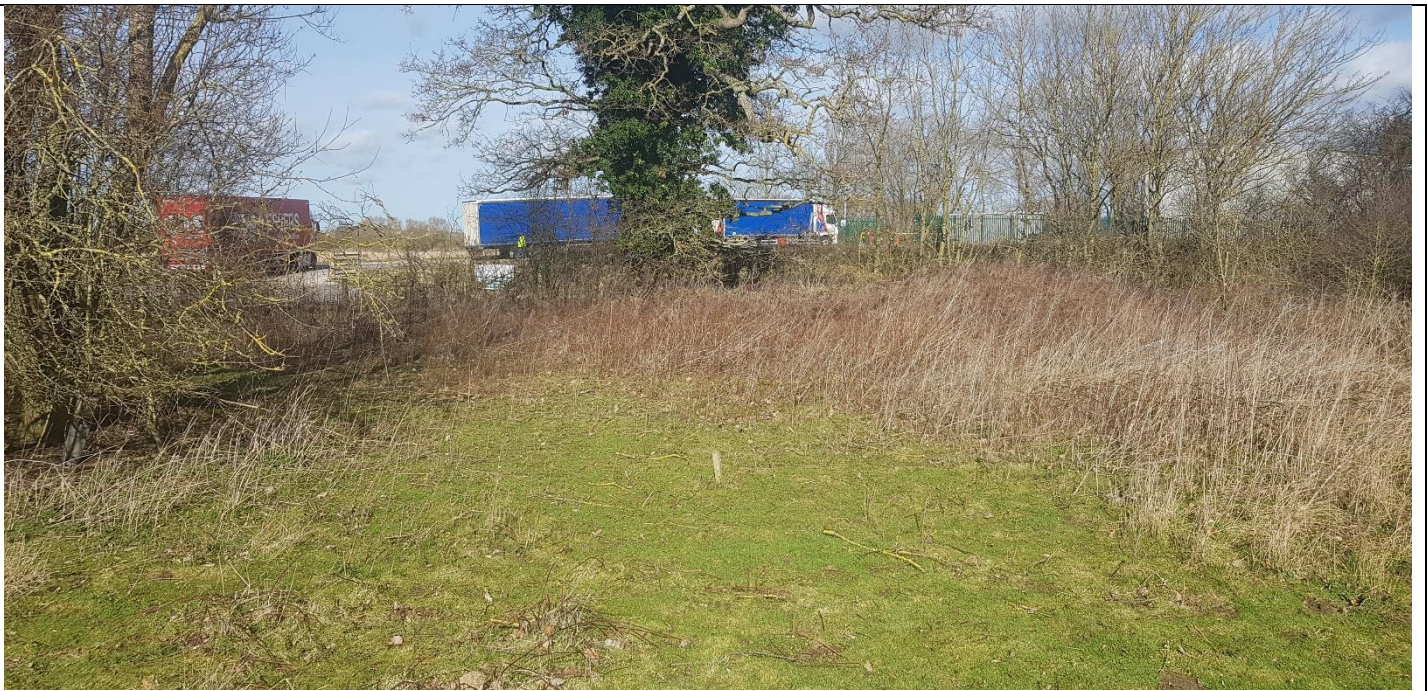
Figure 6: View looking north through the site.

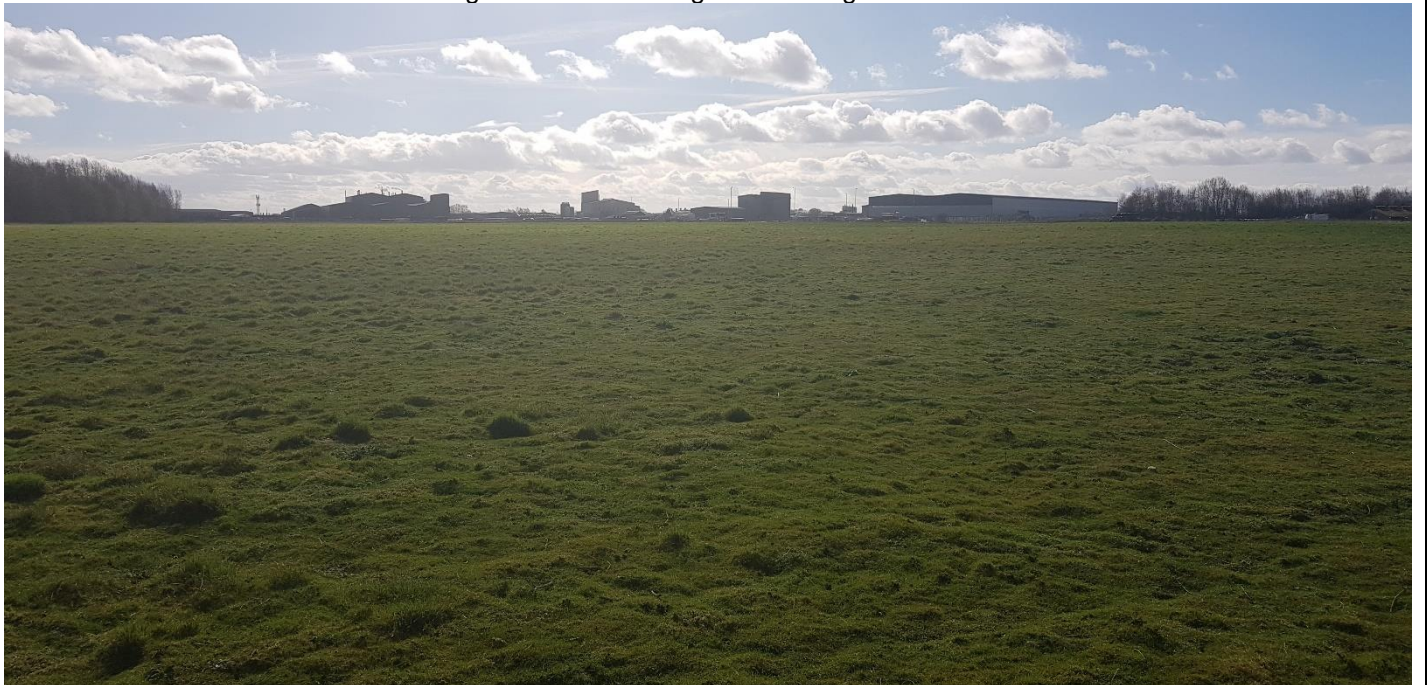
Figure 7: View looking south through the site.
